From: [Ennis, Gerard](#)
To: [Taylor, Maryanne](#)
Cc: [Pelton, Jason M \(DEC\)](#); [O'Rourke, Daniel](#); [Frantz, Aaron](#)
Subject: RE: Recharge Basin Question
Date: Wednesday, September 15, 2021 1:53:13 PM
Attachments: [image002.png](#)
[image003.png](#)
[image004.png](#)
[NC Basin 253.pdf](#)
[NC Basin 276.pdf](#)
[NC Basin 185.pdf](#)
[NC Basin 182.pdf](#)
[NC Basin 335.pdf](#)

Following your request for information on several Nassau County Recharge basins (146, 182, 185, 276, 253, 317, 335), I would like to provide some preliminary data as it relates to basin construction, capacity and available volume. A site visit was made to each location in early spring of 2021. Basin maps/details have been attached where available. For reference, the definitions for available volume vs. required volume used by NC are as follows:

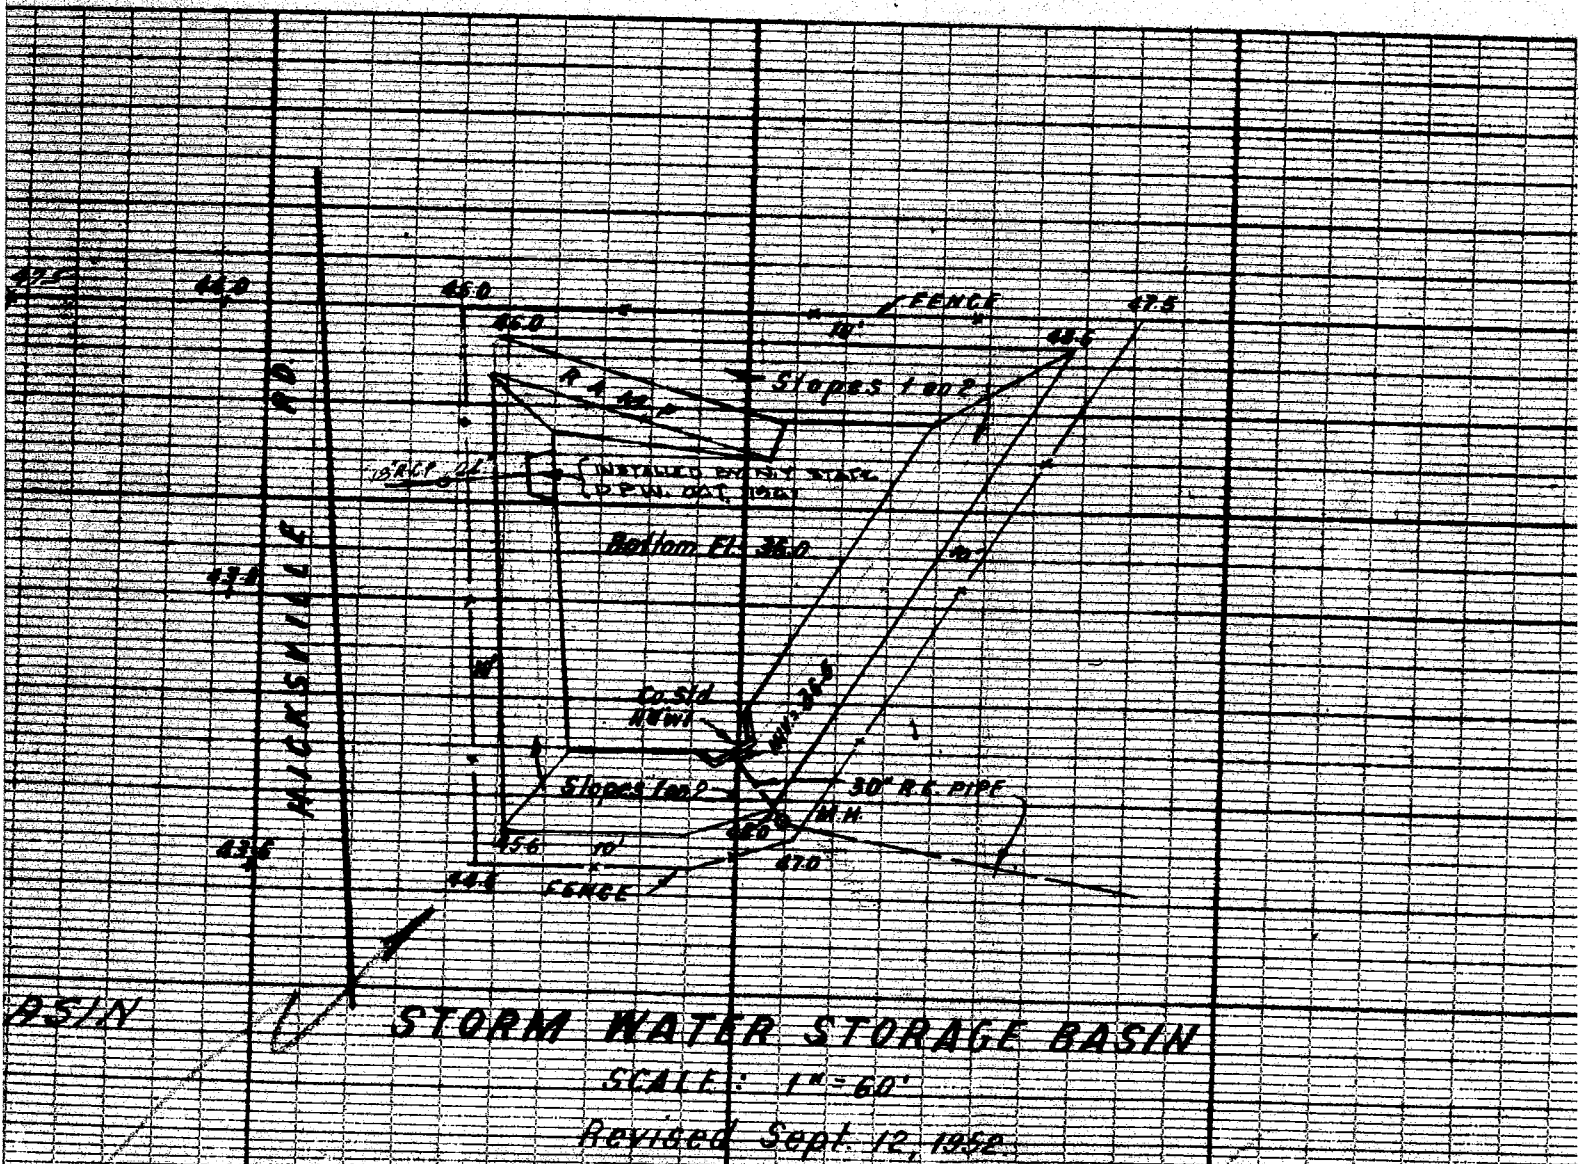
Basin #182

Available Volume: 112,000ft³

Required Volume: 125,000ft³

The basin is slightly undersized based on the design calculations but was dry at the time of the visit.
