**2007 FIVE-YEAR
REVIEW FOR SITES 1, 2, AND 3**

**NWIRP BETHPAGE
Bethpage, New York**

**Naval Facilities Engineering Command
Mid-Atlantic**

APRIL 2008

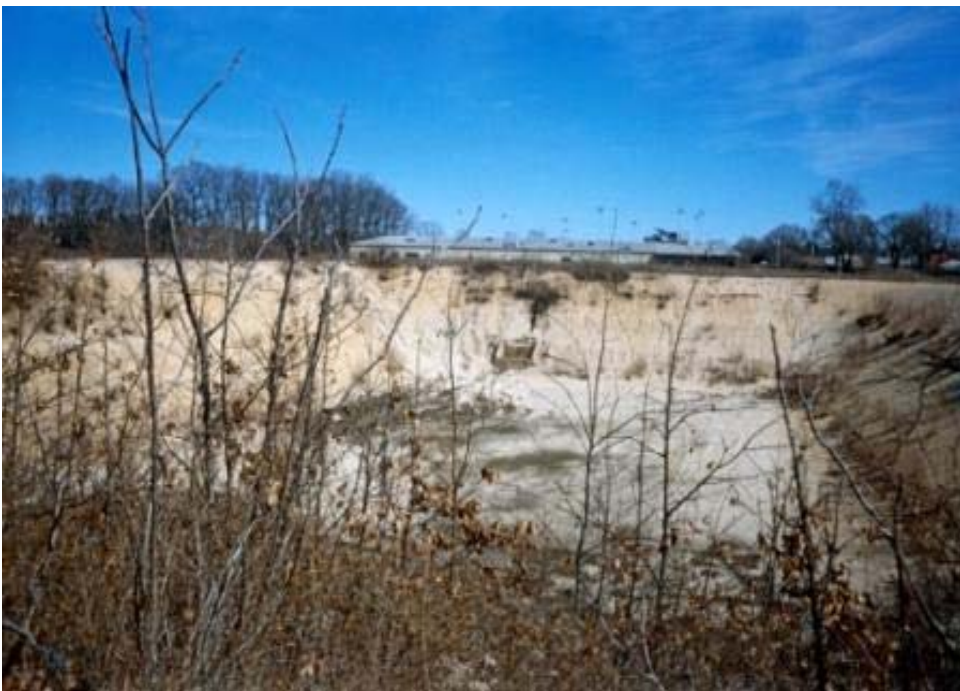
Some erosion was noted within the recharge basins. At this time, the erosion has not extended to soil cover at the top of the basins. Continued monitoring, and if required repair, of the erosion needs to be conducted to ensure that contaminated soils do not become exposed.

Photo 8 –Site 2, Southeast Recharge Basin, western portion of the basin looking east

2.	Cracks <i>N/A</i> Lengths _____ Widths _____ Remarks _____	Location shown on site map Depths _____	Cracking not evident
3.	Erosion Areal extent <i>20x40 feet</i> Remarks <i>Erosion noted on eastern wall of Southeastern basin. Erosion being monitored.</i>	Location shown on site map Depth <i>2 feet</i>	Erosion not evident

9.	Slope Instability	Slides Location shown on site map	No evidence of slope instability
	Areal extent <u>20x40 feet</u>		
	Remarks <u>Side walls of recharge basins exhibit some erosion due to broken inlet pipe.</u>

1. Continue to monitor the recharge basins for erosion. If the erosion reaches a point that a wall collapse is a concern or erosion of the soil cover occurs, repairs would be needed.
