**2007 FIVE-YEAR  
REVIEW FOR SITES 1, 2, AND 3**

**NWIRP BETHPAGE  
Bethpage, New York**

**Naval Facilities Engineering Command  
Mid-Atlantic**

**APRIL 2008**

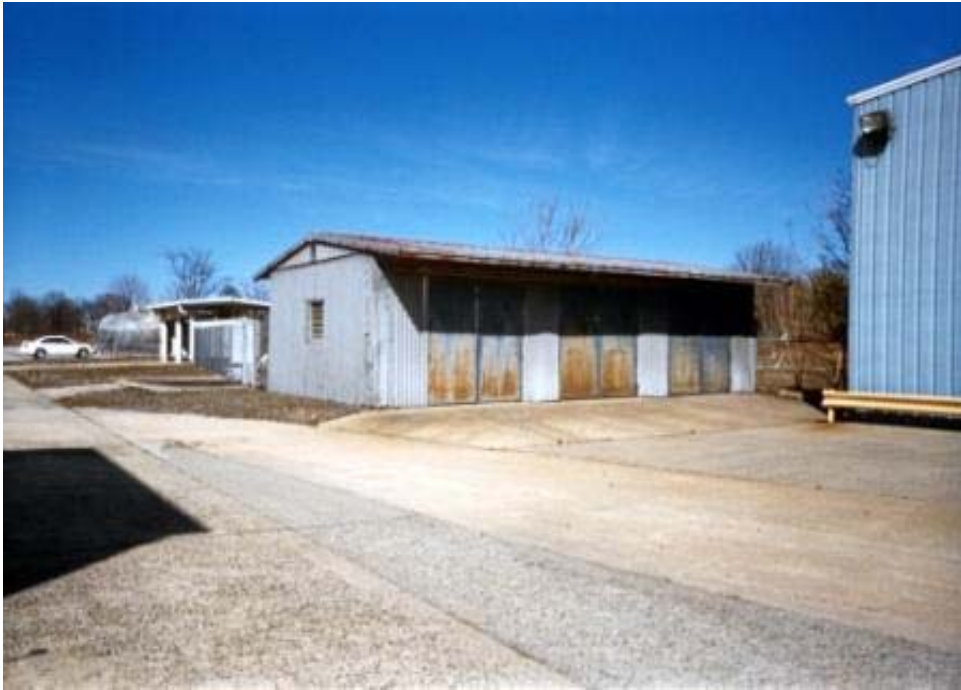
**Photo 1 – Site 1, metal buildings, southwest concrete pad situated in the southwestern portion of the Site, looking northeast.**

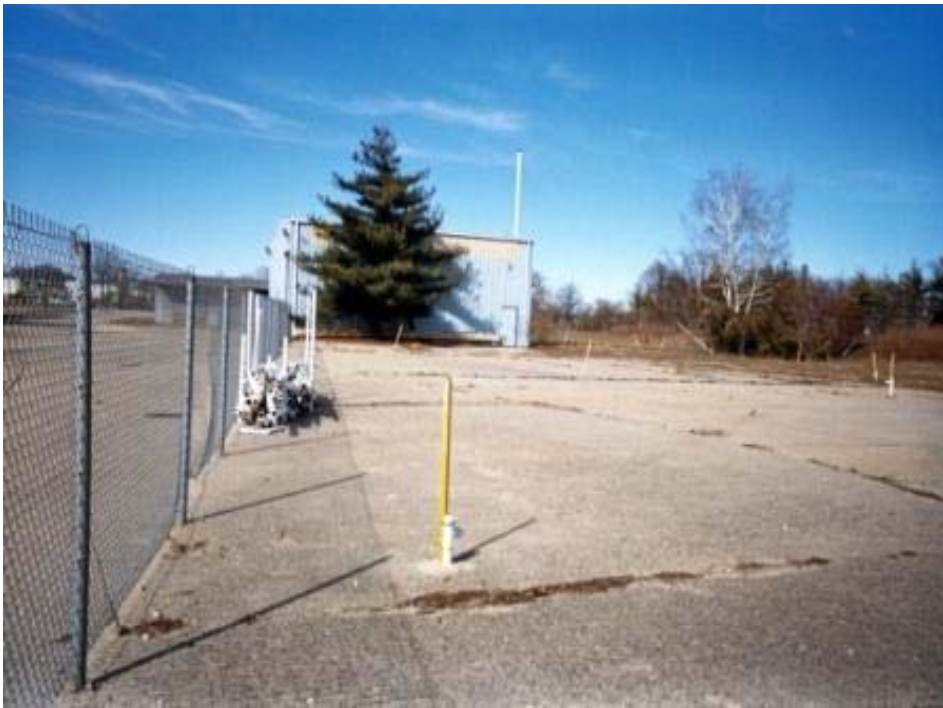
**Photo 2 – Site 1, southwest concrete pad situated in the southwestern portion of the site, looking north**

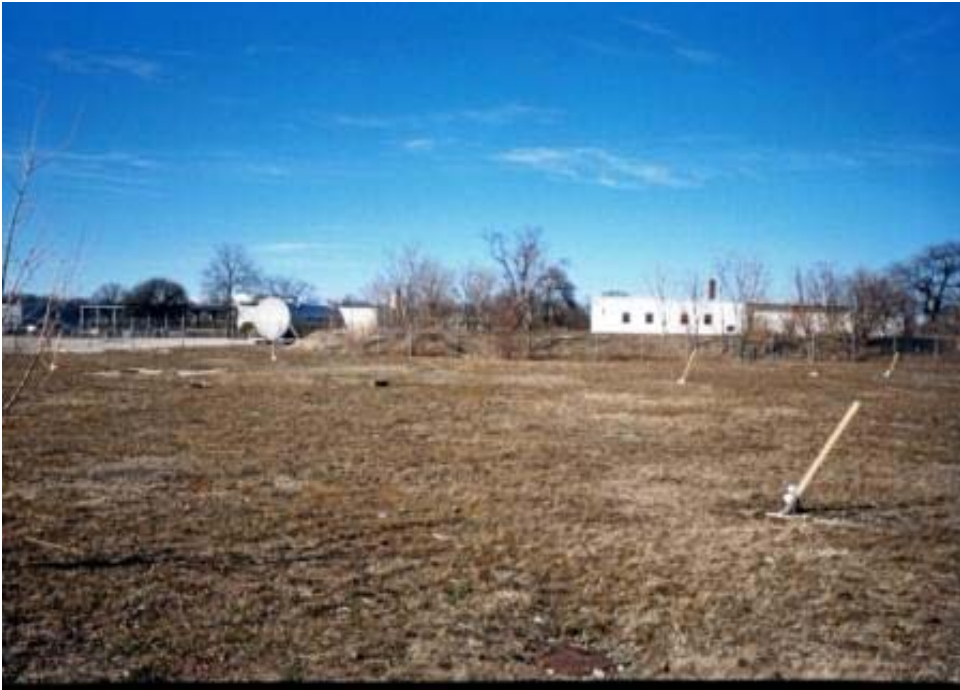
**Photo 3 – Site 1, northern portion of the Site, looking north.**

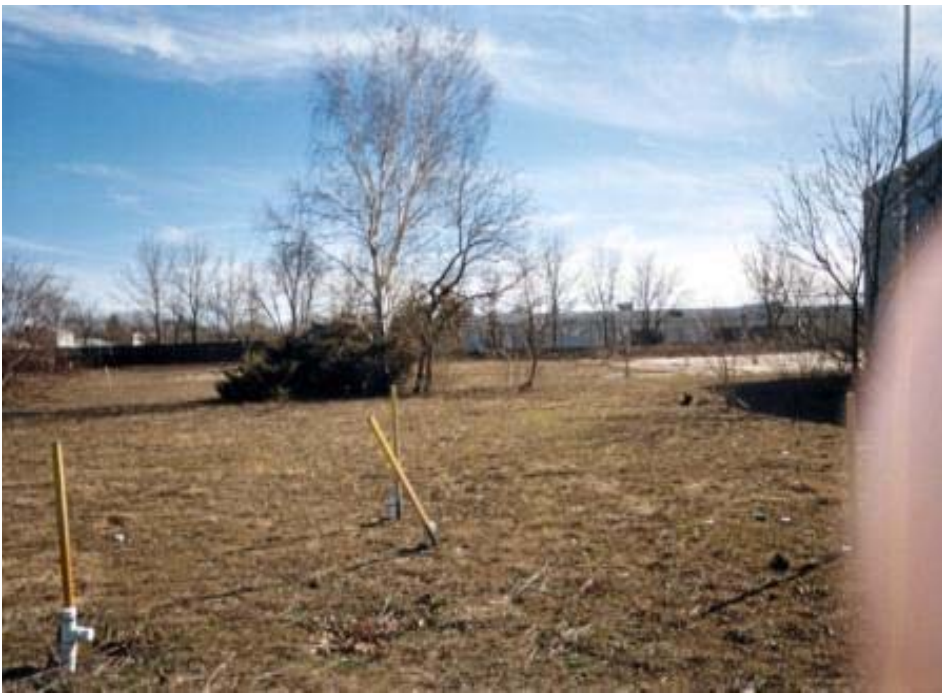
**Photo 4 – Site 1, central portion of the Site, looking south.**

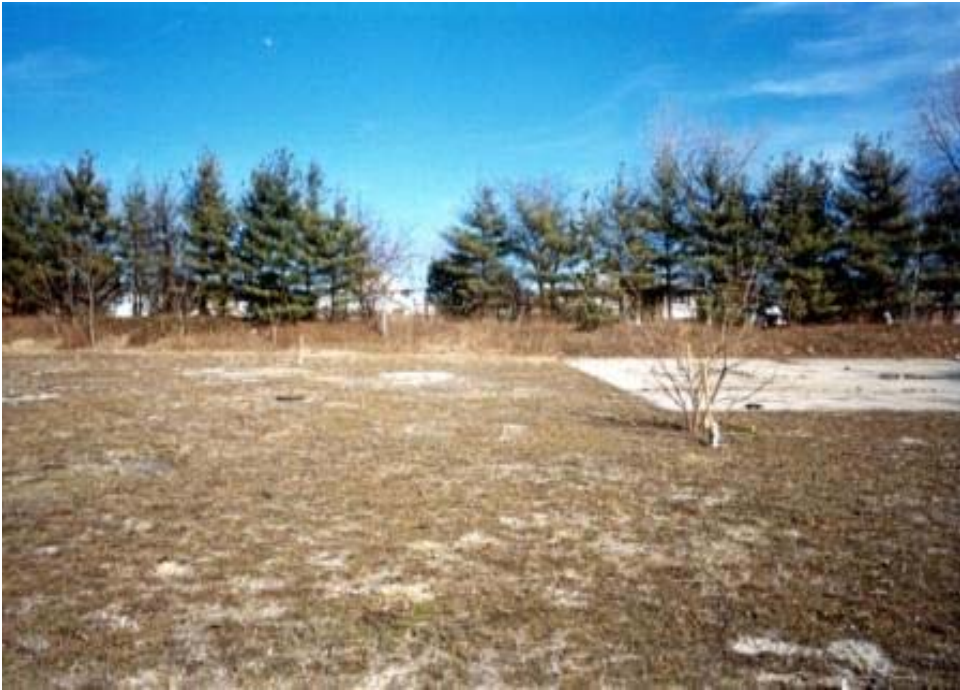
**Photo 5 – Site 1, central portion of the Site, looking east.**

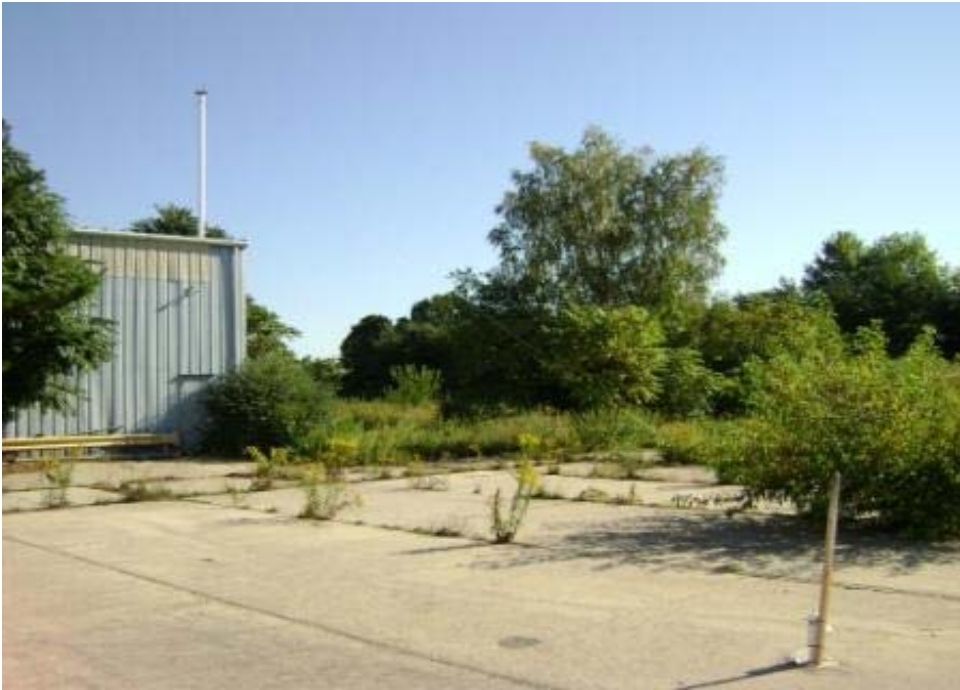
**Photo 7 – Site 1, southwestern portion of the Site, looking northeast.**

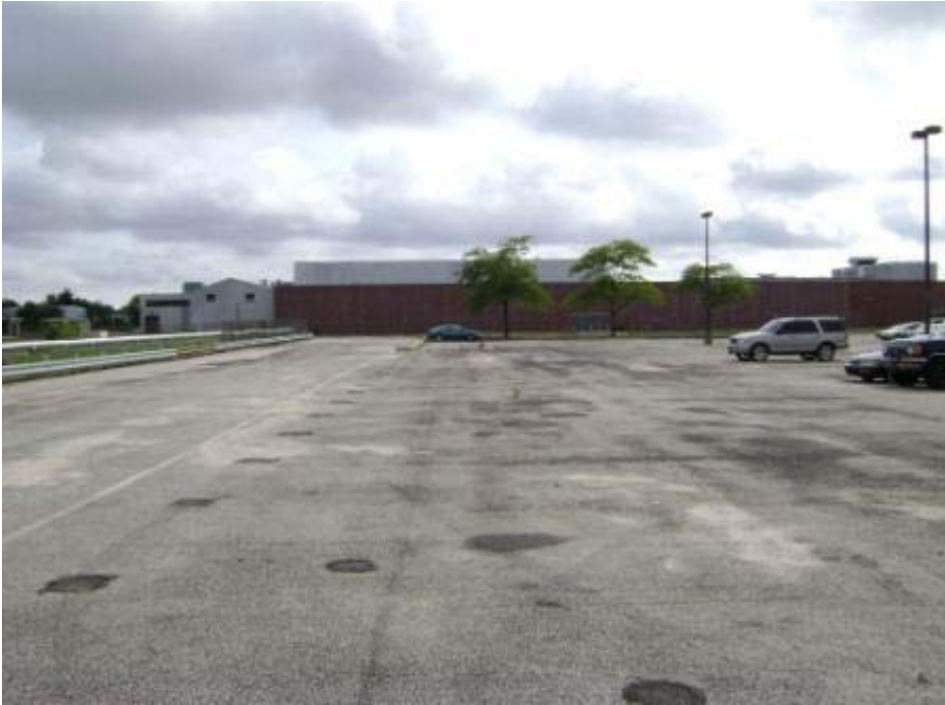
**Photo 11 – Site 3, western portion of Impound Lot 1, looking south.**

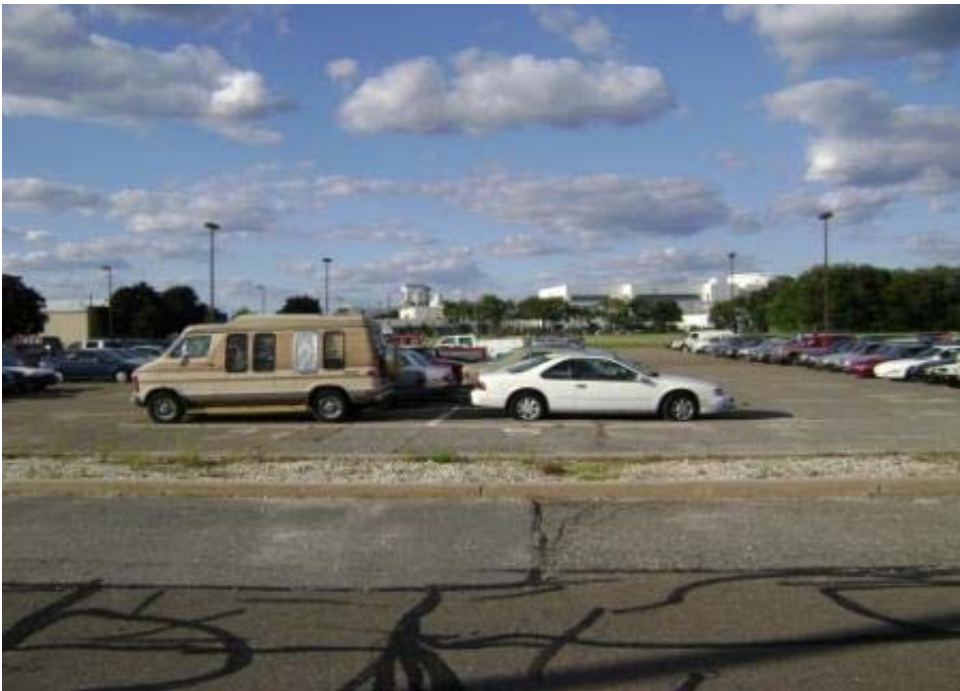
**Photo 12 – Site 3, central portion of Impound Lot 1, looking north.**

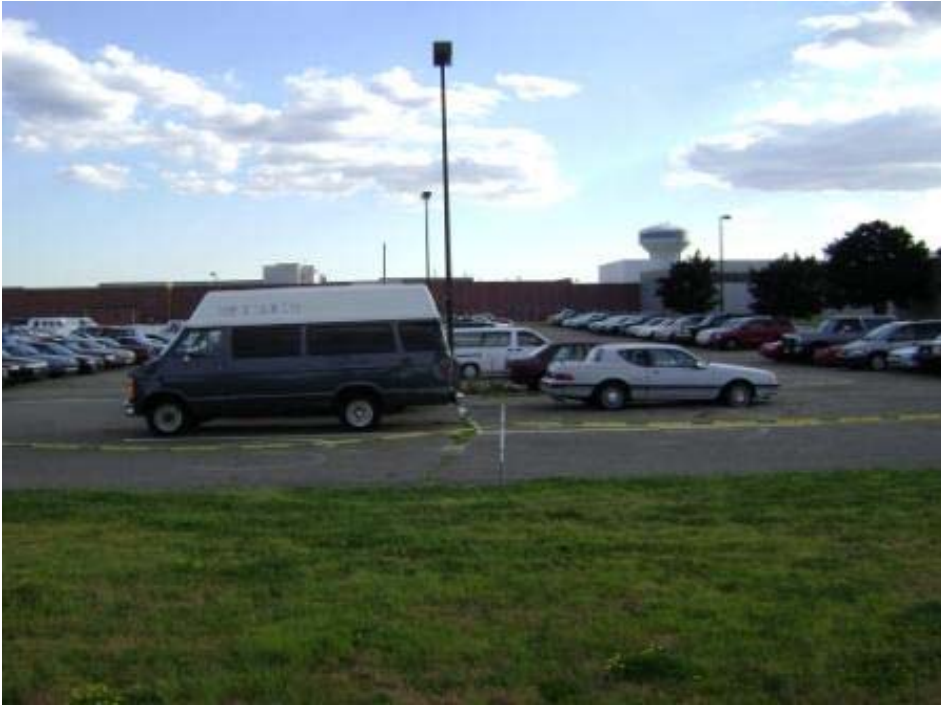
**Photo 13 – Site 3, eastern portion of Impound Lot 1, looking south.**
