Subj: 2007 FIVE-YEAR REVIEW FOR SITE 1 – FORMER DRUM MARSHALLING  
AREA; SITE 2 – RECHARGE BASINS; SITE 3 – SALVAGE STORAGE AREA;  
NAVAL WEAPON INDUSTRIAL RESERVE PLANT (NWIRP) BETHPAGE, NEW  
YORK; EPA ID # NYD002047967

**2007 FIVE-YEAR  
REVIEW FOR SITES 1, 2, AND 3**

**NWIRP BETHPAGE  
Bethpage, New York**

**APRIL 2008**

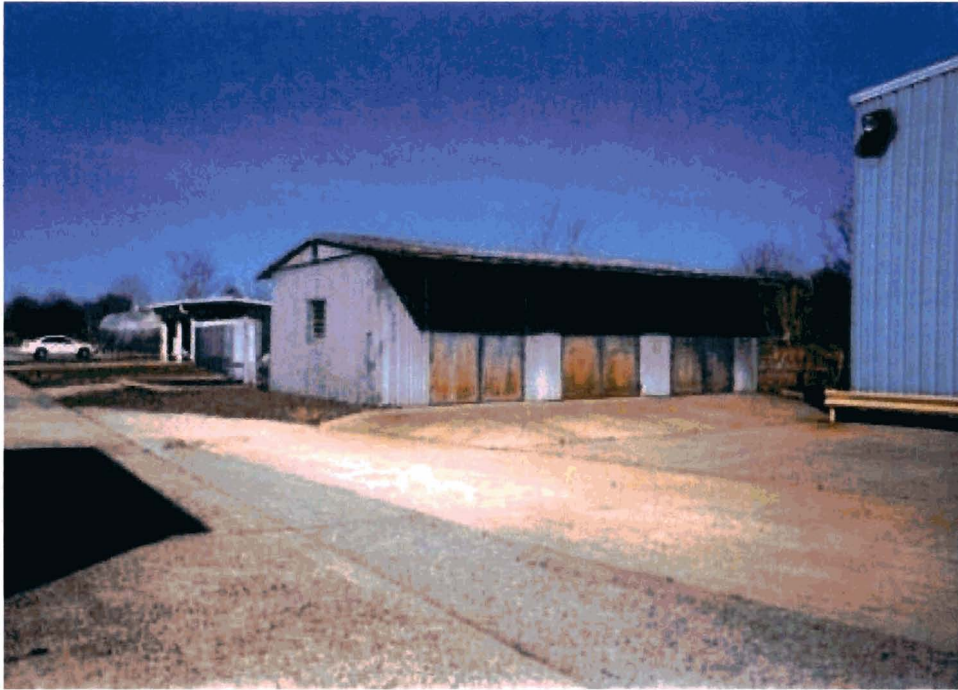
**Photo 1 – Site 1, metal buildings, southwest concrete pad situated in the southwestern portion of the Site, looking northeast.**

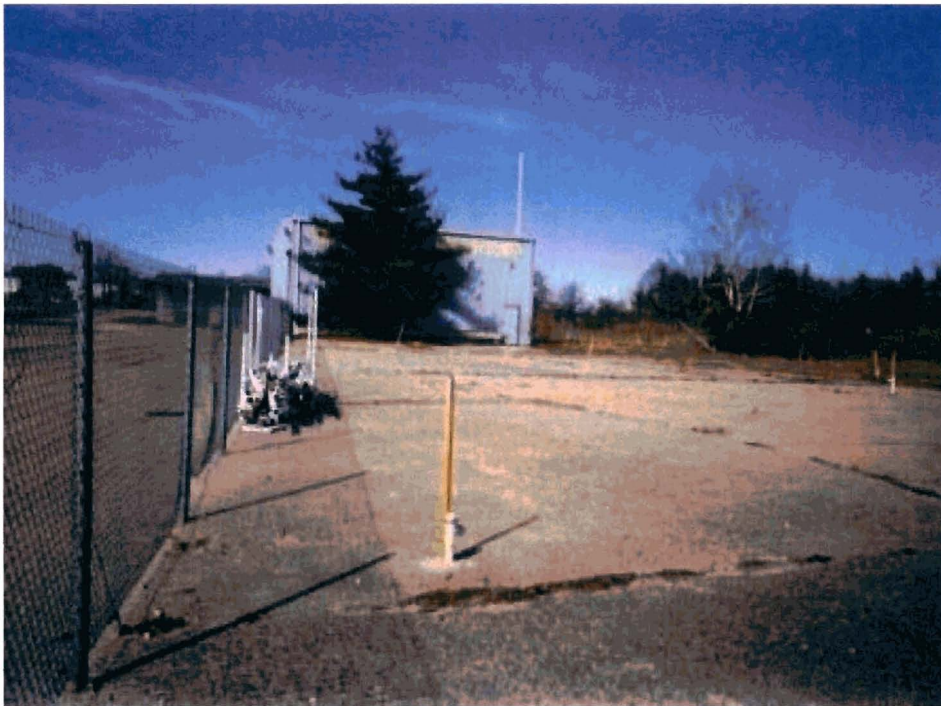
**Photo 2 – Site 1, southwest concrete pad situated in the southwestern portion of the site, looking north**

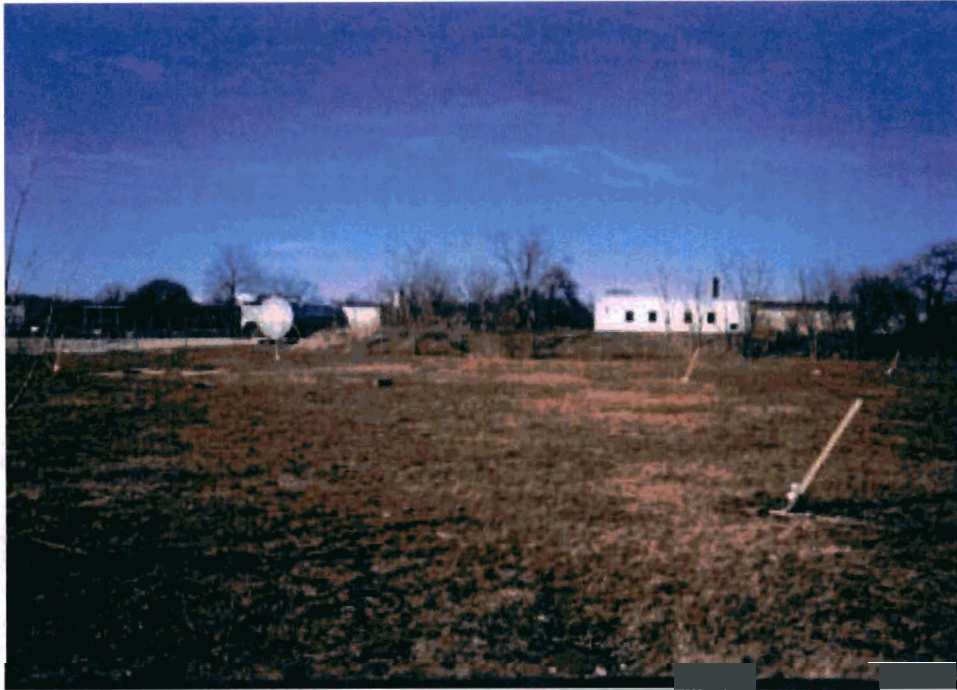
**Photo 3 – Site 1, northern portion of the Site, looking north.**

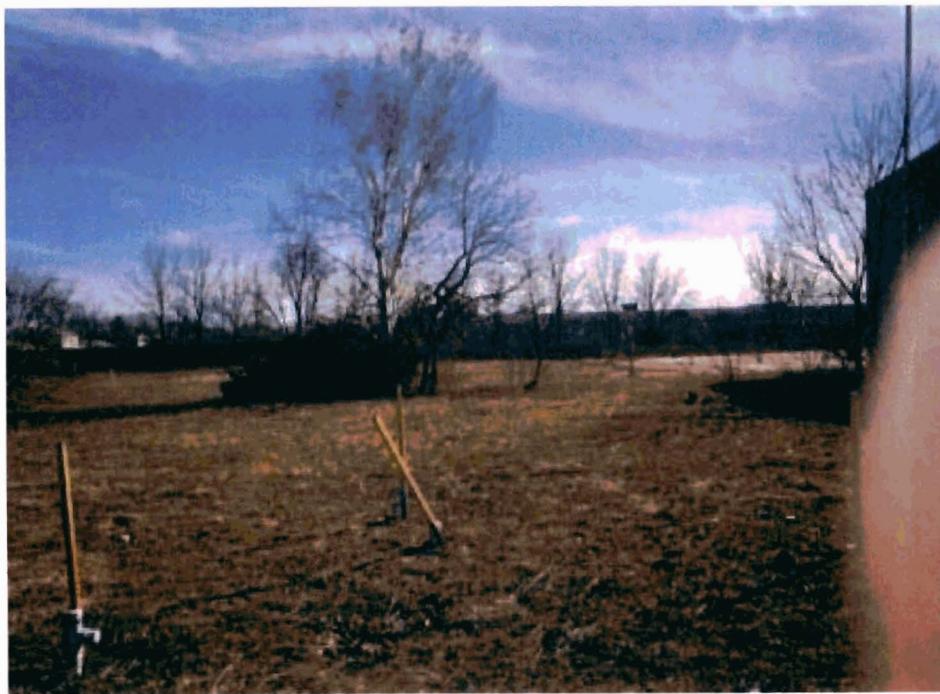
**Photo 4 – Site 1, central portion of the Site, looking south.**

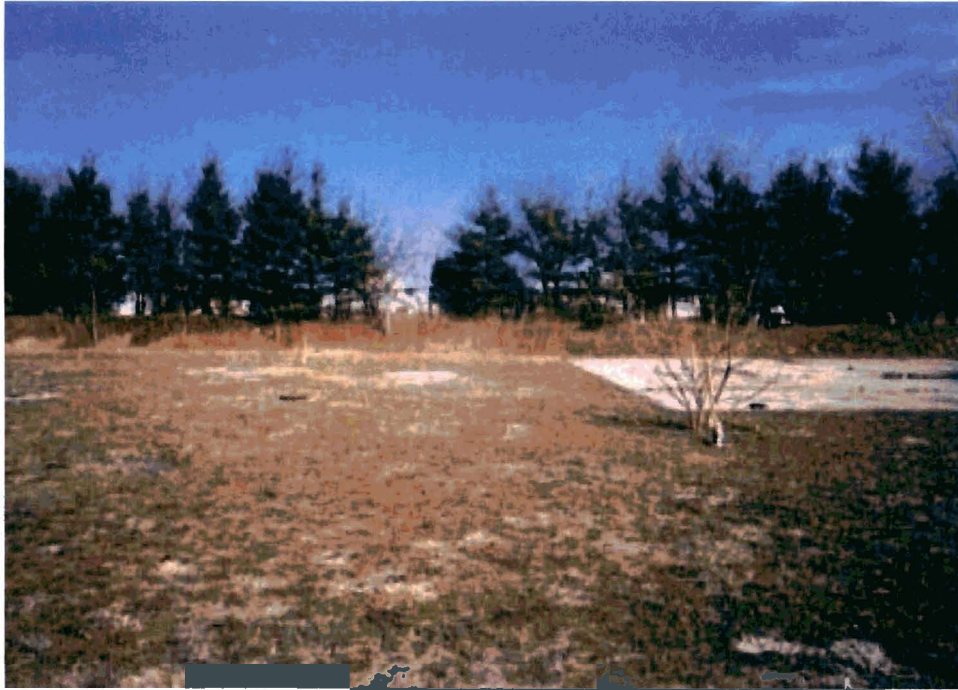
**Photo 5 – Site 1, central portion of the Site, looking east.**

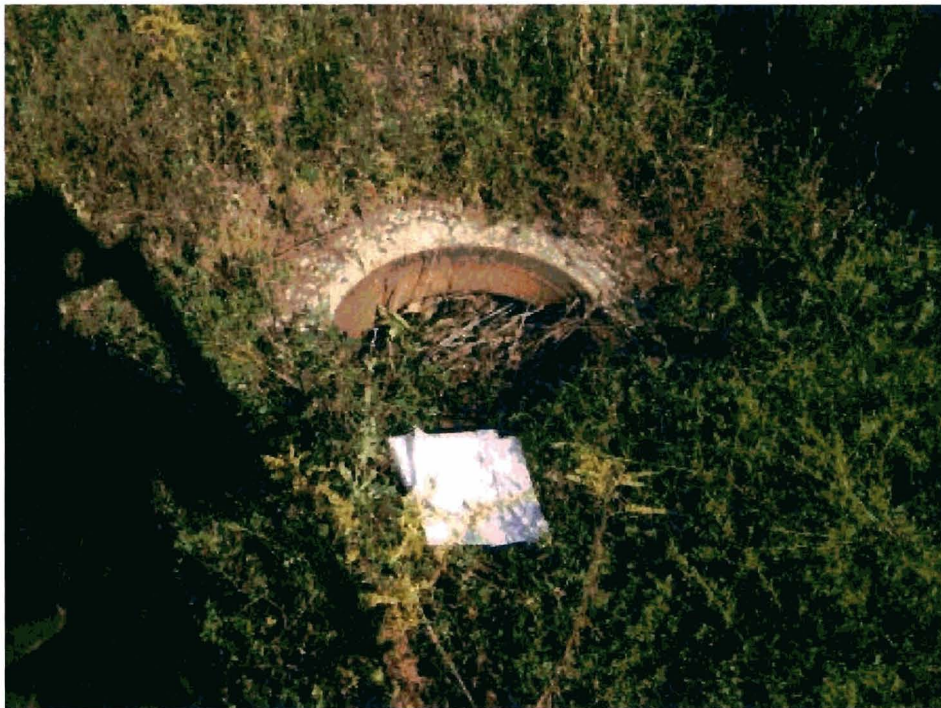
**Photo 6 – Site 1, former cesspool.**

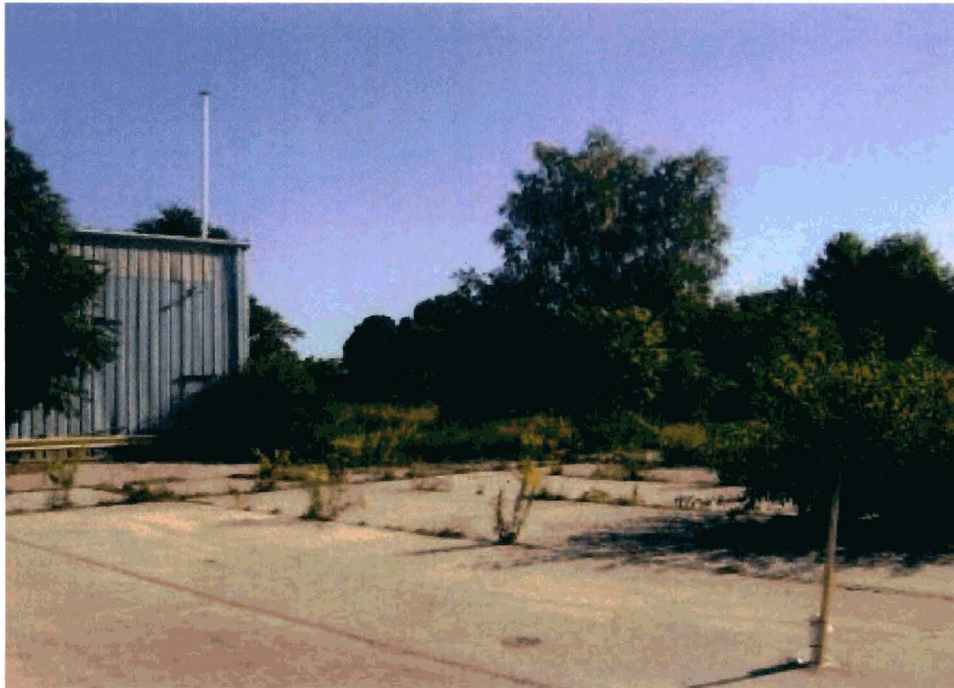
**Photo 7 – Site 1, southwestern portion of the Site, looking northeast.**

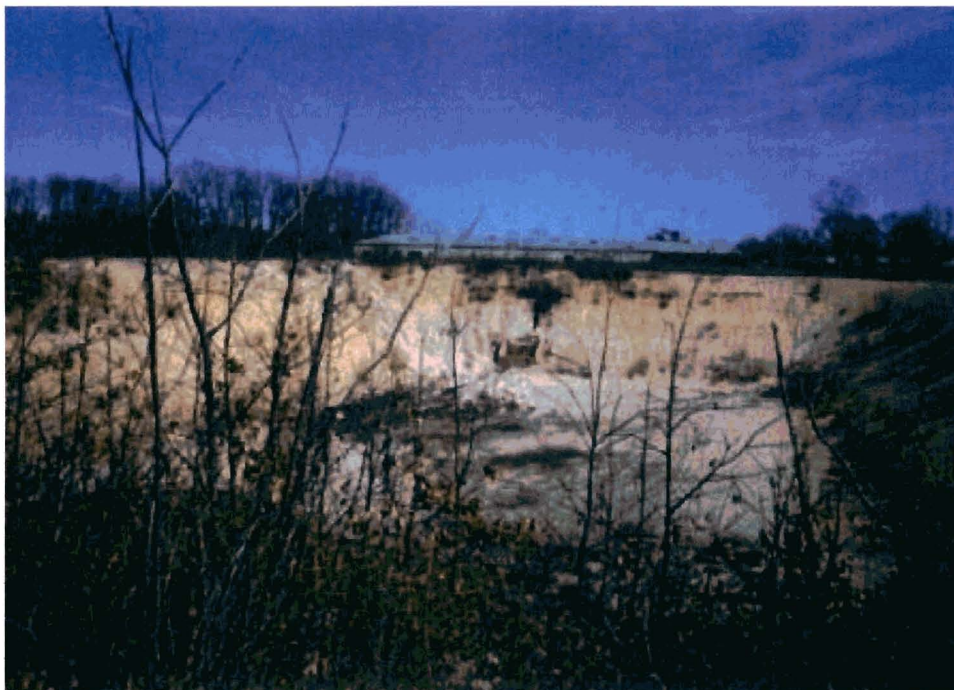
Some erosion was noted within the recharge basins. At this time, the erosion has not extended to soil cover at the top of the basins. Continued monitoring, and if required repair, of the erosion needs to be conducted to ensure that contaminated soils do not become exposed.

**Photo 8 – Site 2, Southeast Recharge Basin, western portion of the basin looking east**

1. Continue to monitor the recharge basins for erosion. If the erosion reaches a point that a wall collapse is a concern or erosion of the soil cover occurs, repairs would be needed.

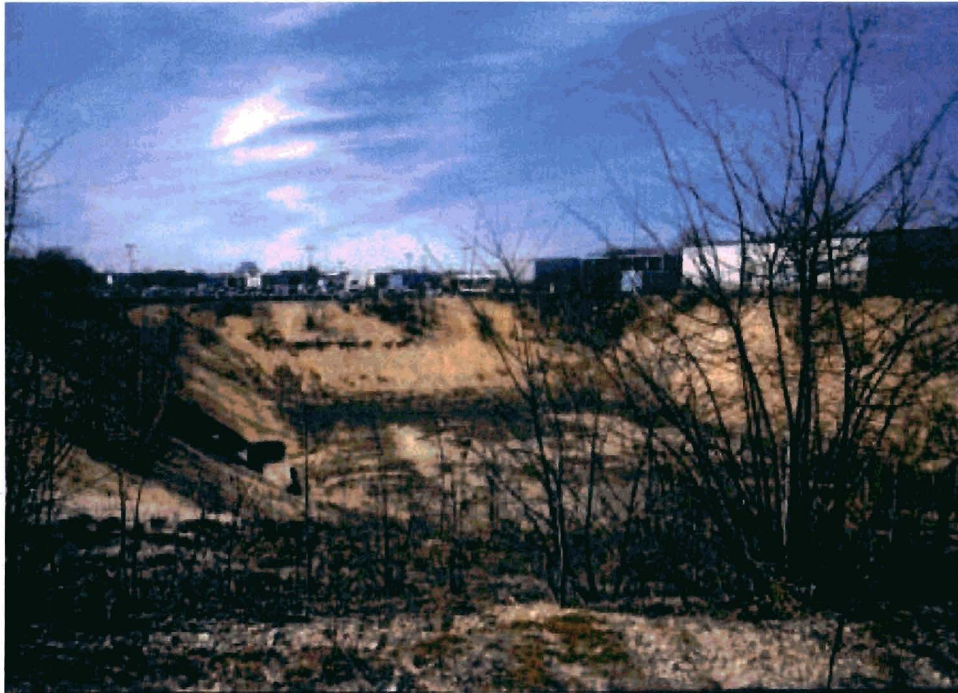
**Photo 9 – Site 2, Southwest Recharge Basin, eastern portion of the basin looking west.**

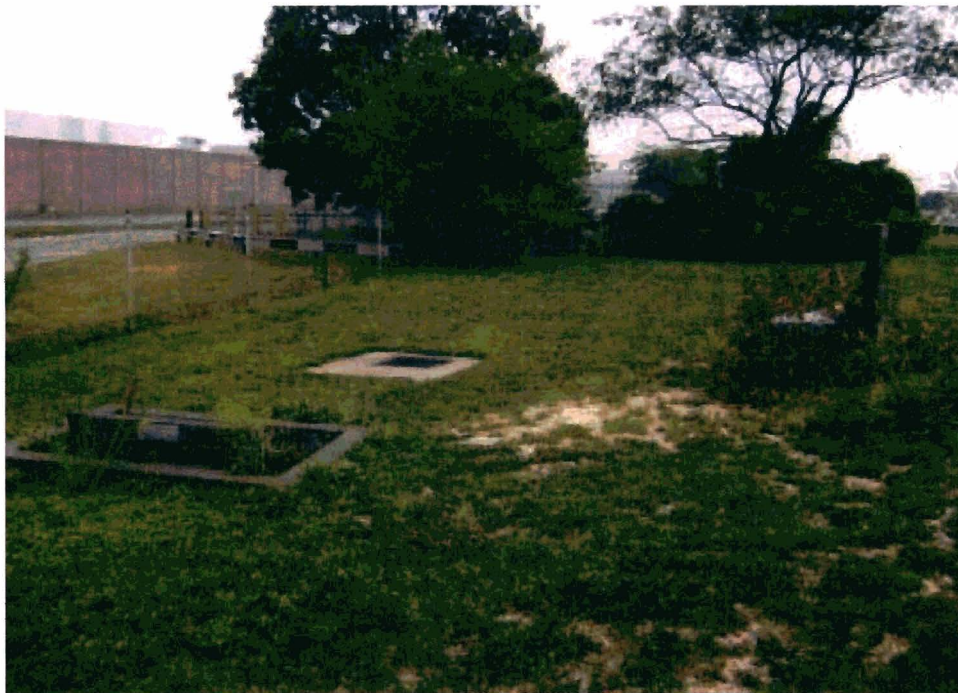
**Photo 10 – Site 2, storm water diverter situated in the southeast portion of the Site.**

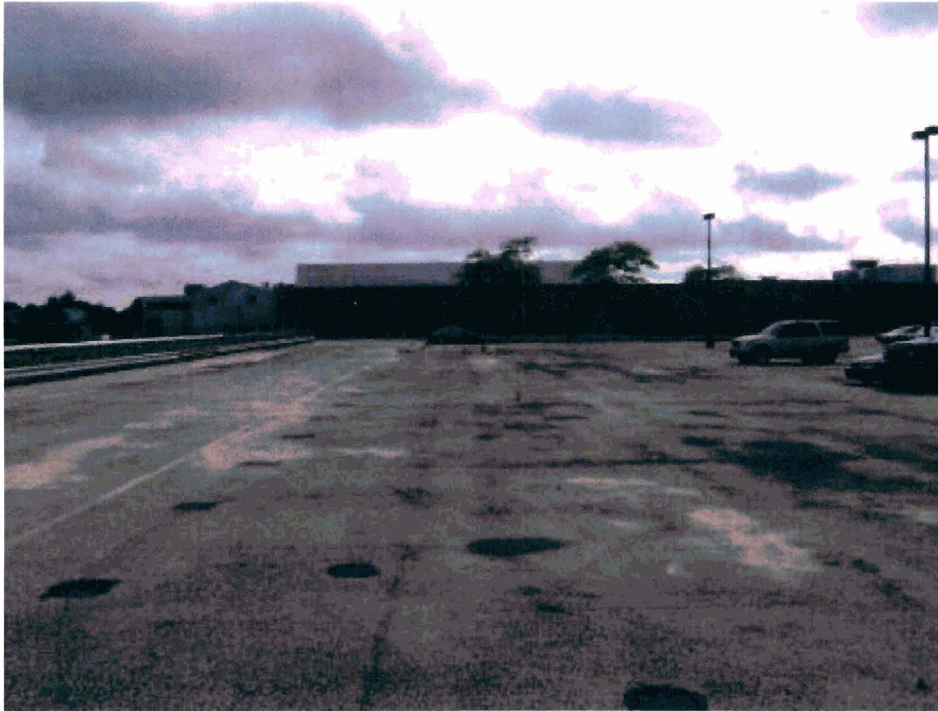
**Photo 11 – Site 3, western portion of Impound Lot 1, looking south.**

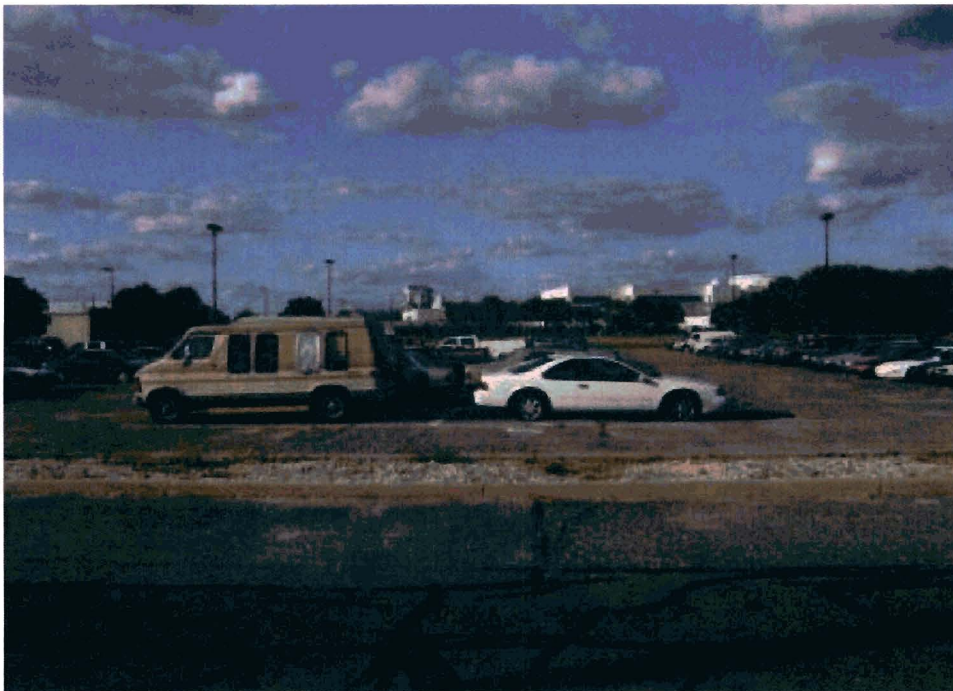
**Photo 12 –Site 3, central portion of Impound Lot 1, looking north.**

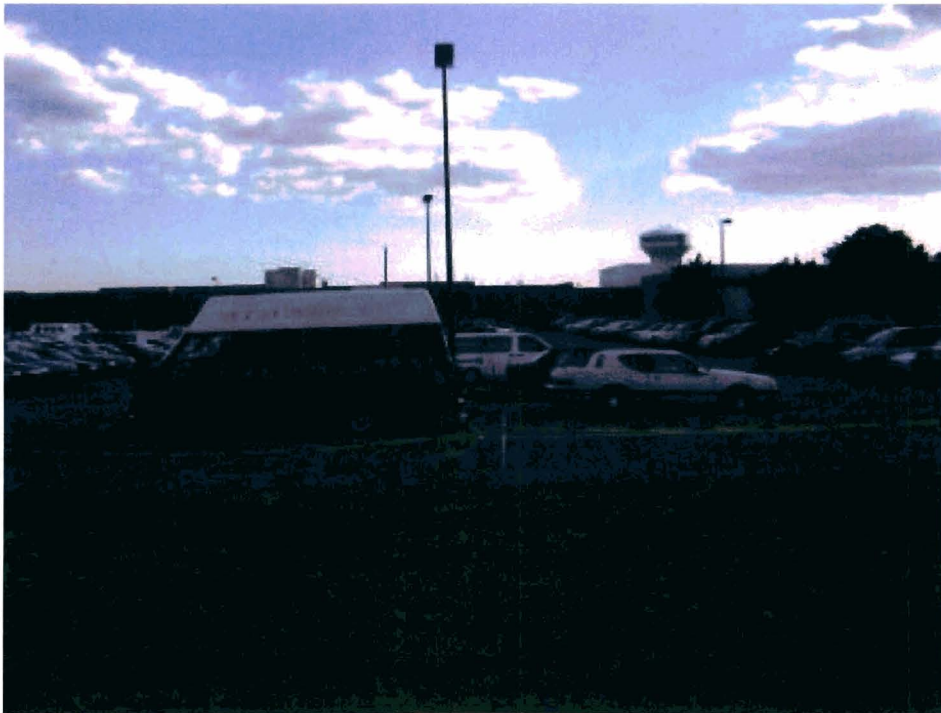
**Photo 13 – Site 3, eastern portion of Impound Lot 1, looking south.**
