**2007 FIVE-YEAR
REVIEW FOR SITES 1, 2, AND 3**

**NWIRP BETHPAGE
Bethpage, New York**

**Naval Facilities Engineering Command
Mid-Atlantic**

APRIL 2008

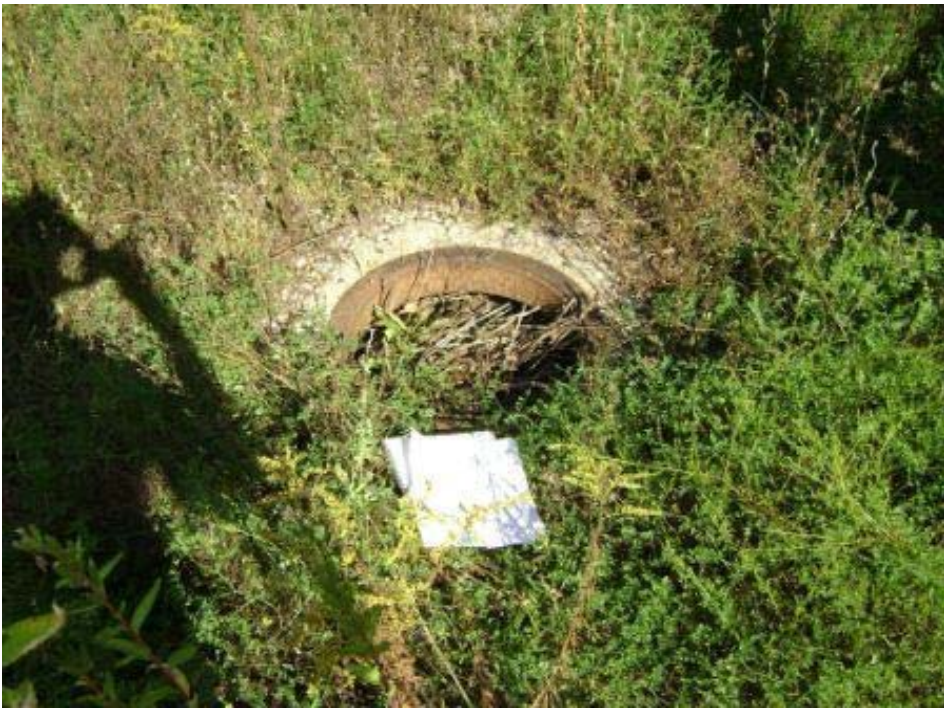
Photo 6 –Site 1, former cesspool.

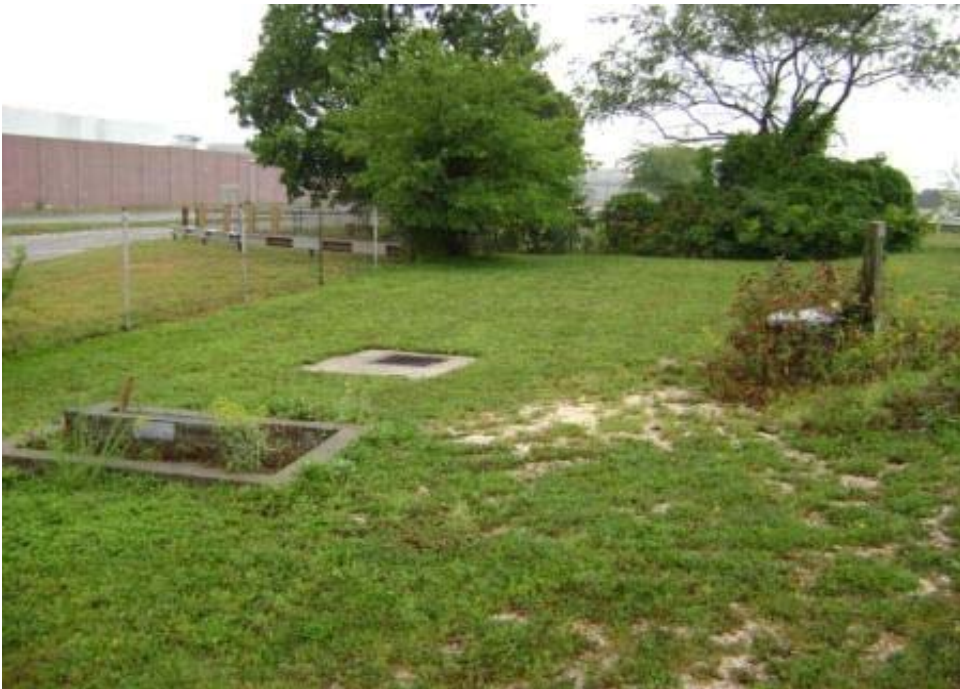
Photo 10 –Site 2, storm water diverter situated in the southeast portion of the Site.
