Subj: 2008 FIVE-YEAR REVIEW FOR SITE 1 – FORMER DRUM MARSHALLING AREA;  
SITE 2 – RECHARGE BASINS; SITE 3 – SALVAGE STORAGE AREA; NAVAL  
WEAPON INDUSTRIAL RESERVE PLANT (NWIRP) BETHPAGE, NEW YORK; EPA  
ID # NYD002047967

**2008 FIVE-YEAR  
REVIEW FOR SITES 1, 2, AND 3**

**NWIRP BETHPAGE  
Bethpage, New York**

**DECEMBER 2008**

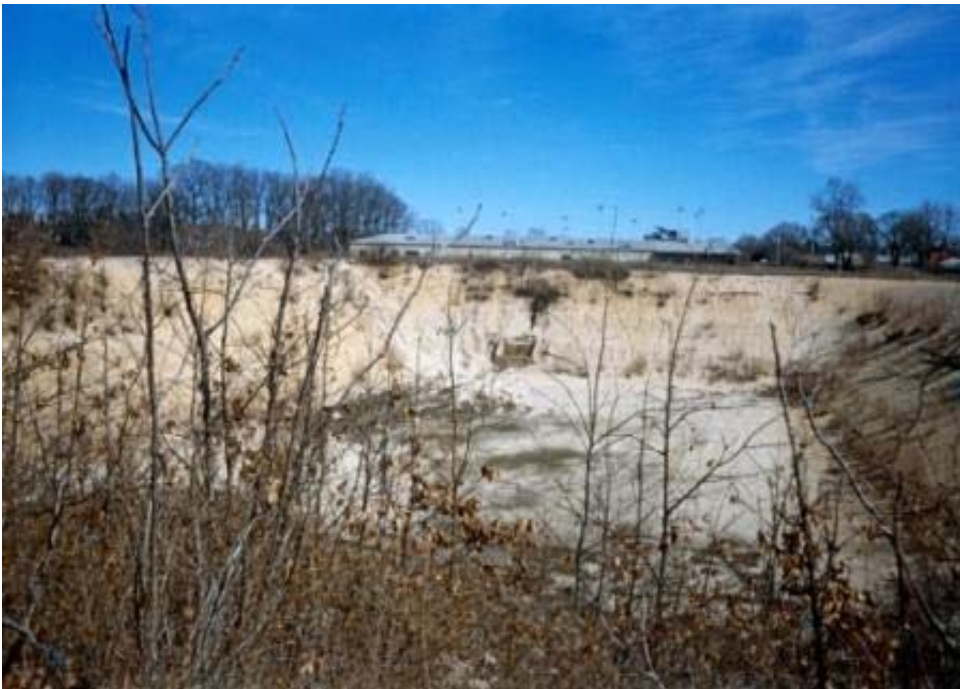
Some erosion was noted within the recharge basins. At this time, the erosion has not extended to soil cover at the top of the basins. Continued monitoring, and if required repair, of the erosion needs to be conducted to ensure that contaminated soils do not become exposed.

**Photo 8 –Site 2, Southeast Recharge Basin, western portion of the basin looking east**

1. Continue to monitor the recharge basins for erosion. If the erosion reaches a point that a wall collapse is a concern or erosion of the soil cover occurs, repairs would be needed.

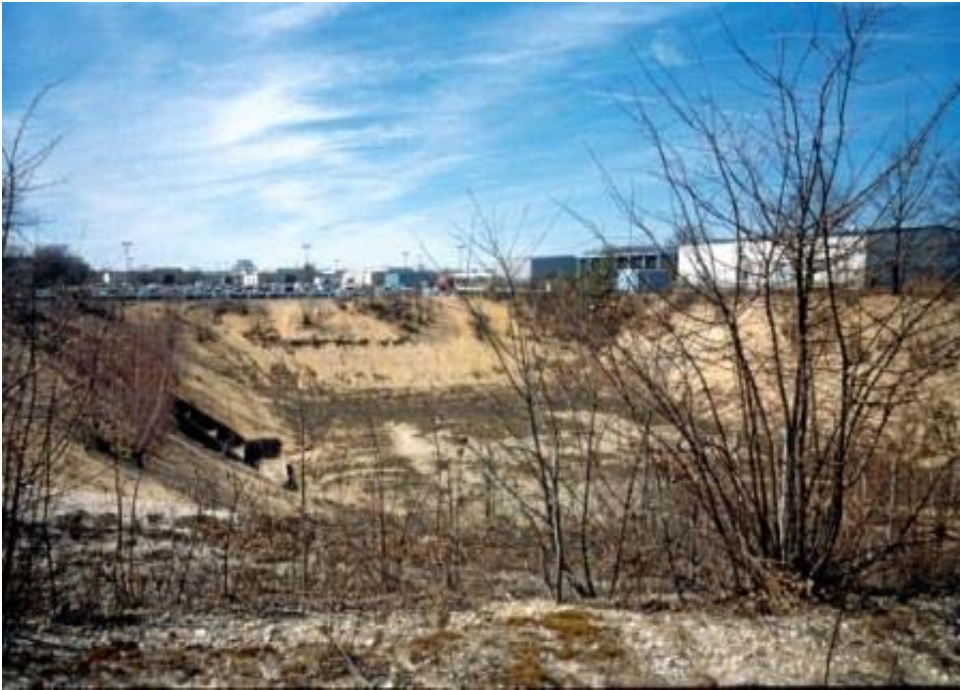
**Photo 9 – Site 2, Southwest Recharge Basin, eastern portion of the basin looking west.**

2.	<b>Cracks</b> <i>N/A</i> Lengths _____ Remarks _____	Widths _____ Depths _____ Location shown on site map	Cracking not evident
3.	<b>Erosion</b> Areal extent <i>20x40 Feet</i> Remarks <i>Erosion noted on certain wall of Southwestern basin. Erosion being monitored.</i>	Location shown on site map Depth <i>2 Feet</i>	Erosion not evident

9.	<b>Slope Instability</b> Slides	Location shown on site map	No evidence of slope instability
	Areal extent <u>20x40 feet</u>		
	Remarks <u>Side walls of rock-j basin exhibit some erosion due to broken inlet pipe.</u>		
<b>B. Benches</b> Applicable <u>(N/A)</u>			
(Horizontally constructed mounds of earth placed across a steep landfill side slope to interrupt the slope in order to slow down the velocity of surface runoff and intercept and convey the runoff to a lined channel.)
