**Subject:** **Annual LUC Inspection Report, Sites 1, 2, and 3 — NWIRP Bethpage**

**Date:** 3 June 2014

This memorandum documents the 2013 Annual Land Use Control (LUC) Inspections performed for Naval Weapons Industrial Reserve Plant (NWIRP) Bethpage Sites 1, 2, and 3 on 16 May 2013. These 2013 annual LUC inspections were performed in conjunction with the Five Year Review inspections, and fulfill the requirements of both. The Navy performs annual inspections of Sites 1, 2, and 3 to ensure that LUCs designed to minimize risk exposure pathways are being maintained as intended as part of the site remedies. The following report presents a general site background for each site; details of land use control implementations as required by the 1995 Operable Unit (OU) — 1 Record of Decision (ROD) for Sites 1, 2, and 3; and summaries of the annual site inspections. In addition, Appendix A contains the site inspection checklists and interview summaries and Appendix B contains the Site Inspection Photo log. The inspections, documenting current conditions and ensuring that LUCs have been implemented and are functioning properly, have also been included in the 2013 Five Year Review prepared for

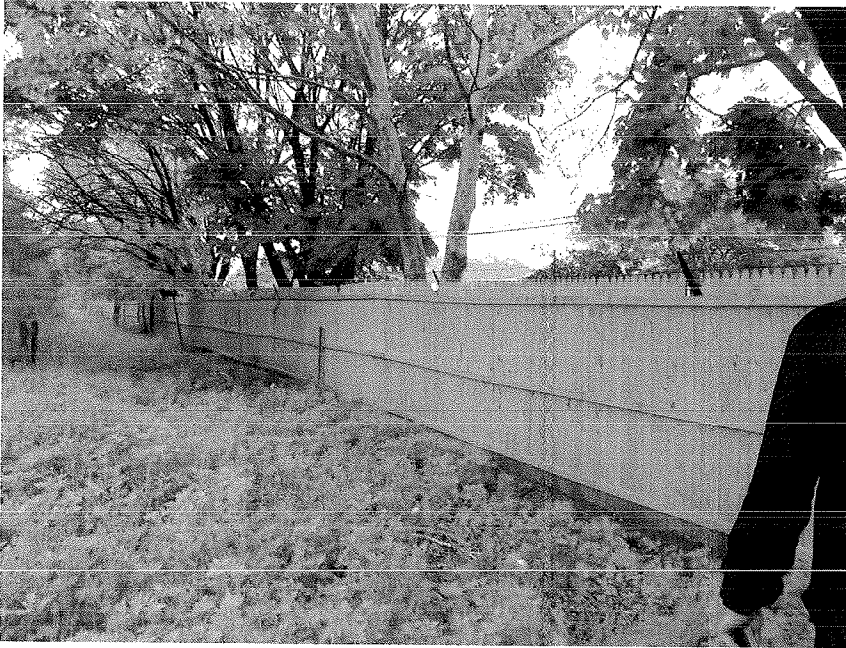
- Several onsite wells need to have the security locks replaced
- Several cesspool lids are missing
- There is minor debris (car battery, miscellaneous garbage) along the eastern perimeter fence
- Soil cover and perimeter fencing is intact
- Front gate security (operated by Steel-Los III, LP) is operational

Eastern Perimeter Fence looking north - Site 1

**Resolution of noted issues:** Nuts will be added to Blower 1-B nuts in 2014; onsite well locks will be replaced during next sampling; Facility Manager will arrange to have eastern perimeter fence checked for debris periodically; missing cesspool lids will be replaced.

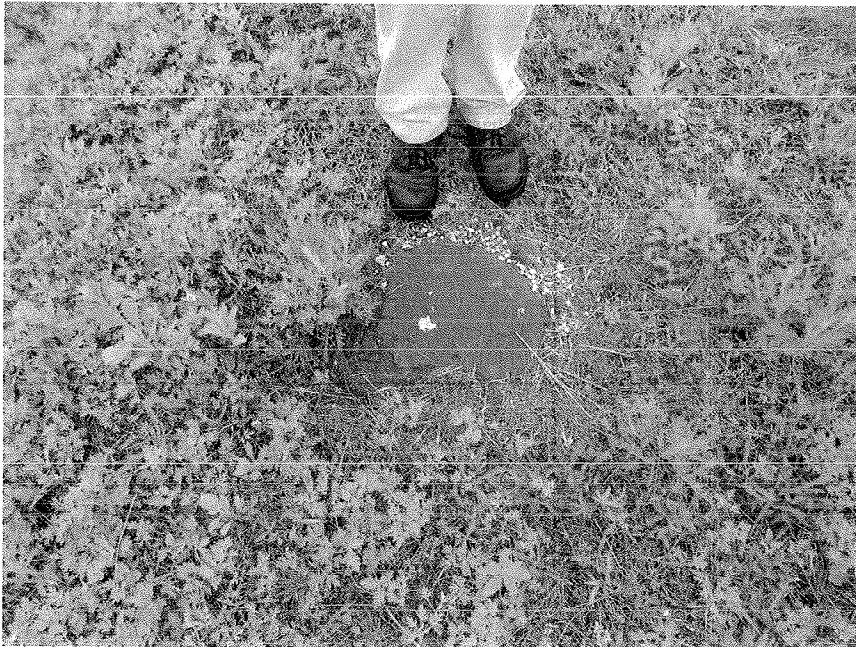
Cess pool – Site 1

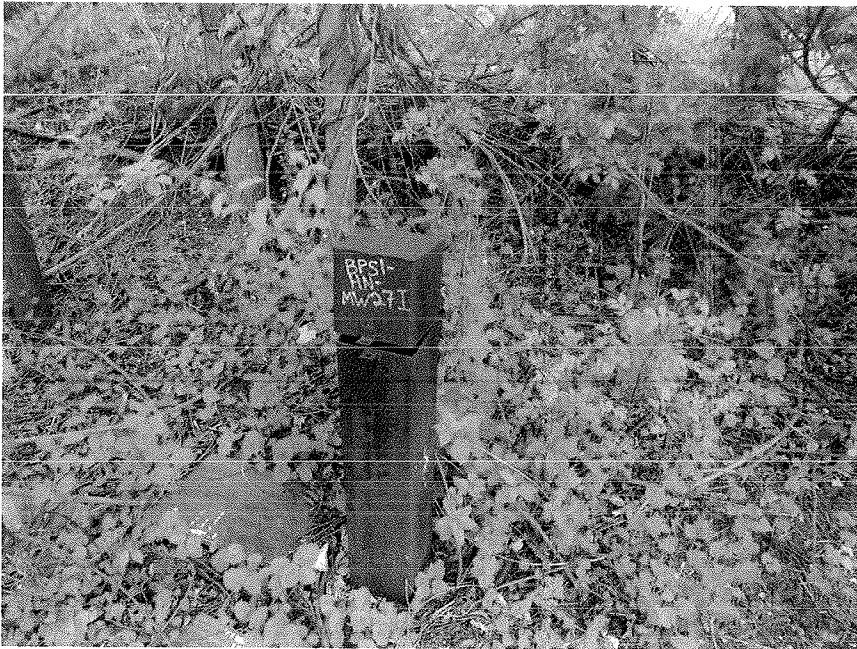
BPSI-HN- MW271 – Site 1 (needs lock)

All remedial elements are operating properly, and there were no observations that Remedial Action Objectives are not being met. Recommendations include the replacement of the missing security locks on monitoring wells, and removal of the noted debris along the eastern perimeter fence.

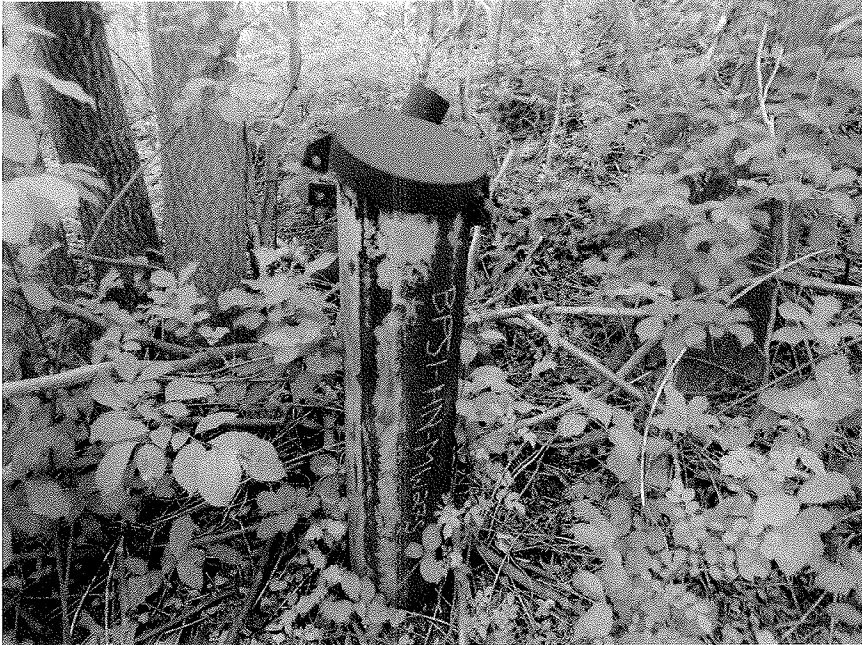
BPSI-HN-MW27S – Site 1 (needs lock)

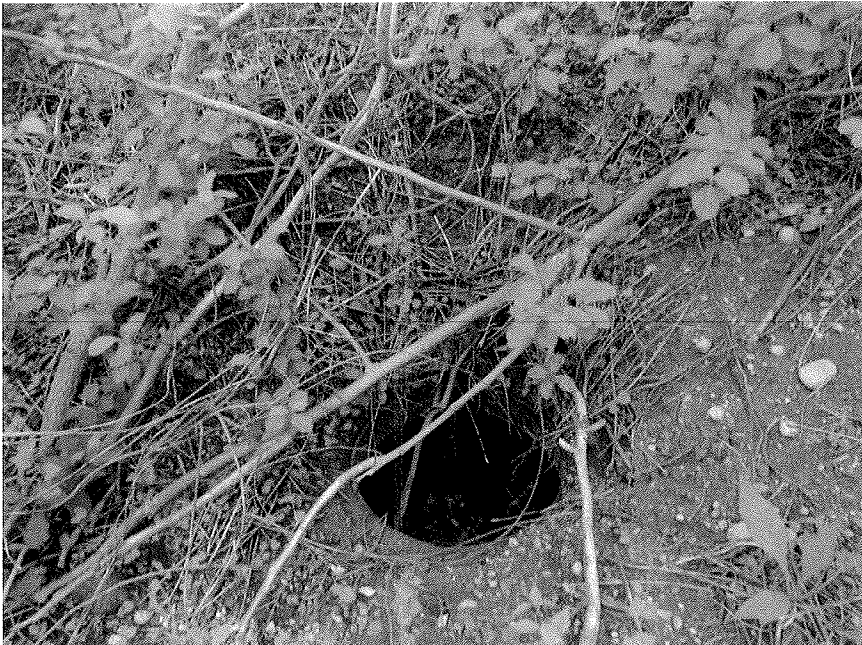
Cess Pool between BPSI-HN- MW271 and BPSI-HN-MW27S – Site 1

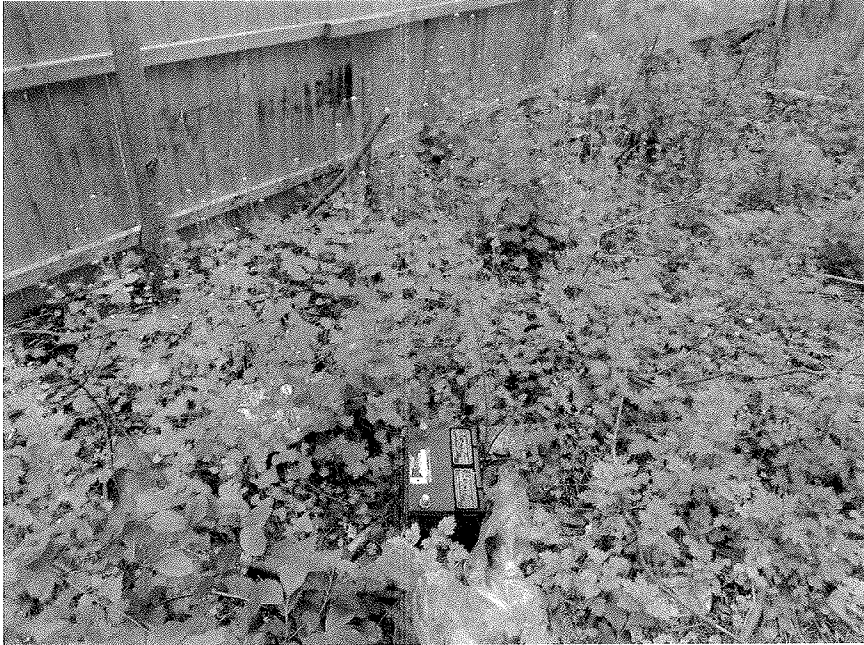
Battery between SVE105 & 104 – Site 1 (needs removal)

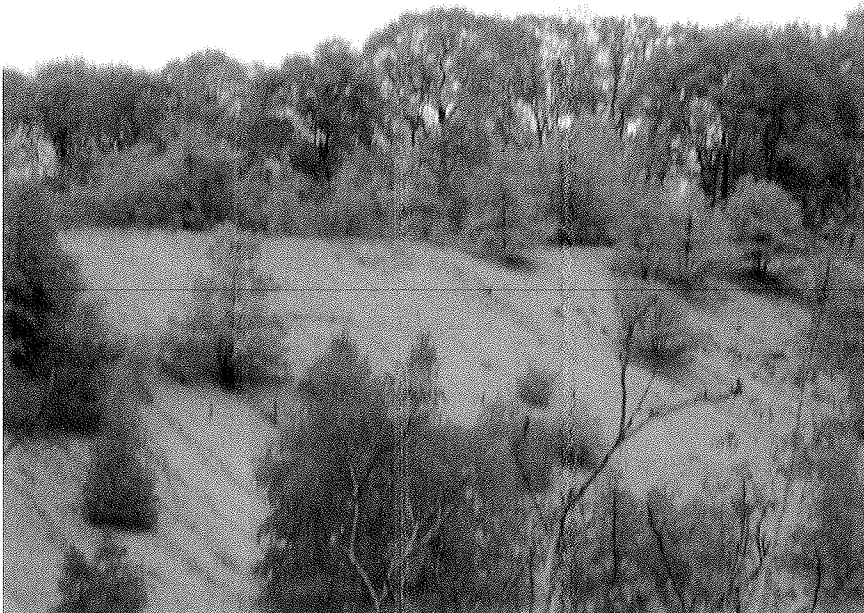
- There is slight erosion on the slopes of the recharge basins, but the soil cover is intact — there is no imminent risk of collapse at the edge of the basins
- Perimeter fencing is intact
- Front gate security (operated by Steel-Los III, LP) is operational

Southern Basin erosion east side – Site 2

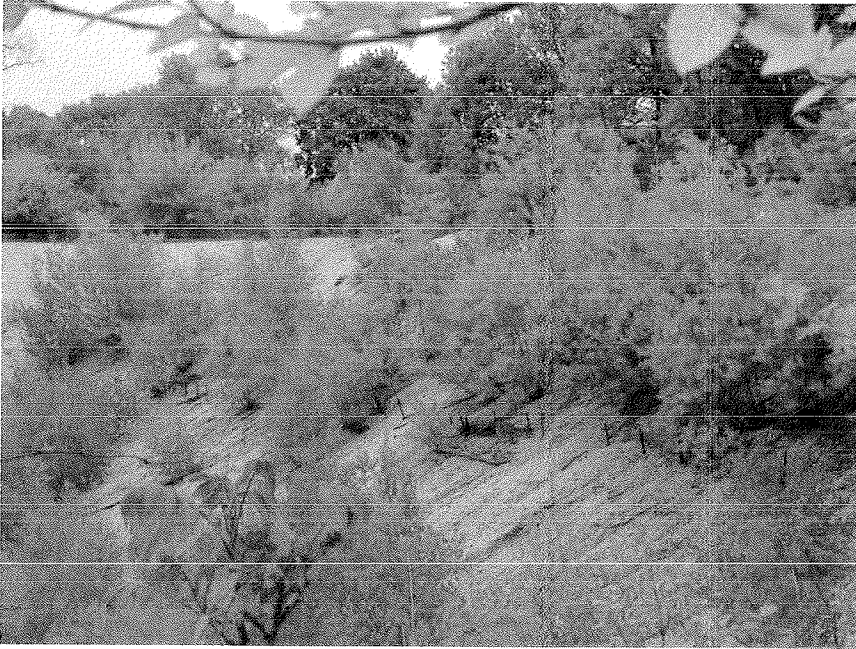
Erosion east side of Southern Basin – Site 2

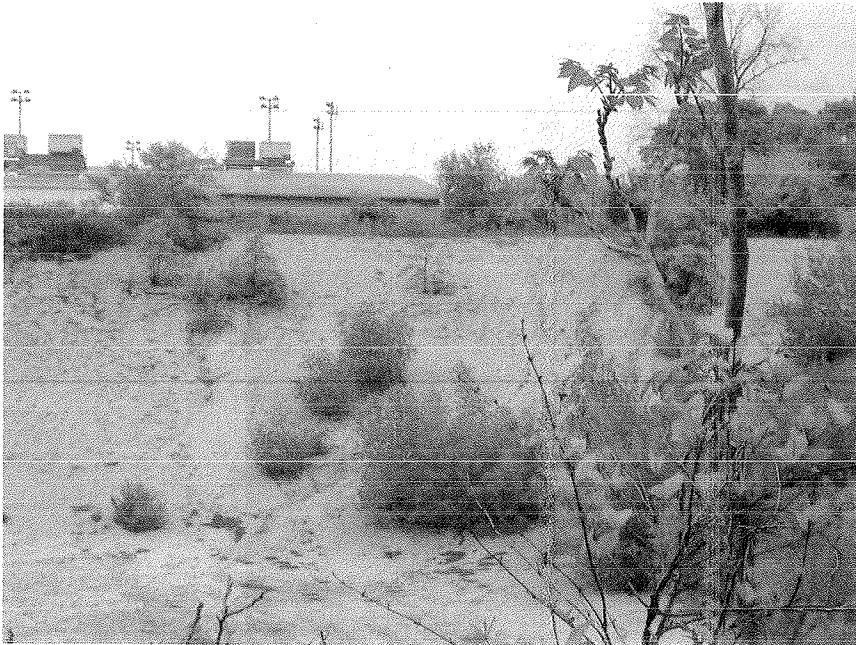
Erosion east side of Southern Basin – Site 2

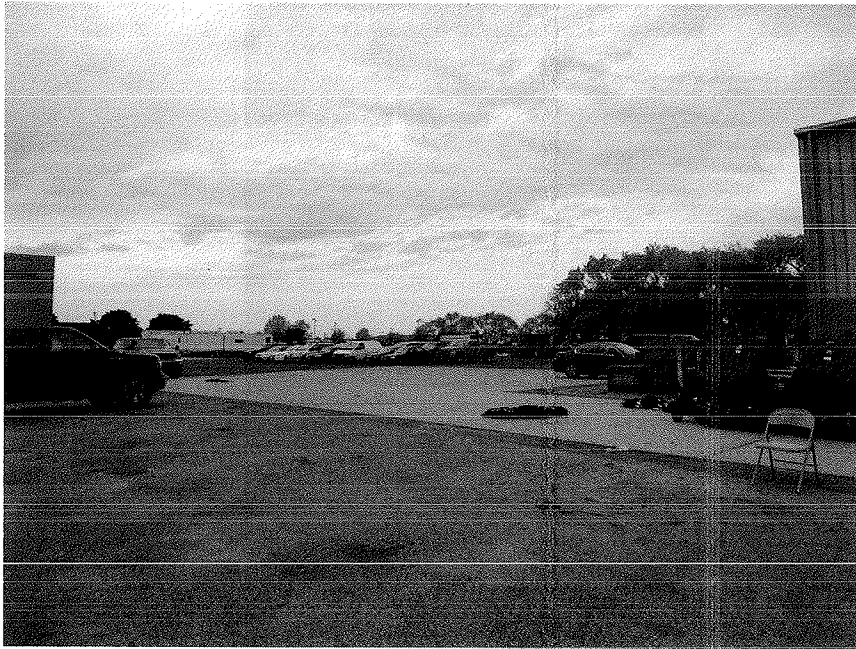
- Pavement has been maintained and improved by Steel-Los III, LP
- Asphalt cover has been repaired and improved in the northwestern portion of the site
- Perimeter fencing is intact
- Front gate security (operated by Steel-Los III, LP) is operational

Asphalt that was replaced for movie set – Site 3
