Subject: Annual LUC Inspection Report, Sites 1, 2, and 3 — NWIRP Bethpage

Date: February 2016

This memorandum documents the inventory of 123 groundwater monitoring wells for NWIRP Bethpage shown in Figure 1. The purpose of the well inventory was to locate, photograph, evaluate the physical condition of, and measure the groundwater level and depth of each well to assure that data collected from these wells is representative of subsurface conditions, and to evaluate the physical condition of each well.

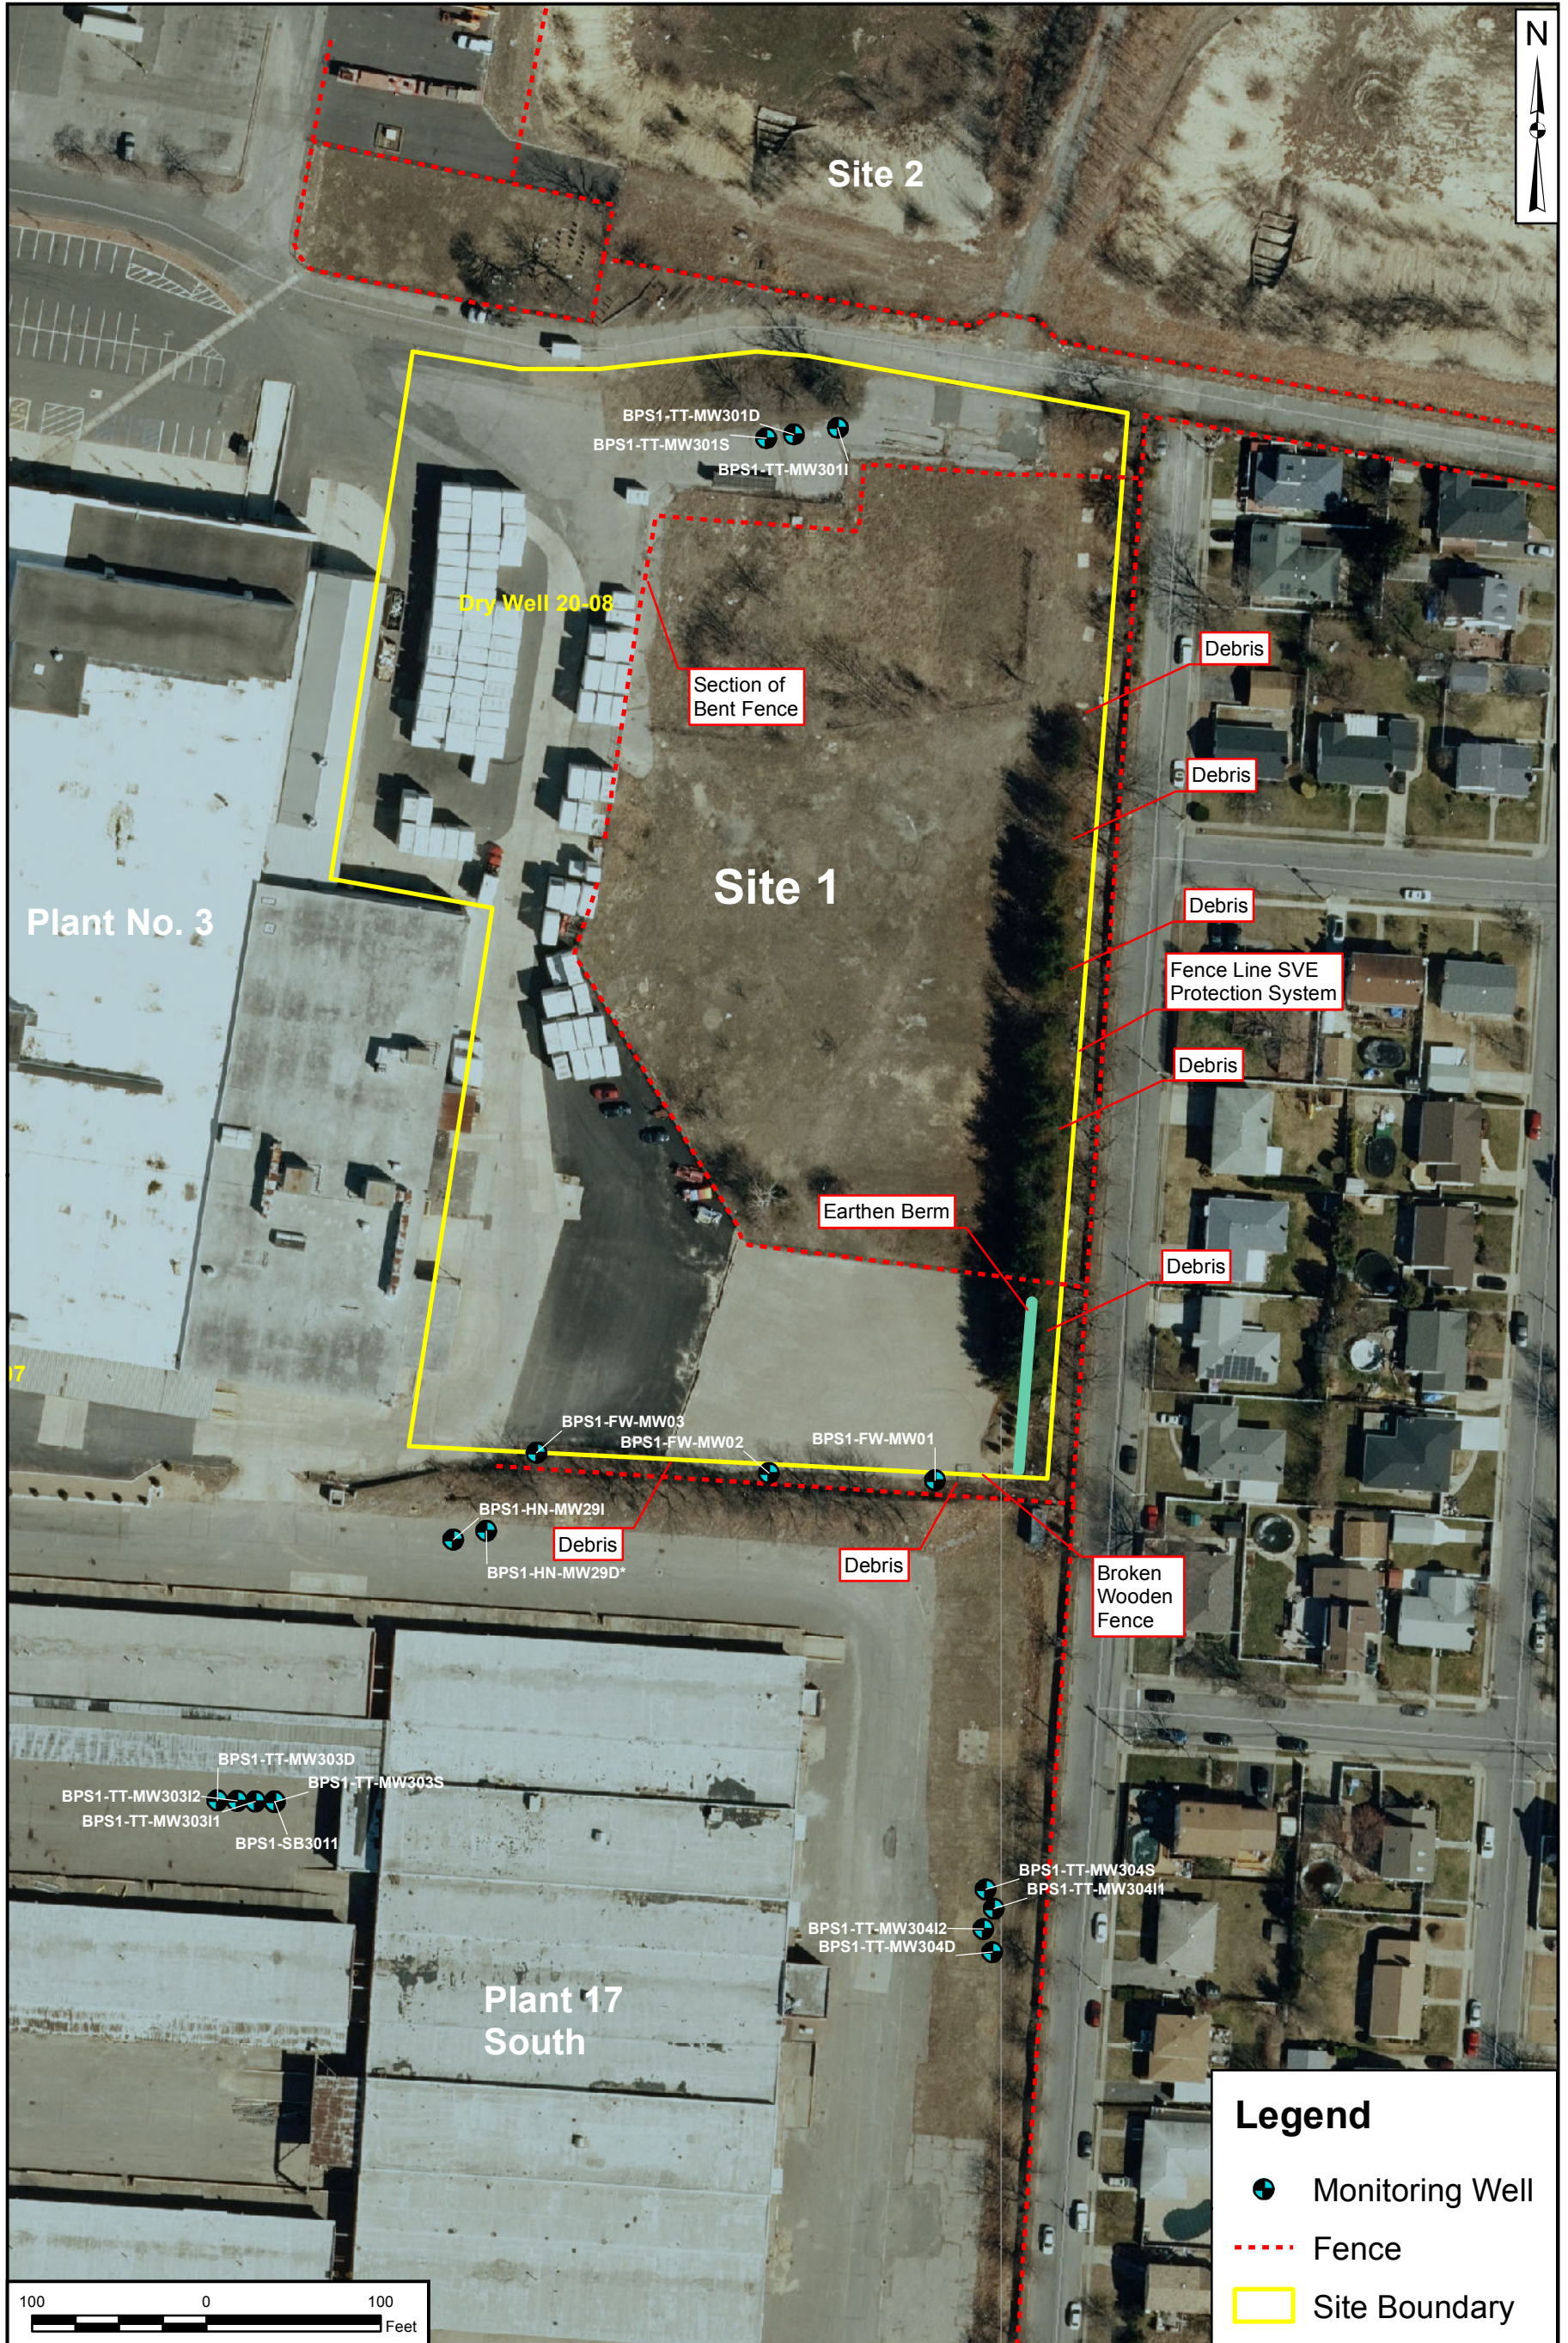
SITE 1 - FORMER DRUM MARSHALLING AREA  
LAYOUT MAP  
NAVAL WEAPONS INDUSTRIAL RESERVE PLANT  
BETHPAGE, NEW YORK

- The presence of a soil berm on the east boundary of the site south of the fenced in area.
- There is minor debris on the south fence between 150 feet east and 300 feet east of western site line. The southern outer wooden fence at approximately 300 feet east of western site line is broken. There is debris along the eastern fence line 100 to 375 feet north of the south fence.
- The fence is bent on one short section the northeastern corner.
- Internal fencing inside the perimeter fence area is bent; the facility manager has notified Steel Equities of this for repair.

The fence should be repaired. The debris was removed.

All remedial elements are operating properly, and Remedial Action Objectives are being met. Recommendations include landscaping of the eastern berm, Facility manager will arrange to have eastern perimeter fence checked for debris periodically; missing cesspool lids have been replaced; the nuts on Blower 1-B and locks have been replaced.

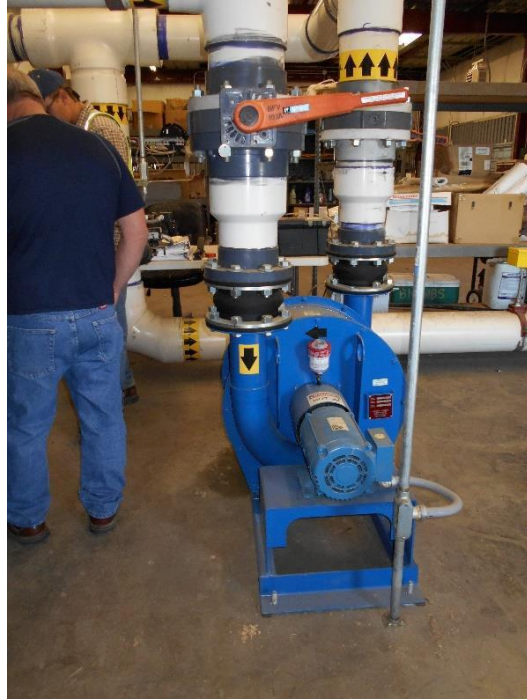
*Photo 1:* Site 1- Blower B-1A bolts missing

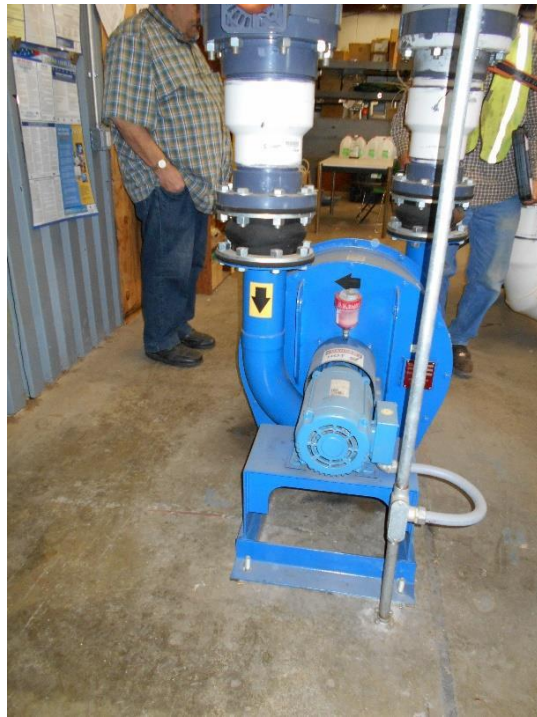
<i>(If no, explain in Remarks)</i>			
<b>Pumps and Electrical:</b>		X	Blower 1B was still missing nuts; these have since been replaced
<b>Extraction system pipelines, valves, valve boxes, and appurtenances:</b>	X		
<b>Treatment technologies:</b>	X		
<b>Discharge structures and appurtenances:</b>	X		
<b>Recovery wells:</b>	X		
<b>Do any observations indicate that RAO's are not being met?</b>			
<i>(If yes, note on map and explain in Remarks), note on map and explain in</i>		X	
<b>Has land use on- or offsite changed?</b>			
<i>(If yes, explain in Remarks)</i>		X	
<b>Are monitoring wells functioning, locked and in good condition?</b>	X		
<i>(If no, explain in Remarks)</i>			
<b>Is the site free of identifiable concerns, such as dumping of chemicals or debris, or unanticipated activity?</b>		X	
<i>(If no, explain in Remarks)</i>			There is minor debris on the south fence between 150 feet east and 300 feet east of western site line. The southern outer wooden fence at approximately 300 feet east of western site line is broken. There is debris along the eastern fence line 100 to 375 feet north of the south fence. The debris has since been removed. The fence is bent on a short northeastern section. There are two cesspools that need covers. The covers were replaced

*Photo 2:* Site 1- Blower B-1B bolts missing

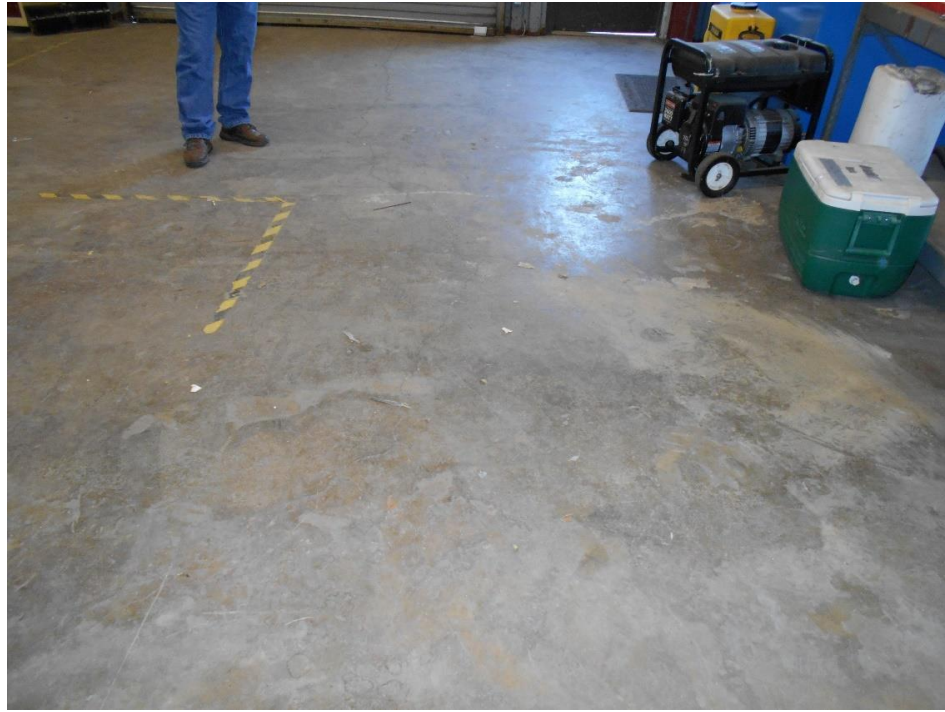
Photo 3: Site 1- Floor crack

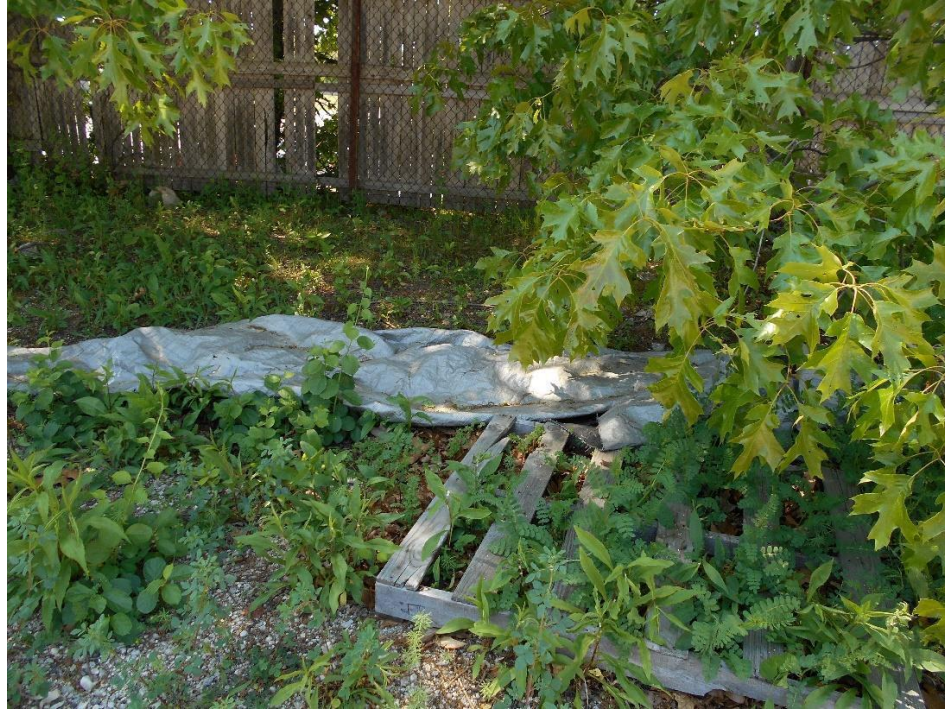
*Photo 5:* Site 1- Pallet and tarp on ground between MW02 and MW03

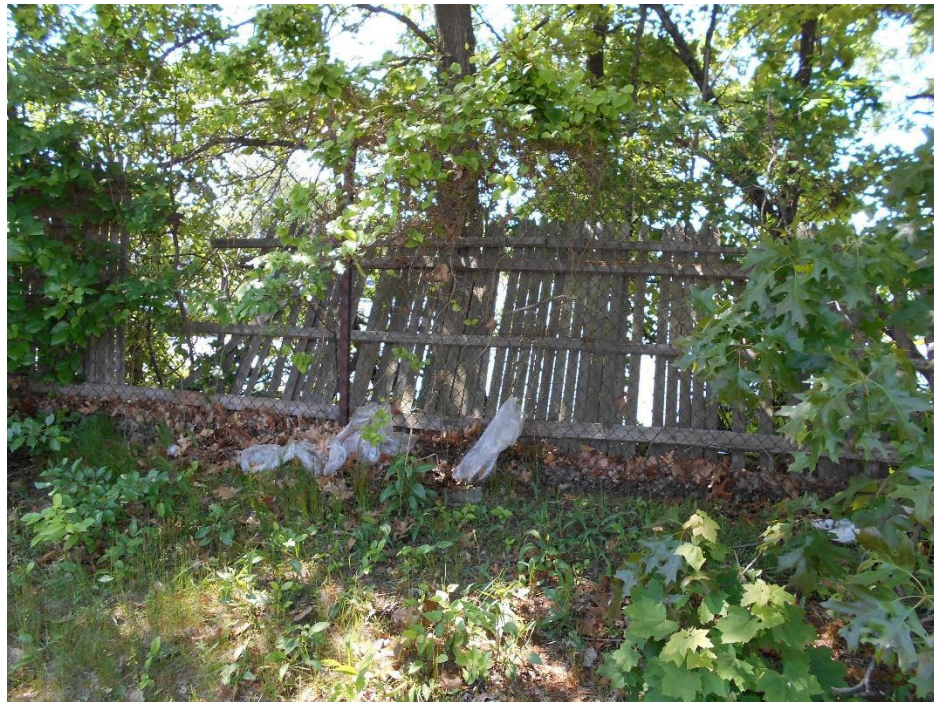
*Photo 6:* Site 1- Wood fence outside broken

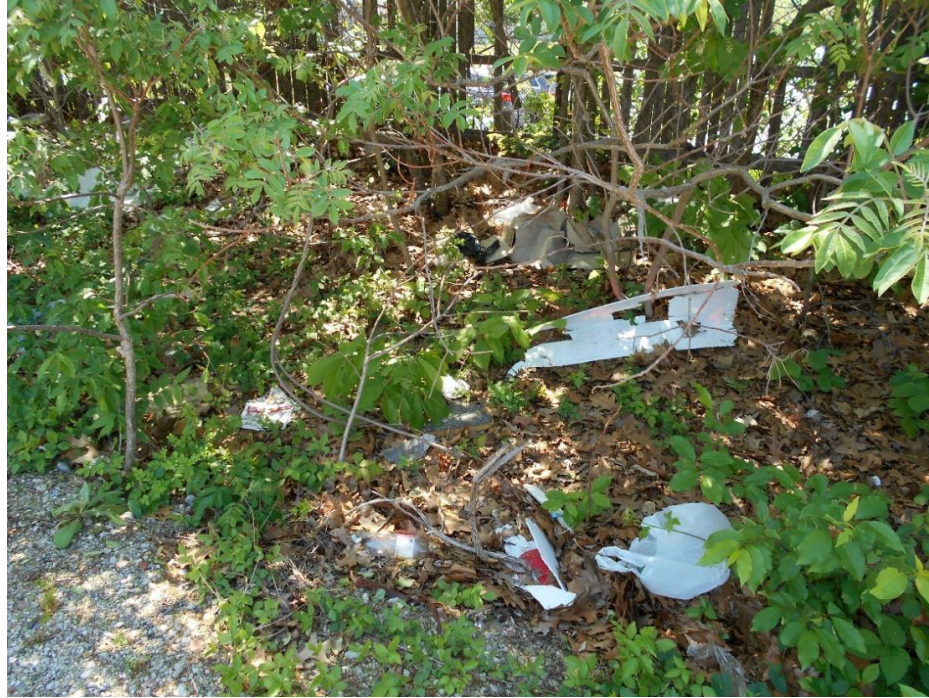
*Photo 7:* Site 1- Debris near MW01

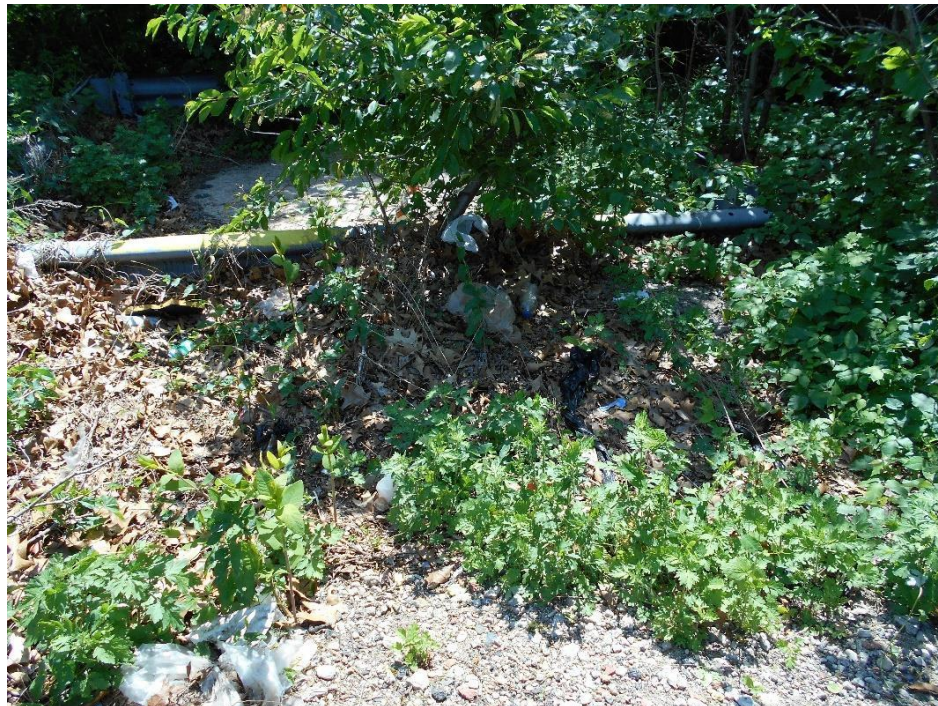
*Photo 8* Site 1- Debris at sump

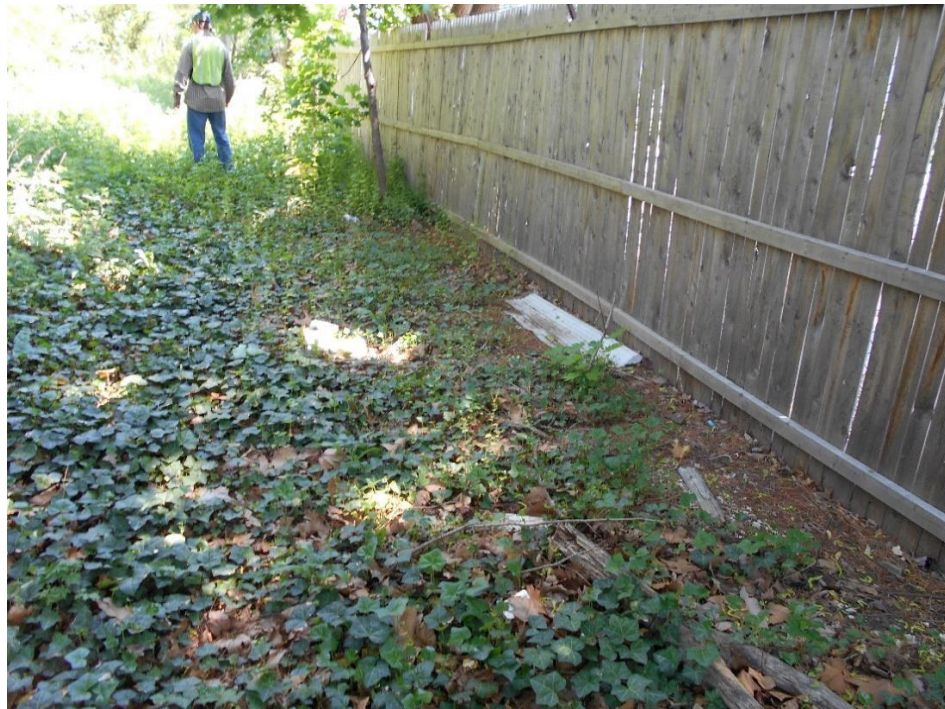
*Photo 10:* Site 1- Debris along east wall

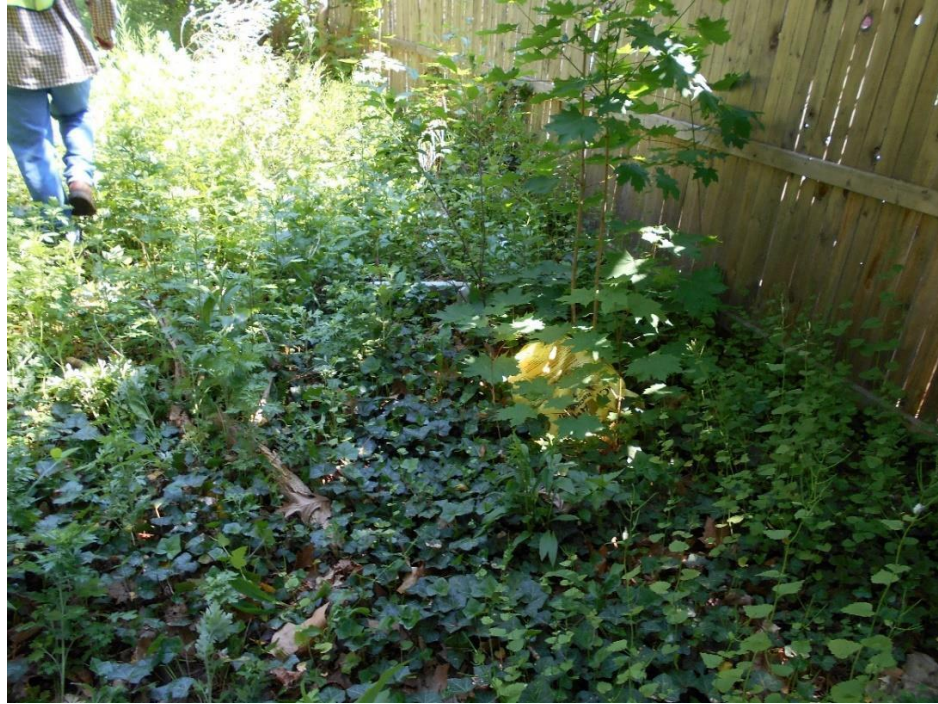
*Photo 11:* Site 1- Debris North of SVE 101I and SVE 101D

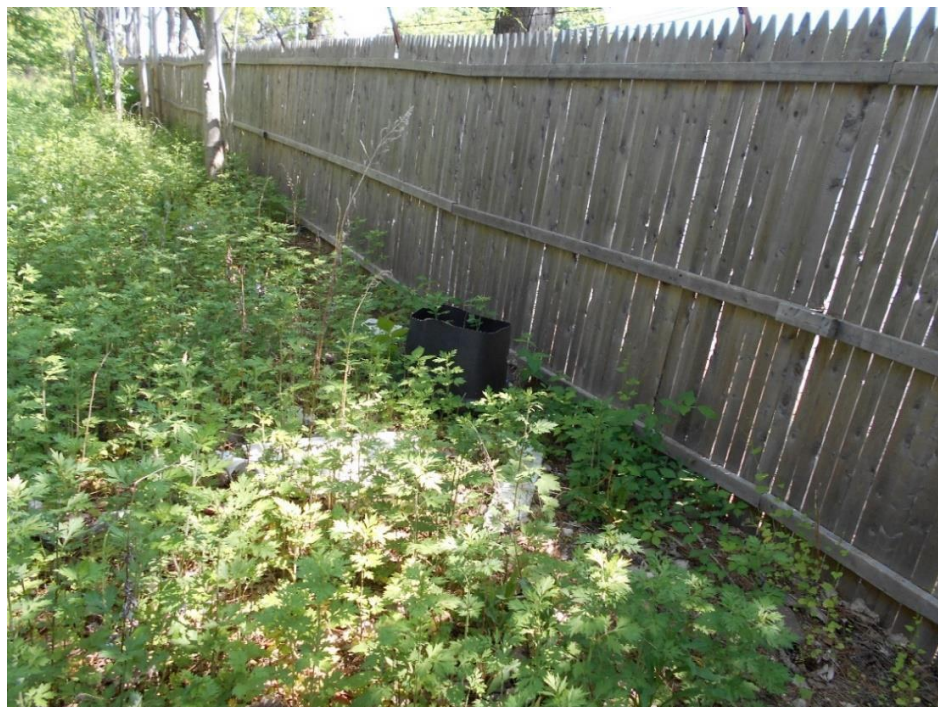
*Photo 14:* Site 1- Debris behind 103 and 104

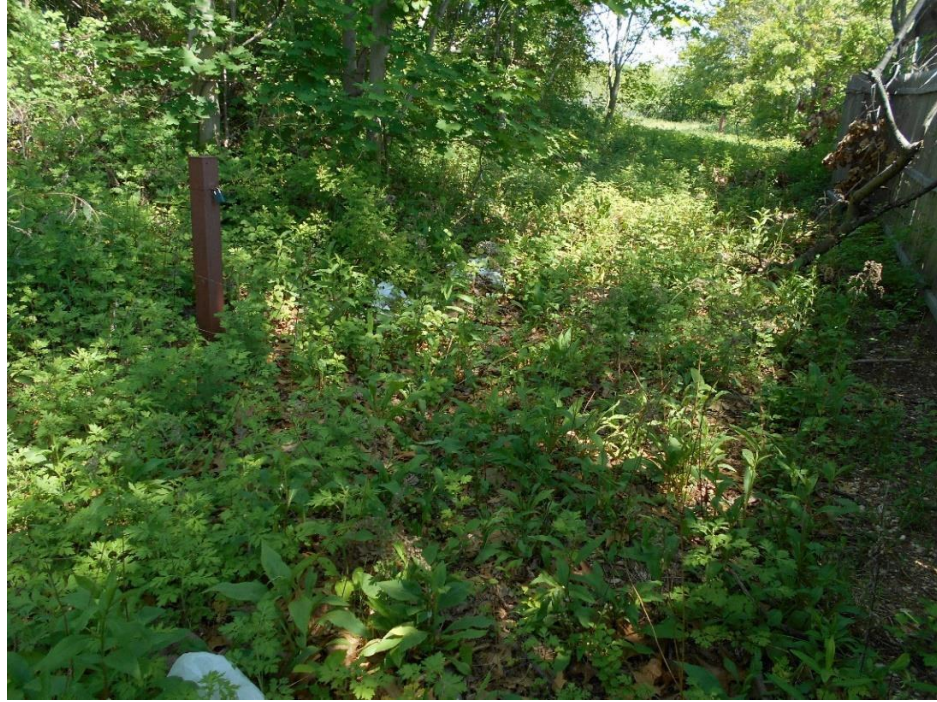
*Photo 17* Site 1- Debris near SVE 105I and SVE 105D

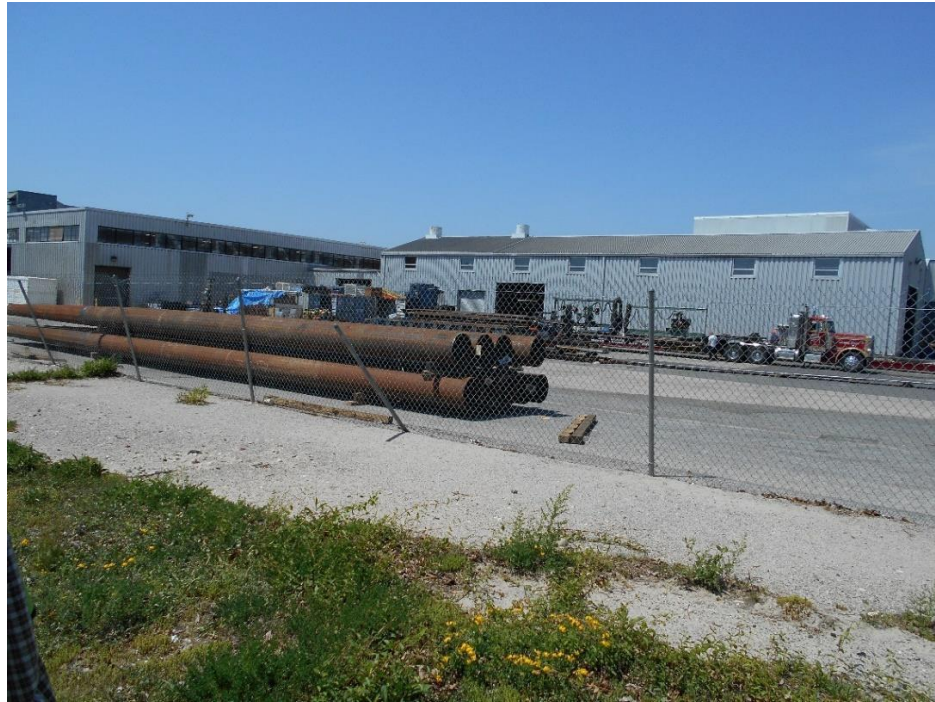
*Photo 19:* Site 1- Bent fence on West side

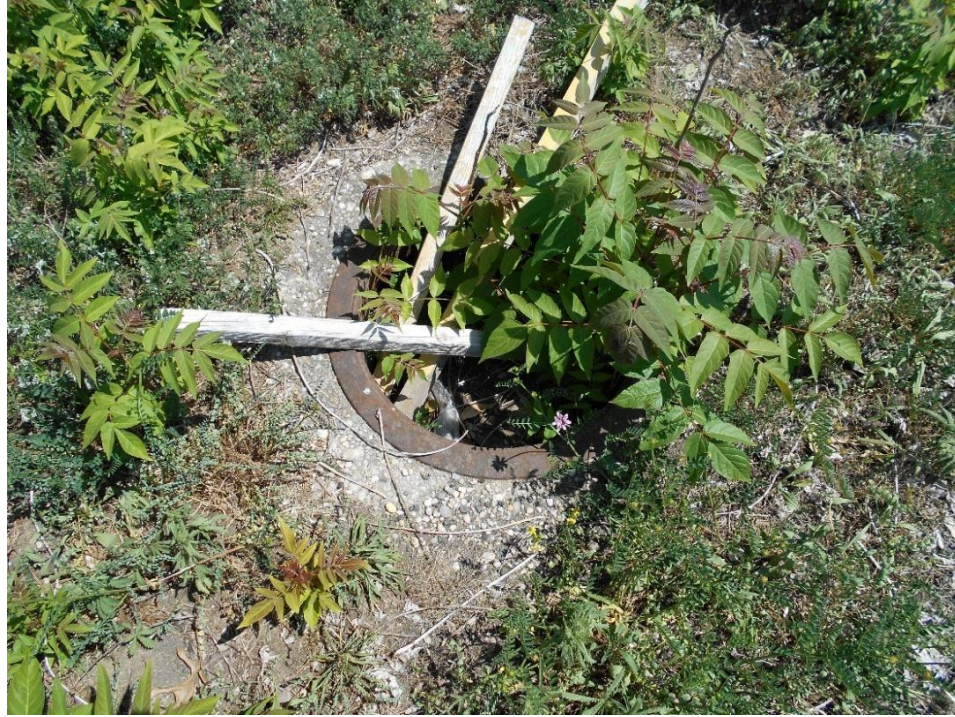
*Photo 21:* Site 1- Cesspool without lid

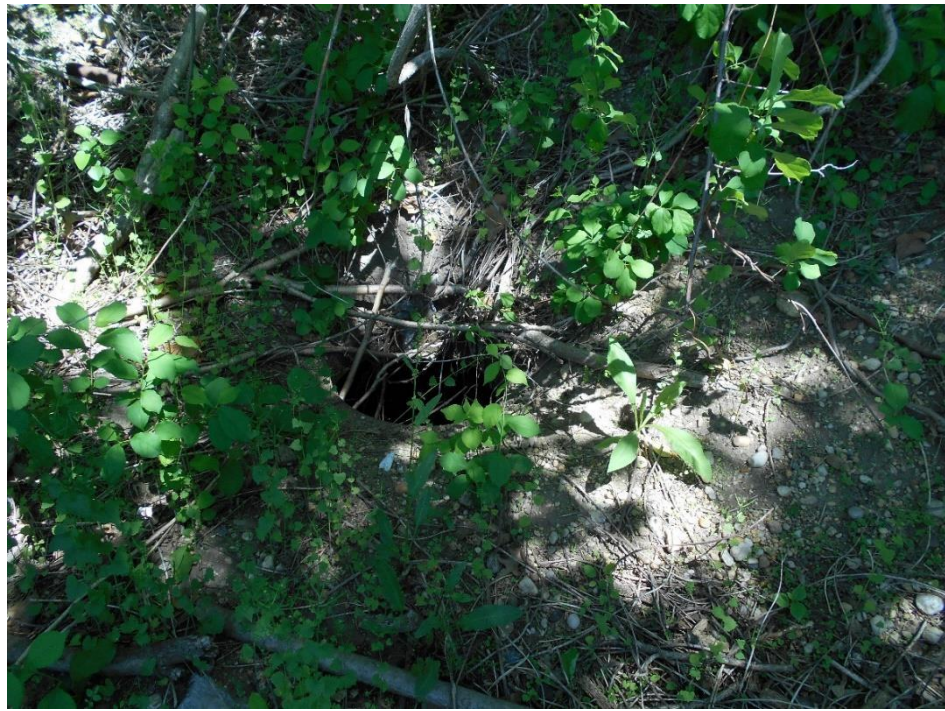
*Photo 22* Site 1- : Cesspool without lid

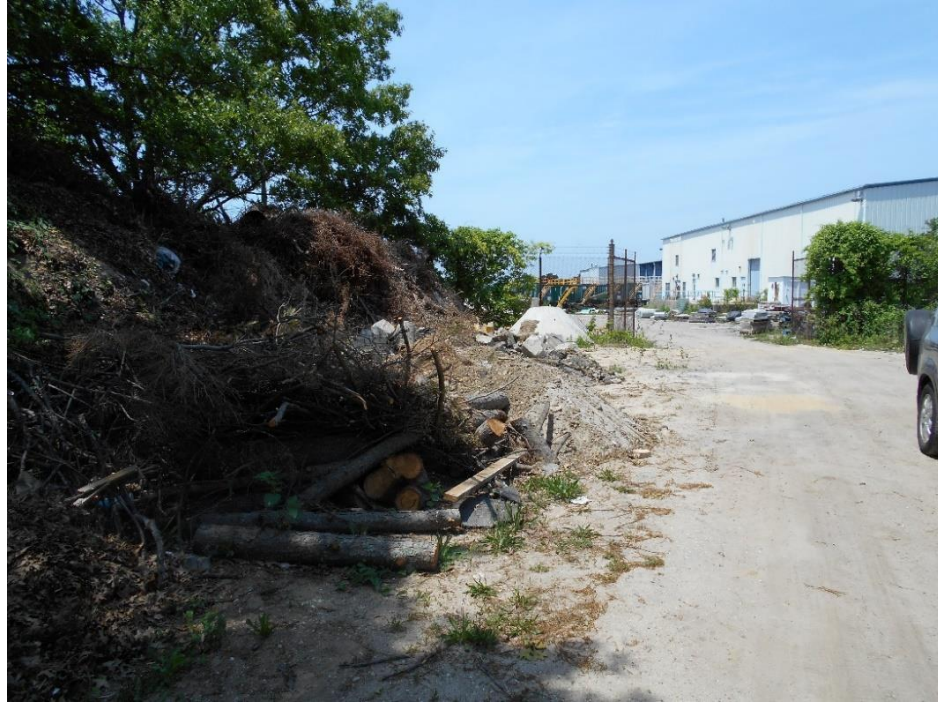
*Photo 25:* Site 2- More debris across from 308

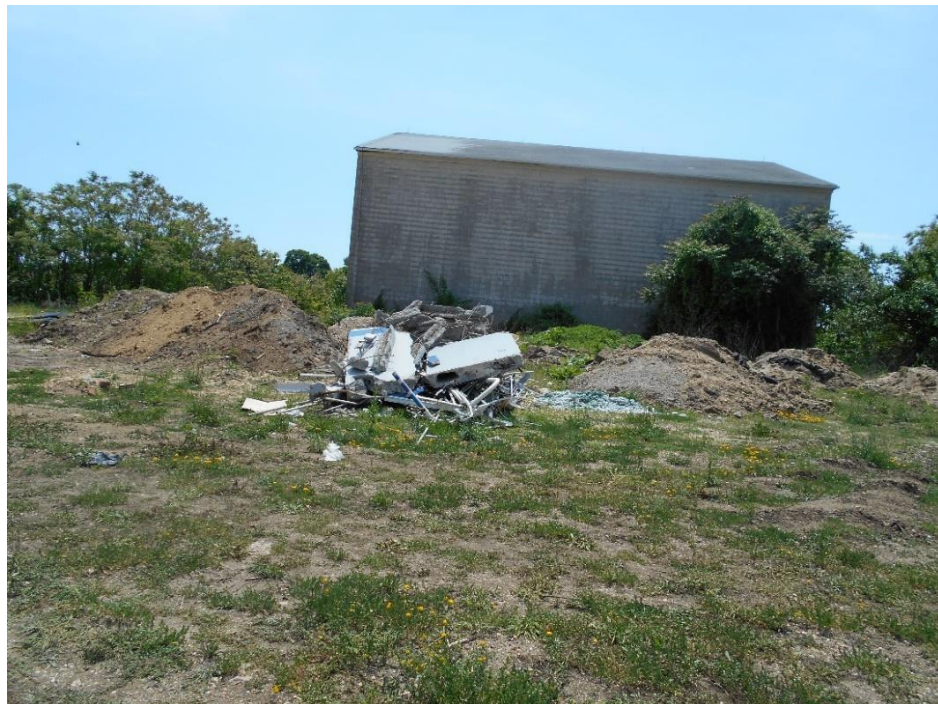
*Photo 26:* Site 2- Debris near salt storage shed

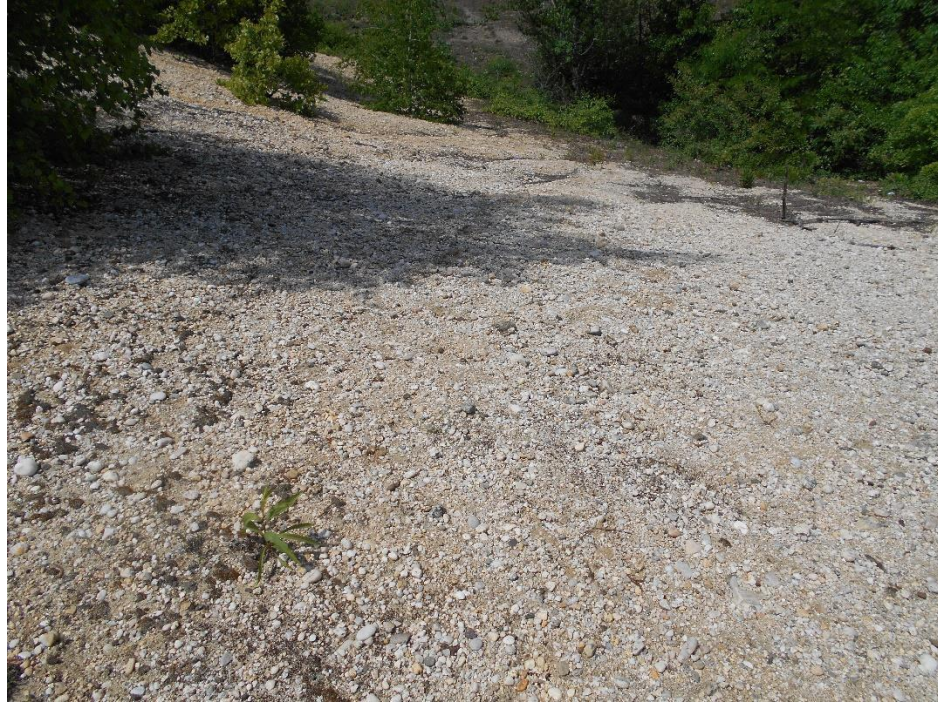
*Photo 35:* Site 2- Southwest basin facing north, some slope erosion

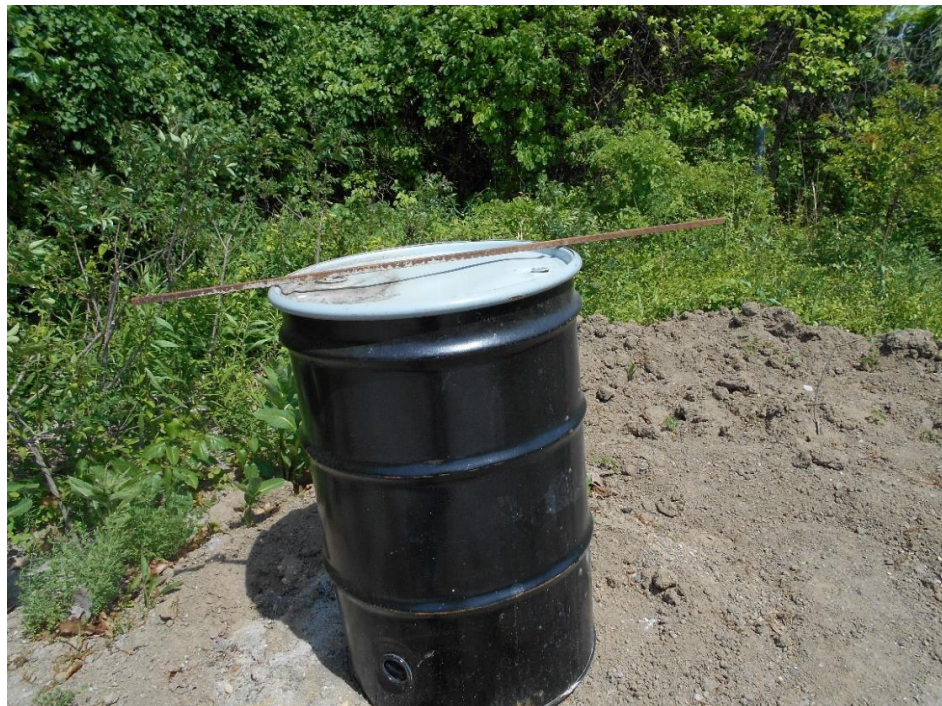
*Photo 40:* Site 3- Northwest corner outside fence, unlabeled 55 gallon soil drum

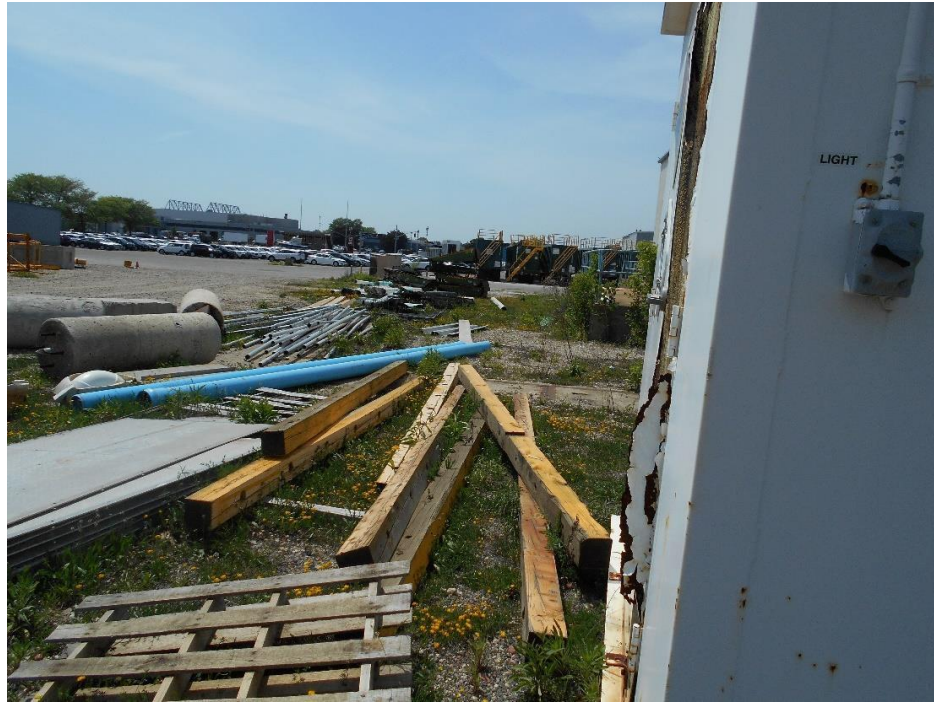
Photo 43: Site 3- South of county building, various pipe, rebar, and pvc

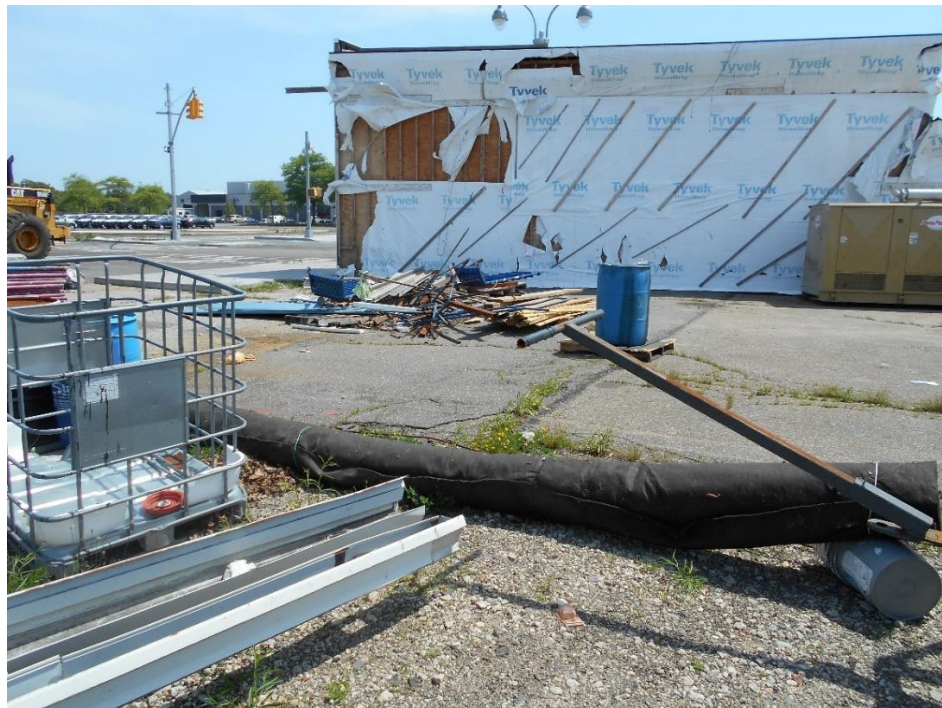
*Photo 48:* Site 3- Debris behind ticket booth

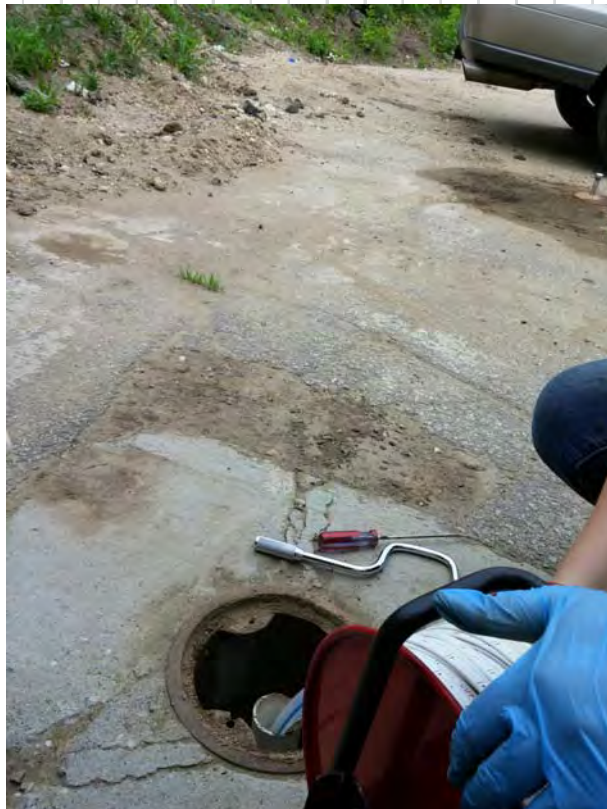
<b>Field Inventory Results</b>	
<b>Needs Bolts:</b>	Yes
<b>Needs Lock:</b>	No
<b>Date/Time Measured:</b>	5/27/2015 2:58:48 PM
<b>Depth of Water:</b>	46.5
<b>Depth of Boring:</b>	290
<b>Notes:</b>	southwest side of south warehouse buildings; 052715: manhole needs repair, one bolt ear broken
Note: N/A - not applicable

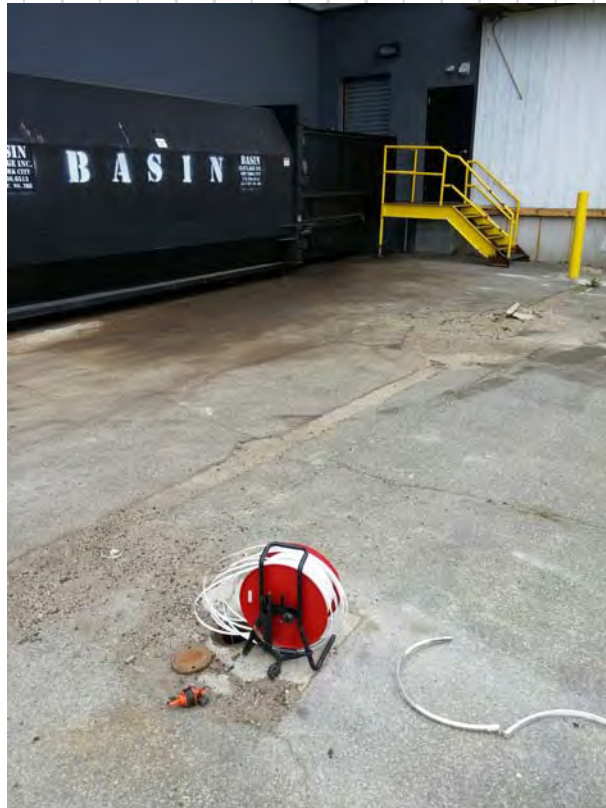
<b>Needs Bolts:</b>	Yes
<b>Needs Lock:</b>	No
<b>Date/Time Measured:</b>	5/27/2015 2:37:19 PM
<b>Depth of Water:</b>	44.72
<b>Depth of Boring:</b>	55.8
<b>Notes:</b>	052715 standing water in well box at top of riser pipe, well box needs to be replaced due to cracked concrete
Note: N/A - not applicable

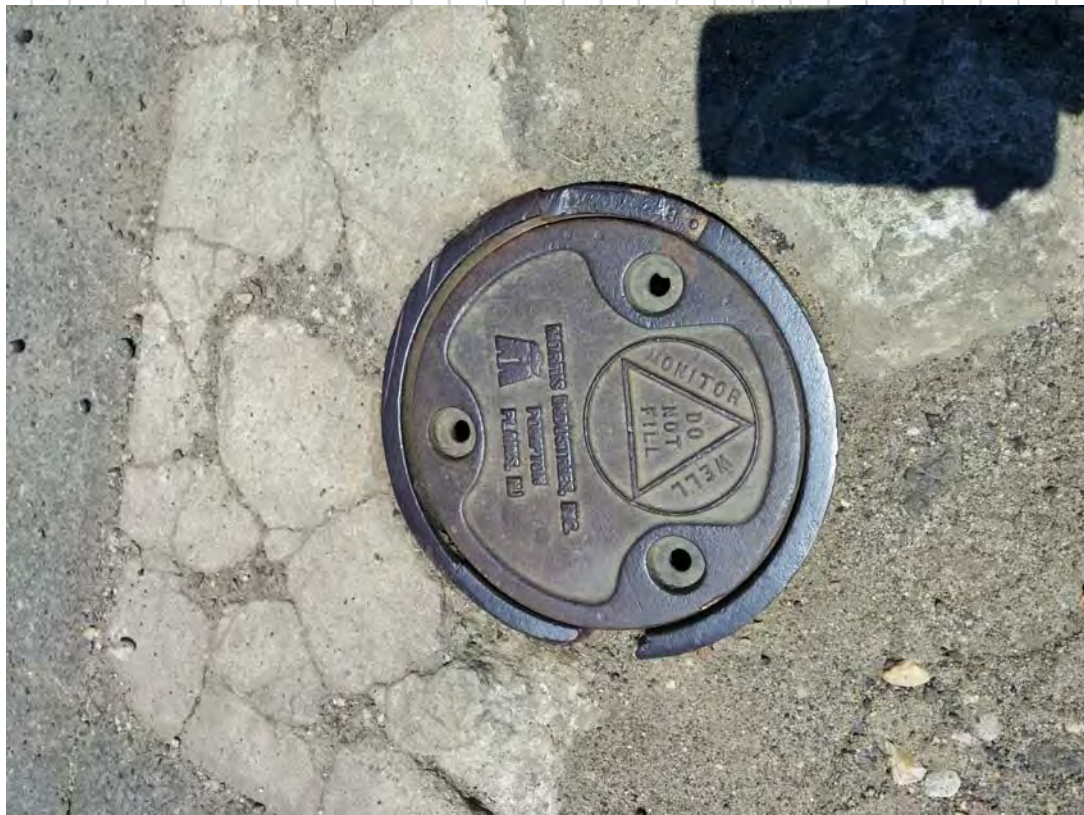
<b>Needs Bolts:</b>	Yes
<b>Needs Lock:</b>	Yes
<b>Date/Time Measured:</b>	5/28/2015 1:45:00 PM
<b>Depth of Water:</b>	49.39
<b>Depth of Boring:</b>	62.5
<b>Notes:</b>	Site 4; 13:45, all bolts stripped, manhole and pad cracked and need to be replaced, well in high-traffic area

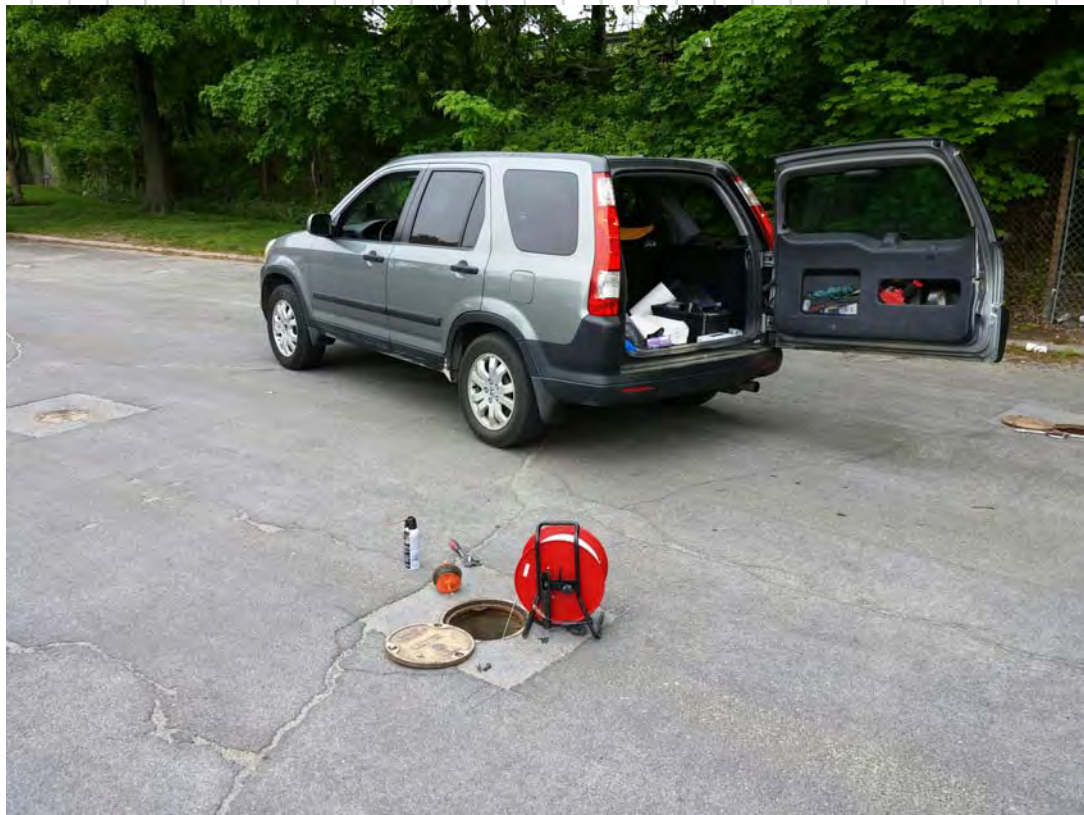
<b>Needs Bolts:</b>	No
<b>Needs Lock:</b>	No
<b>Date/Time Measured:</b>	5/28/2015 9:25:00 AM
<b>Depth of Water:</b>	22.23
<b>Depth of Boring:</b>	517
<b>Notes:</b>	052815 annulus subsided 4' with standing water, one bolt ear broken
