RESOLUTION CONSULTANTS

Subject: **Well Inventory Memorandum – Navy-Owned Wells, NWIRP Bethpage**

Date: October 2020

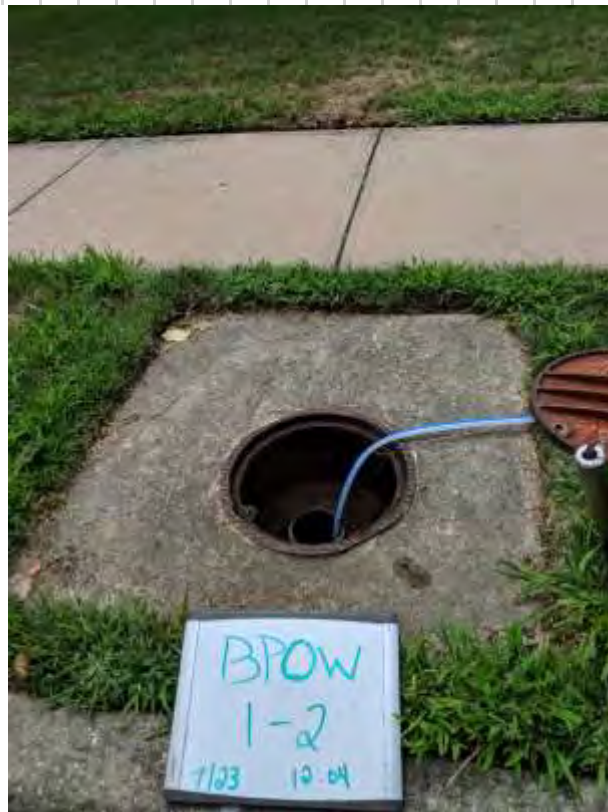
Notes: BPOW 1-2 is in fair condition. BPOW 1-2 has 2 stripped tabs, which need to be retapped. 22% of the screen is silted. There is a bladder pump assembly present in the well.
 Note: NA - not applicable

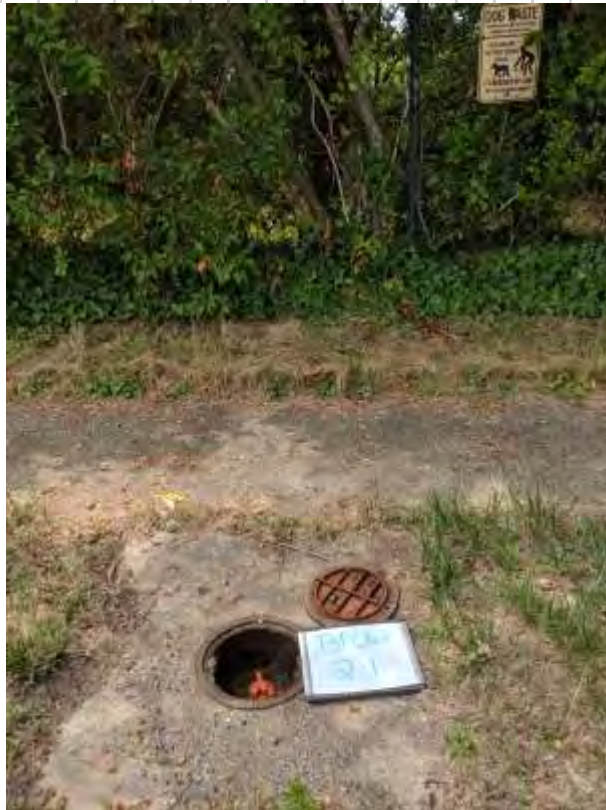
Notes: BPOW 2-1 is in fair condition. BPOW 2-1 has 1 missing bolt, 1 missing tab, which needs to be retapped, and no lock. There is a bladder pump assembly present in the well. BPOW 2-1 is a 2" well.
 Note: NA - not applicable

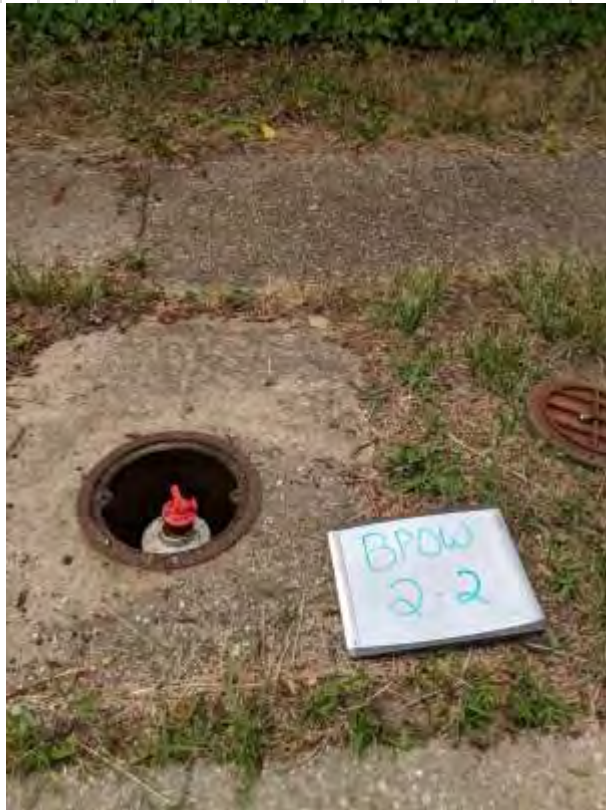
Notes: BPOW 2-2 is in fair condition. BPOW 2-2 needs 1 bolt and has 2 stripped tabs, which will need to be retapped. There is a bladder pump assembly present in the well. BPOW 2-2 is a 2" well.
 Note: NA - not applicable

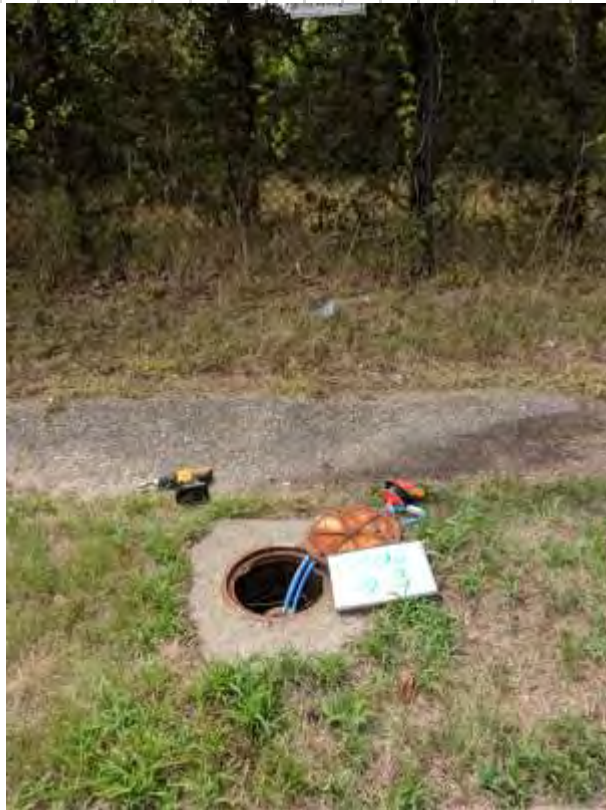
BPOW 2-3	POOR	7/17/18	25.63	568.50	No log	564	594	BPOW 2-3 is in poor condition. BPOW 2-3 has 3 stripped tabs, which will need to be retapped. The screen is 85% silted. There is a bladder pump assembly present in the well.	1127377.78	199725.23
BPOW 3-1	GOOD	7/16/18	27.92	488.63	487	418	487	BPOW 3-1 is in good condition. There is a bladder pump assembly present in the well.	1124804.49	198628.43

Notes: BPOW 2-3 is in poor condition. BPOW 2-3 has 3 stripped tabs, which will need to be retapped. The screen is %85 silted. There is a bladder pump assembly present in the well.
 Note: NA - not applicable

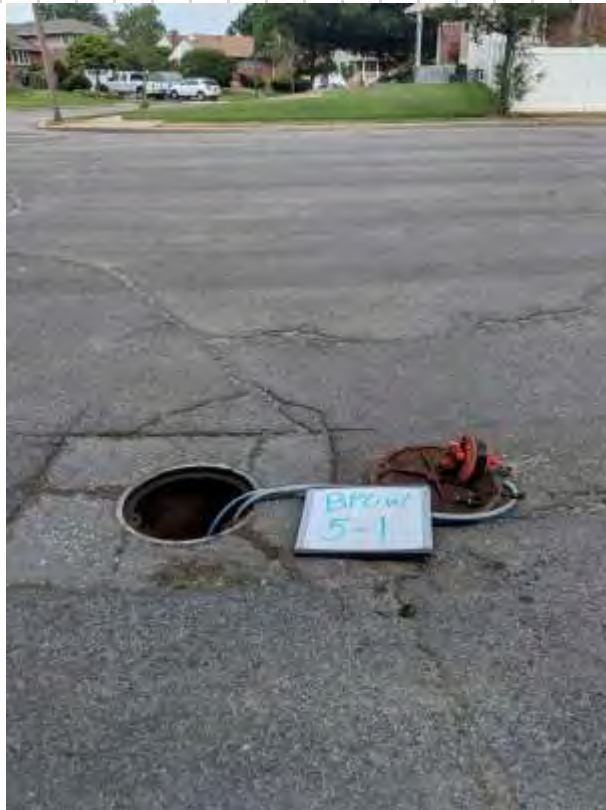
Notes: BPOW 5-1 is in poor condition. BPOW 5-1 has 3 stripped tabs, which need to be retapped. There is a bladder pump assembly present in the well. There is a deep annular void approx 16.5'
 Note: NA - not applicable

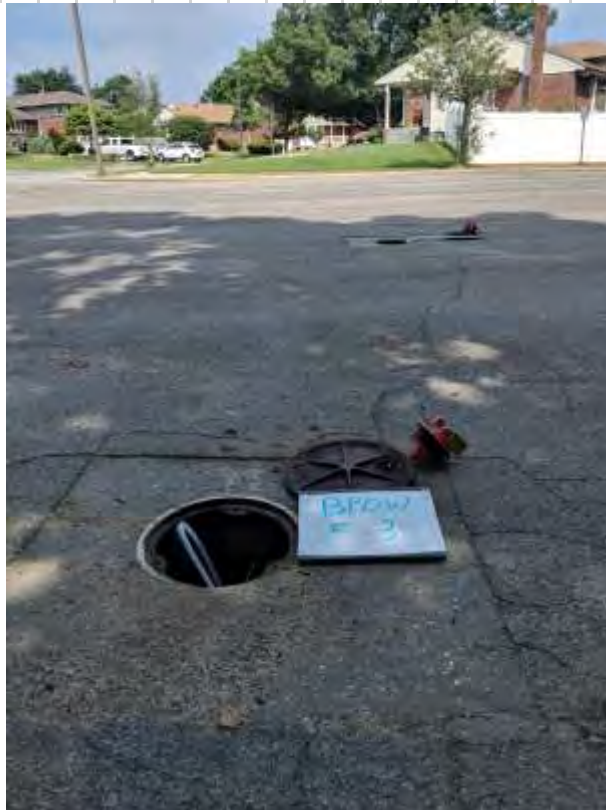
Notes: BPOW 5-3 is in fair condition. BPOW 5-3 has 3 stripped tabs, which will need to be retapped. There is a bladder pump assembly present in the well.
 Note: NA - not applicable

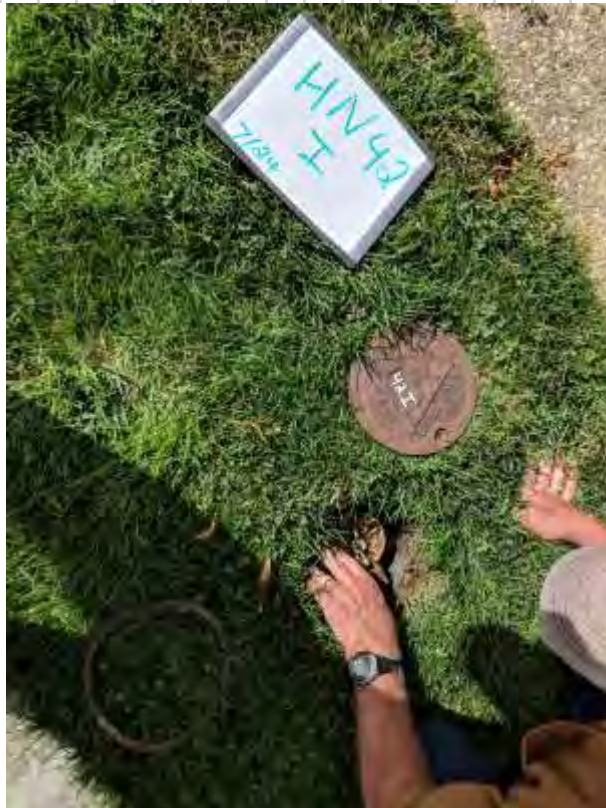
Notes: HN-42I is in fair condition. HN-42I has 2 stripped tabs, which will need to be retapped.
 Note: NA - not applicable

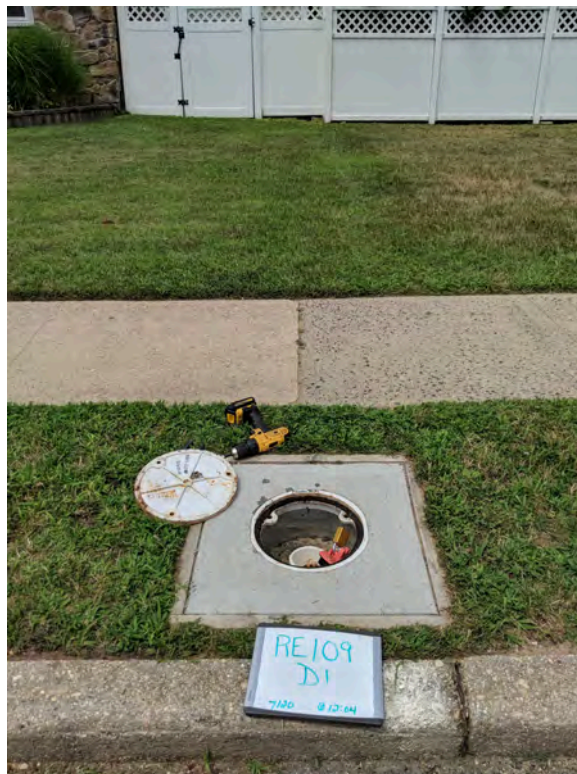
Needs Bolts: Yes
Needs Lock: No
Date/Time Measured: 2018-7-20 12:03
Depth of Water: 46.51
Depth of Boring: 535.10
Notes: RE109D1 is in fair condition. RE109D1 is missing one bolt.

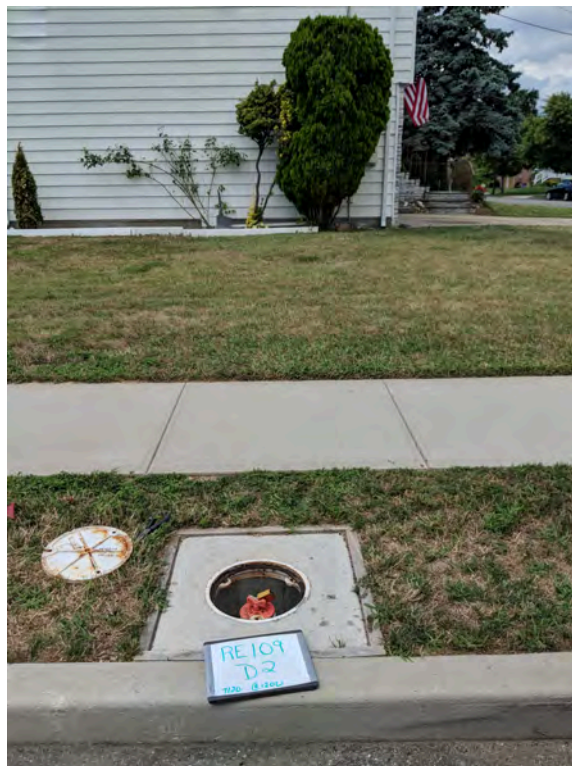
RE109D2	FAIR	7/20/18	46.80	573.70	575	550	570	RE109D2 is in fair condition. RE109D2 is missing 1 bolt	1126657.28	208579.57
RE109D3	GOOD	7/20/18	46.80	601.23	605	580	600	RE109D3 is in good condition.	1126656.45	208562.31
RE114D1	GOOD	7/18/18	33.30	559.45	560	535	555	RE114D1 is in good condition. There is tubing present in the well.	1124289.94	201728.64

Needs Bolts:	Yes
Needs Lock:	No
Date/Time Measured:	2018-7-20 12:03
Depth of Water:	46.80
Depth of Boring:	573.70
Notes:	RE109D2 is in fair condition. RE109D2 is missing one bolt.

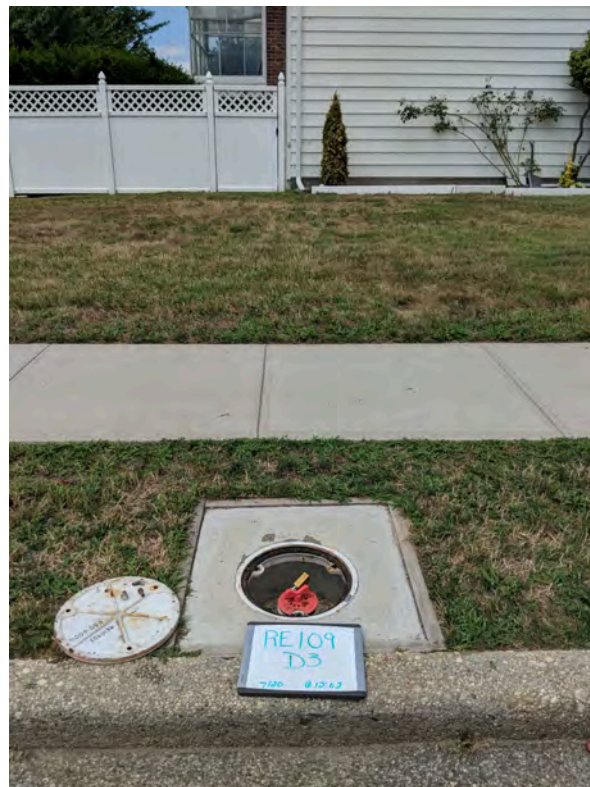
Needs Bolts:	No
Needs Lock:	No
Date/Time Measured:	2018-7-20 12:05
Depth of Water:	46.80
Depth of Boring:	601.23
Notes:	RE109D3 is in good condition.

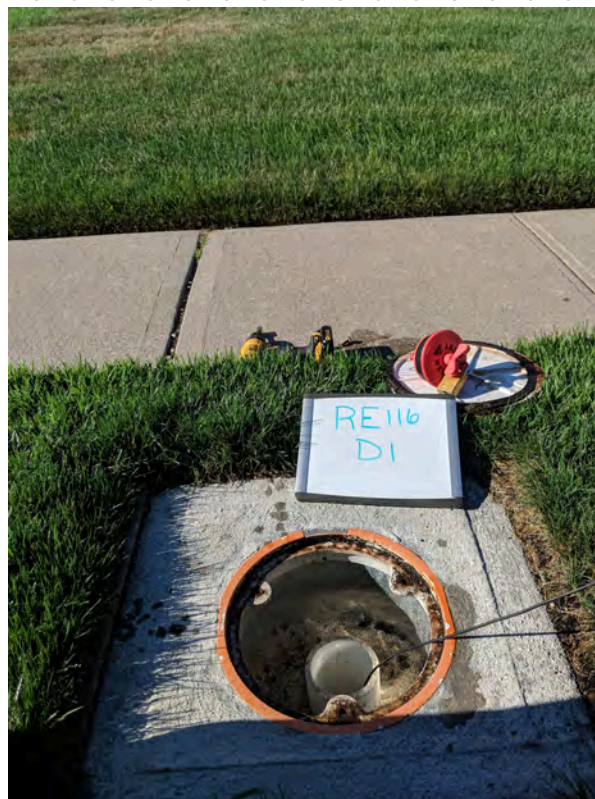
Needs Bolts: No
Needs Lock: No
Date/Time Measured: 2018-7-18 8:16
Depth of Water: 31.12
Depth of Boring: 589.60
Notes: RE116D1 is in good condition.
