Memorandum

To: Scott Sokolowski, NAVFAC MIDLANT
From: Richard Moore, Tetra Tech
Date: September 27, 2024
Re: Annual LUC Inspection and Operation Summary Report: Sites 1, 2, 3, and 4 –
NWIRP Bethpage
Contract/CTO Number: N6247016D9008/WE16

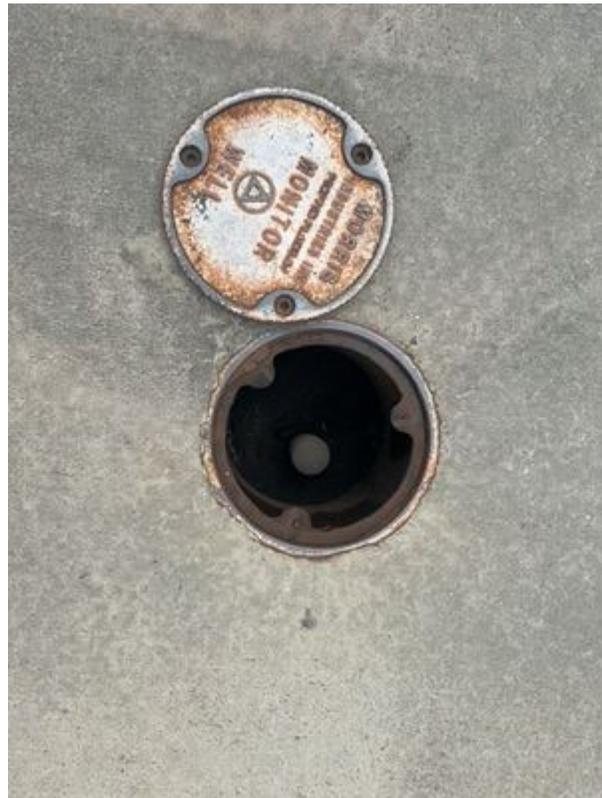
Client: Navy CLEAN	Facility: NWIRP Bethpage
Project Number: 112G08005-WE13	Location: Bethpage, New York
Date: August 6, 2024 10:57	Personnel: Jake Marlow
Well ID: BPS1-TT-MW308I	Well Location: 214990.080681704 1124924.24039046
Well Status: In Use (Confirmed)	Screen Interval: 156-166
WELL INVENTORY CONDITION	
Concrete pad in acceptable condition i.e. no cracks?	YES
Manhole cover present and in working condition?	YES
All bolts on manhole present and not stripped?	YES
Well plug present, locked and in good working condition?	YES
OVERALL CONDITION:	FAIR
Notes (Explain if answered No to any of the above) Bolts broken off where they screw into manhole

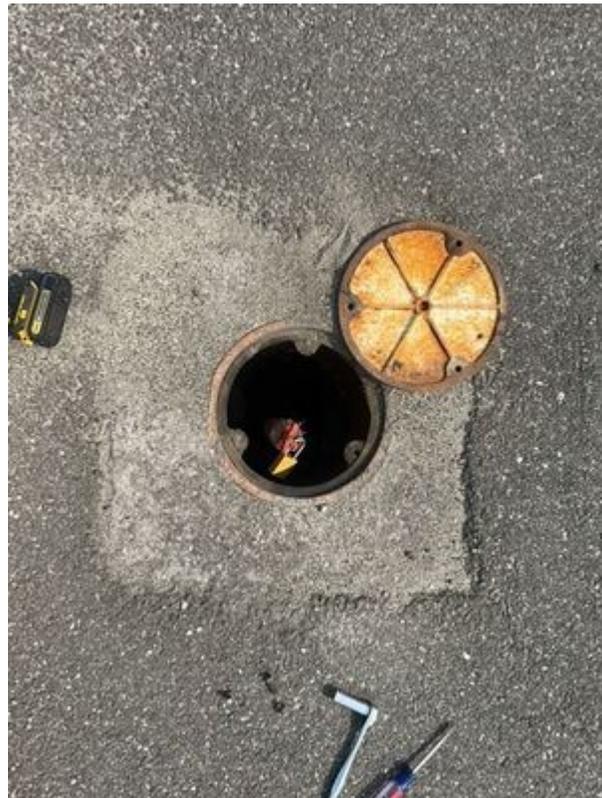
Client: Navy CLEAN	Facility: NWIRP Bethpage
Project Number: 112G08005-WE13	Location: Bethpage, New York
Date: August 6, 2024 10:13	Personnel: Jake Marlow
Well ID: BP-TT-MW202S	Well Location: 215102.989636835 1122994.73035238
Well Status: In Use (Confirmed)	Screen Interval: 54-64
WELL INVENTORY CONDITION	
Concrete pad in acceptable condition i.e. no cracks?	YES
Manhole cover present and in working condition?	YES
All bolts on manhole present and not stripped?	NO
Well plug present, locked and in good working condition?	YES
OVERALL CONDITION:	FAIR
Notes (Explain if answered No to any of the above) Bolts sheared off in manhole

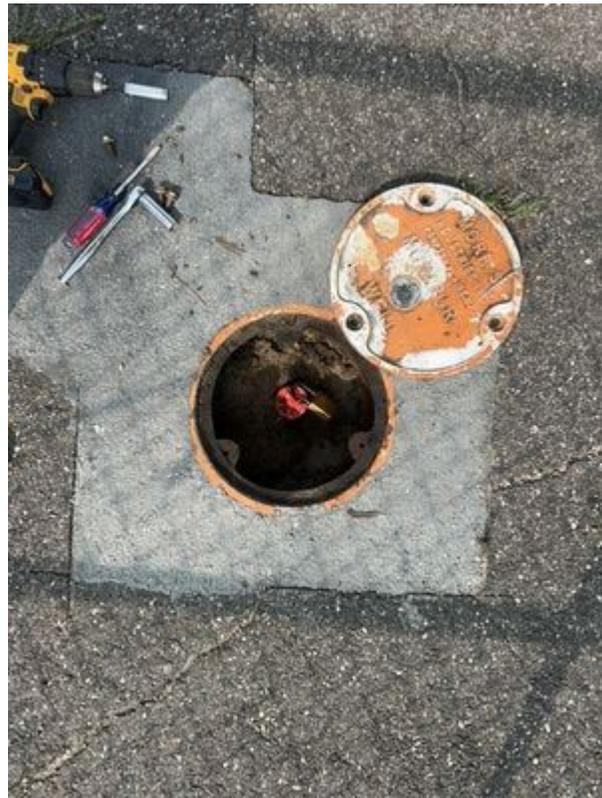
Client: Navy CLEAN	Facility: NWIRP Bethpage
Project Number: 112G08005-WE13	Location: Bethpage, New York
Date: August 6, 2024 10:06	Personnel: Jake Marlow
Well ID: BP-TT-MW202D1	Well Location: 215082.786999131 1122982.35382794
Well Status: In Use (Confirmed)	Screen Interval: 425-440
WELL INVENTORY CONDITION	
Concrete pad in acceptable condition i.e. no cracks?	YES
Manhole cover present and in working condition?	YES
All bolts on manhole present and not stripped?	NO
Well plug present, locked and in good working condition?	YES
OVERALL CONDITION:	FAIR
Notes (Explain if answered No to any of the above) Bolts are sheared off in manhole

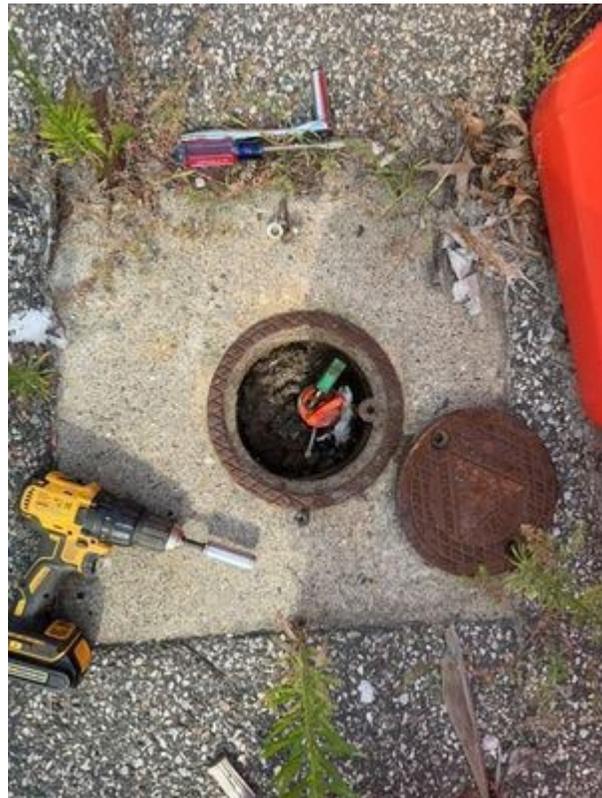
Client: Navy CLEAN	Facility: NWIRP Bethpage
Project Number: 112G08005-WE13	Location: Bethpage, New York
Date: August 6, 2024 09:46	Personnel: Jake Marlow
Well ID: BPTTAOC22MW11	Well Location: 214146.640736664 1123549.39779192
Well Status: In Use (Confirmed)	Screen Interval: 53-63
WELL INVENTORY CONDITION	
Concrete pad in acceptable condition i.e. no cracks?	YES
Manhole cover present and in working condition?	NO
All bolts on manhole present and not stripped?	NO
Well plug present, locked and in good working condition?	YES
OVERALL CONDITION:	FAIR
Notes (Explain if answered No to any of the above) Part of manhole where bolts screw in is broken off

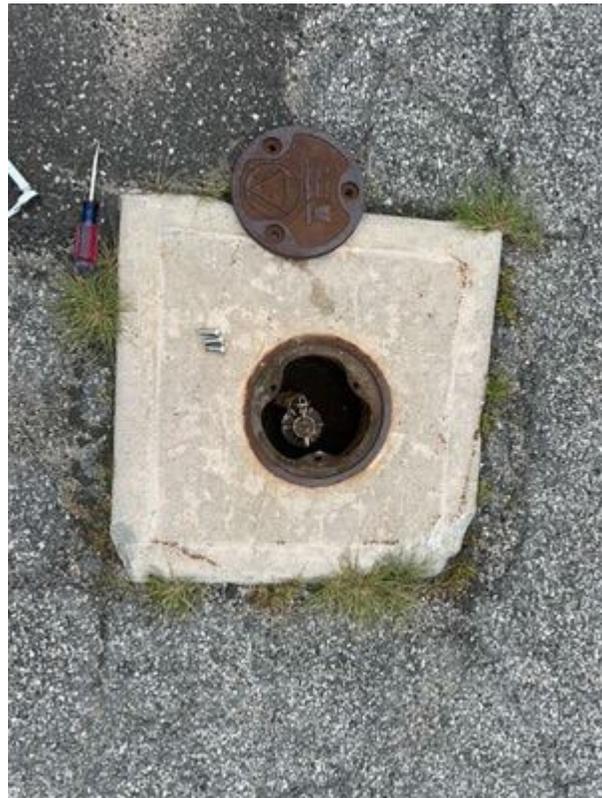
Client: Navy CLEAN	Facility: NWIRP Bethpage
Project Number: 112G08005-WE13	Location: Bethpage, New York
Date: August 6, 2024 08:27	Personnel: Jake Marlow
Well ID: BPTTAOC22MW09	Well Location: 214009.495992885 1123534.77073395
Well Status: In Use (Confirmed)	Screen Interval: 52-62
WELL INVENTORY CONDITION	
Concrete pad in acceptable condition i.e. no cracks?	NO
Manhole cover present and in working condition?	YES
All bolts on manhole present and not stripped?	YES
Well plug present, locked and in good working condition?	YES
OVERALL CONDITION:	FAIR
Notes (Explain if answered No to any of the above) Crack in pad

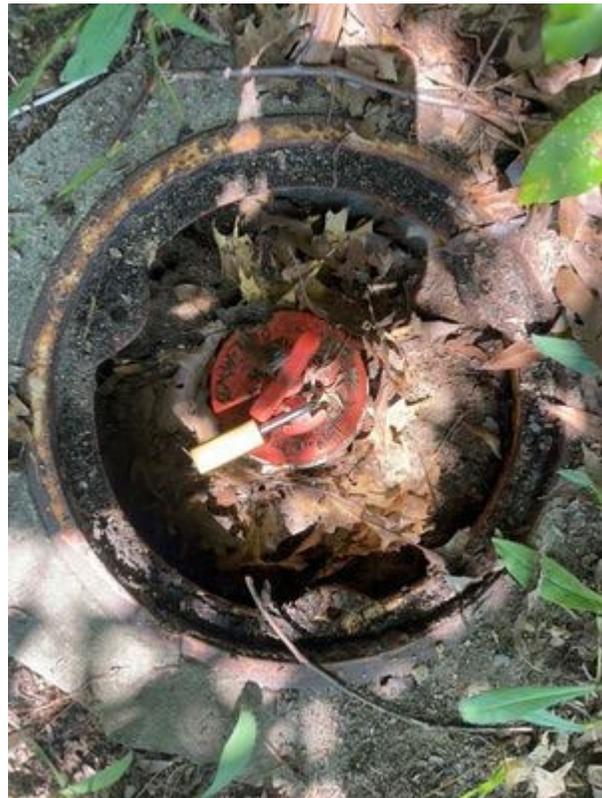
Client: Navy CLEAN	Facility: NWIRP Bethpage
Project Number: 112G08005-WE13	Location: Bethpage, New York
Date: July 19, 2024 10:58	Personnel: Jake Marlow
Well ID: BPHNMW42E	Well Location: 213790.027434996 1126052.10688273
Well Status: In Use (Confirmed)	Screen Interval: 50-60
WELL INVENTORY CONDITION	
Concrete pad in acceptable condition i.e. no cracks?	YES
Manhole cover present and in working condition?	NO
All bolts on manhole present and not stripped?	YES
Well plug present, locked and in good working condition?	YES
OVERALL CONDITION:	FAIR
Notes (Explain if answered No to any of the above) Threads where bolts attach to manhole are stripped

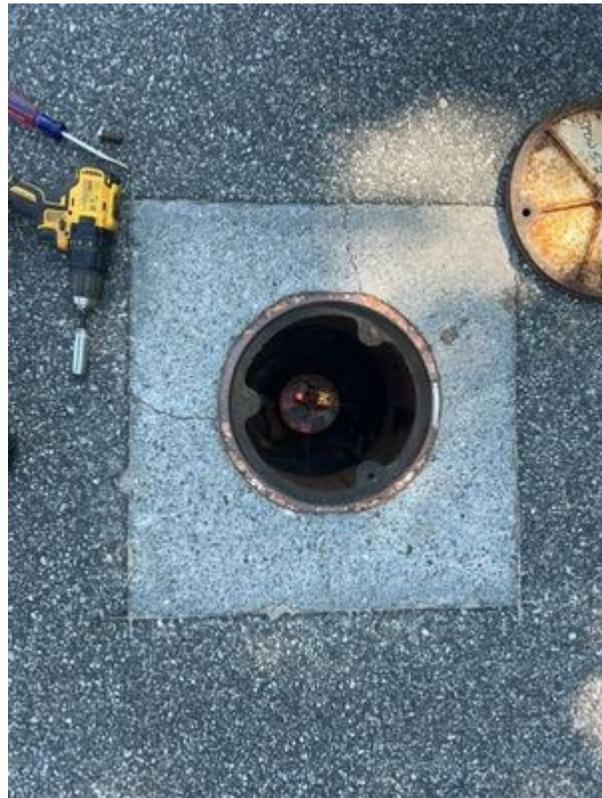
Client: Navy CLEAN	Facility: NWIRP Bethpage
Project Number: 112G08005-WE13	Location: Bethpage, New York
Date: July 19, 2024 09:32	Personnel: Jake Marlow
Well ID: BPOW5-2	Well Location: 198410.124010887 1127154.18468571
Well Status: In Use (Confirmed)	Screen Interval: 540-580
WELL INVENTORY CONDITION	
Concrete pad in acceptable condition i.e. no cracks?	NO
Manhole cover present and in working condition?	YES
All bolts on manhole present and not stripped?	NO
Well plug present, locked and in good working condition?	YES
OVERALL CONDITION:	FAIR
Notes (Explain if answered No to any of the above) Cracks in pad, bolts sheared off in manhole

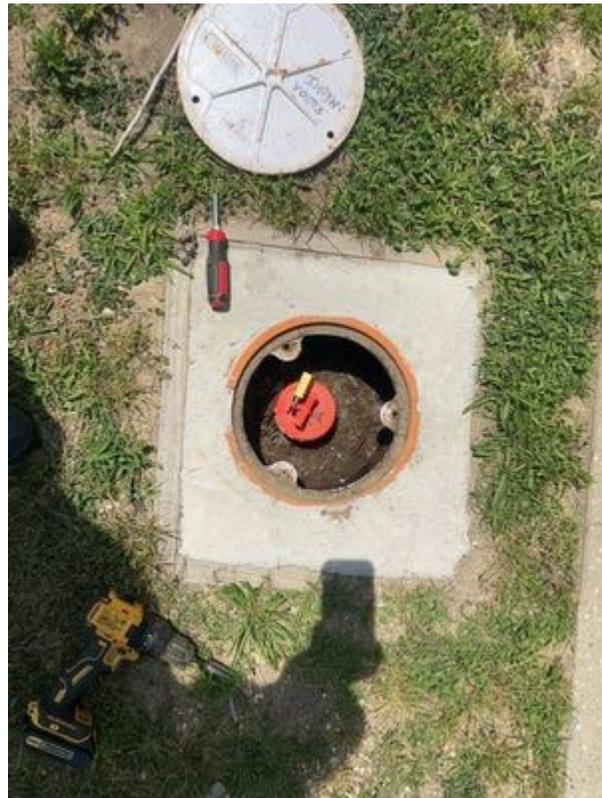
Client: Navy CLEAN	Facility: NWIRP Bethpage
Project Number: 112G08005-WE13	Location: Bethpage, New York
Date: June 13, 2024 13:24	Personnel: Jake Marlow
Well ID: BPOW2-3	Well Location: 199716.628183534 1127374.40432031
Well Status: In Use (Confirmed)	Screen Interval: 564-594
WELL INVENTORY CONDITION	
Concrete pad in acceptable condition i.e. no cracks?	NO
Manhole cover present and in working condition?	YES
All bolts on manhole present and not stripped?	NO
Well plug present, locked and in good working condition?	YES
OVERALL CONDITION:	FAIR
Notes (Explain if answered No to any of the above) Cracked pad, bolt threads on manhole are stripped

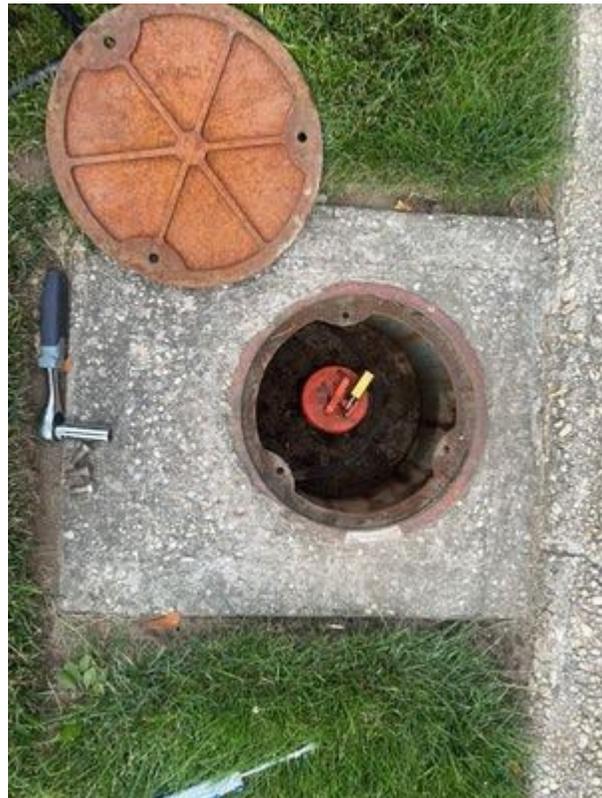
Client: Navy CLEAN	Facility: NWIRP Bethpage
Project Number: 112G08005-WE13	Location: Bethpage, New York
Date: June 12, 2024 17:45	Personnel: Jake Marlow
Well ID: RE103D3	Well Location: 206691.075809102 1125144.33629072
Well Status: In Use (Confirmed)	Screen Interval: 715-730
WELL INVENTORY CONDITION	
Concrete pad in acceptable condition i.e. no cracks?	YES
Manhole cover present and in working condition?	YES
All bolts on manhole present and not stripped?	NO
Well plug present, locked and in good working condition?	YES
OVERALL CONDITION:	FAIR
Notes (Explain if answered No to any of the above) Bolt threads on manhole are stripped
