Bayer MaterialScience LLC  
125 New South Road – Hicksville, New York  
Administration Building  
Pre-Demolition Survey Report

On behalf of Bayer MaterialScience LLC (Bayer), ARCADIS of New York, Inc. (ARCADIS) has prepared this letter summarizing the results of the November 2013 pre-demolition survey activities conducted at the Administration Building of the Bayer facility located in Hicksville, New York (site). The pre-demolition survey activities were conducted to locate, identify, quantify, and sample building materials and other materials of concern, including asbestos. The survey activities were conducted to provide data and information for evaluating material handling in connection with the planned demolition of the Administration Building.

January 29, 2014

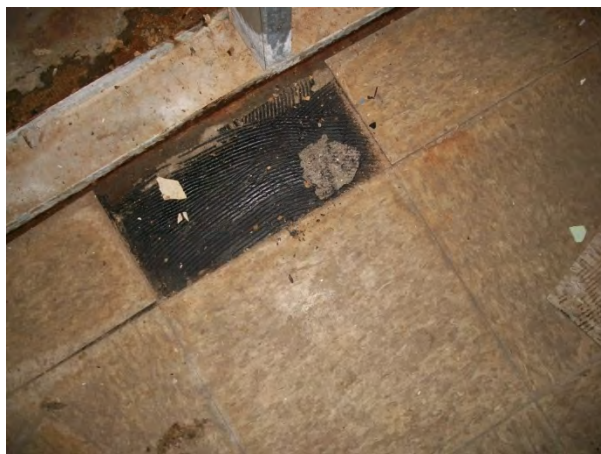
| HA No. | Material Description | Room(s)/Location | Sample Number | Condition | Friability | Asbestos Content | Estimated Quantity | Unit | Notes |
|---|---|---|---|---|---|---|---|---|---|
| 1 | 12" x 12" Beige with Brown Specks Floor Tile | South East Offices | 175685<br>175686 | Damaged | Non-Friable | NAD | 360 | SF | |

HA-1: 12" x 12" Beige with Brown Specks Floor Tile; HA-2: Black Mastic associated with HA-1

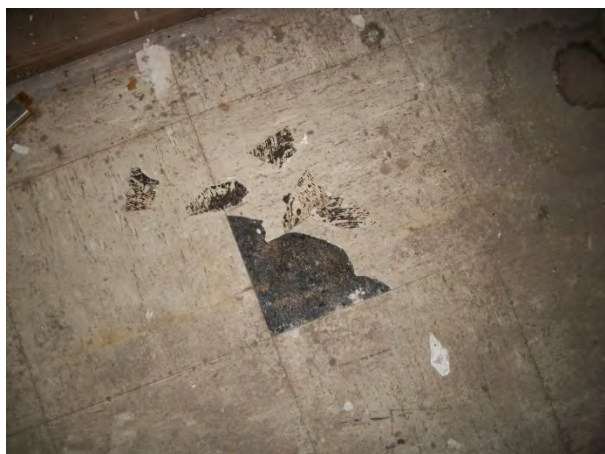
| HA No. | Material Description | Room(s)/Location | Sample Number | Condition | Friability | Asbestos Content | Estimated Quantity | Unit | Notes |
|---|---|---|---|---|---|---|---|---|---|
| 3 | 12" x 12" White with Black Specks Floor Tile | Former Lab | 175689<br>175690<br>175691 | Damaged | Non-Friable | 3.5% Chrysotile | 730 | SF | |

HA-3: 12" x 12" White with Black Specks Floor Tile; HA-4: Black Mastic associated with HA-3

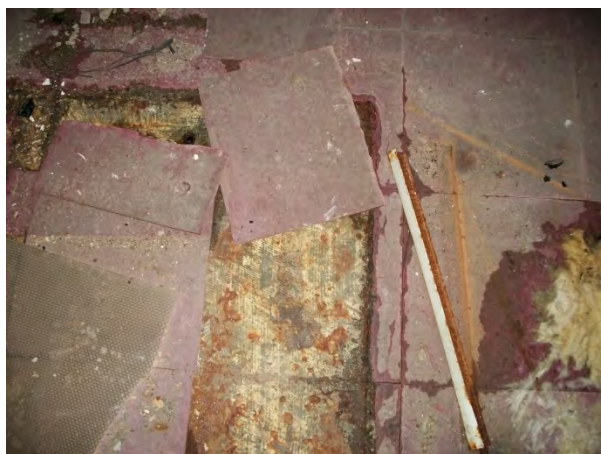
| HA No. | Material Description | Room(s)/Location | Sample Number | Condition | Friability | Asbestos Content | Estimated Quantity | Unit | Notes |
|---|---|---|---|---|---|---|---|---|---|
| 5 | 12" x 12" Purple Mottled Floor Tile | East Office | 175695<br>175696 | Damaged | Non-Friable | <1% Chrysotile | 150 | SF | U.S. EPA regulates material containing greater than 1% asbestos. |

HA-5: 12" x 12" Purple Mottled Floor Tile; HA-6: Yellow Mastic associated with HA-5

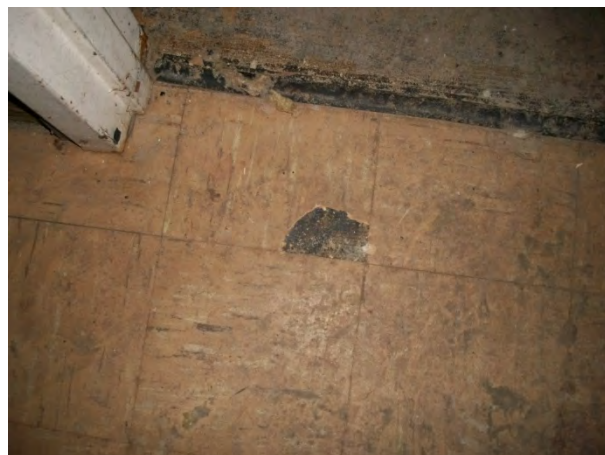
| HA No. | Material Description | Room(s)/Location | Sample Number | Condition | Friability | Asbestos Content | Estimated Quantity | Unit | Notes |
|---|---|---|---|---|---|---|---|---|---|
| 7 | 9" x 9" Beige with Brown Streaks Floor Tile | North East Hallway and associated Offices | 175699<br>175700<br>175701 | Damaged | Non-Friable | 2.3% Chrysotile | 360 | SF | |

HA-7: 9" x 9" Beige with Brown Streaks Floor Tile; HA-8: Black Mastic associated with HA-7

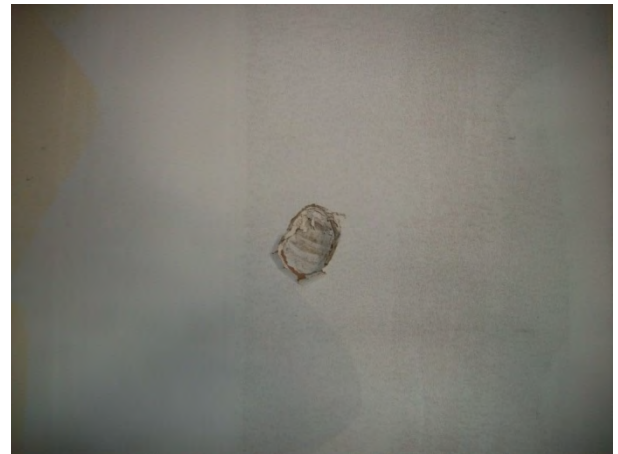
| HA No. | Material Description | Room(s)/Location | Sample Number | Condition | Friability | Asbestos Content | Estimated Quantity | Unit | Notes |
|---|---|---|---|---|---|---|---|---|---|
| 15 | Gypsum Board | Throughout | 175718<br>175719<br>175720 | Damaged | Friable | NAD | 15,220 | SF | Due to the inability to effectively separate the non-asbestos-containing gypsum board (HA-15) from the asbestos-containing joint compound (HA-16), the gypsum board should be managed as asbestos waste. |

HA-15: Gypsum Board

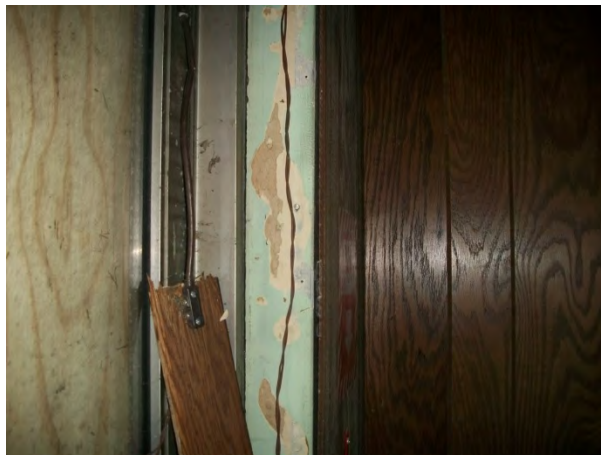
| HA No. | Material Description | Room(s)/Location | Sample Number | Condition | Friability | Asbestos Content | Estimated Quantity | Unit | Notes |
|---|---|---|---|---|---|---|---|---|---|
| 16 | Yellow Joint Compound associated with HA-15 | East Side | 175721<br>175722<br>175723<br>175724<br>175725 | Damaged | Friable | 3.39% Chrysotile | 8,220 | SF | Material was damaged and contamination was observed throughout the east side of the building. |

HA-16: Yellow Joint Compound associated with HA-15

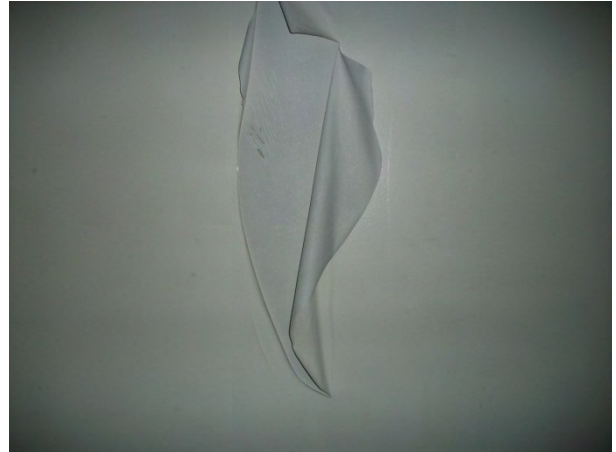
| HA No. | Material Description | Room(s)/Location | Sample Number | Condition | Friability | Asbestos Content | Estimated Quantity | Unit | Notes |
|---|---|---|---|---|---|---|---|---|---|
| 19 | White Joint Compound associated with HA-15 | West Side | 175732<br>175733<br>175734<br>175735<br>175736 | Damaged | Friable | NAD | 7,000 | SF | |

HA-19: White Joint Compound associated with  
HA-15

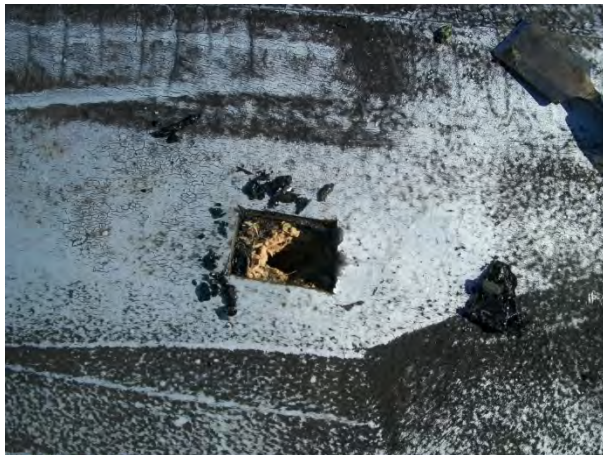
| HA No. | Material Description | Room(s)/Location | Sample Number | Condition | Friability | Asbestos Content | Estimated Quantity | Unit | Notes |
|---|---|---|---|---|---|---|---|---|---|
| 27 | Built-Up Roofing | Main Roof Field | 175758<br>175759<br>175760 | Damaged | Non-Friable | 2.1% Chrysotile | 7,560 | SF | Layer 2 |

**HA-26: Silver Coated Rolled Asphalt Roofing;  
HA-27: Built-Up Roofing associated with Main  
Roof Field**

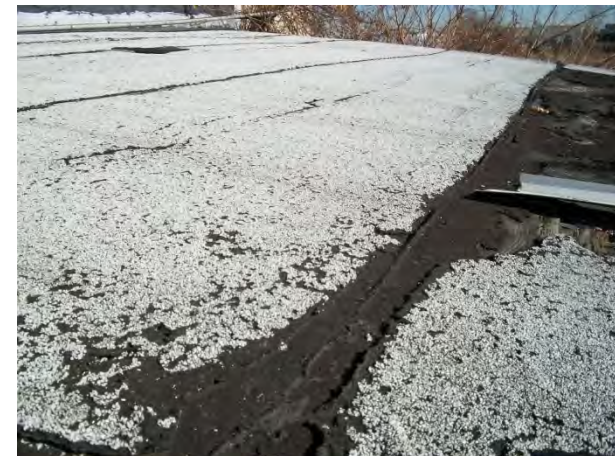
| HA No. | Material Description | Room(s)/Location | Sample Number | Condition | Friability | Asbestos Content | Estimated Quantity | Unit | Notes |
|---|---|---|---|---|---|---|---|---|---|
| 30 | Rolled Asphalt Shingle | South East Storage Roof | 175767<br>175768 | Damaged | Non-Friable | NAD | 400 | SF | |

**HA-30: Rolled Asphalt Shingle associated with  
South East Storage Roof**
