MEMO

Bayer MaterialScience LLC
125 New South Road, Hicksville, New York
Phase 2 Operable Unit 4 Remedial Activities
October 1, 2014 Weekly Construction Coordination Meeting Summary
Weekly Progress Report #4 (September 22, 2014 – September 26, 2014)

Weekly Progress Report #4 (September 22, 2014 – September 26, 2014)

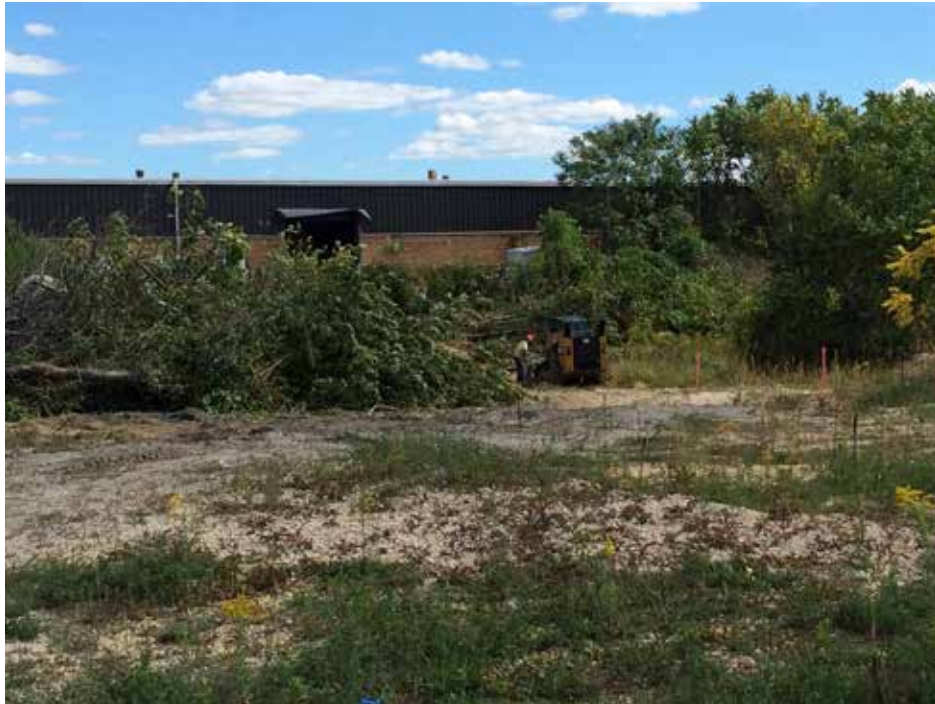
Posillico conducting site clearing activities with the Caterpillar 299D Compact Track Loader.

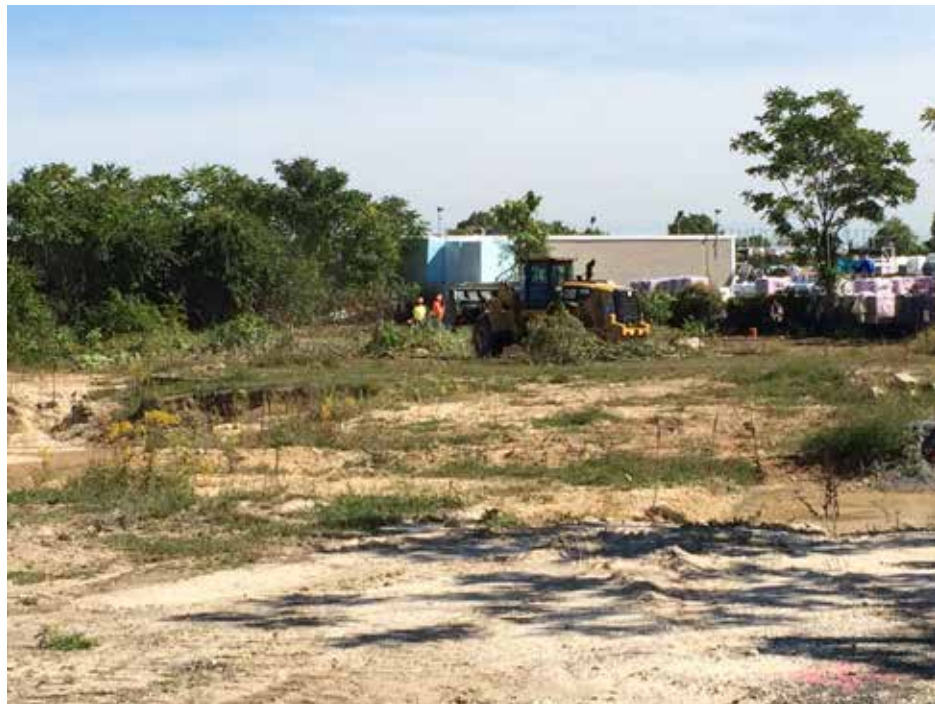
Posillico conducting site clearing activities with the Caterpillar 950K Loader.

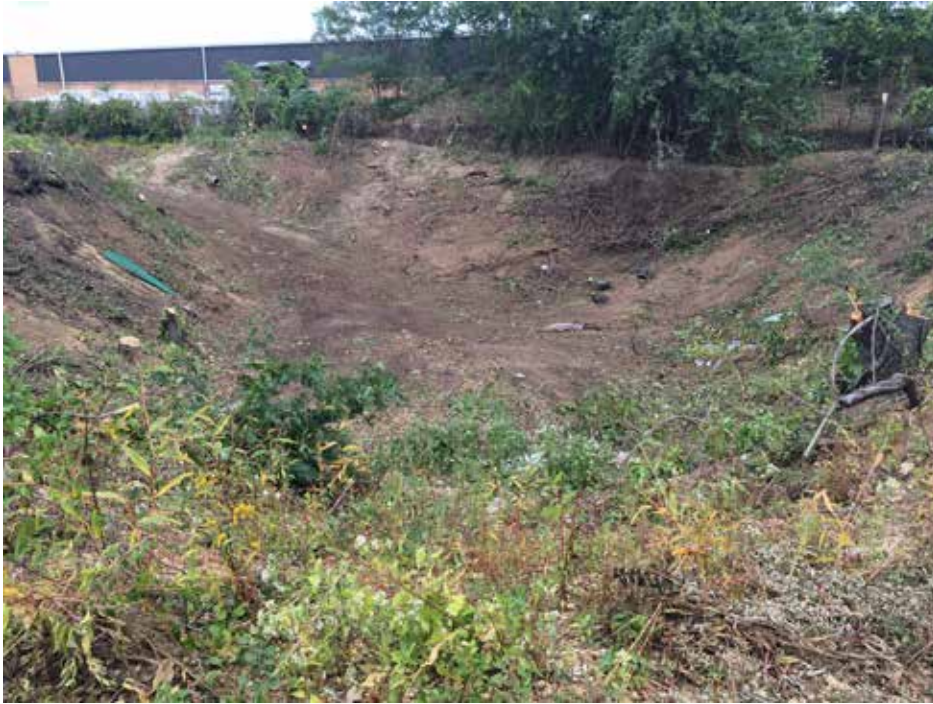
View of Sump No. 1 Area with clearing completed.

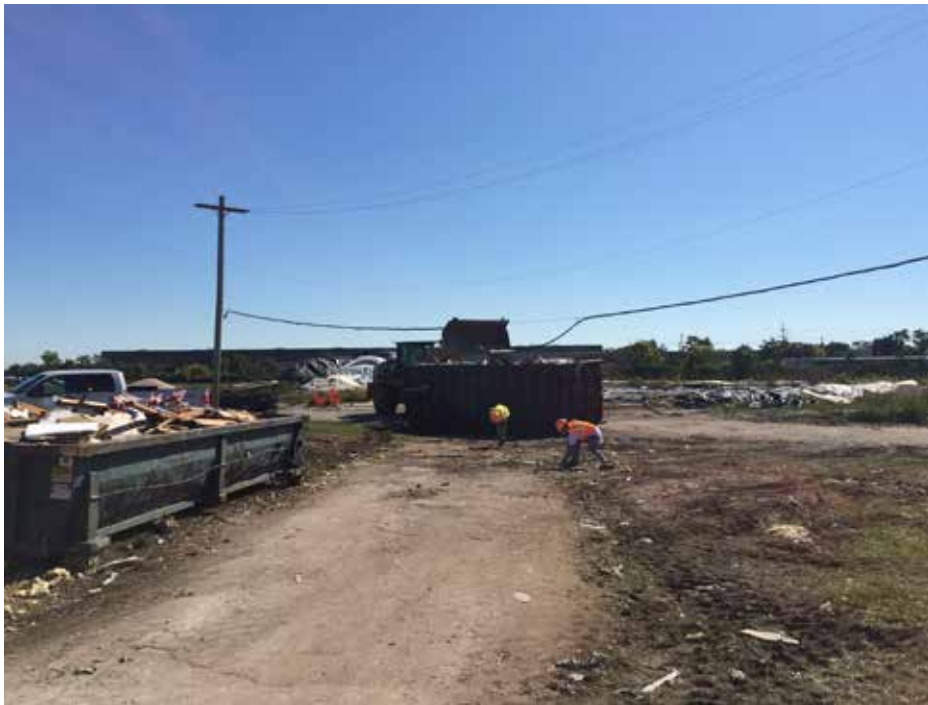
Posillico loading scrap metal into roll-off container.

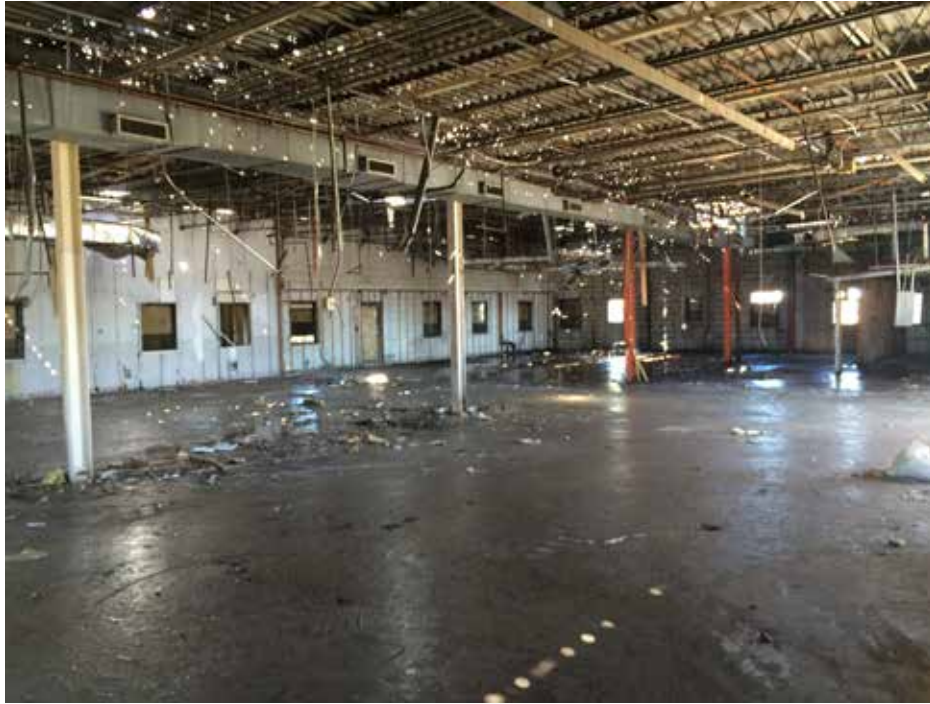
The inside of the Administration Building (east side) showing construction and demolition debris removal completion.

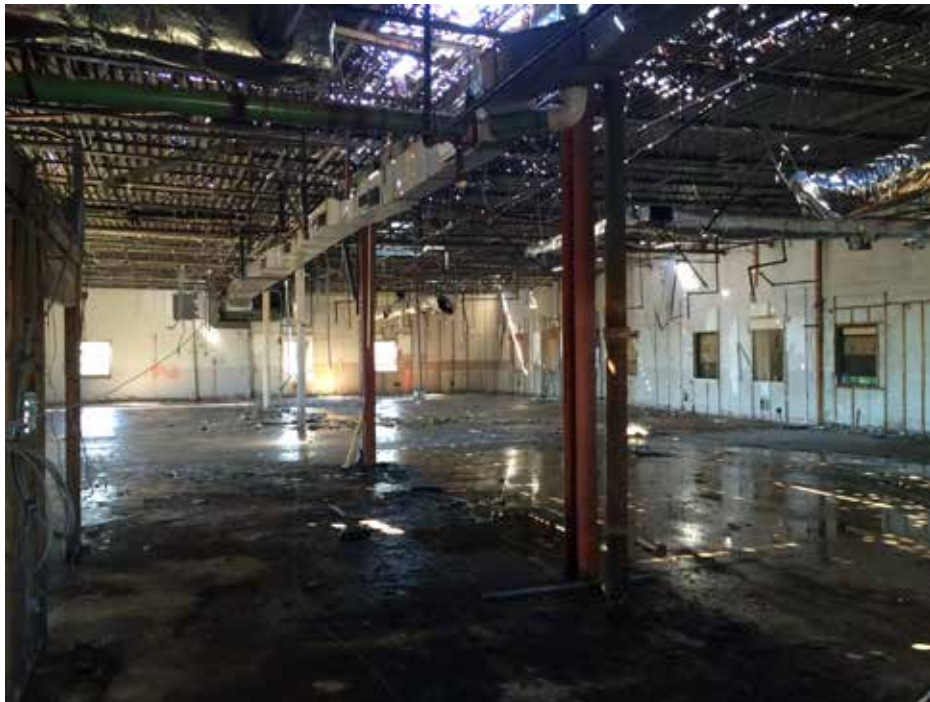
The inside of the Administration Building (west side) showing construction and demolition debris removal completion.

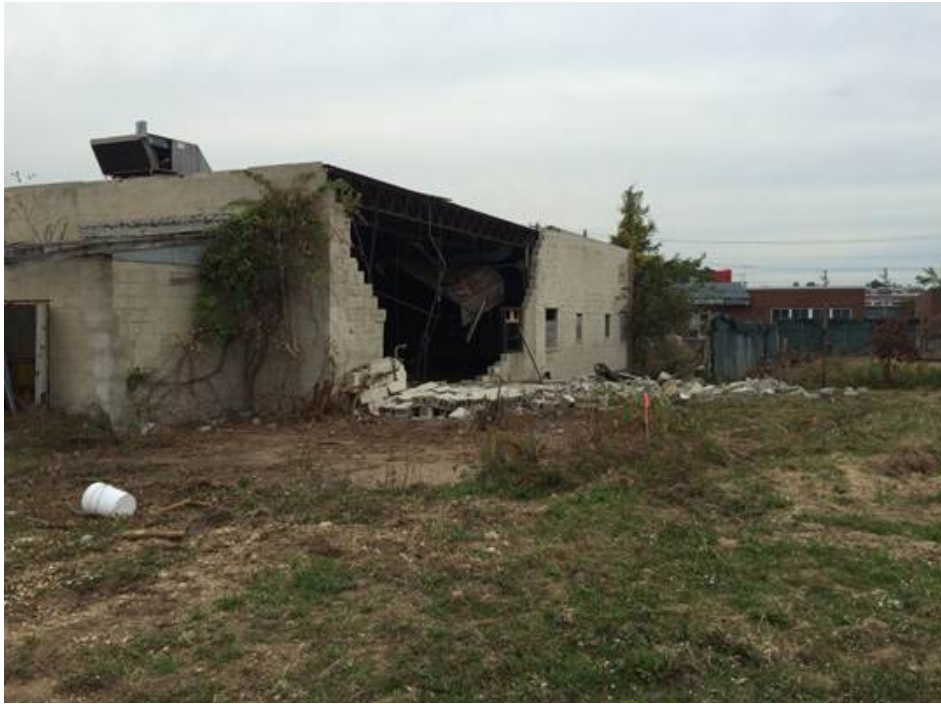
- ARCADIS informed the NYSDEC that part of the cinderblock wall on the eastern exterior of the Administration Building collapsed outward during the removal of a mezzanine from inside the eastern portion of the building. Posillico's team working inside the building observed the wall starting to bow outward and kept a safe distance as the wall collapsed. No injuries were reported. Posillico cordoned off the area. The wall that collapsed did not appear to be a load-bearing wall. However, no additional work will be performed inside the building until Posillico's licensed professional engineer (structural engineer) inspects the building, assesses the cause of the collapse, and develops a plan for safely addressing conditions. The inspection will also focus on actions necessary to safely remove the nearby rooftop heating, ventilation, and air conditioning unit and small amount of remaining asbestos under the unit.

East side of Administration Building after cinderblock wall collapsed outward.
