MEMO

Bayer MaterialScience LLC
125 New South Road, Hicksville, New York
Phase 2 Operable Unit 4 Remedial Activities
May 6, 2015 Bi-Weekly Construction Coordination Meeting Summary
Progress Report #26 (May 4, 2015 – May 19, 2015)

Weekly Progress Report #26 (May 4, 2015 – May 19, 2015)

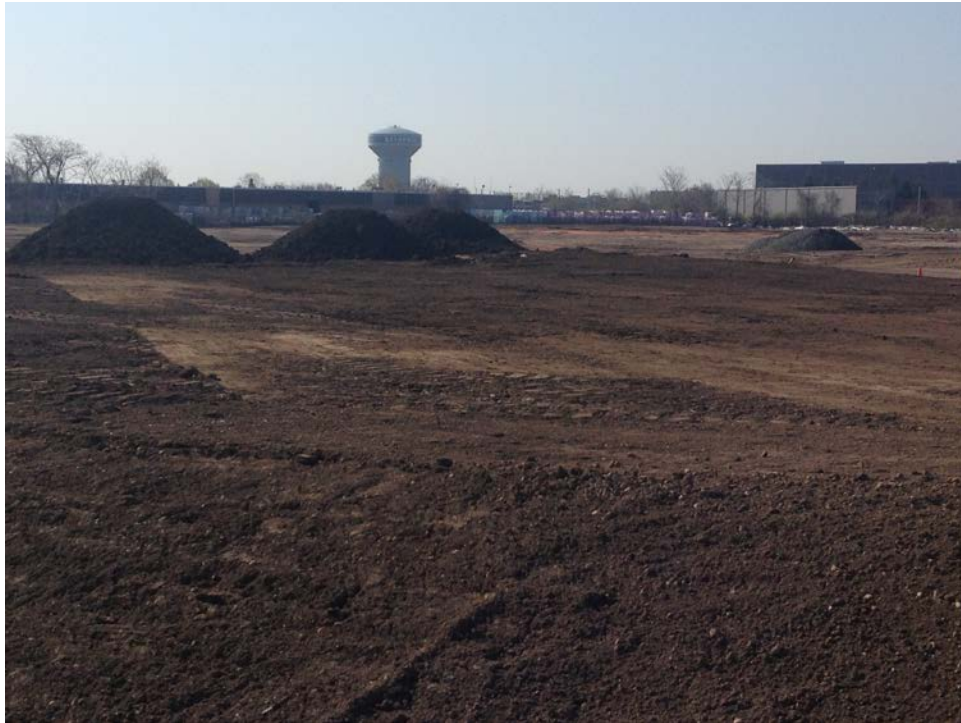
Posillico spreading topsoil across the middle of the property west of the railroad spur.

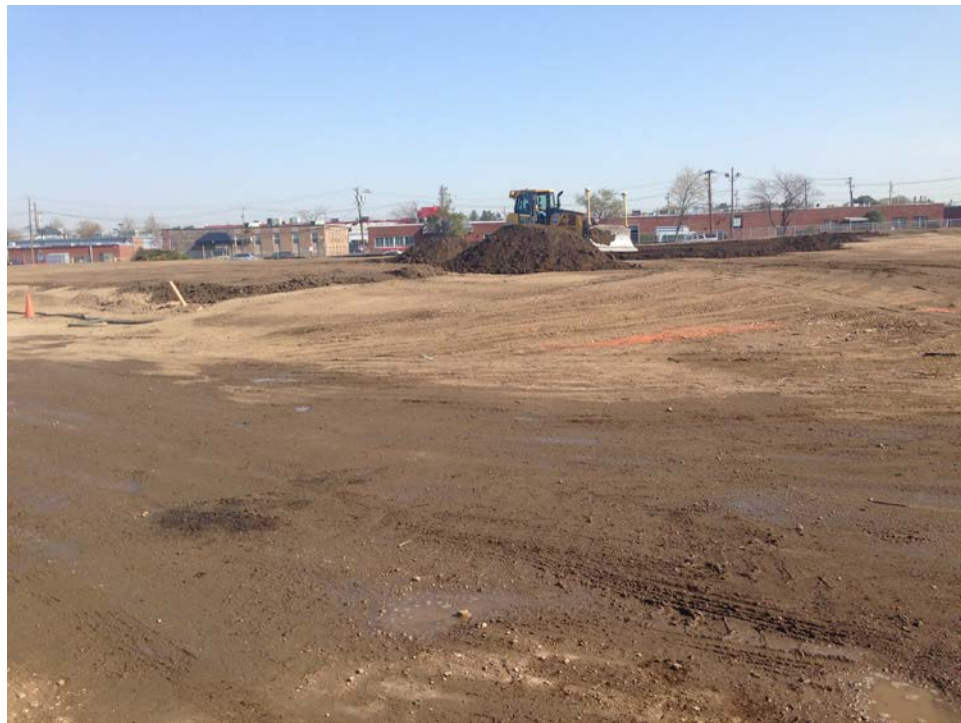
Posillico stockpiling topsoil near the middle of the Site.

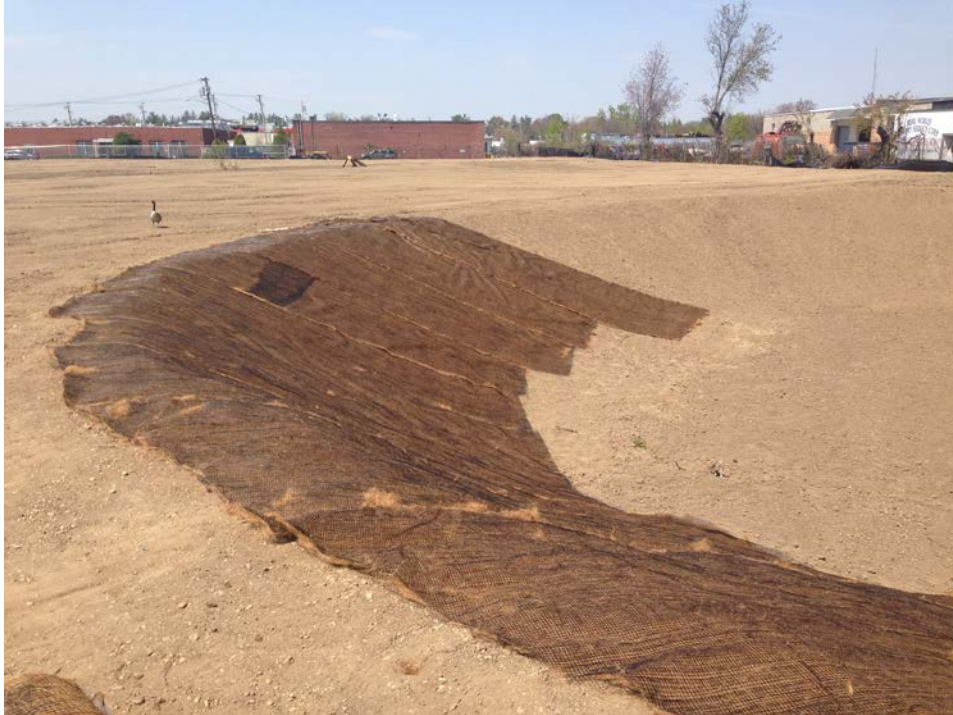
Posillico installing erosion blankets at Sump #1.

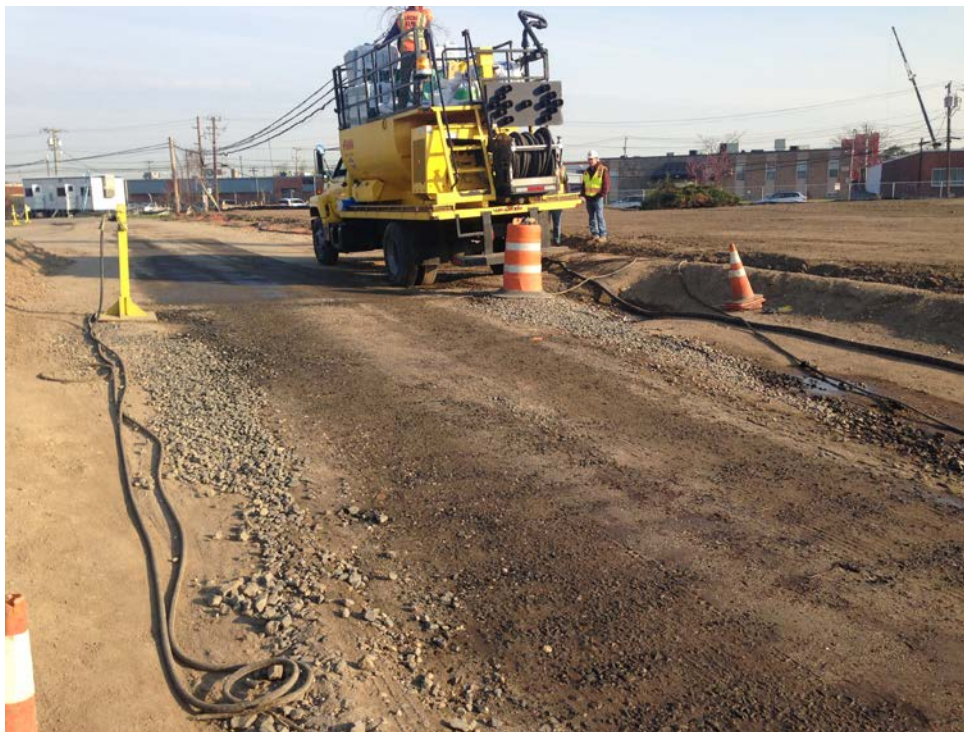
Hydroseed mixture being prepared for application.

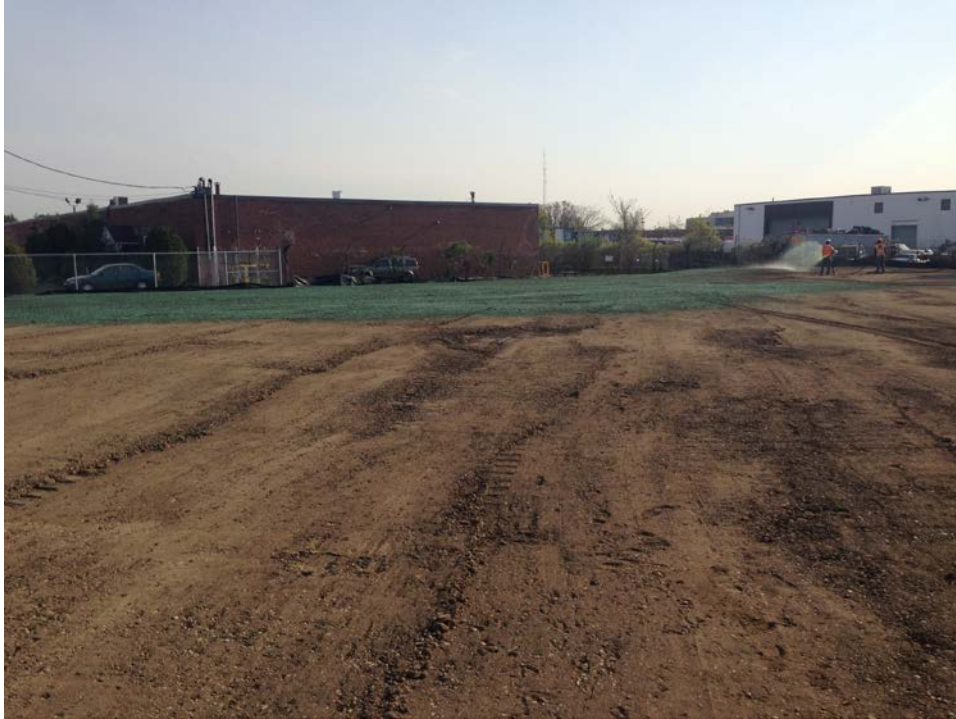
Posillico hydroseeding the northeastern corner of the Site.

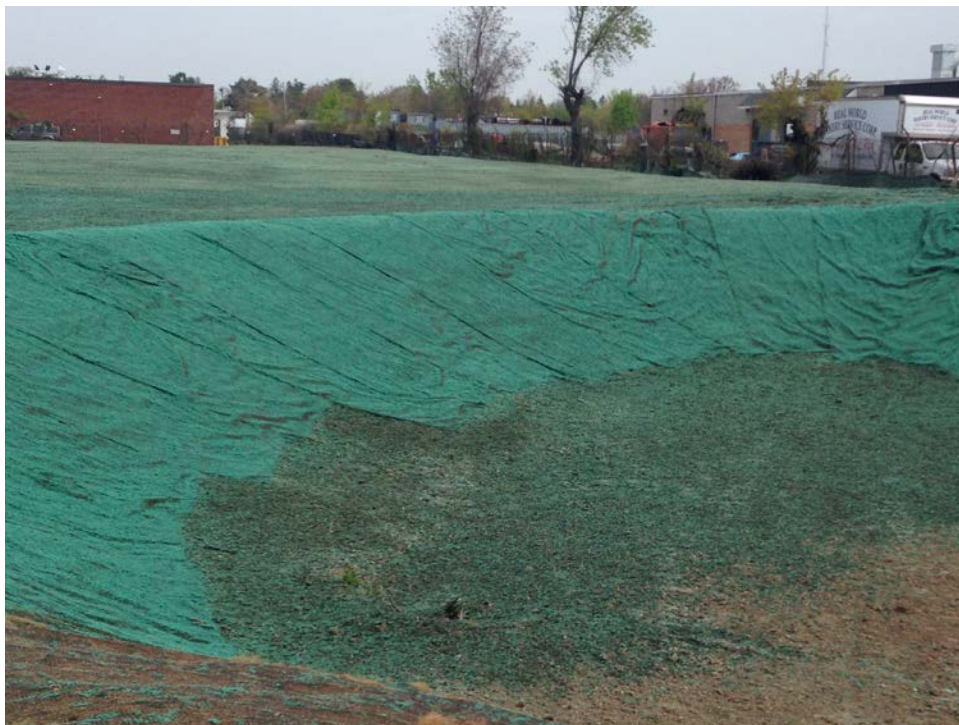
Sump #1 showing the erosion control blanket installed and hydroseeding completed.

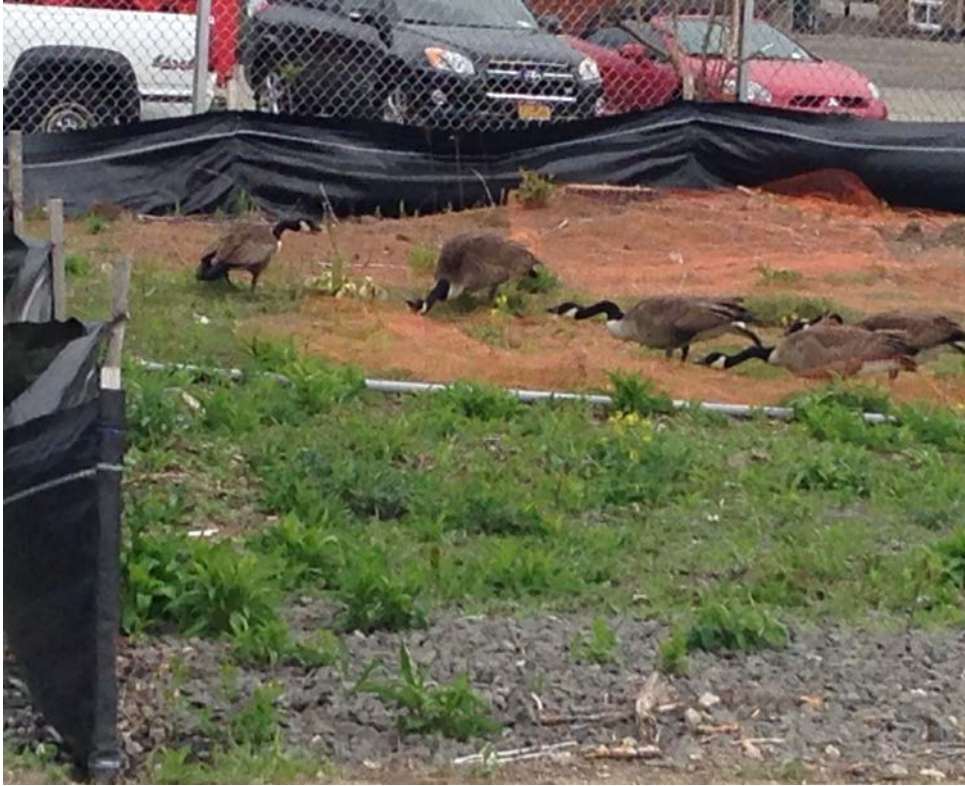
Canada geese with goslings that hatched onsite during the remedial activities.

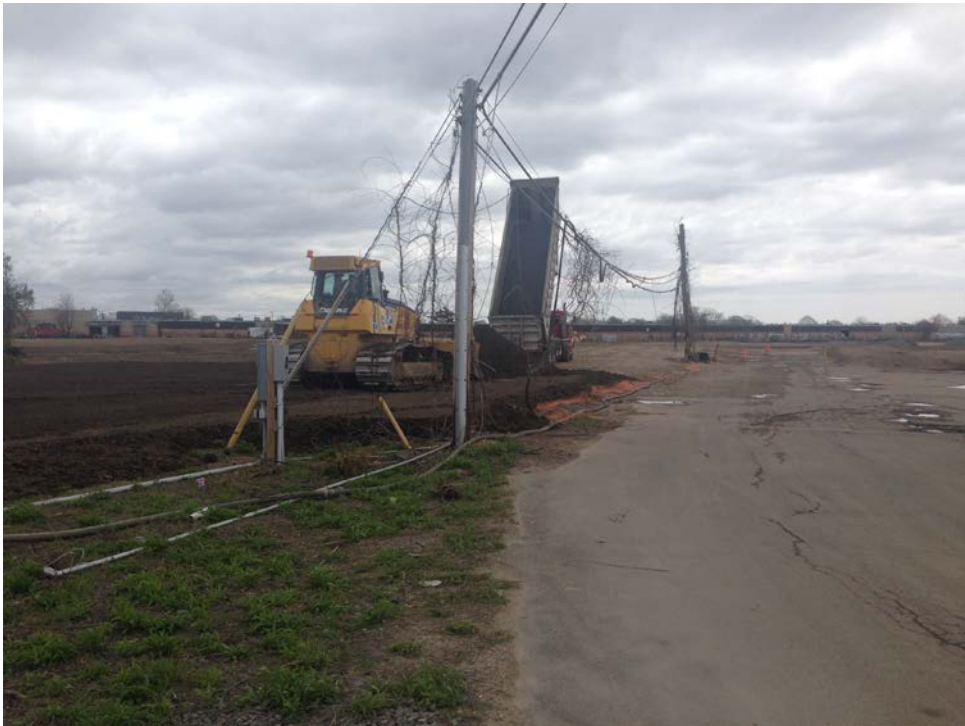
Posillico applying topsoil to the northwestern portion of the Site.

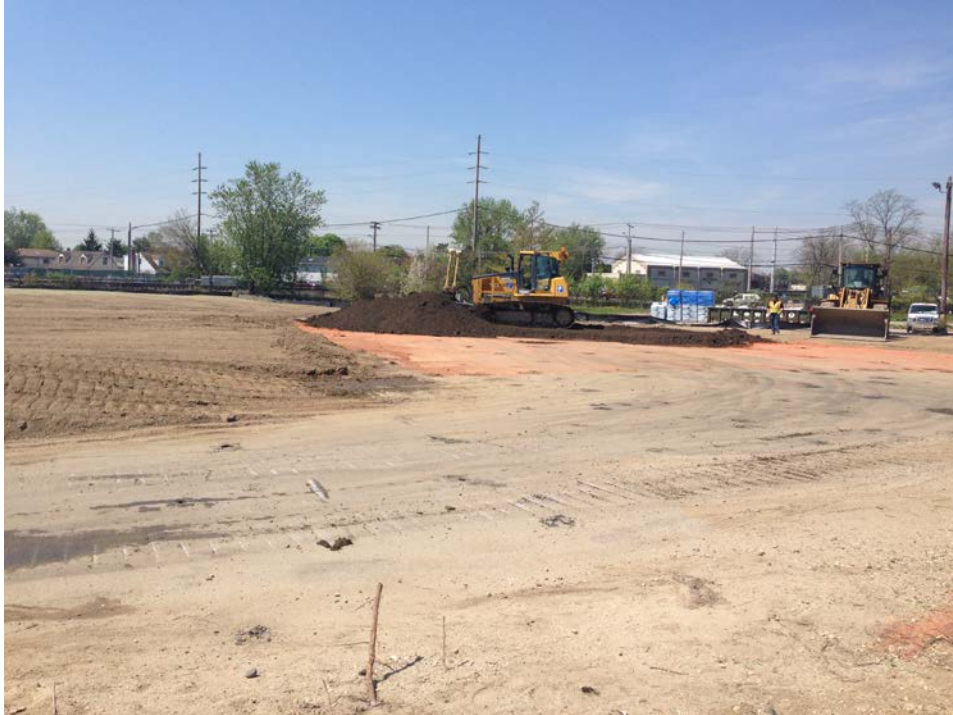
Posillico spreading general fill after placing the demarcation layer.

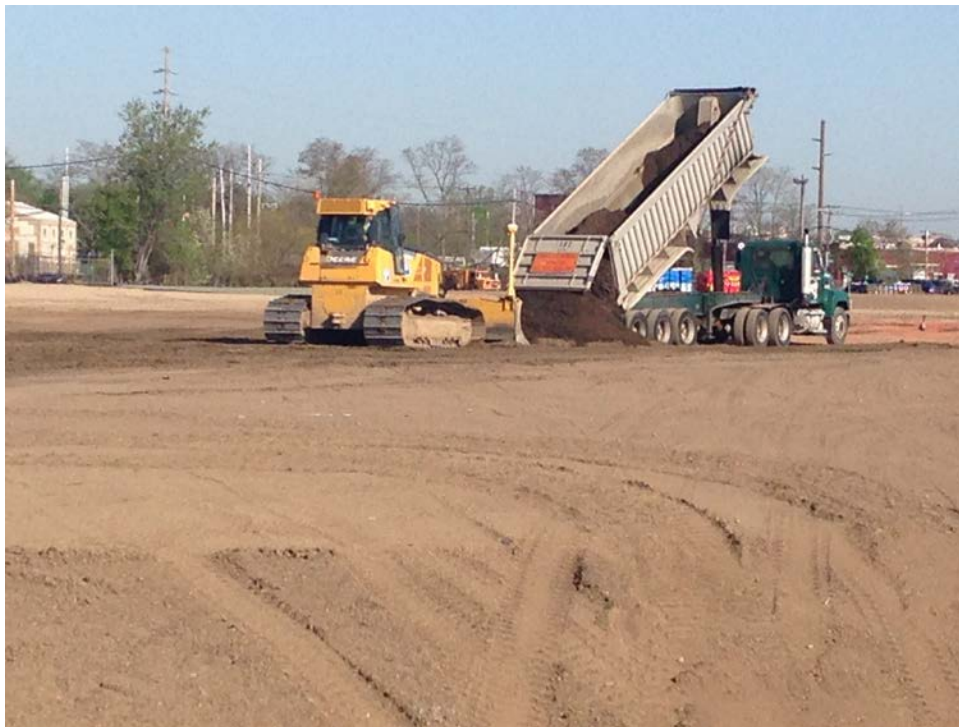
Posillico stockpiling general fill in southeastern corner of the Site.

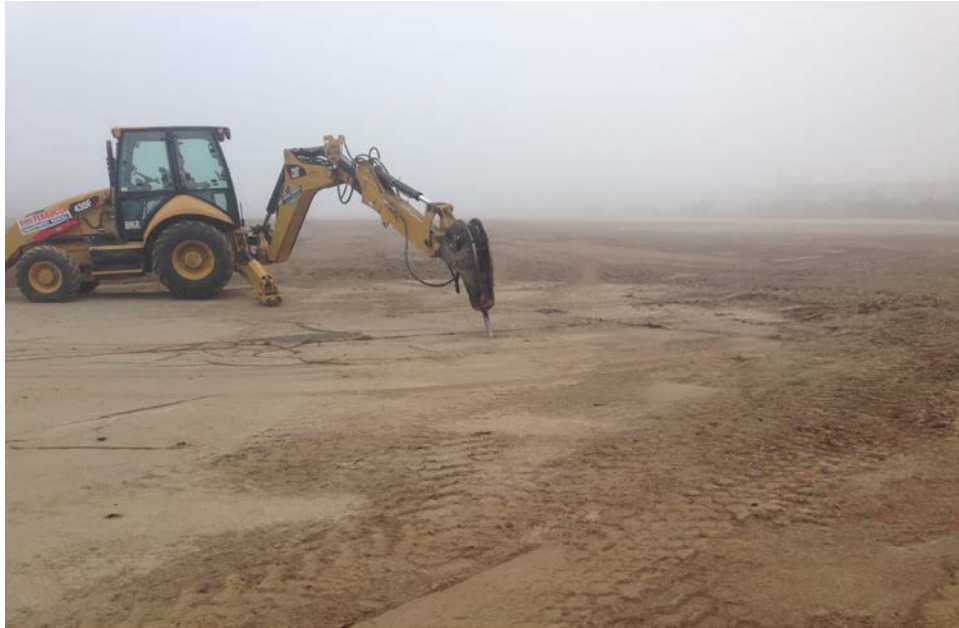
Posillico using a hoe ram to puncture holes in the asphalt pavement area before placing the soil cover system.

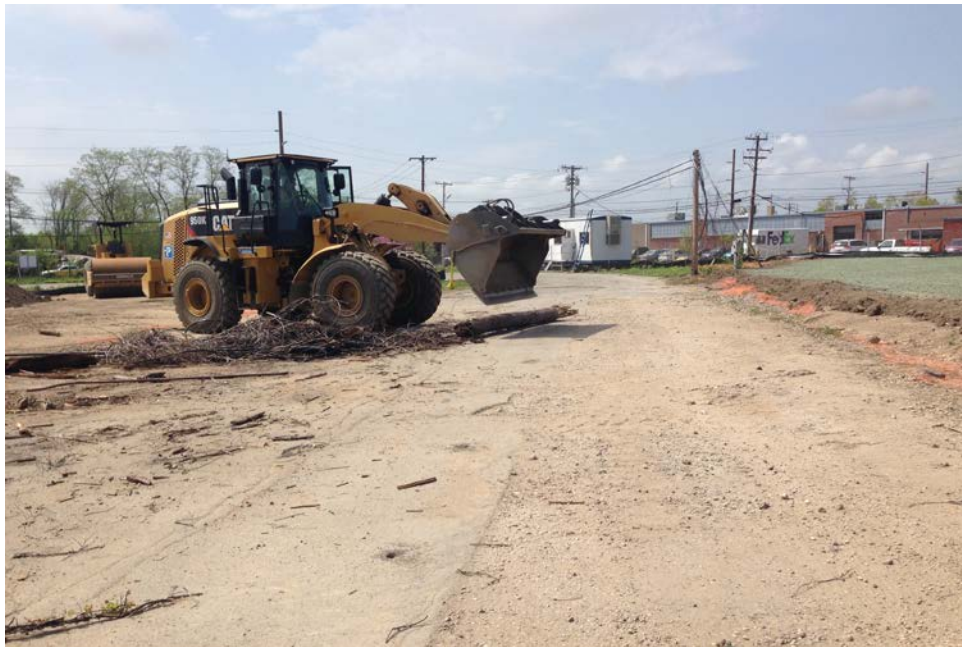
Posillico removing utility poles at the northern end of the Site.

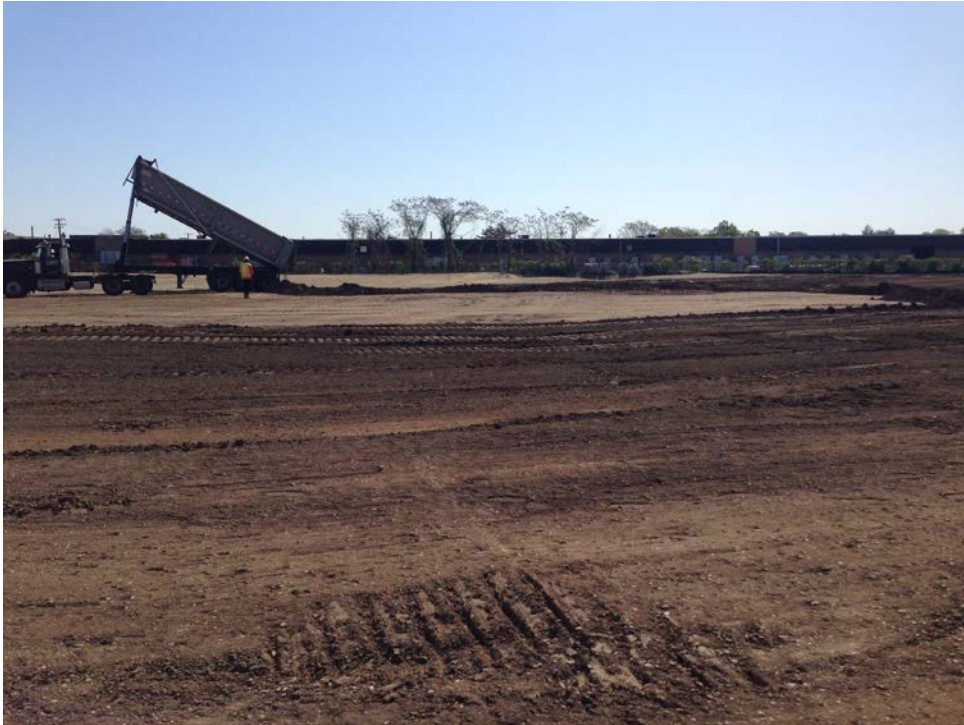
Posillico stockpiling topsoil in the southeastern corner of the Site.

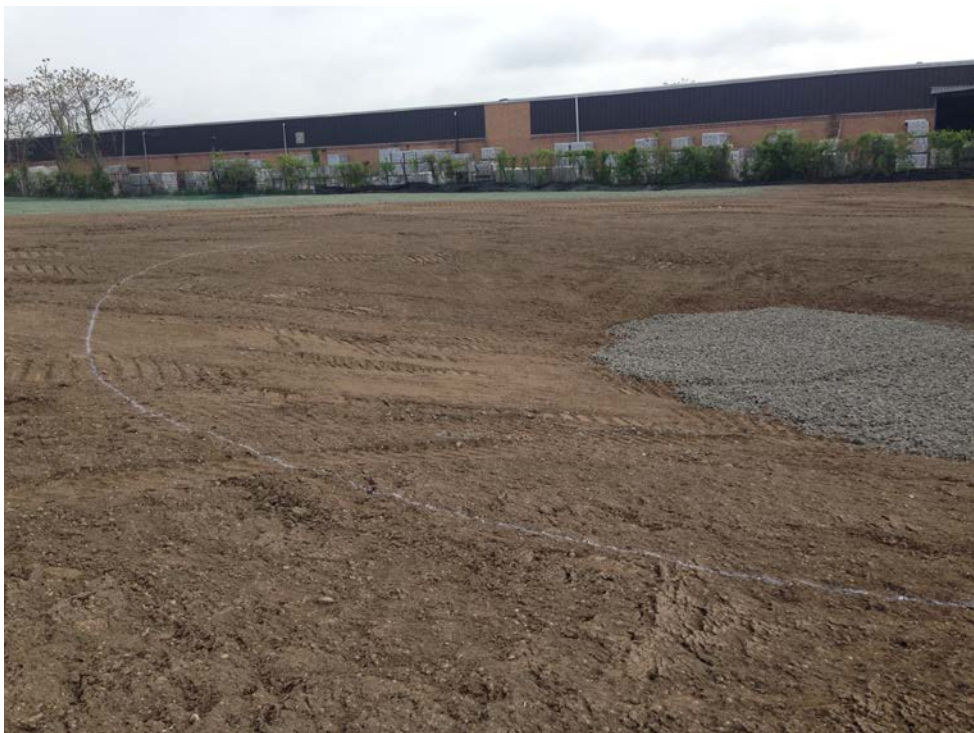
Posillico marking area to place the erosion control blankets in Sump #3.

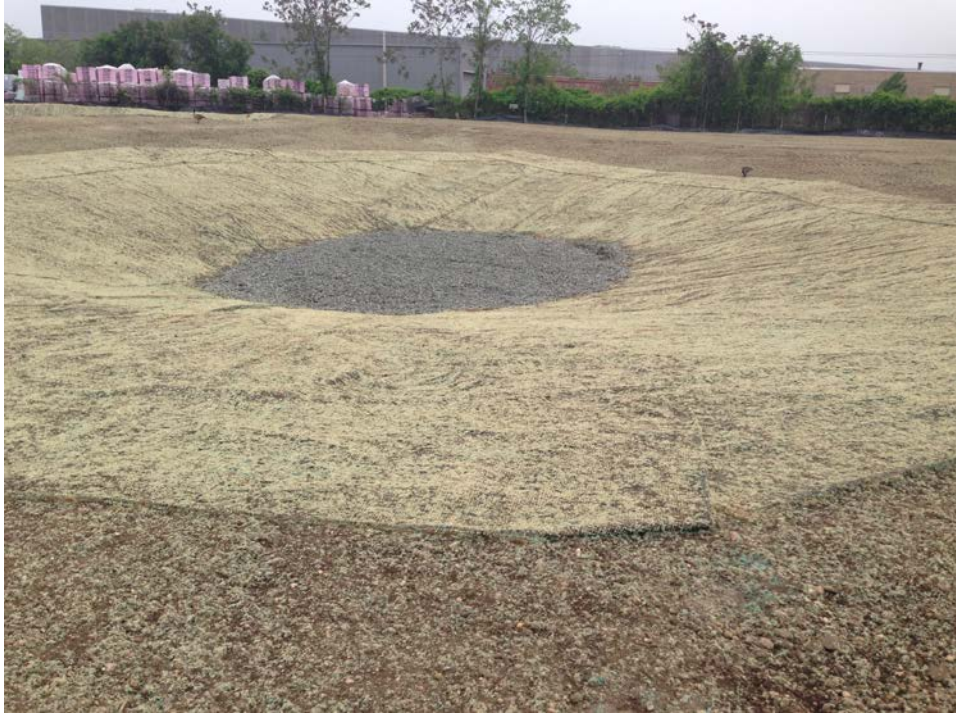
Posillico installing erosion control blanket in Sump #3.

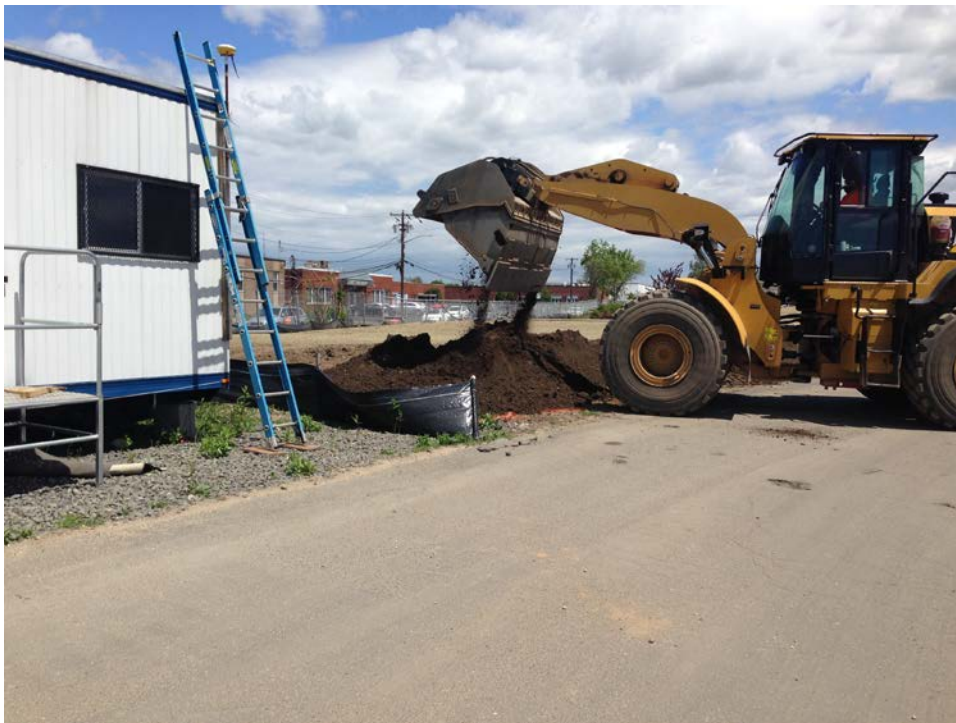
Posillico placing fill along the northwestern limit of the soil cover.

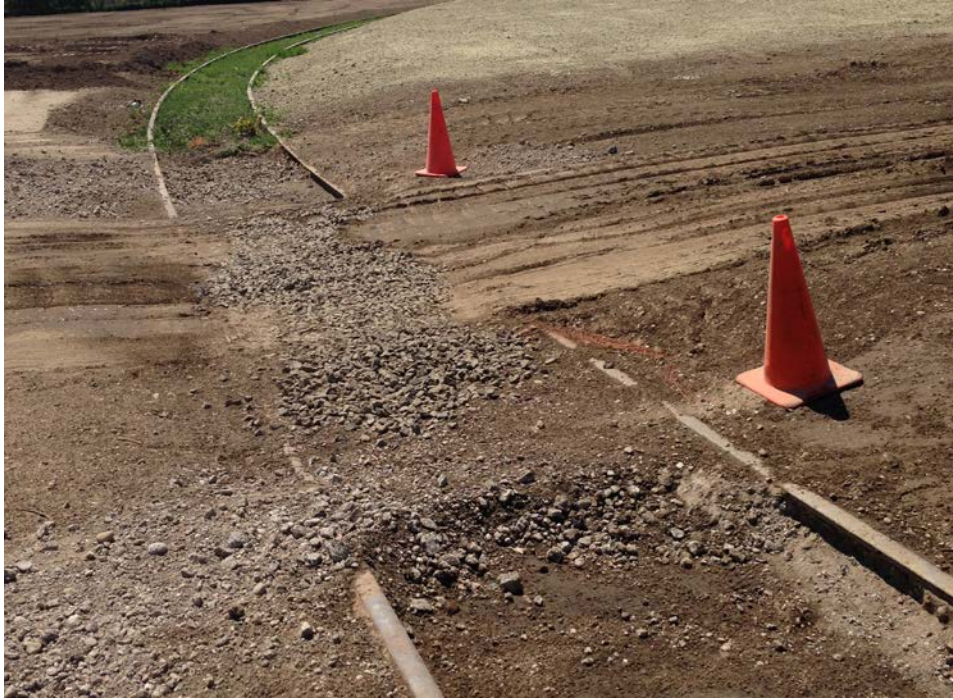
Railroad spur showing area with stone remaining to allow access to the eastern side of the site for potential lawn maintenance.

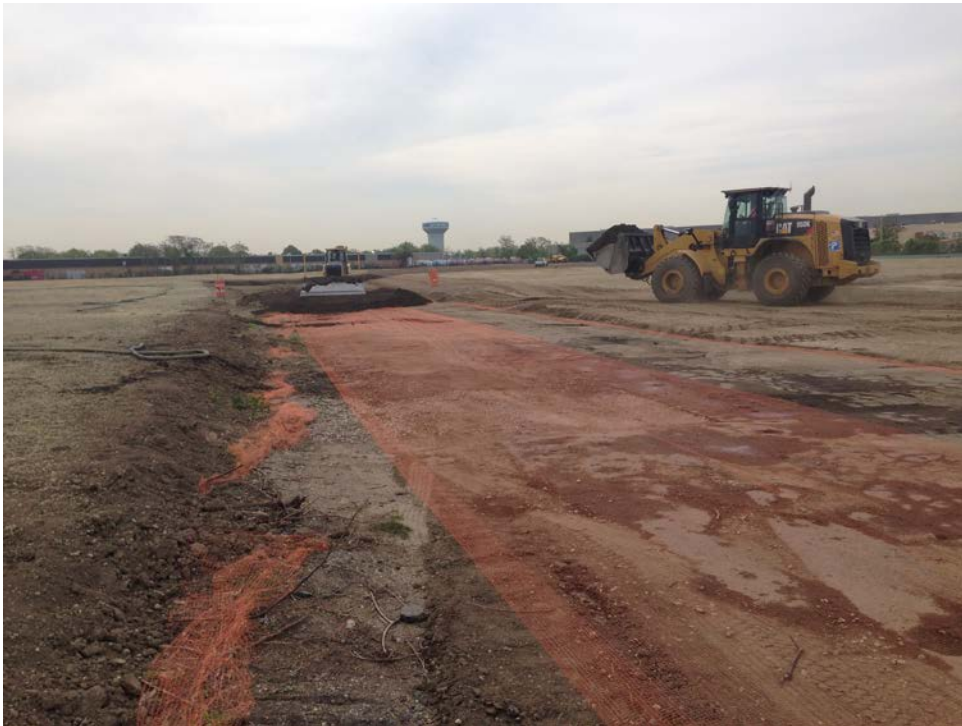
Posillico grading general fill over a demarcation layer across the truck tire wash area/site access road (remaining portion of Excavation Area 24C).

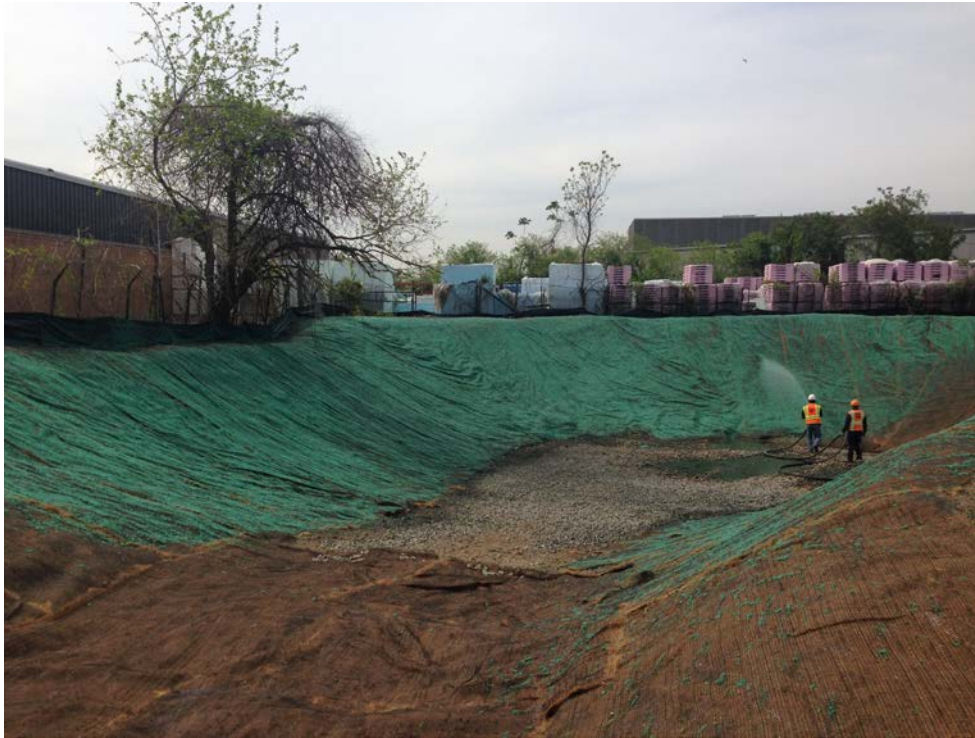
Posillico hydroseeding Sump #4 after placing the erosion control blanket.

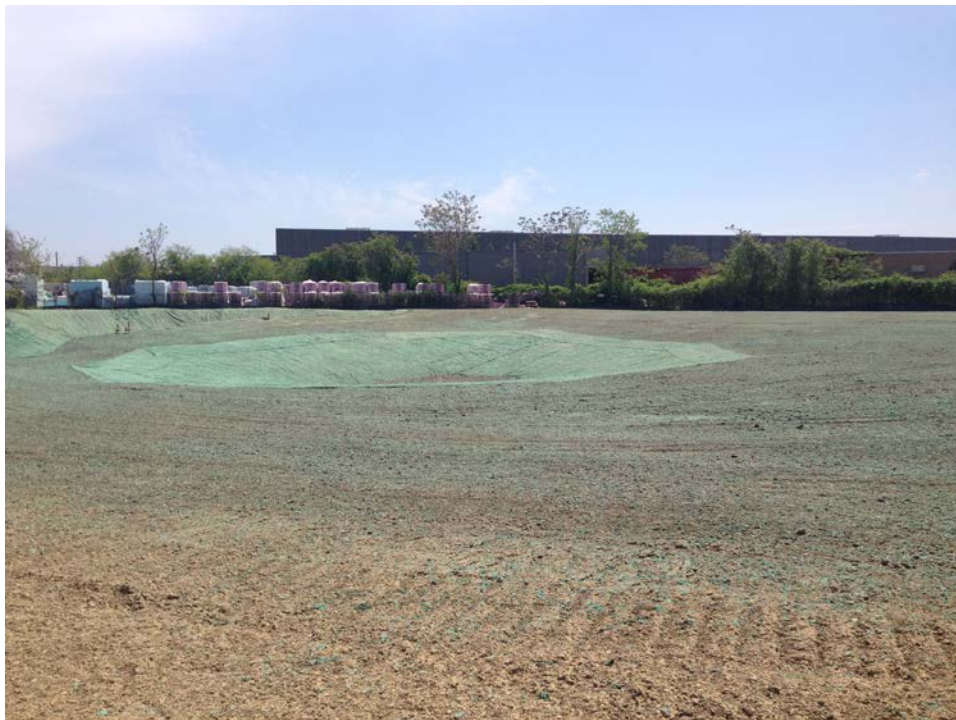
Hydroseeding completed in areas surrounding Sumps #3 and #4 (southeast corner of Site).

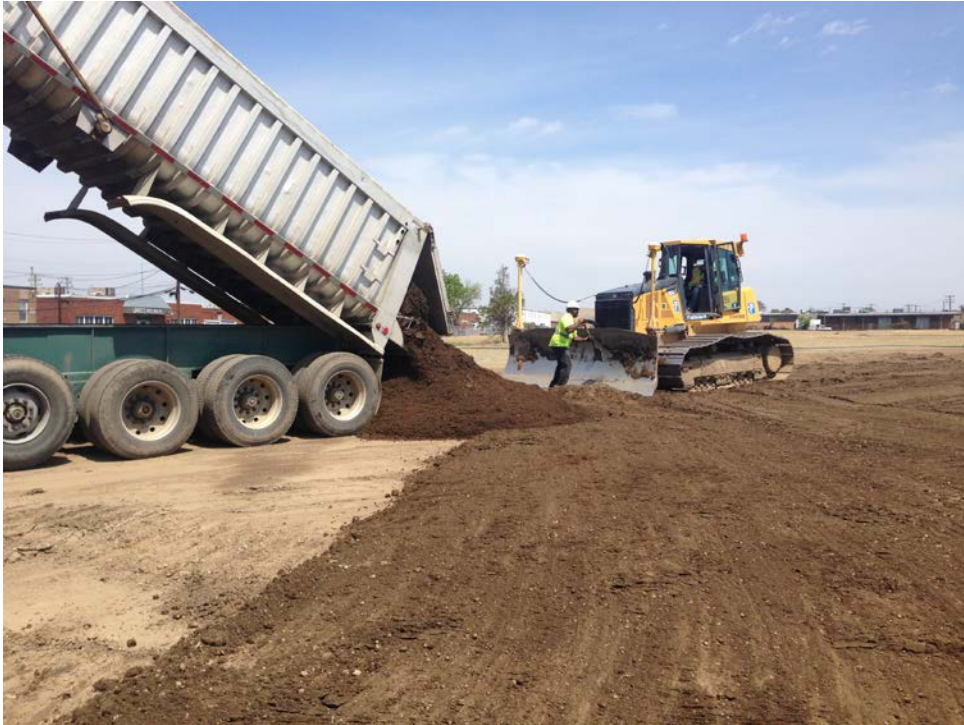
Posillico grading the final load of topsoil.

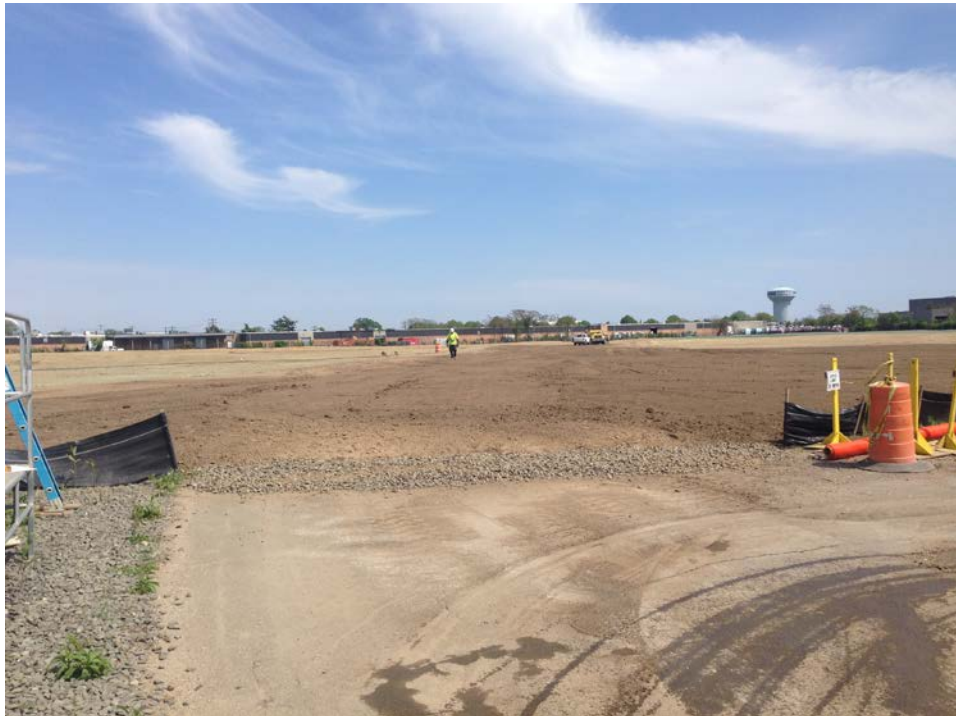
View of site from northwest asphalt parking lot showing the completed soil cover ready for hydroseeding.

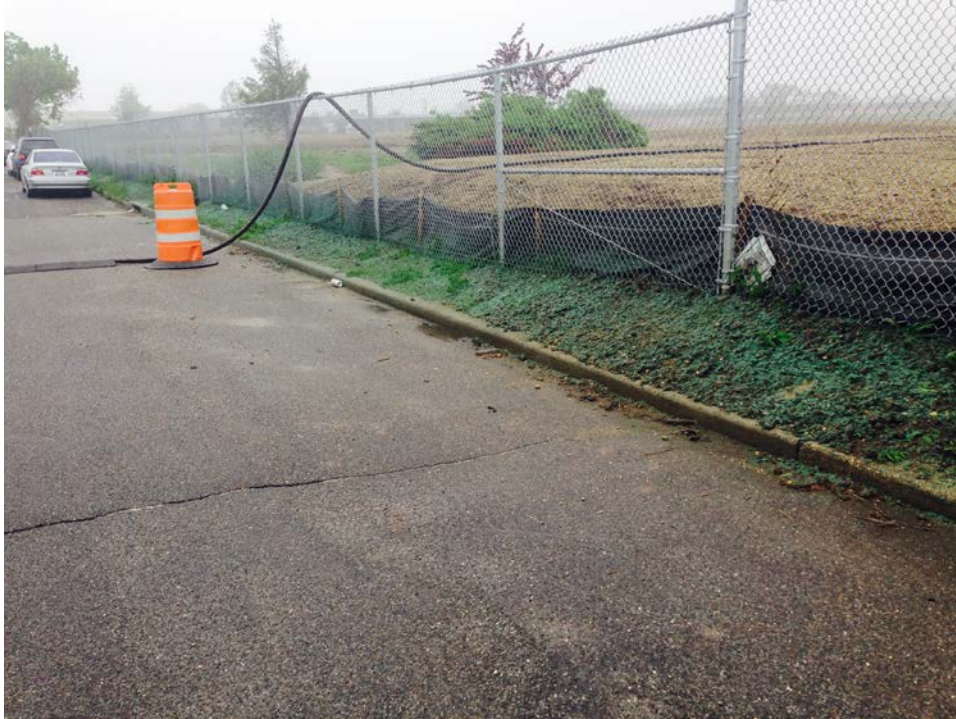
Hydroseed placed along the northern site boundary (Commerce Place).
