SYOSSET LANDFILL

2014 ANNUAL POST-CLOSURE SUMMARY REPORT

TOWN OF OYSTER BAY

**DEPARTMENT OF PUBLIC WORKS
SYOSSET, NEW YORK 11791**

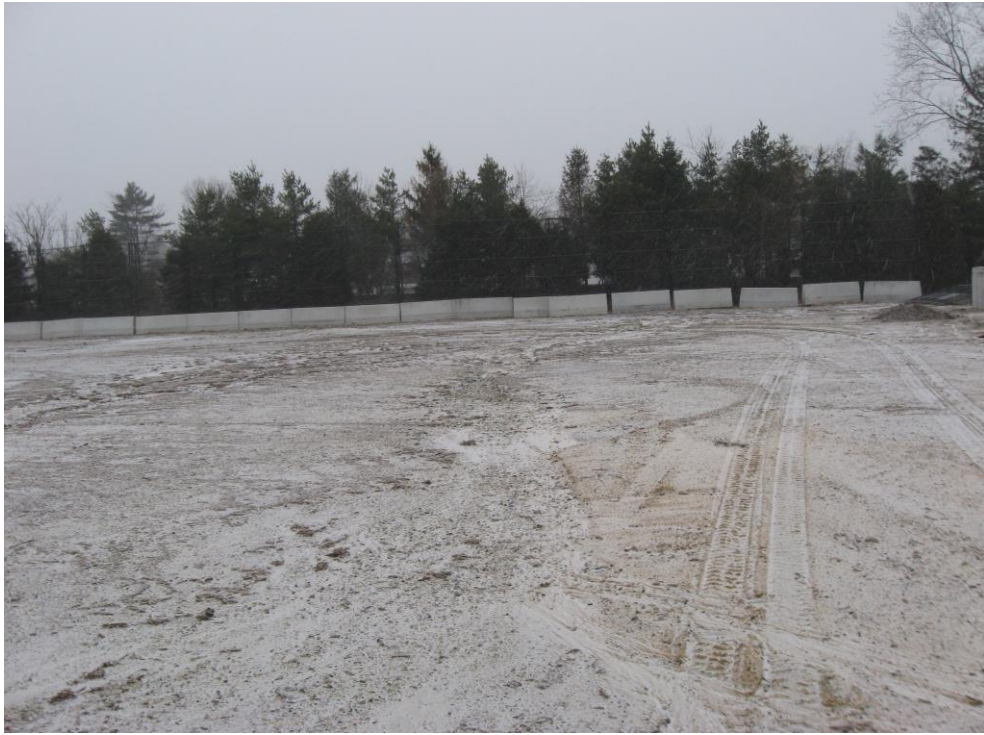
Uneven Grading - Area A

It is recommended that the ruts in the surface be filled with RCA material to prevent further erosion and to re-grade any uneven areas to maintain designed surface slopes. In addition, it is also recommended that stockpiles be placed in configurations that are perpendicular to the perimeter ditches (i.e., parallel to the surface slope) with sufficient space in between piles so that stormwater can flow unimpeded to the perimeter drainage ditches.

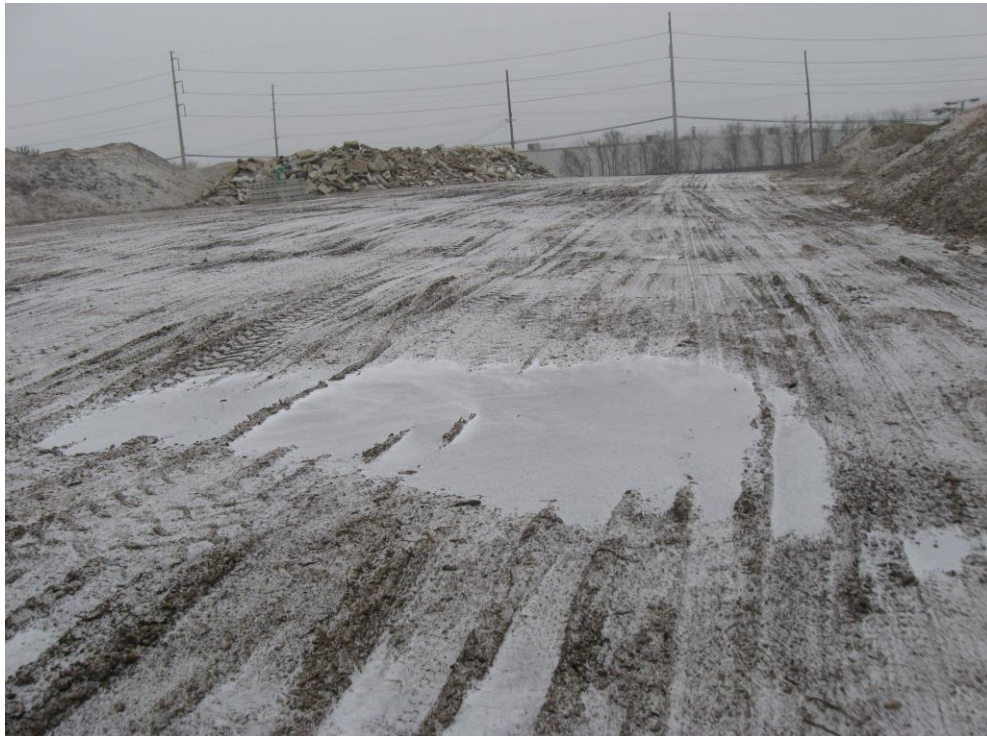
Ponding areas were observed during all four rounds of cover system inspections in 2014. The first area is located near the eastern section of the Highway Department Material Storage Facility (Area A/C border) along the asphalt access road just south of Ridge Vent R-12. This area was repaved in 2011 and while the condition improved, some ponding still occurs after rain events. The remaining ponding areas were due to uneven grading of the RCA (Areas A and B) and potholes (Areas C and E).

Ponding - Area A

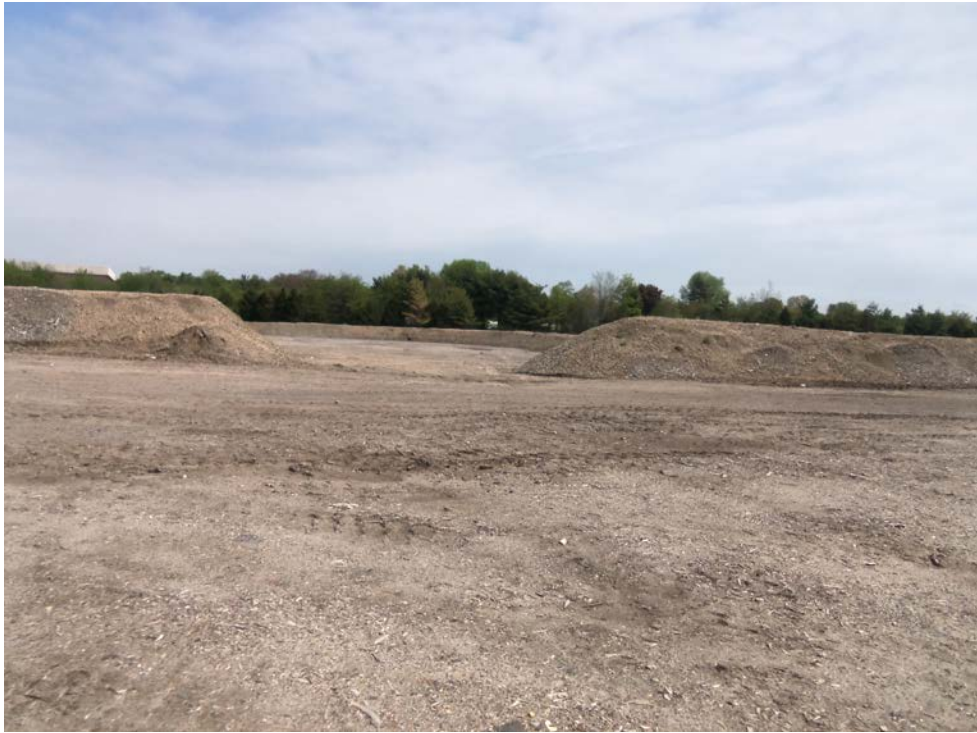
Uneven Grading - Area A

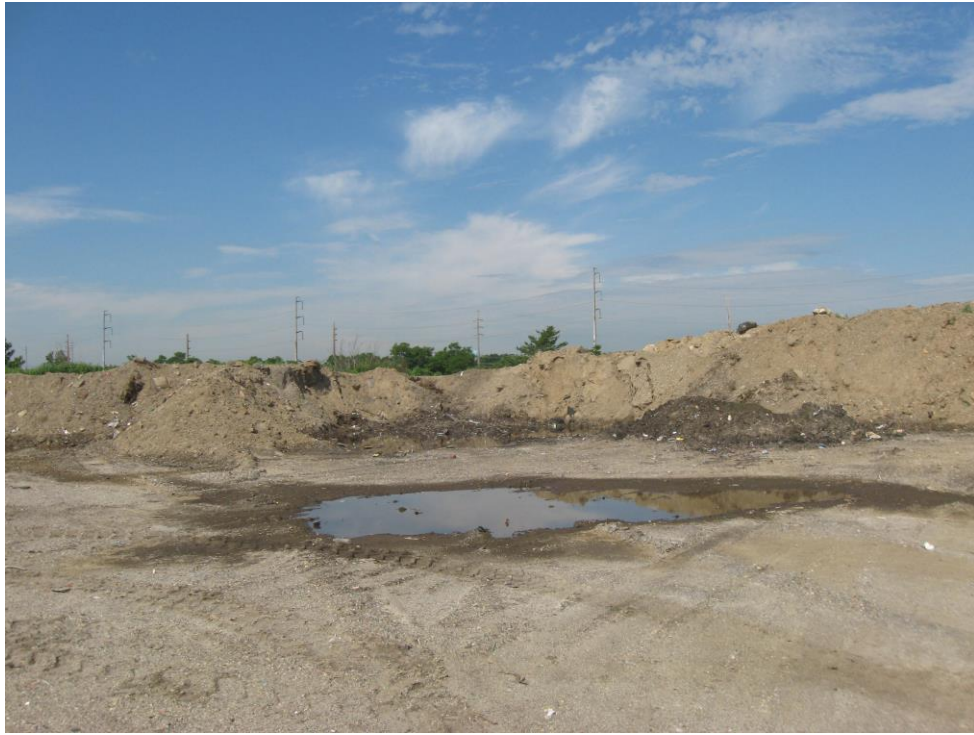
Ponding - Area A

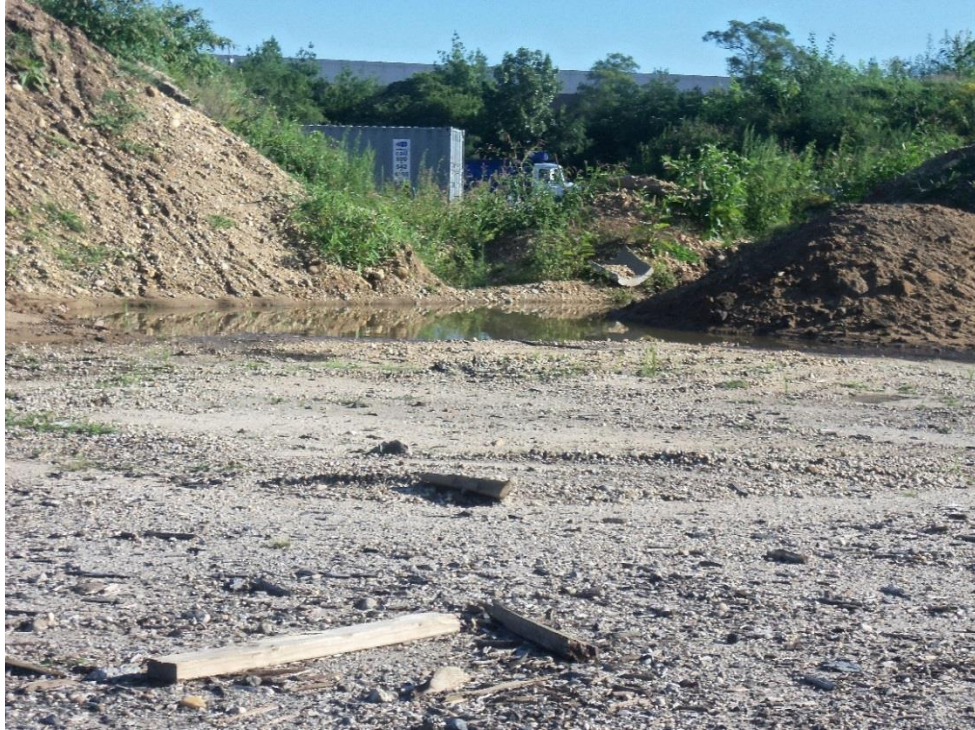
Ponding in Area A

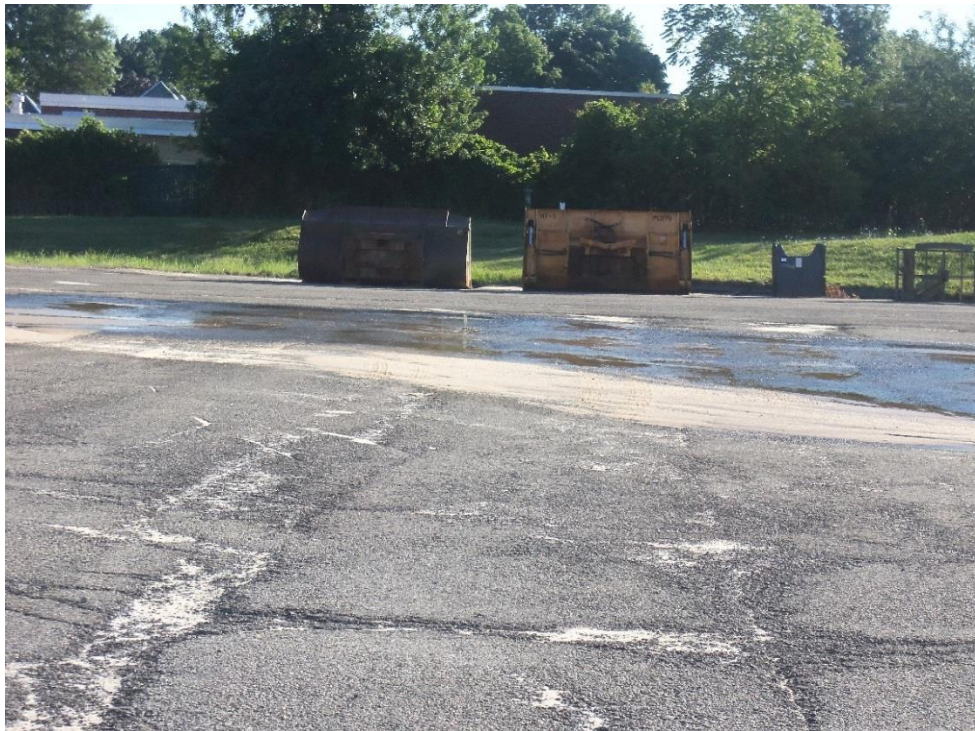
Ponding in Area C

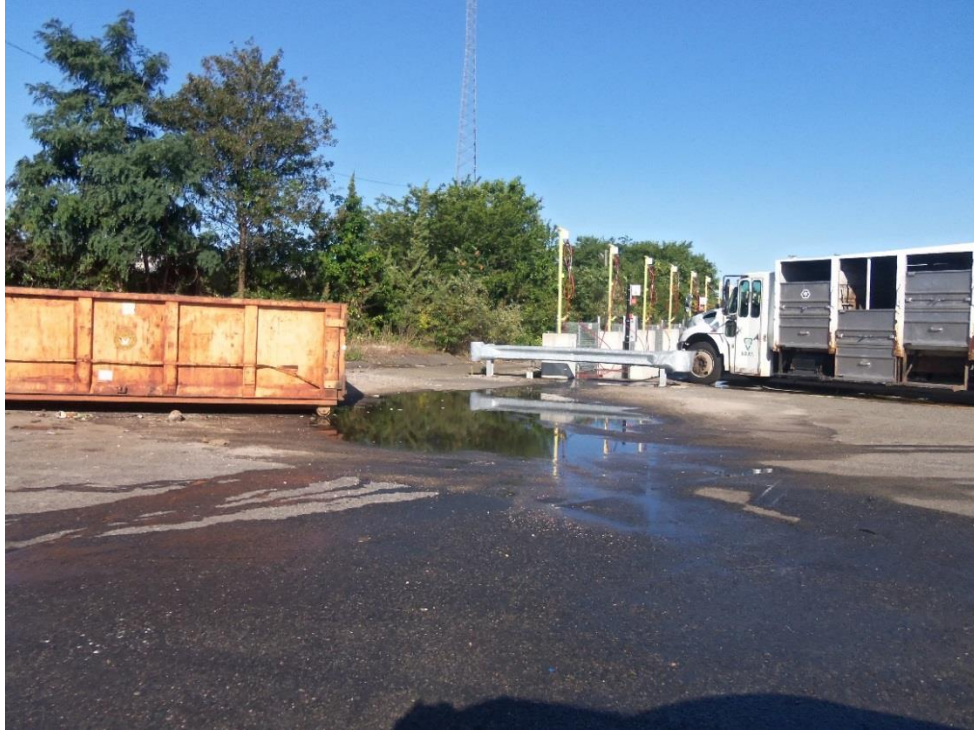
Ponding in Area E

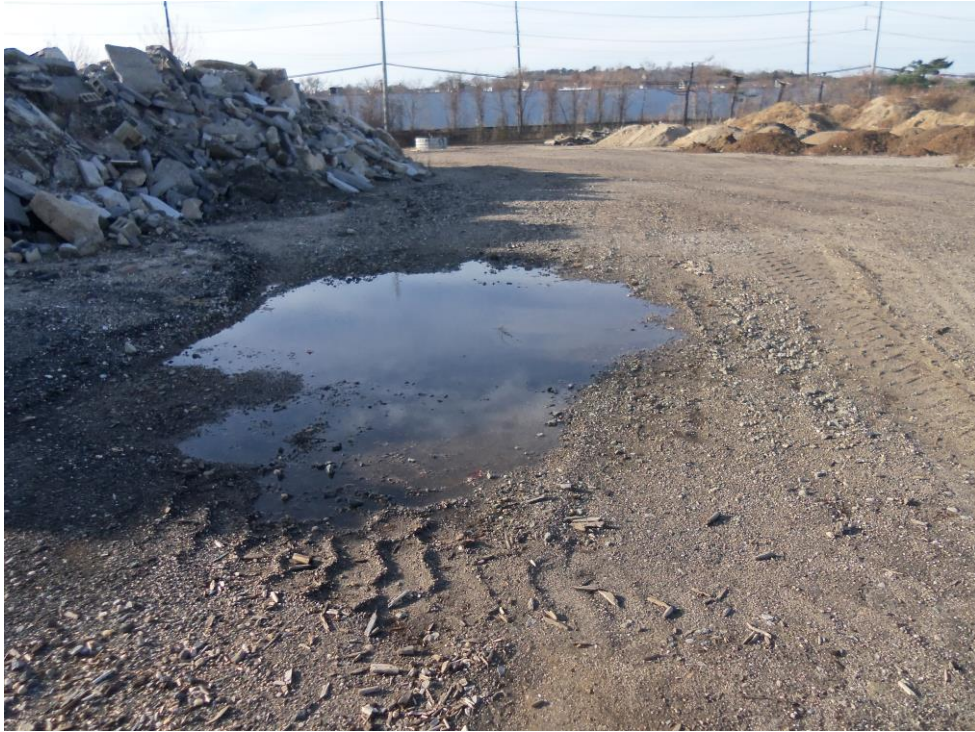
Ponding in Area A

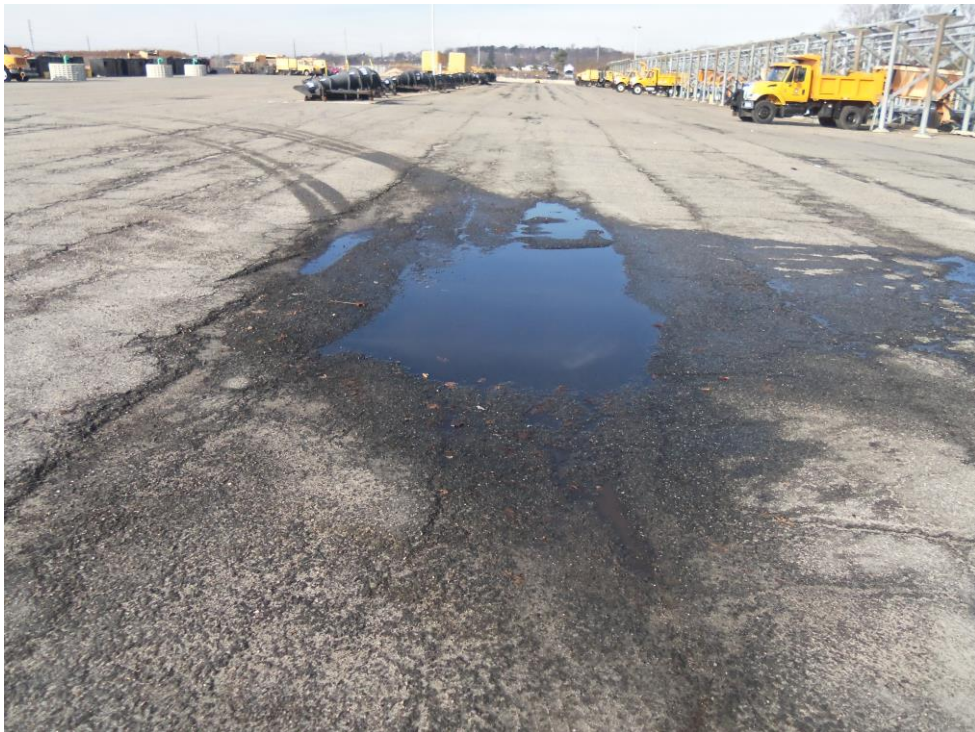
Ponding in Area C

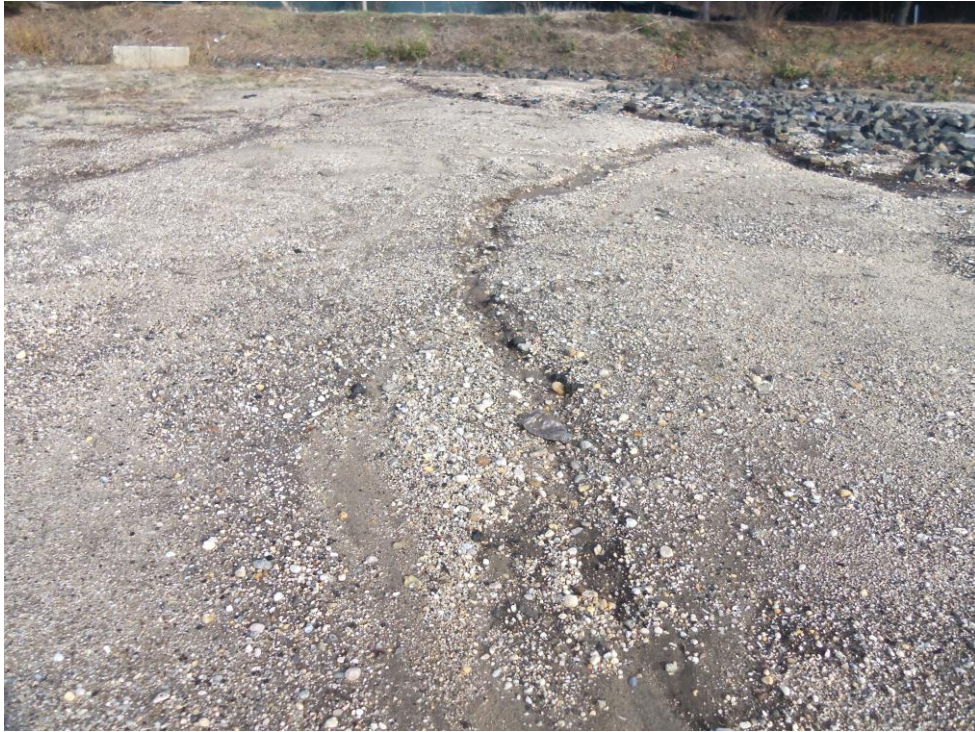
Surface Material Erosion in Area C

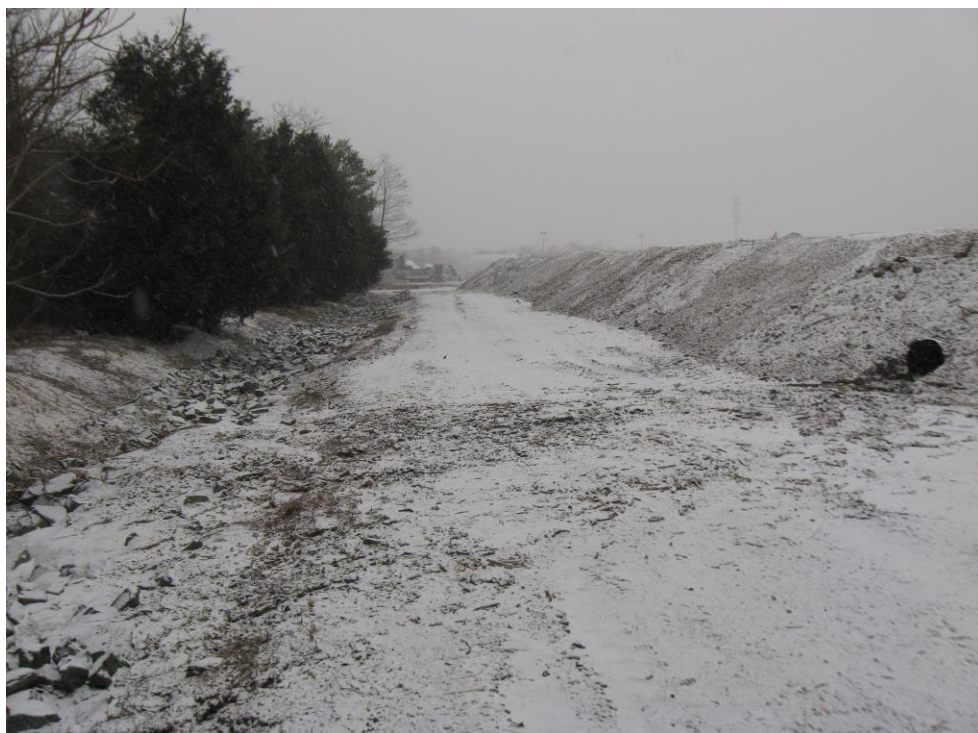
The apparent cause of most of the ditch siltation seems to be from the erosion of materials stored in stockpiles onsite. Erosion control techniques should be implemented around the material stockpiles to prevent the transport of silt and sediment from the piles to the drainage ditches. The stockpiles that are located in closest proximity to the perimeter drainage ditches should have hay bales placed at the toe of slope on the down slope end of the piles to prevent sediment transport directly into the drainage ditches. Hay bales are also recommended for other stockpiles onsite if erosion of the pile material is observed. However, anchoring of the bales onsite is not allowed due to the risk of penetrating the landfill geomembrane cap. Therefore, stakes (or anything that may penetrate the geomembrane cap) must not be used when placing the hay bales. The use of silt fences is also prohibited, unless they can be secured in location without the use of stakes or other devices that would penetrate the landfill surface. Should the erosion control measures down slope of the stockpiles not be sufficient to eliminate sediment transport into the perimeter drainage ditches, then hay bales should also be placed along the length of the perimeter drainage ditch at the top of slope adjacent to the Material Storage Facility.

Siltation – DS#2

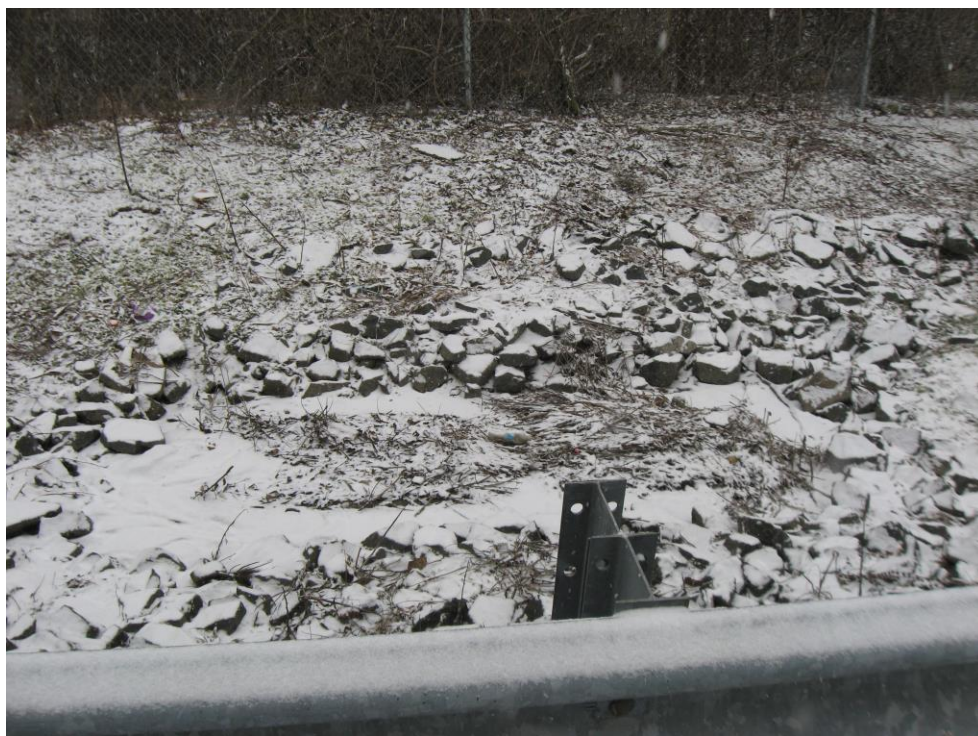
All of the catch basins onsite were inspected. During 2014, debris and silting was detected at catch basins #2 through #5. These conditions are typical for catch basins which collect stormwater runoff from rip rap lined drainage ditches and similar to conditions that occur each year.

Siltation and Debris –CB#2

It is recommended that the silt and sediment be removed on a regular basis from the area in the vicinity of the catch basin inlets and drainage ditches. The hay bale erosion control measures recommended in Section 2.1 should be replaced at catch basins #3, #4, and #5.

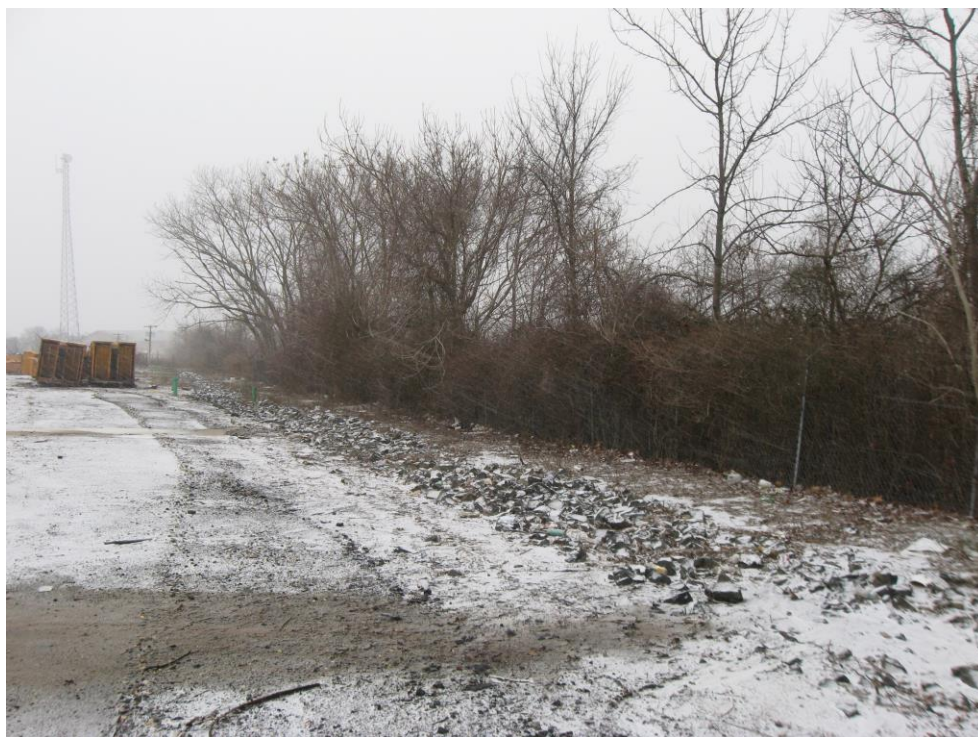
Siltation and Vegetative Growth -DS#6

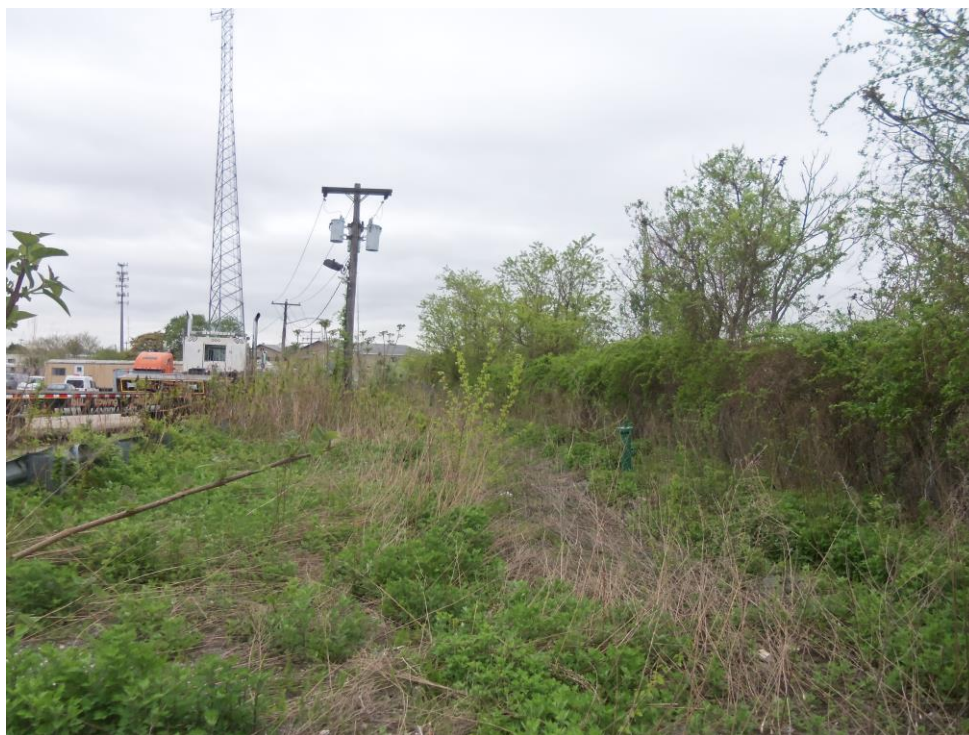
Vegetative Growth – DS#6

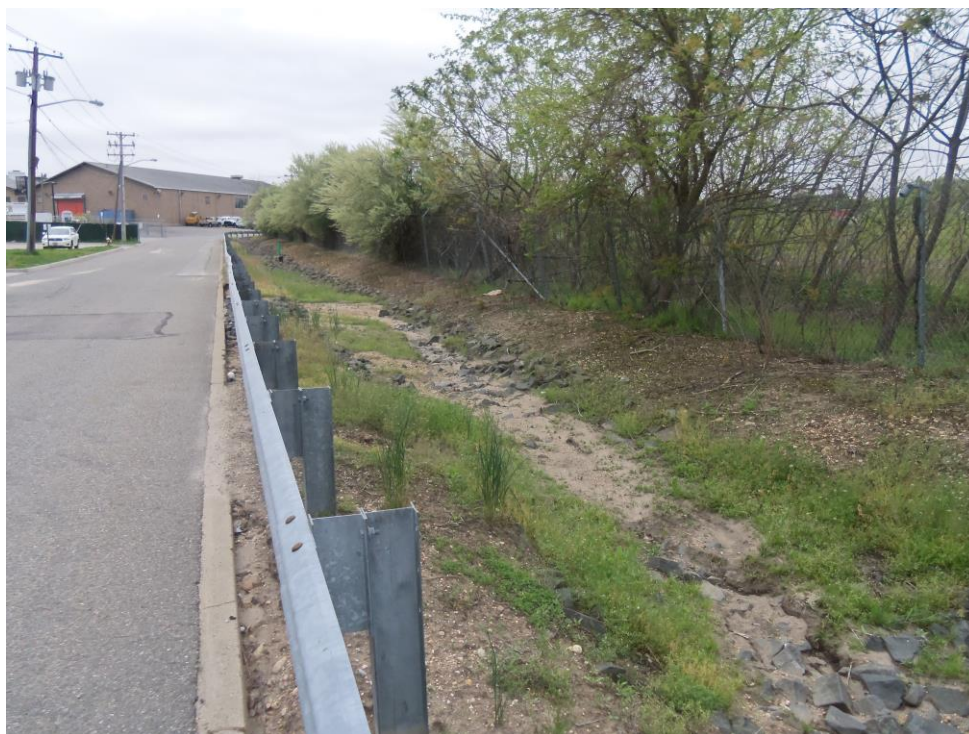
Siltation and Vegetative Growth – DS#7

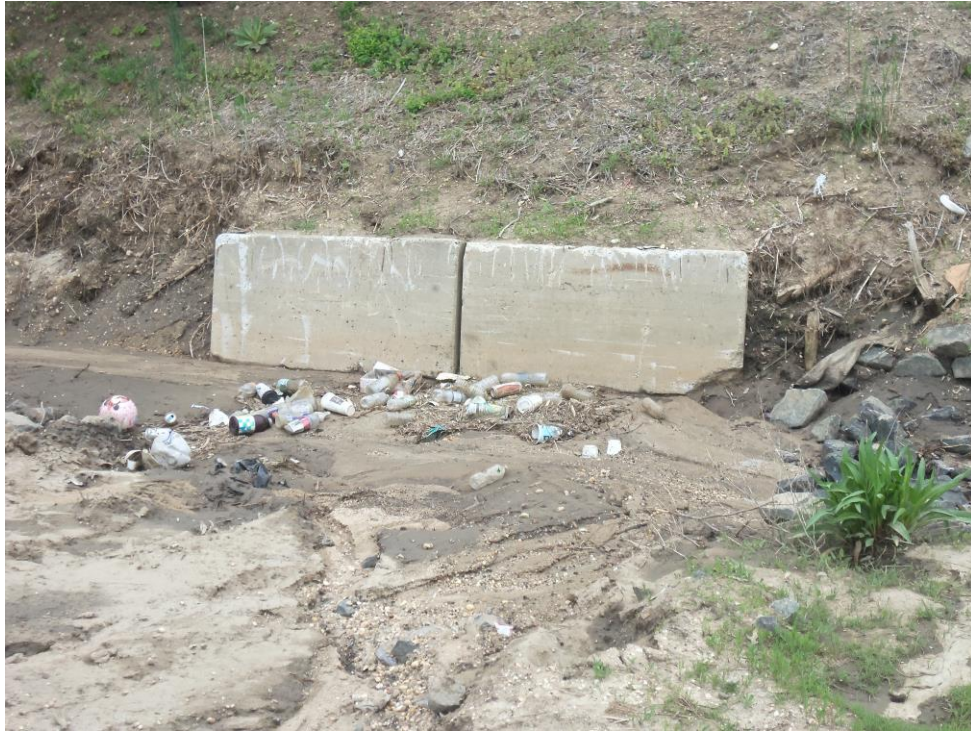
Siltation and Debris CB#5

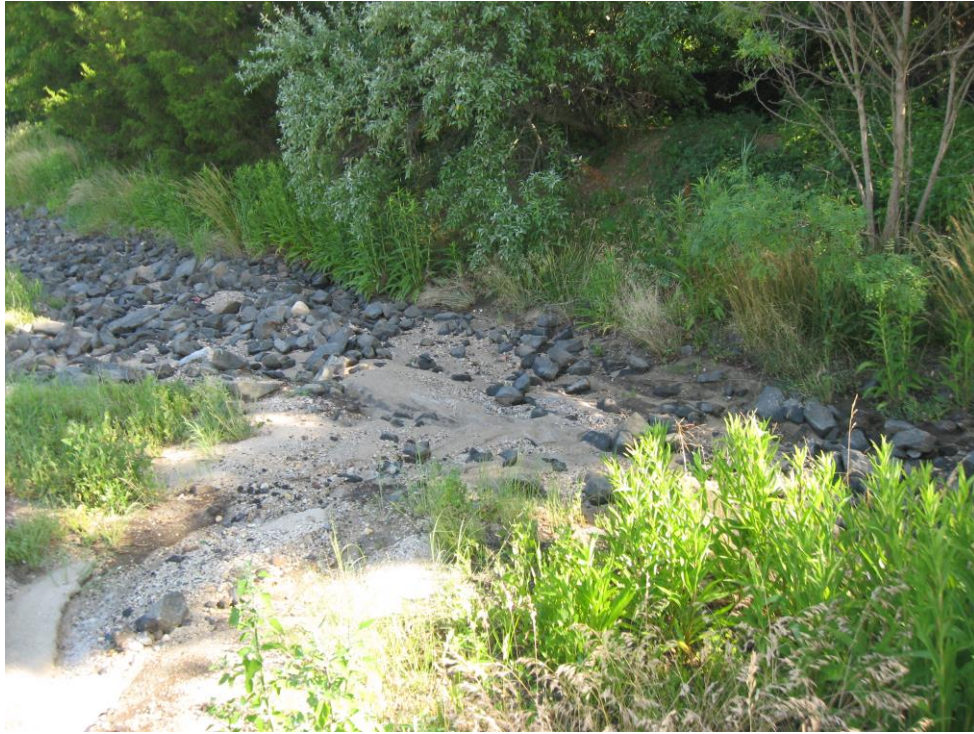
Siltation – DS#2

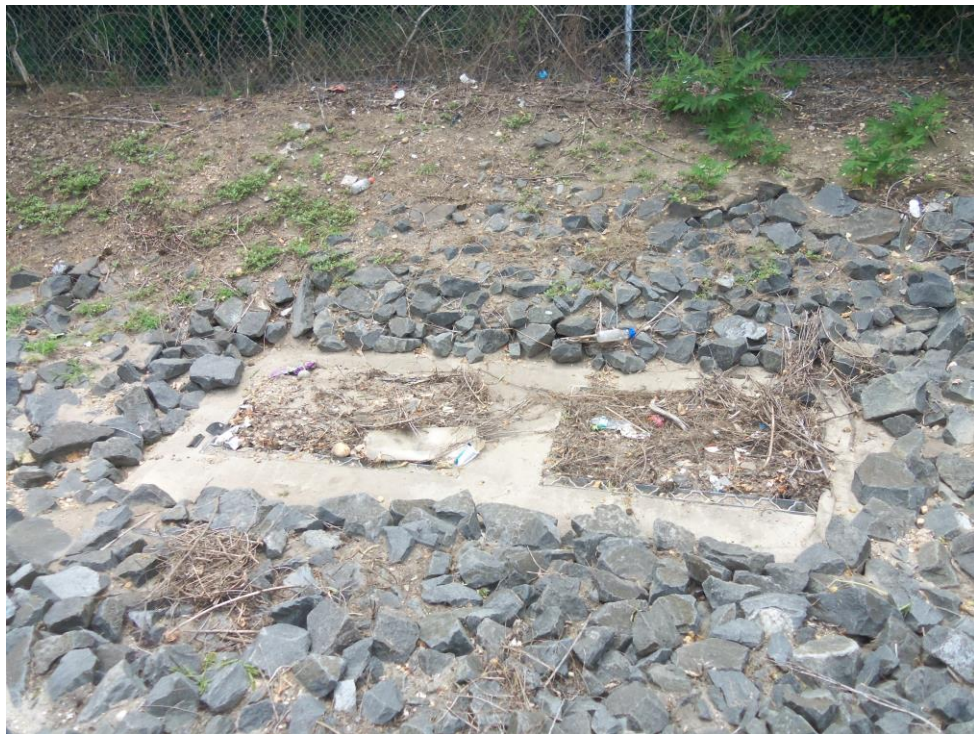
Siltation and Debris - CB#2

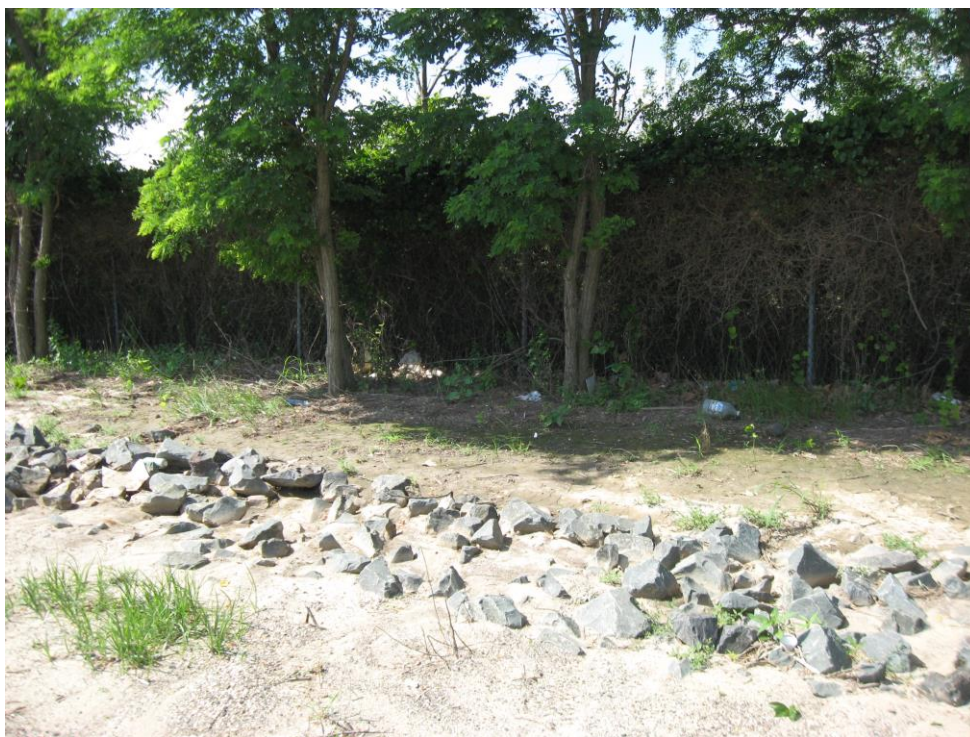
Siltation and Vegetative Growth DS#6

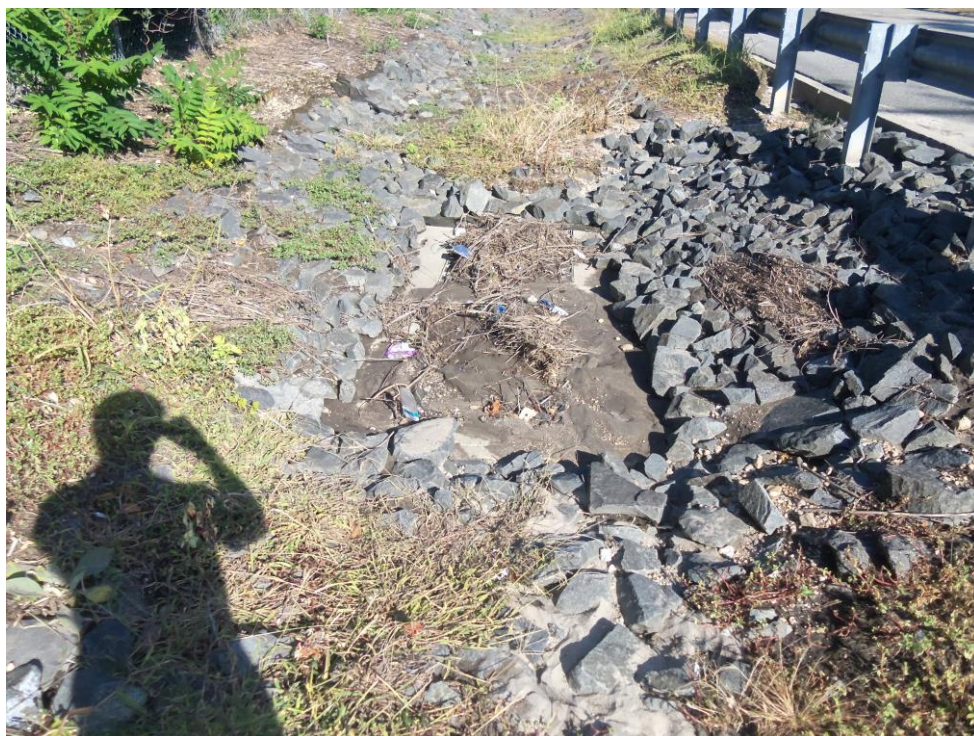
Catch basin #2 siltation and debris

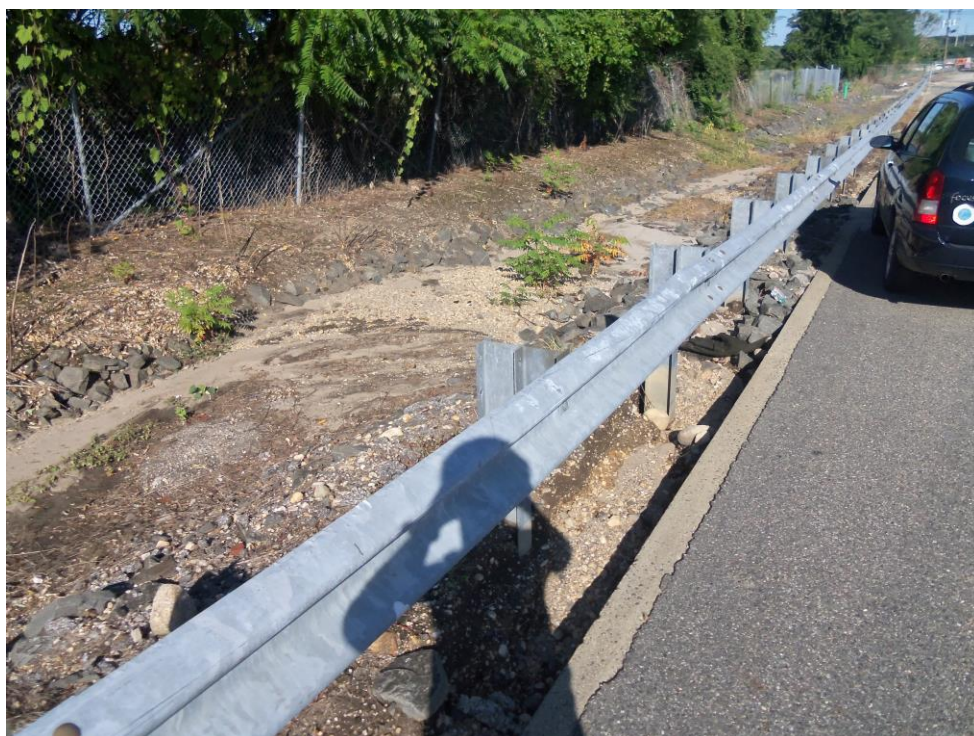
DS #7 siltation and vegetative growth

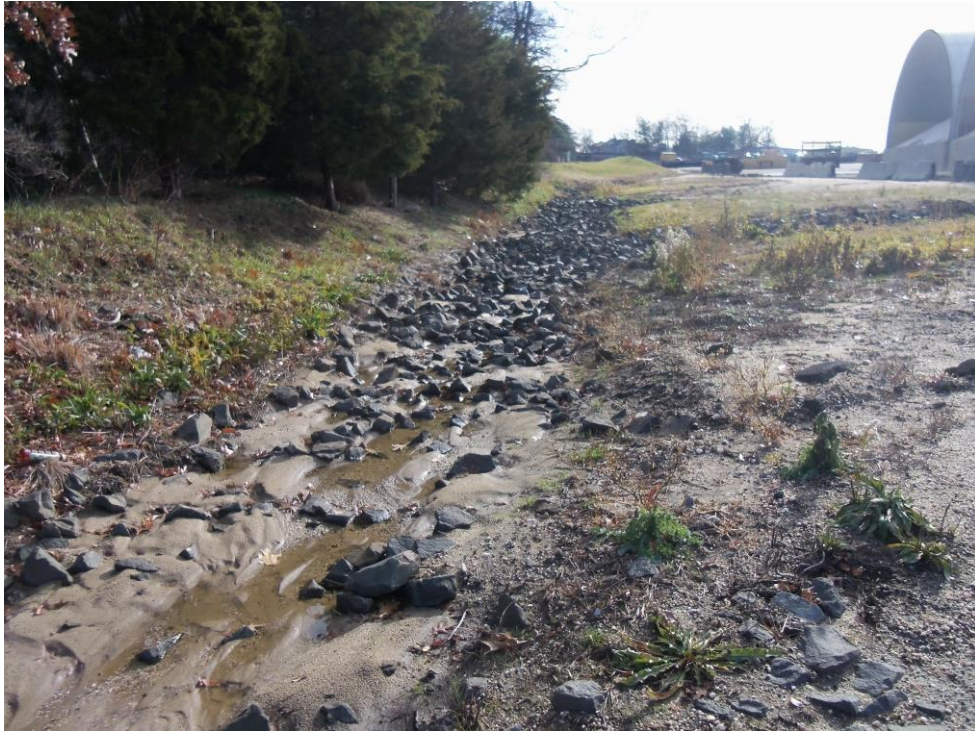
Siltation – DS#2

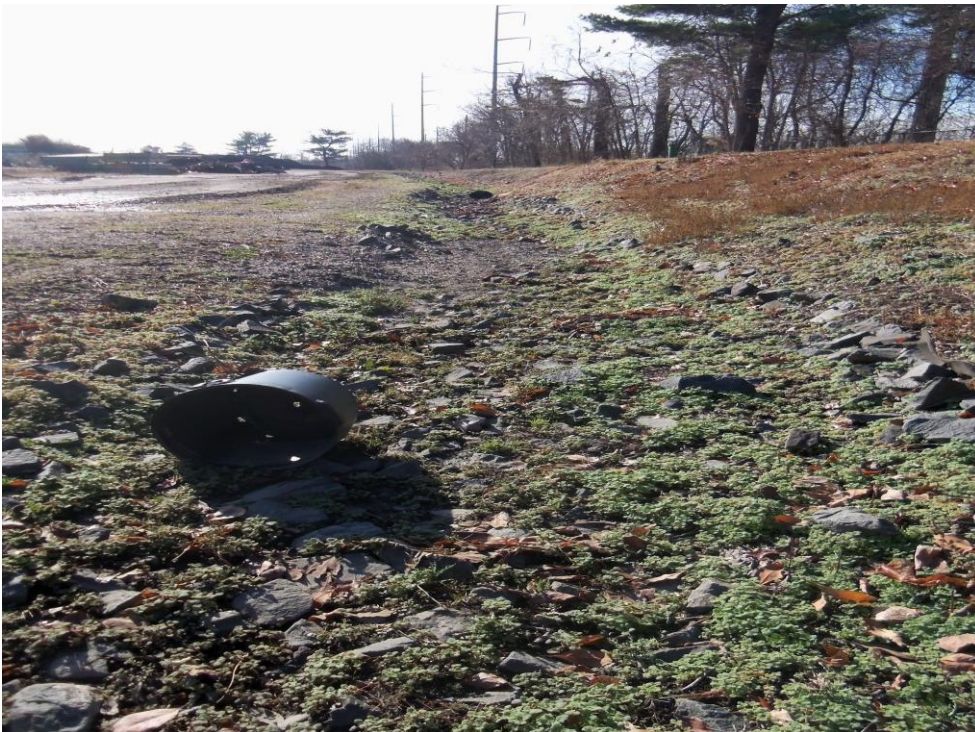
Siltation and Vegetative Growth – DS#5

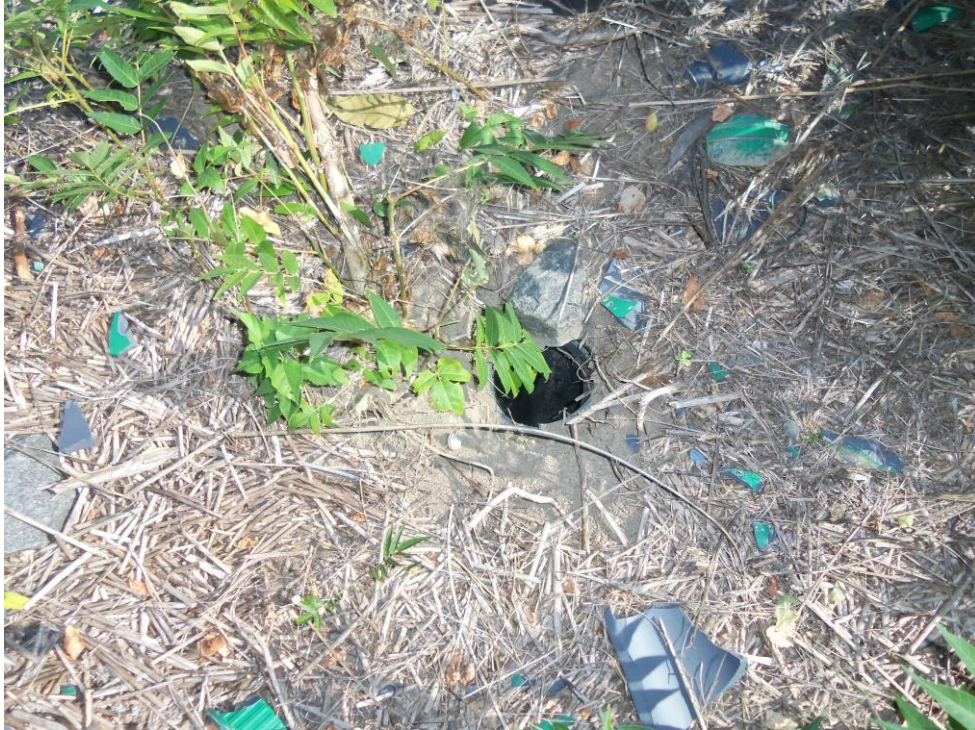
Inspection of each gas vent well was performed prior to each round of gas monitoring. Of the 54 property line and perimeter gas vent wells inspected, only SW-3 was damaged. The upper section of the gas vent well was detached from the well casing pipe at grade and the upper portion was lying on the ground. The well has since been secured with a protective cover. Machinery used in this area combined with overgrown vegetation may have been the cause of the damage. During the post-closure period to date, methane has not been detected at this well. While the well is still capable of venting and being monitored in its current condition, it is recommended that the upper and lower sections of the casing pipe for Gas Vent Well SW-3 be reattached and the well restored to its original configuration during the next well repair contract. Historically gas vent wells have been susceptible to damage; this damage is usually the result of machinery used in this area combined with overgrown vegetation. It is recommended that vegetation near the gas vent wells be maintained on a regular basis to improve visibility and help prevent damage to vent wells in the future.

Well casing broken at grade – SW3
