# *SYOSSET LANDFILL*

## *2015 ANNUAL POST-CLOSURE SUMMARY REPORT*

**DEPARTMENT OF PUBLIC WORKS  
SYOSSET, NEW YORK 11791**

**June 2016**

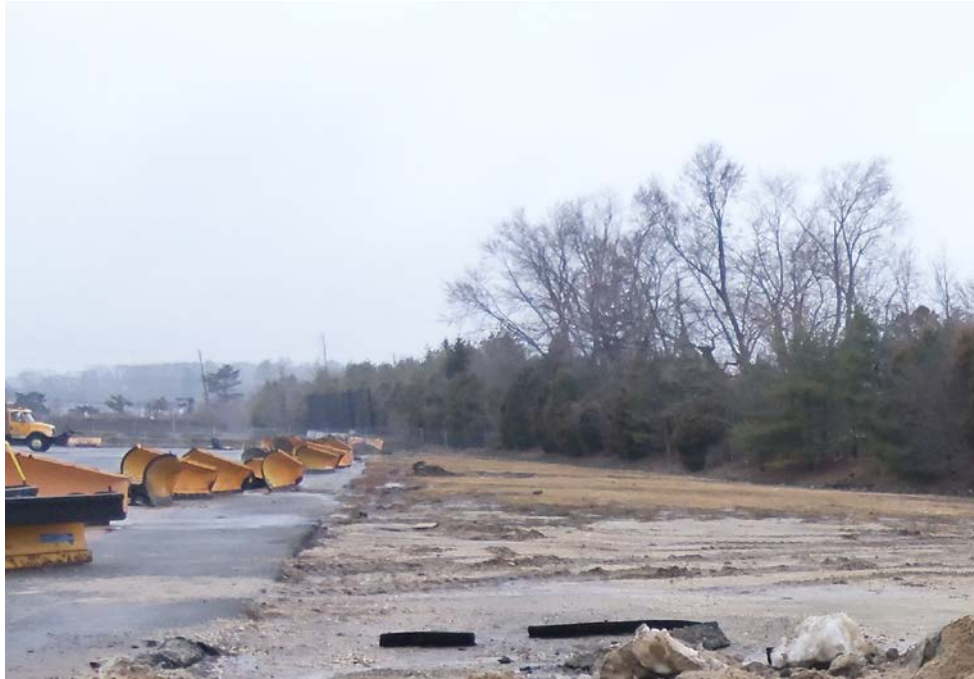
**Erosion/Lack of Vegetation in Area C**

It is recommended that the ruts in the surface material be repaired by removing silt, filling/regrading the surface area to remove the ruts, replacing topsoil that may have eroded away and reseeding this area during the planting season to prevent further erosion problems.

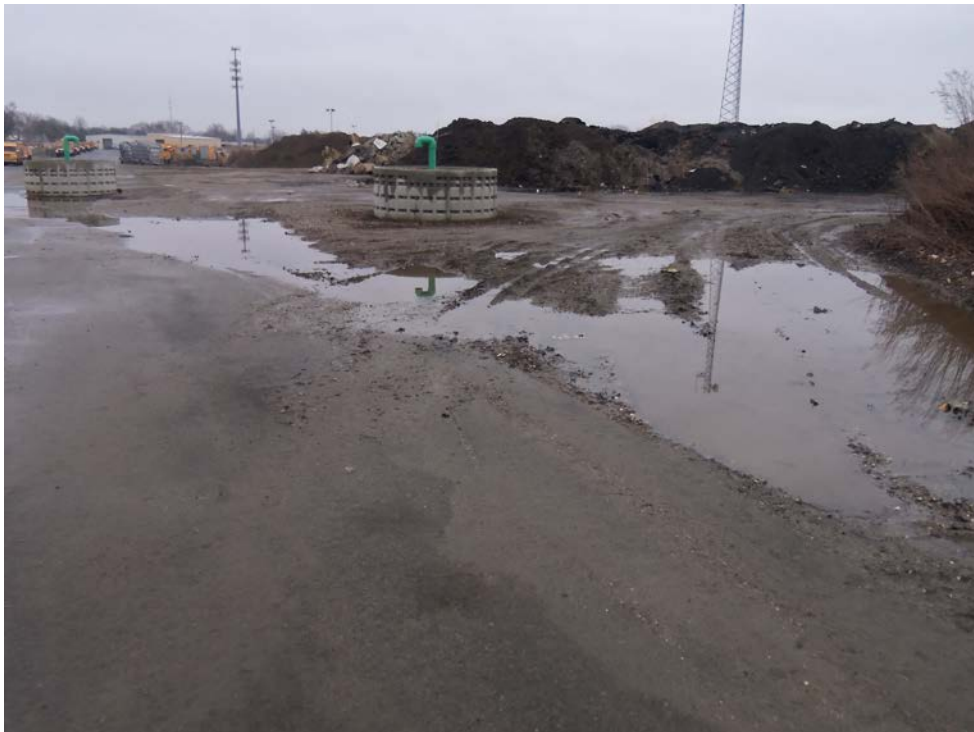
Ponding areas were observed during all four rounds of cover system inspections in 2015. The ponding areas observed during this reporting period were due to uneven grading of the RCA (Areas A and B) and potholes (Areas C and E).

**Ponding in Area A**

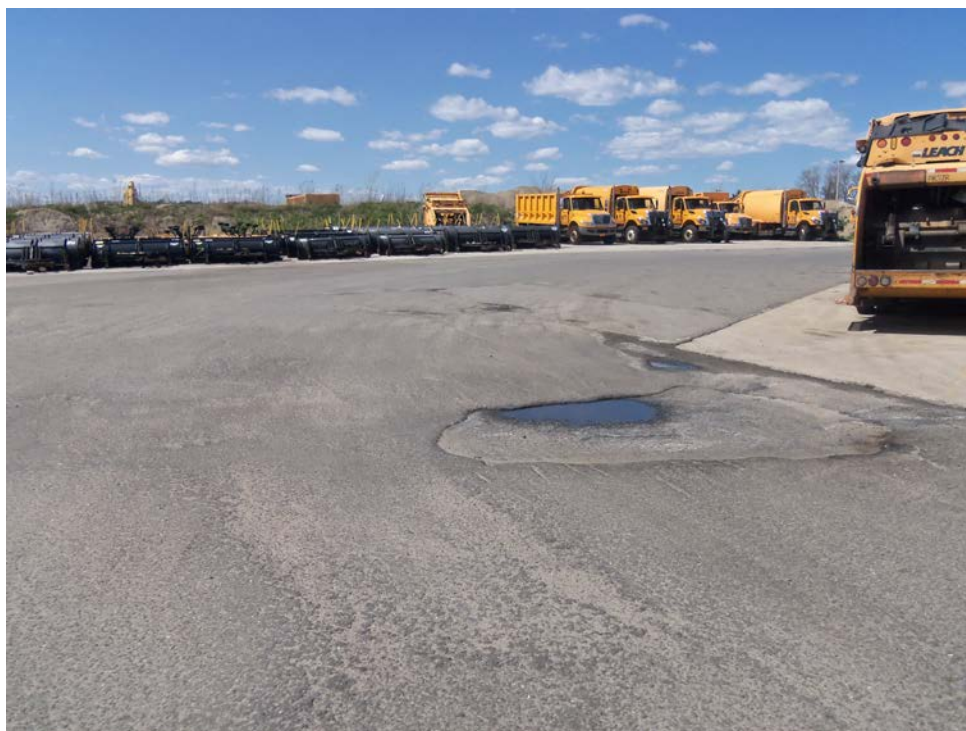
**Pothole in Area E**

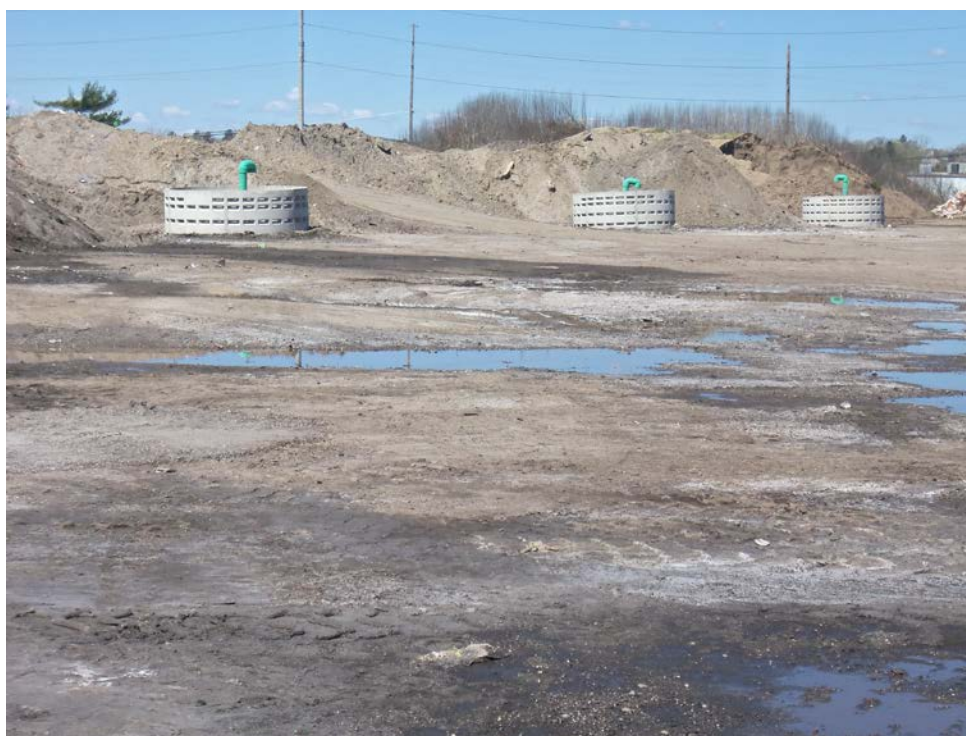
**Ponding in Area A**

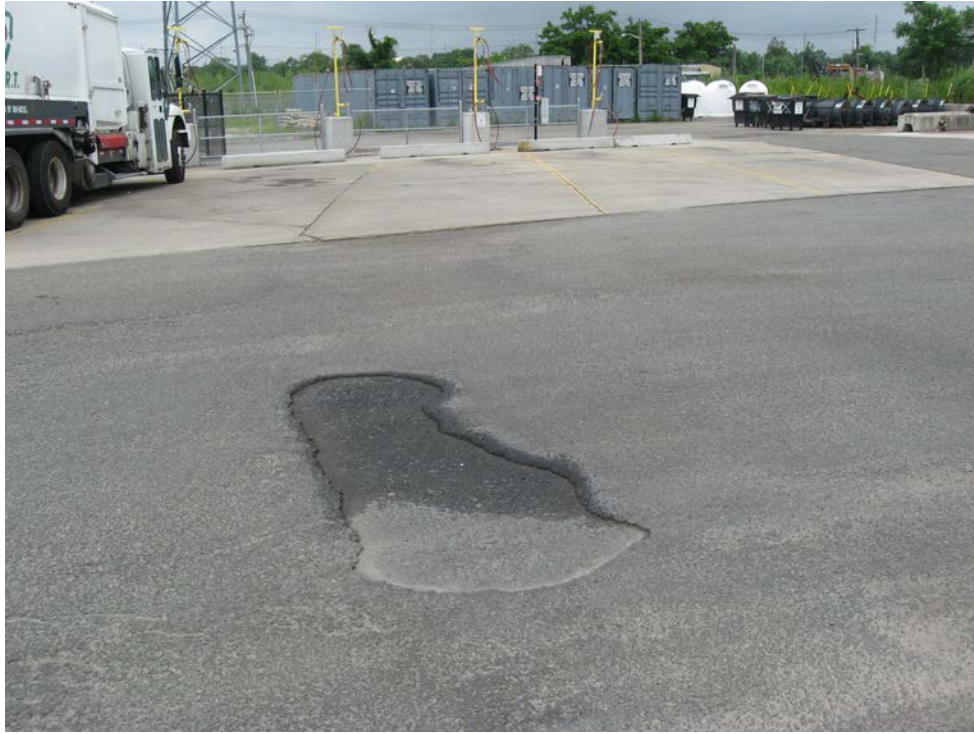
**Pothole in Area E**

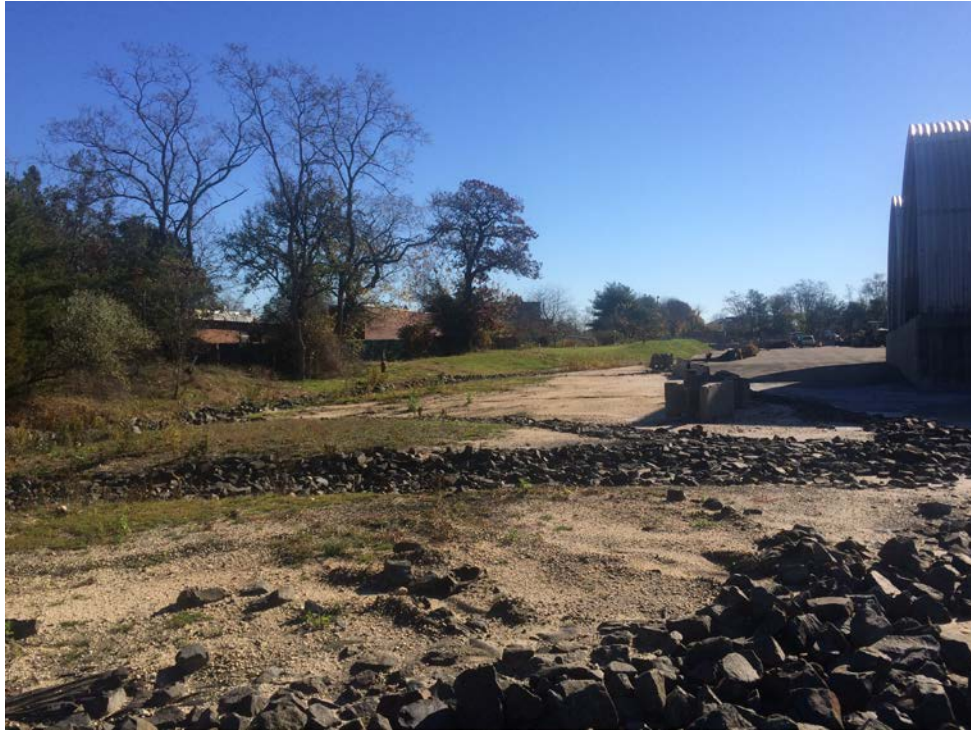
Areas of surface material erosion (i.e., ruts) were found in the vegetative cover buffer area of the Highway Department Material Storage Facility (Area A), the Miscellaneous Equipment Storage Facility (Area B), and the Salt Storage Facility (Area C). The observed cause appears to be stormwater runoff. These Areas are sloped toward the perimeter drainage ditches. The vegetative cover buffer area therefore receives runoff from both RCA and paved areas. Ruts have formed as a result of continued erosion of the surface material from stormwater runoff.

**Erosion in Area C**

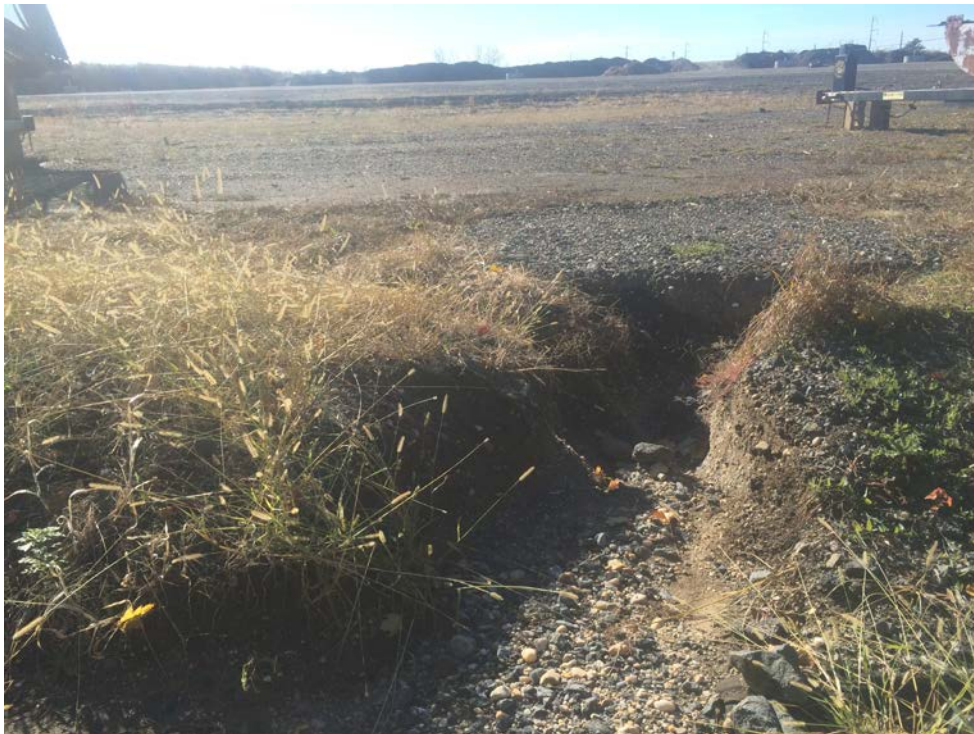
**Washout in Area B**

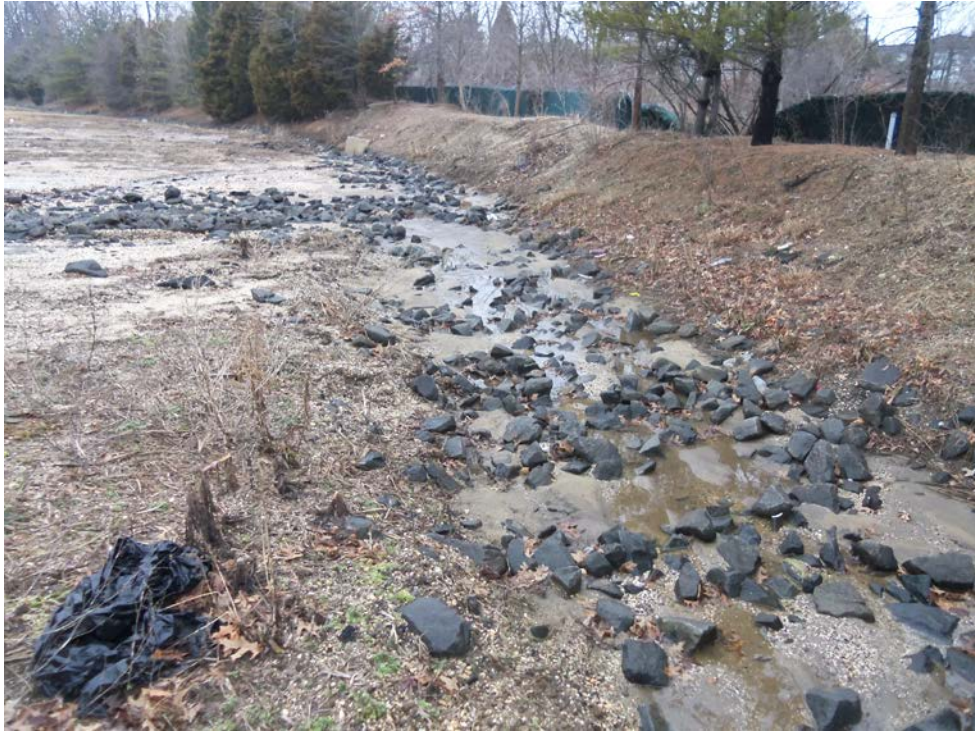
The apparent cause of most of the ditch siltation seems to be from the erosion of materials stored in stockpiles onsite. Erosion control techniques should be implemented around the material stockpiles to prevent the transport of silt and sediment from the piles to the drainage ditches. The stockpiles that are located in closest proximity to the perimeter drainage ditches should have hay bales placed at the toe of slope on the down slope end of the piles to prevent sediment transport directly into the drainage ditches. Hay bales are also recommended for other stockpiles piles onsite if erosion of the pile material is observed. However, anchoring of the bales onsite is not allowed due to the risk of penetrating the landfill geomembrane cap. Therefore, stakes (or anything that may penetrate the geomembrane cap) must not be used when placing the hay bales. The use of silt fences is also prohibited, unless they can be secured in location without the use of stakes or other devices that would penetrate the landfill surface. Should the erosion control measures down slope of the stockpiles not be sufficient to eliminate sediment transport into the perimeter drainage ditches, then hay bales should also be placed along the length of the perimeter drainage ditch at the top of slope adjacent to the Material Storage Facility.

**Siltation – DS#2**

It is recommended that the silt and sediment be removed on a regular basis from the area in the vicinity of the catch basin inlets and drainage ditches. The hay bale erosion control measures recommended in Section 2.1 should be replaced at catch basins #3, #4, and #5.

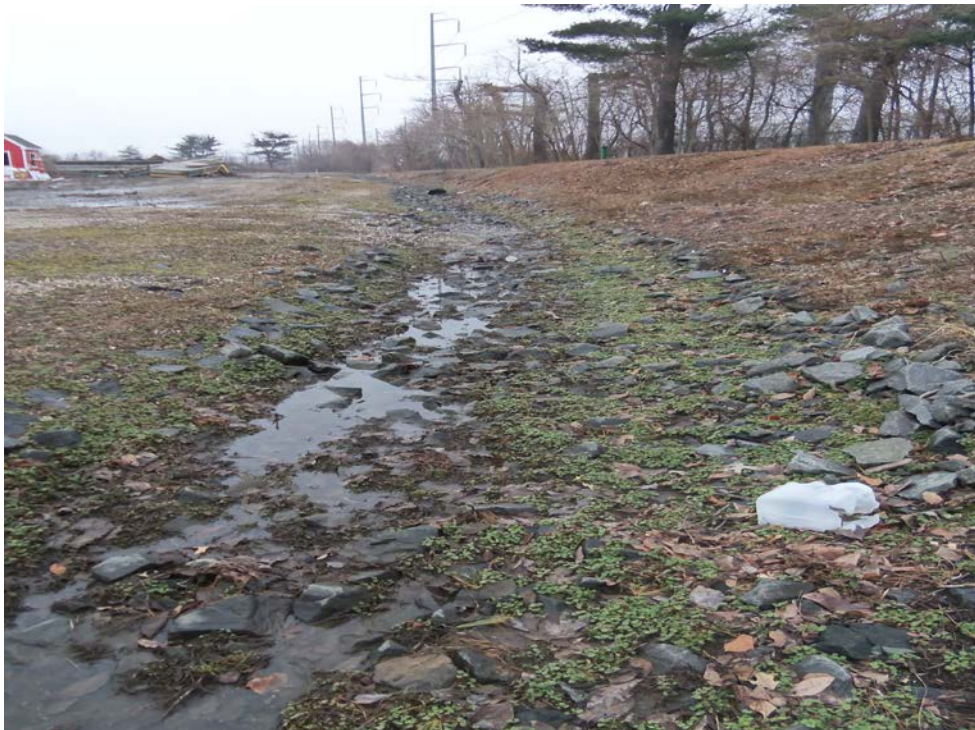
**Siltation and Vegetative Growth – DS#5**

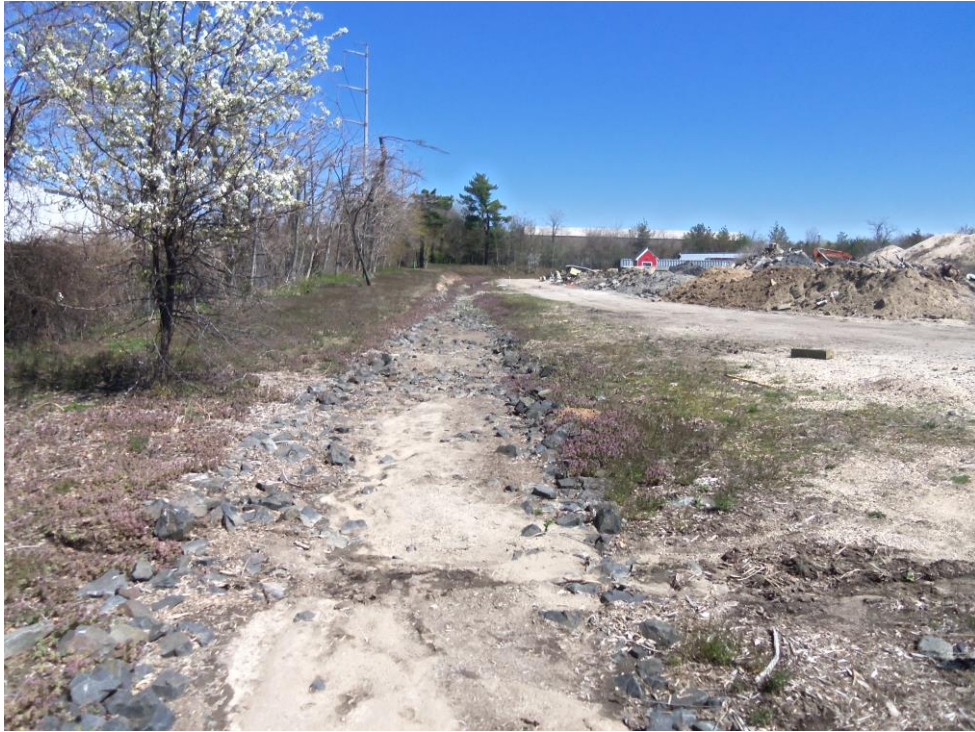
**Siltation – DS#5**

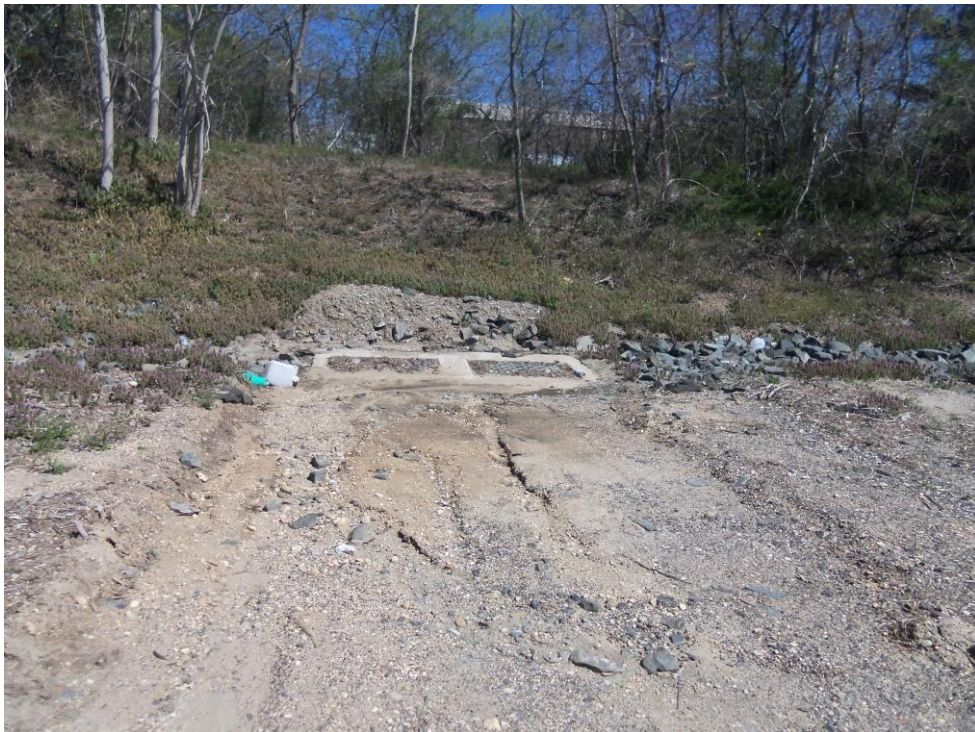
**Siltation – CB#3**

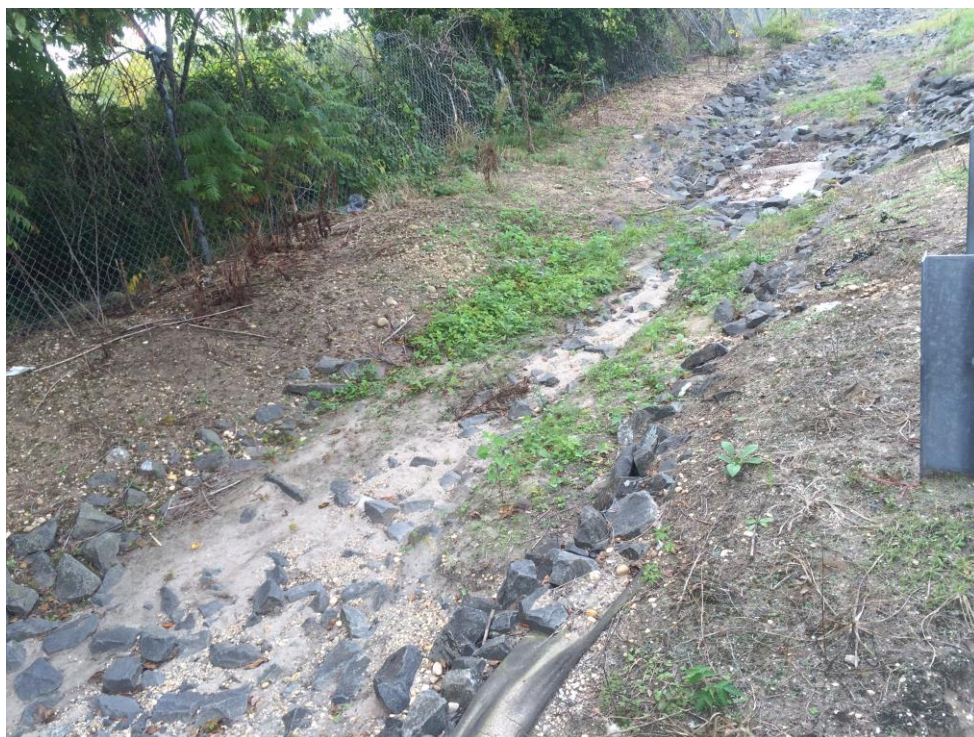
**Siltation – DS#3**

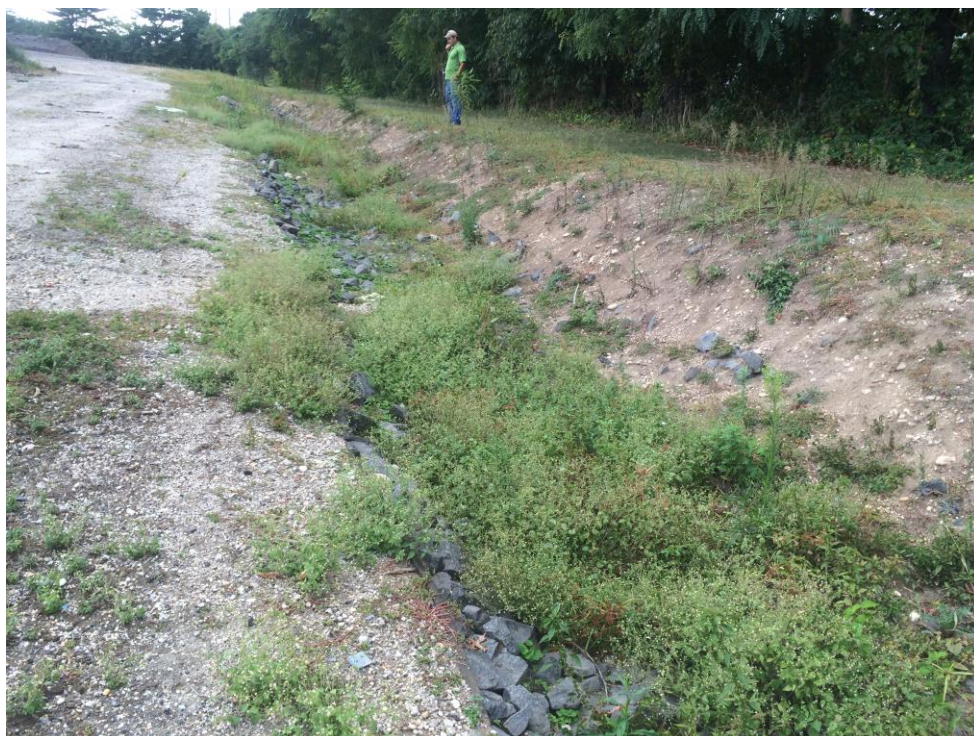
**Vegetative Growth – DS#5**

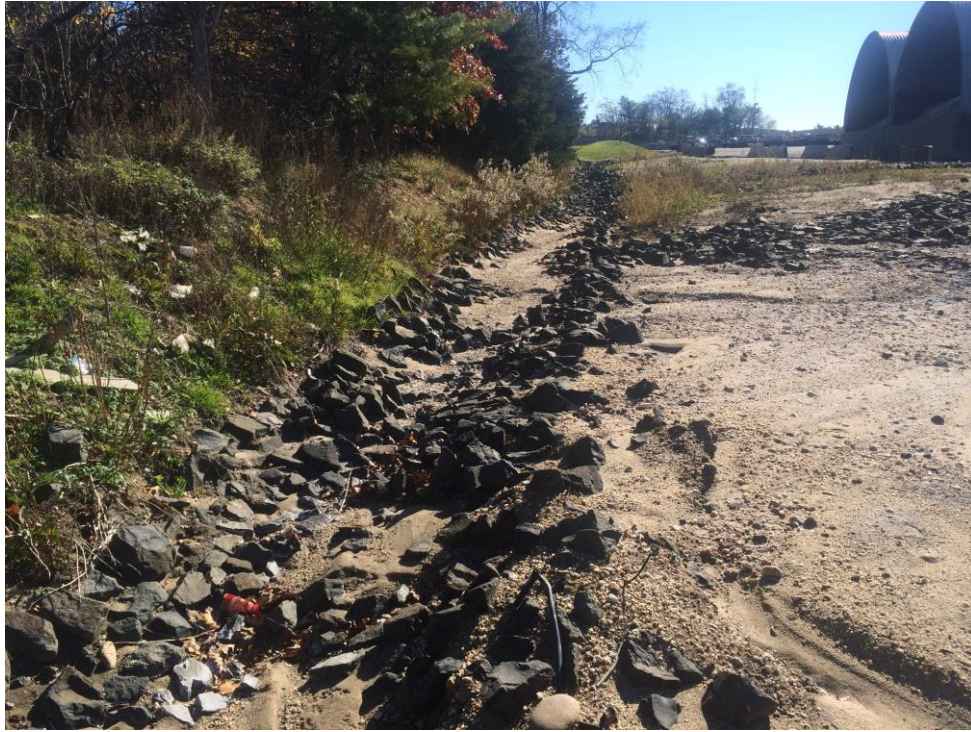
**Siltation – DS#2**

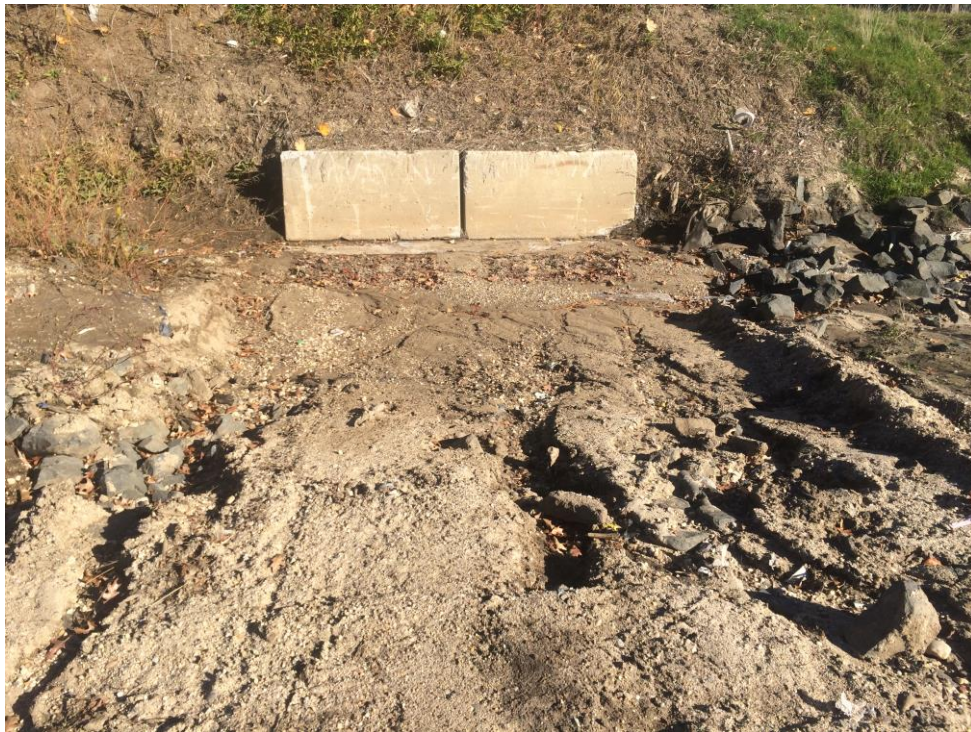
**Siltation – Catch Basin #5**

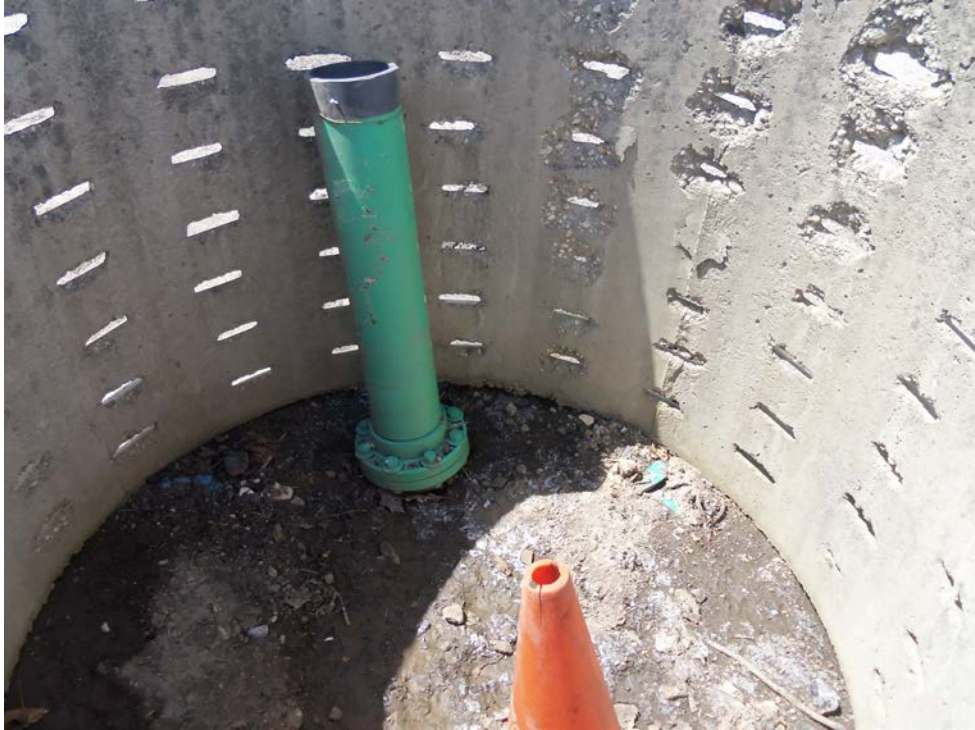
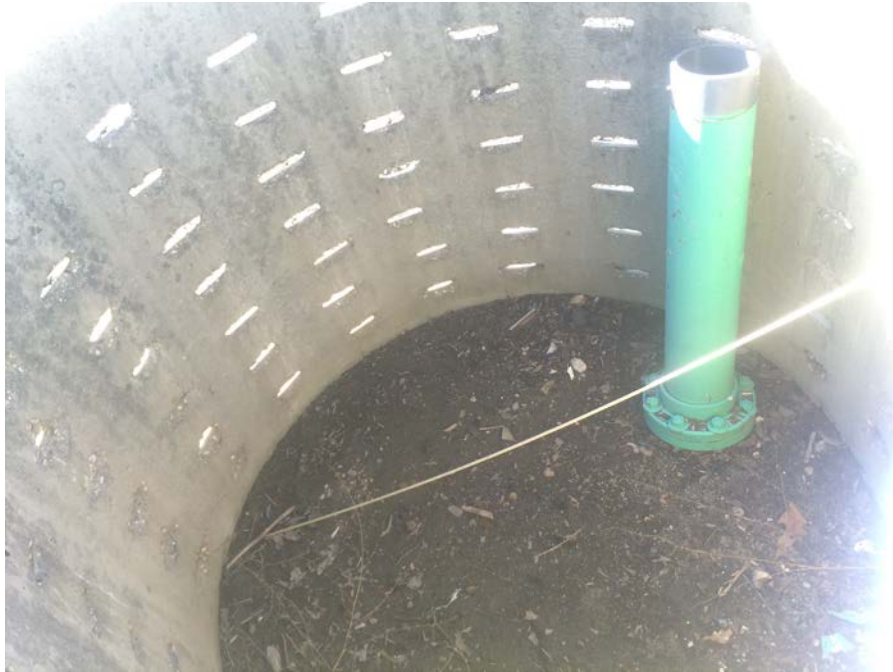
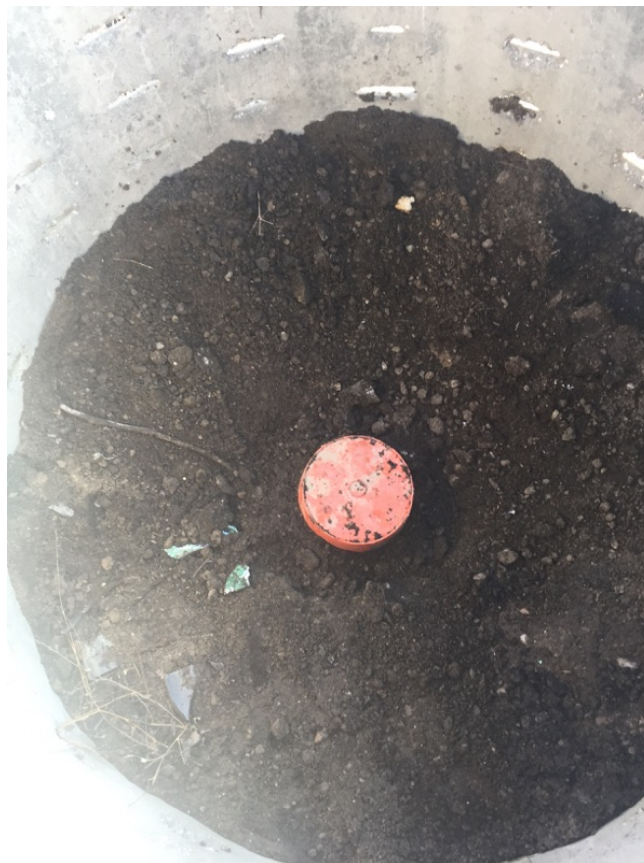
The 2015 ridge vent well inspections showed only damage to the R-8 well casing and the R-1 well concrete ring. The well casing of Well R-8 has been sheared off at/just below grade. The well has since been secured with a protective cover. It is recommended that the Well R-8 be repaired during the next well repair contract. Historically, the leading cause of damage to the ridge vent well casings and protective concrete rings has been attributed to impact with trucks or other vehicles used onsite. It is recommended that stockpiles not be placed within 25 feet of the ridge vent wells to prevent trucks from damaging the wells in the future.

**Well casing broken at/just below grade - R-8**

**Well Casing Broken at/just below Grade- R8**

Gas Venting System: Recommended that stockpiles not be placed within 25 feet of the ridge vent wells to prevent trucks from damaging the wells in

the future. Wells R-8 and SW-3 should be repaired during the next well repair contract.

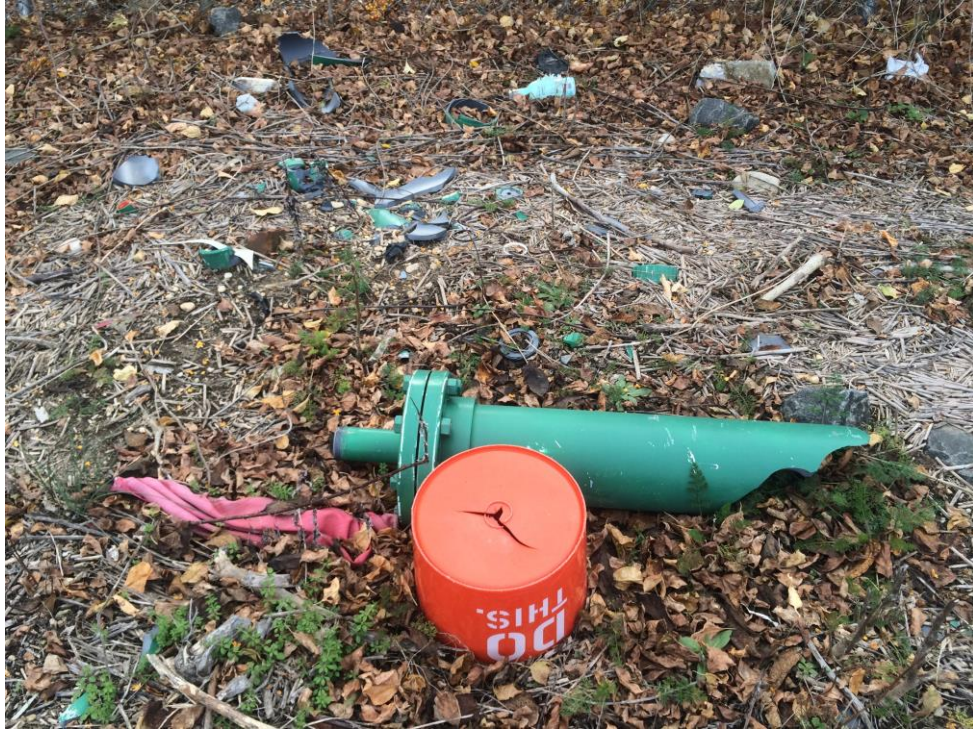
Inspection of each gas vent well was performed prior to each round of gas monitoring. Of the 54 property line and perimeter gas vent wells inspected, only SW-3 was damaged. The upper section of the gas vent well was detached from the well casing pipe at grade and the upper portion was lying on the ground. The well has since been secured with a protective cover. Machinery used in this area combined with overgrown vegetation may have been the cause of the damage. During the post-closure period to date, methane has not been detected at this well. While the well is still capable of venting and being monitored in its current condition when necessary, it is recommended that the upper and lower sections of the casing pipe for Gas Vent Well SW-3 be reattached and the well restored to its original configuration during the next well repair contract. Historically gas vent wells have been susceptible to damage; this damage is usually the result of machinery used in this area combined with overgrown vegetation. It is recommended that vegetation near the gas vent wells be maintained on a regular basis to improve visibility and help prevent damage to vent wells in the future.

**Well Casing Broken at Grade- SW3**

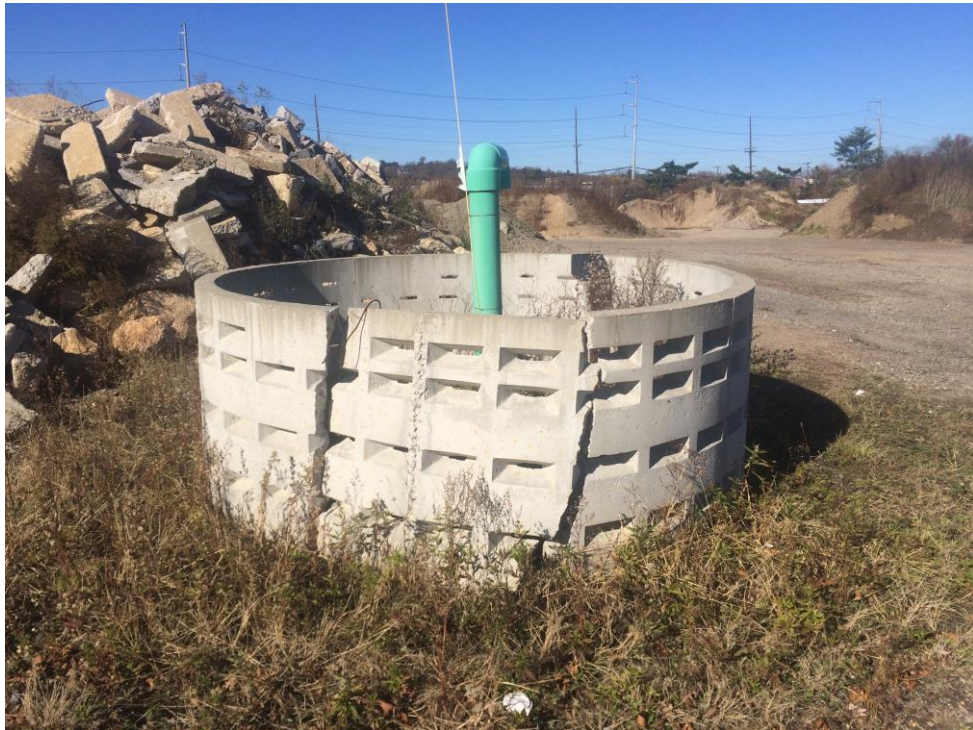
**Protective Ring Damaged – R1**
