SYOSSET LANDFILL

2016 ANNUAL POST-CLOSURE SUMMARY REPORT

TOWN OF OYSTER BAY

LOCKWOOD
KESSLER &
BARTLETT, INC.
SYOSSET, NEW YORK 11791

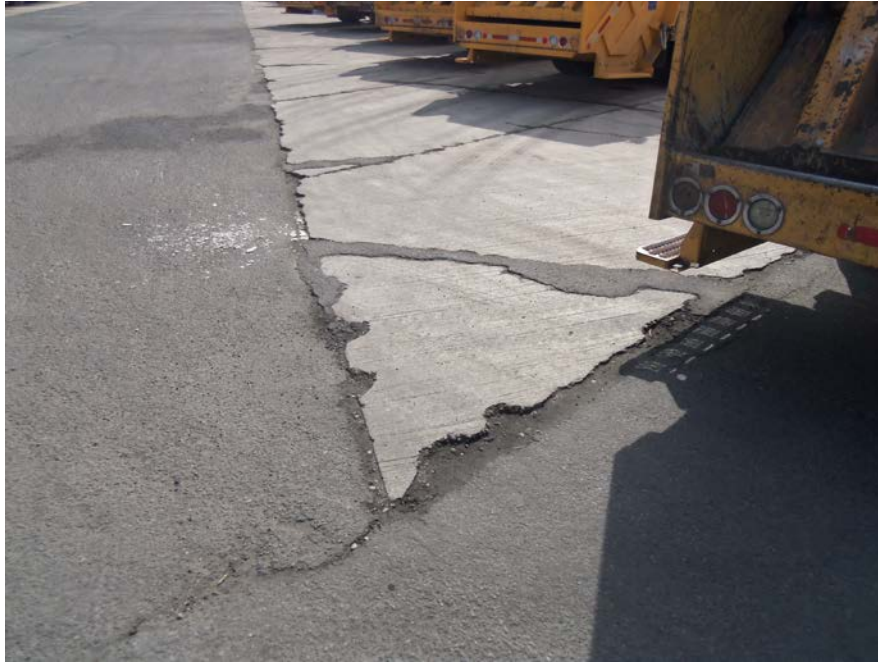
Area E Concrete Pad Repair

<u>ITEM</u>	<u>LOCATION</u>	<u>DESCRIPTION OF REPAIR</u>
<u>5. Settlement</u>	Area E	Concrete Pad repaired

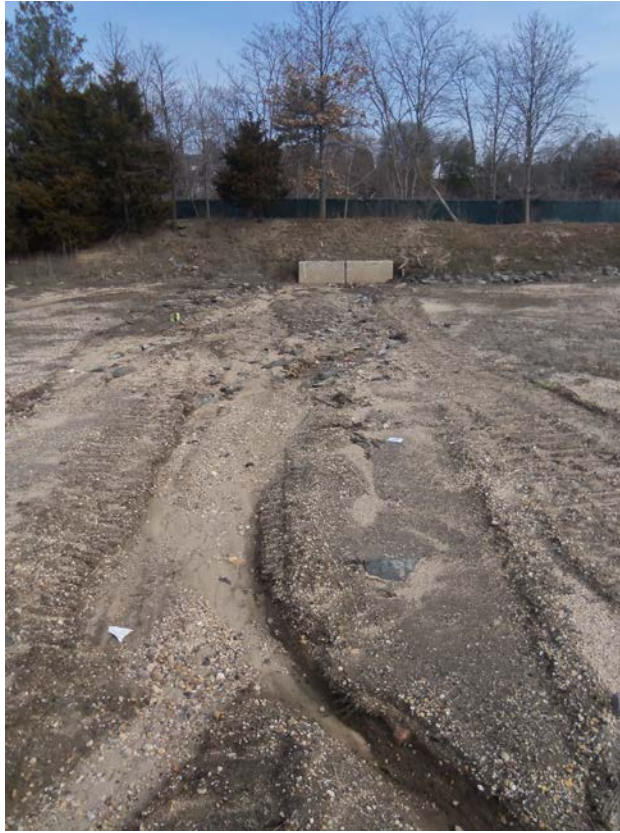
Erosion in Area C

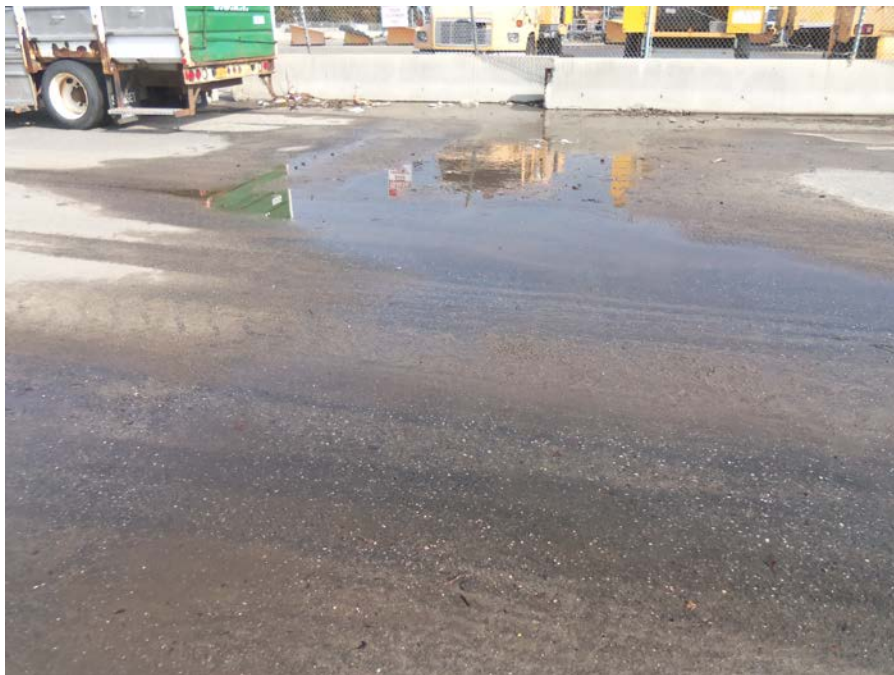
Minor Ponding in Area C

Should ponding conditions recur in the future within the RCA material in Areas A and B, surface grading should be routinely adjusted to remove low points that occur. The asphalt section in the Areas C and E experiencing ponding should be restored in accordance with the original Capping Contract specifications as discussed in Section 1.5 when routine pavement repairs are performed in the future in these areas.

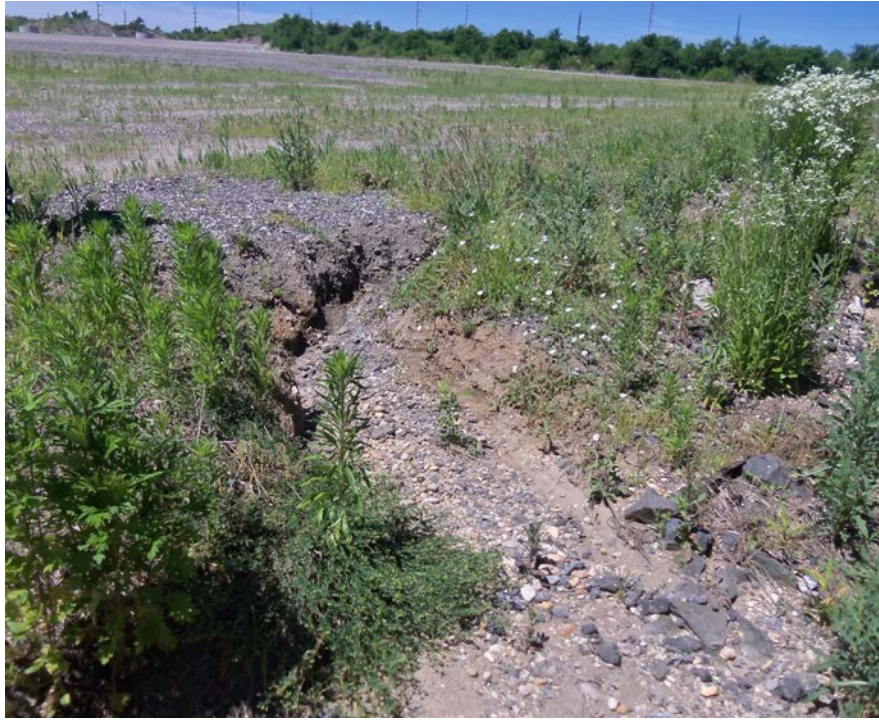
Washout in Area B

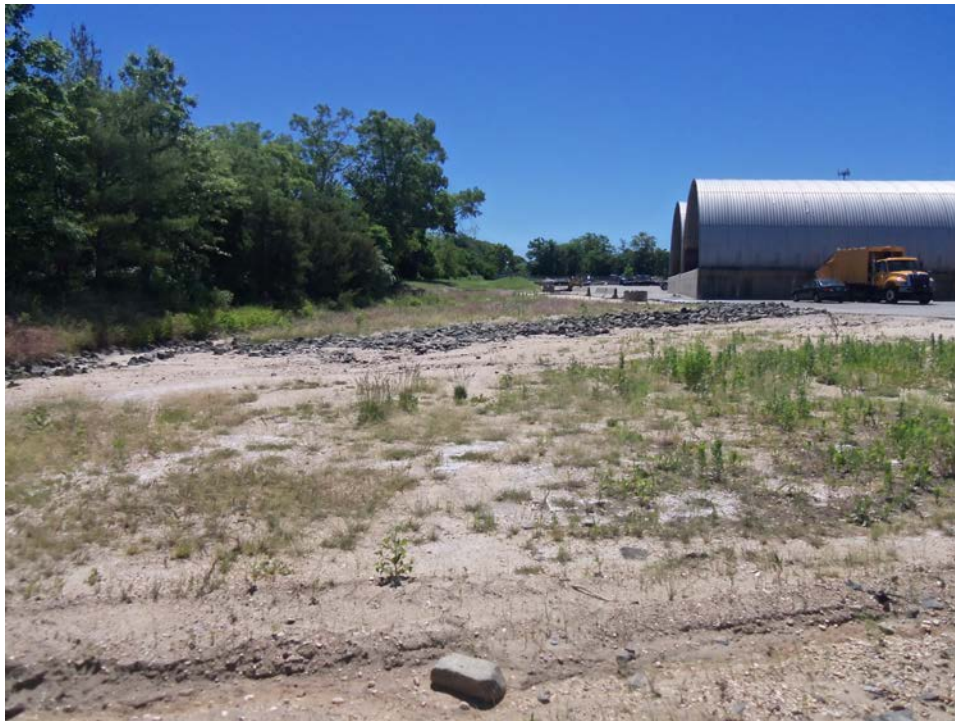
Erosion in Area C

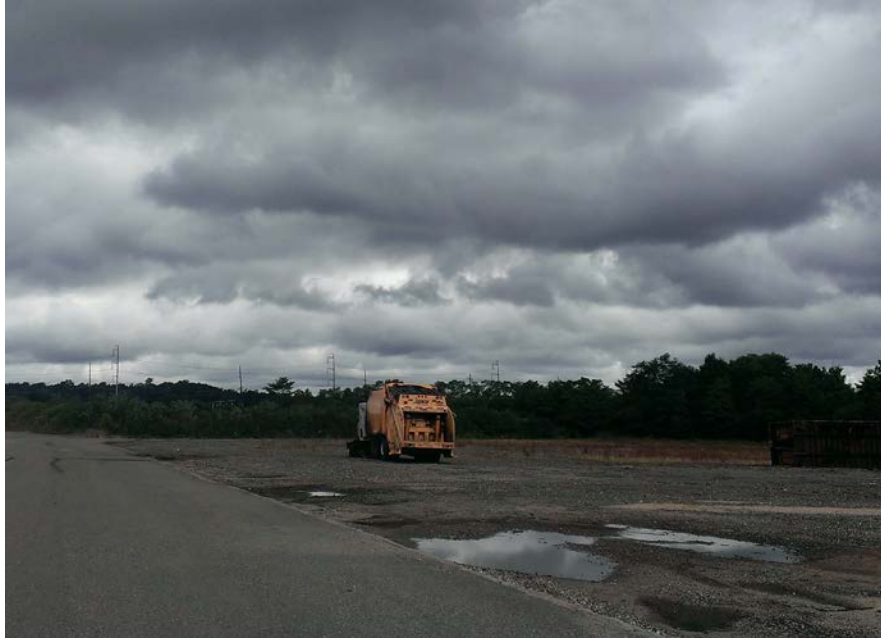
Ponding in Area B

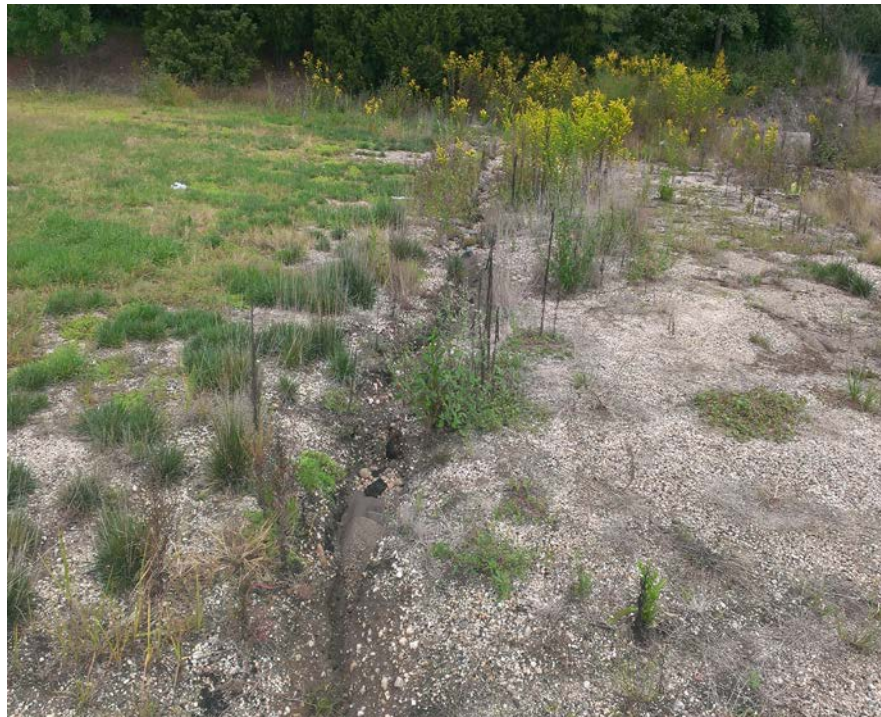
Erosion in Area C

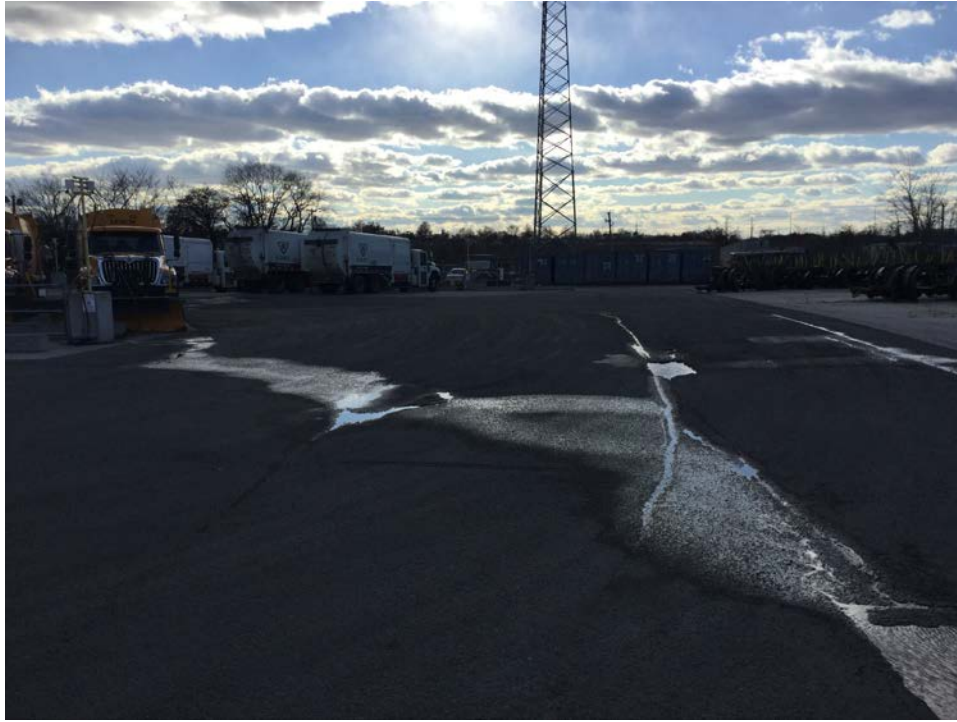
Minor Ponding in Area E

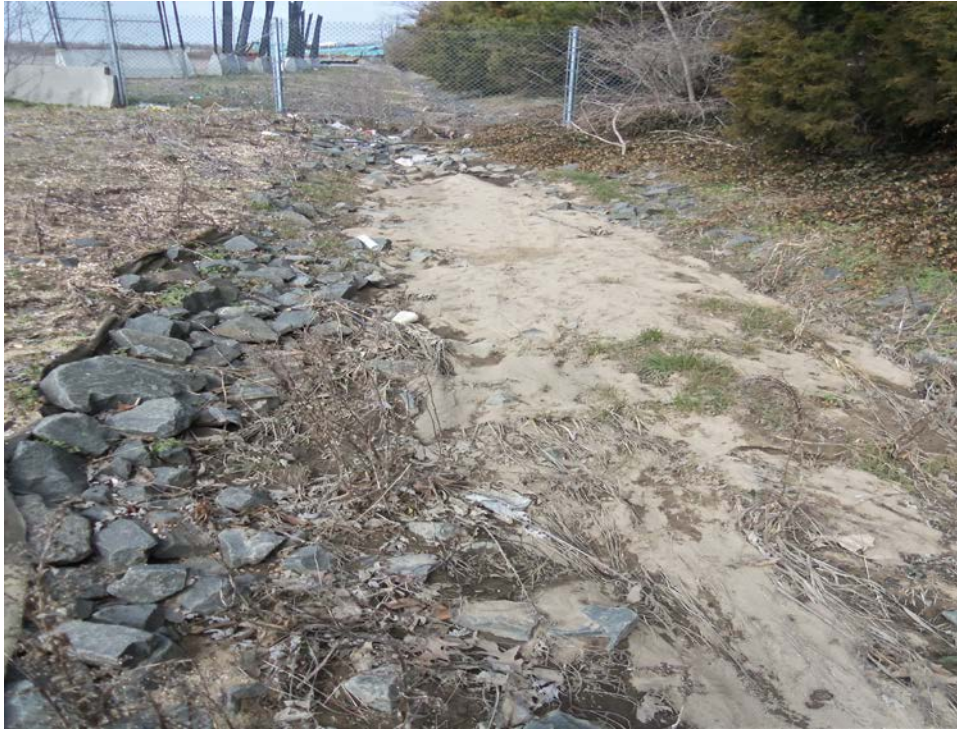
Siltation – DS#3

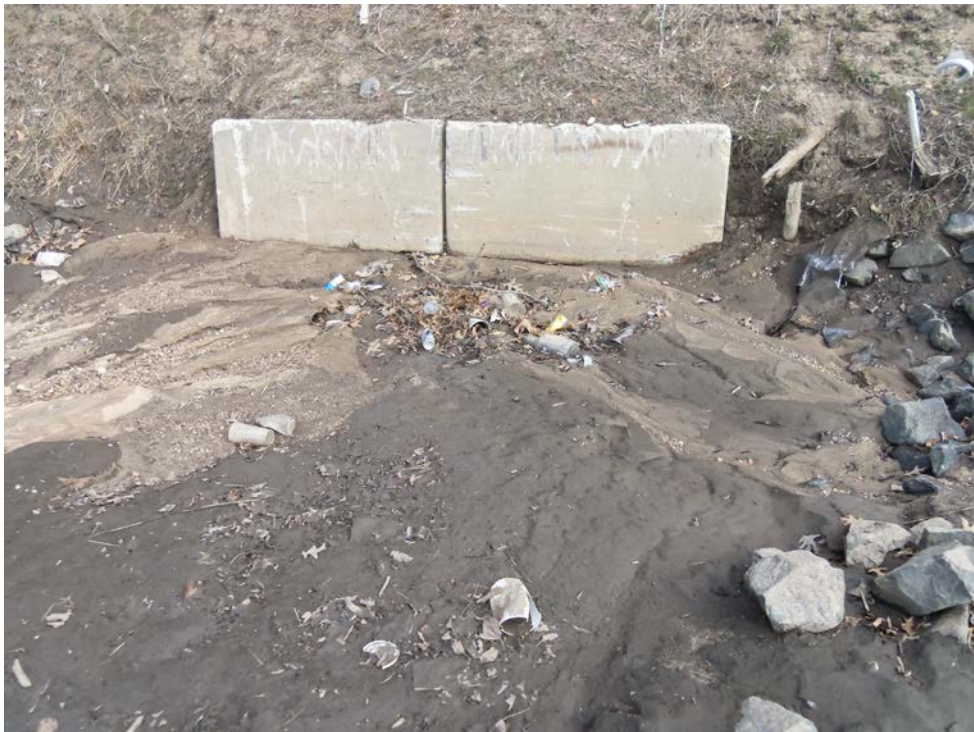
Siltation – Catch Basin #5

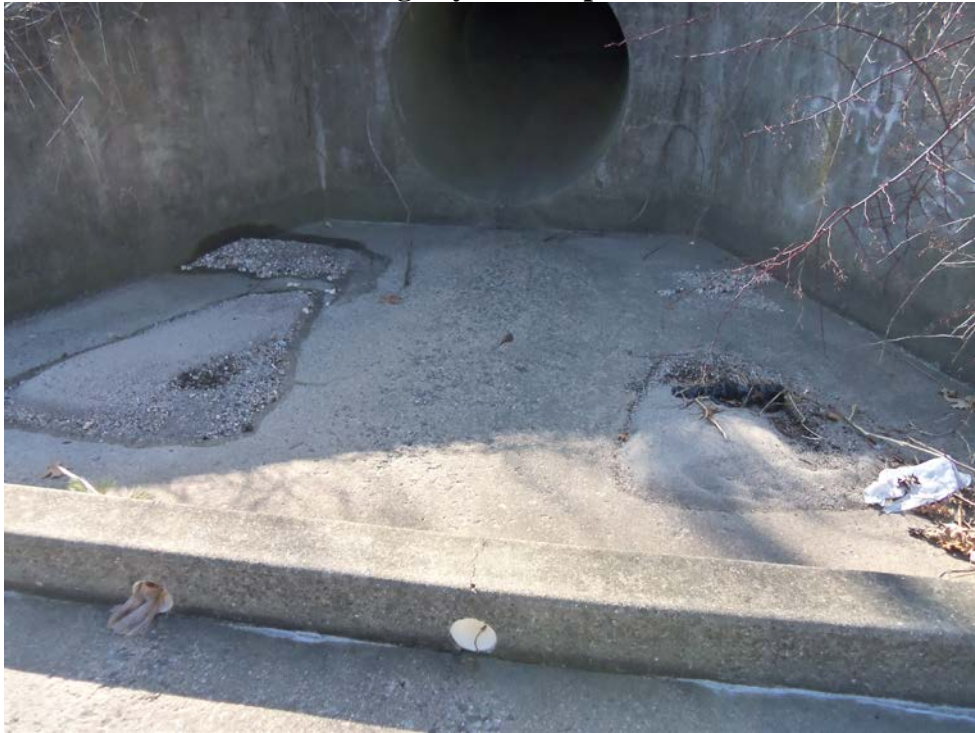
Minor Siltation – RB #571 (HW #1)

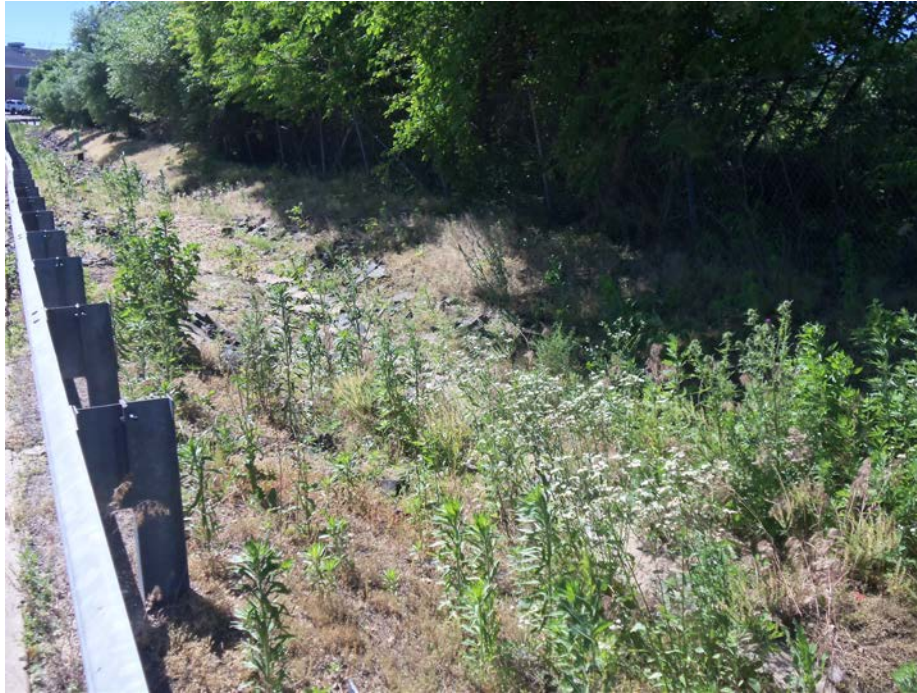
Vegetation – DS#7

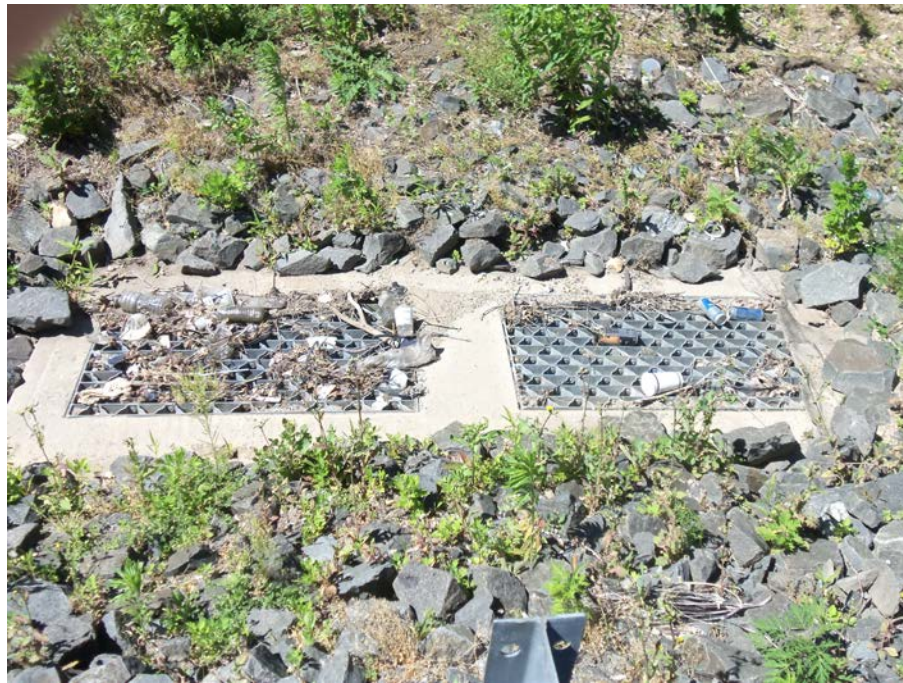
Debris – Catch Basin #2

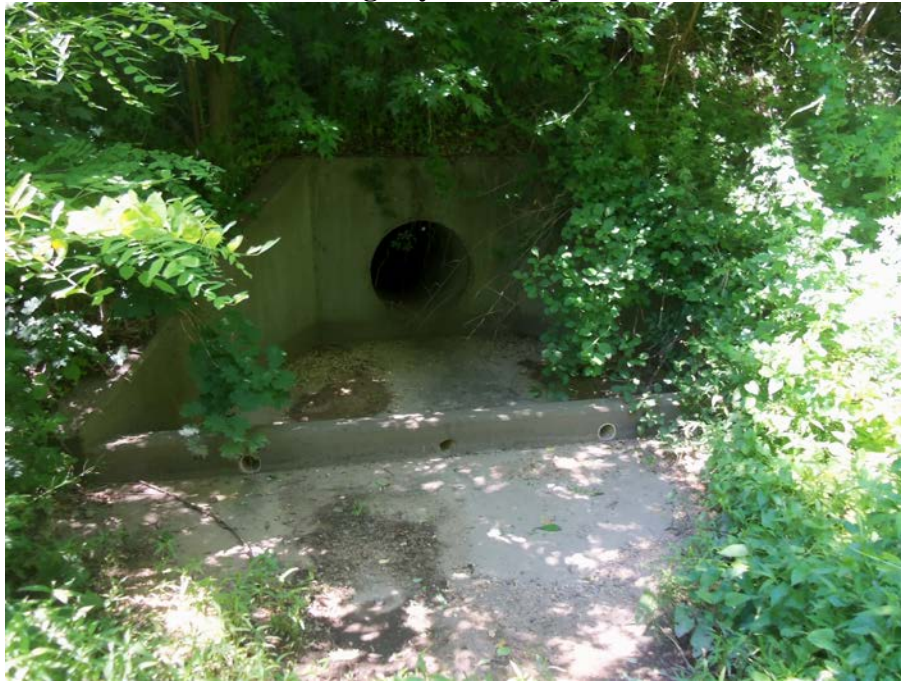
Minor Siltation/ Vegetative Growth –RB #284 (HW #2)

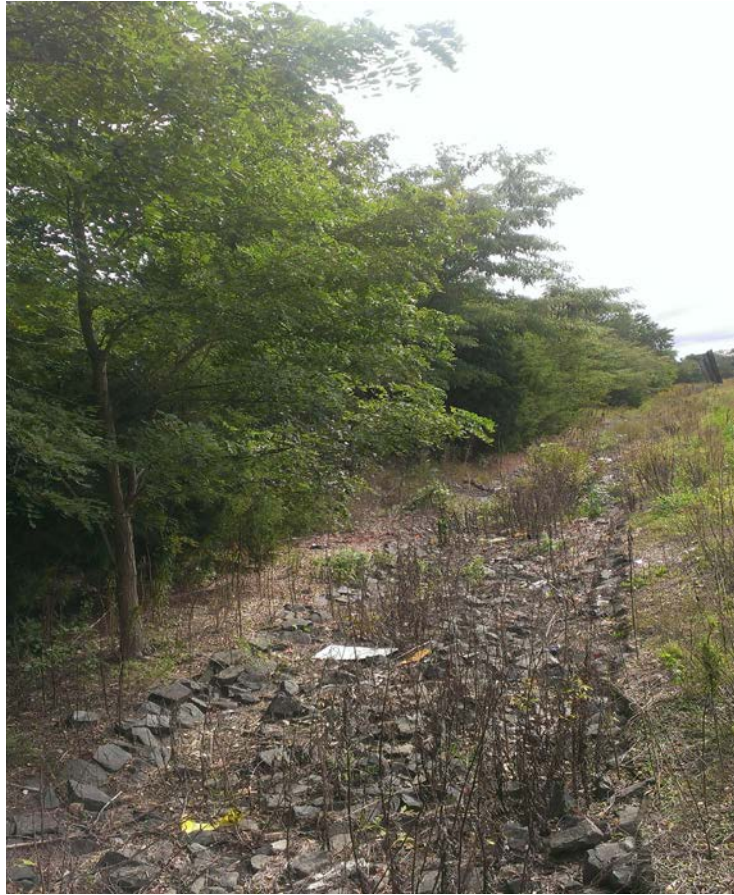
Siltation/Vegetation – DS#5

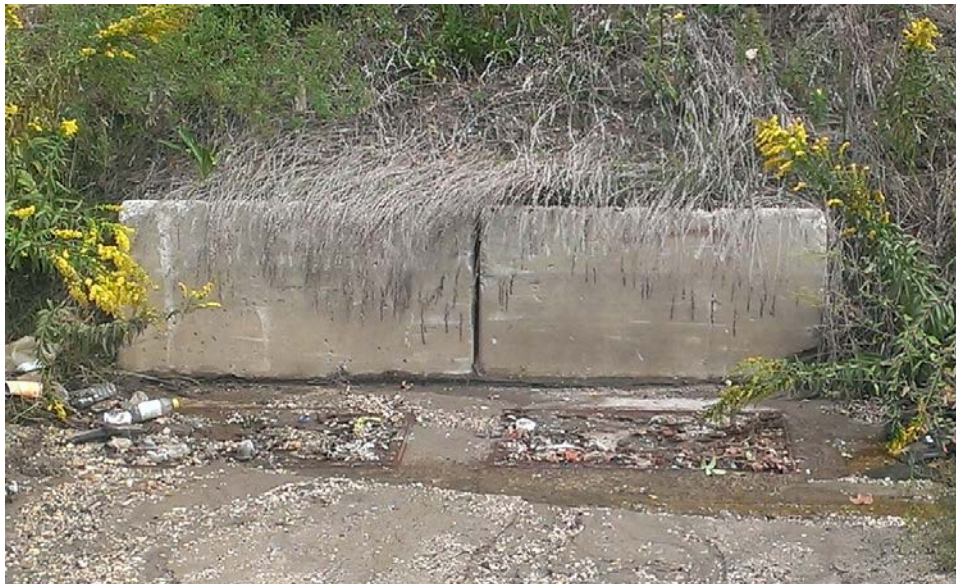
Siltation/Debris – Catch Basin #5

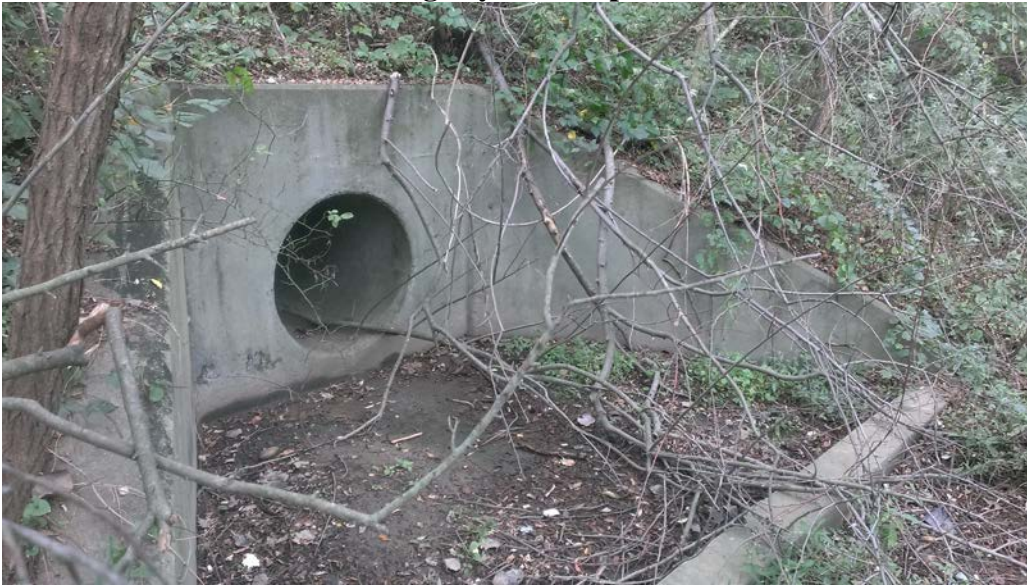
Minor Siltation/Vegetative growth – RB #358 (HW #4)

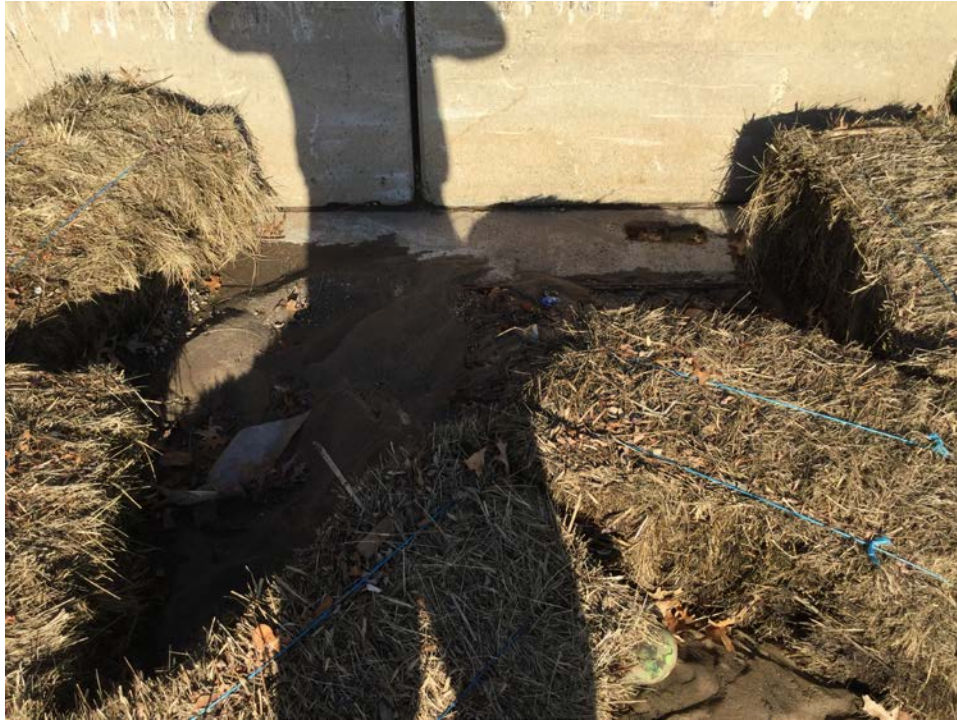
Siltation – Catch Basin #5

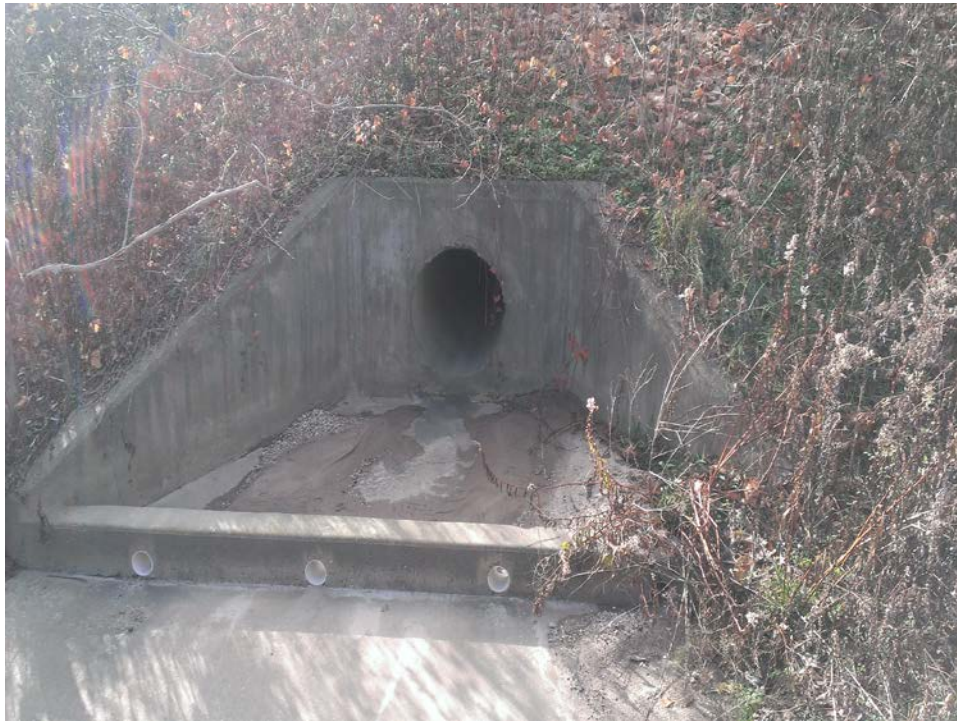
Minor Siltation/Vegetative growth – RB #284 (HW #3)

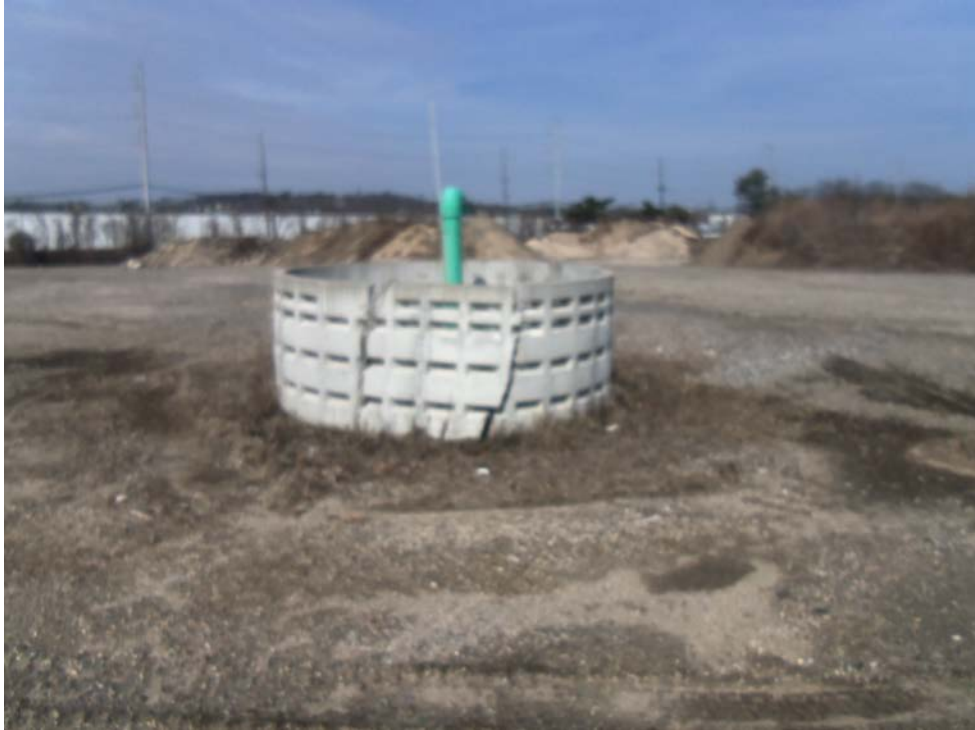
The 2016 ridge vent well inspections conducted during the first, second and third inspection rounds showed only damage to the Well R-8 well casing and the Well R-1 ten foot diameter concrete ring. The well casing of Well R-8 was sheared off at/just below grade above the geomembrane cap. The well was repaired and a new geomembrane boot was installed prior to the fourth round inspection. The damaged ten foot diameter concrete ring at Well R-1 was replaced with an eight foot diameter ring which was stockpiled onsite. Historically, the leading cause of damage to the ridge vent well casings and protective concrete rings has been attributed to impact with trucks or other vehicles used onsite. It is recommended that stockpiles not be placed within 25 feet of the ridge vent wells to prevent trucks from damaging the wells in the future.

Protective Ring Damaged – R1

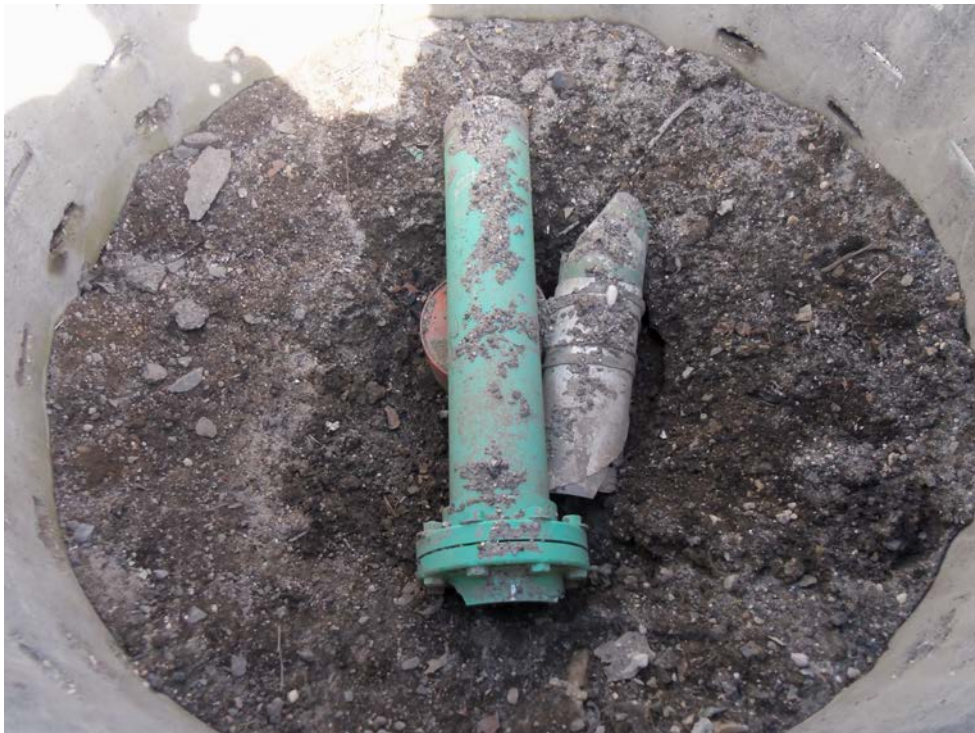
Well Casing Broken at Grade- R8

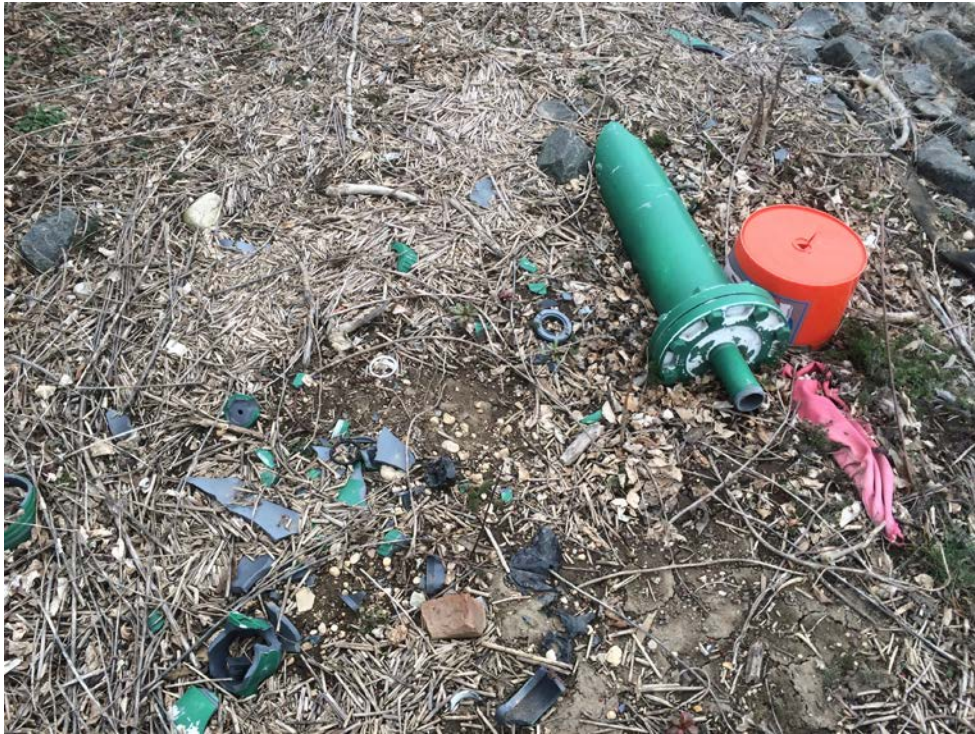
Inspection of each gas vent well was performed prior to each round of gas monitoring. Of the 54 property line and perimeter gas vent wells inspected in the first, second and third inspection rounds, only SW-3 was damaged (the upper section of the gas vent well was detached from the well casing pipe at grade). Well SW-3 was repaired prior to the fourth inspection round. However, during the fourth inspection round, Well NE-16 was found to be similarly damaged. Well NE-16 has since been secured with a protective cover. Machinery used in this area combined with overgrown vegetation may have been the cause of the damage. During the post-closure period to date, methane has not been detected at either of these two wells. While Well NE-16 is still capable of venting and being monitored in its current condition, when necessary, it is recommended that the upper and lower sections of the casing pipe be reattached and the well restored to its original configuration during the next well repair contract. It is recommended that vegetation near the gas vent wells be maintained on a regular basis to improve visibility and help prevent damage to vent wells in the future.

Well Casing Broken at Grade- SW3

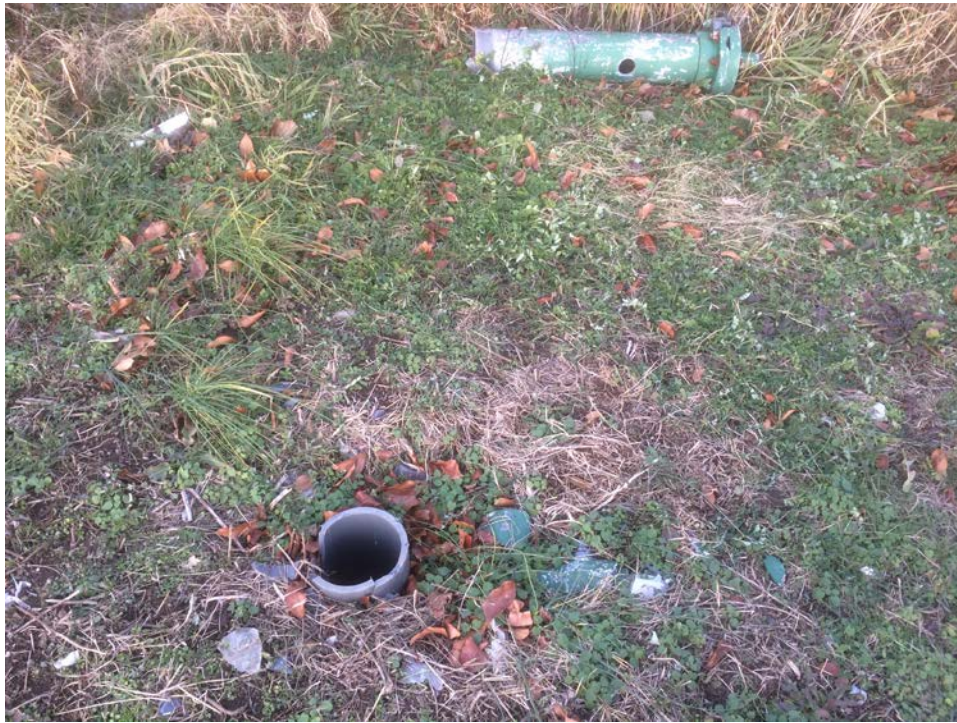
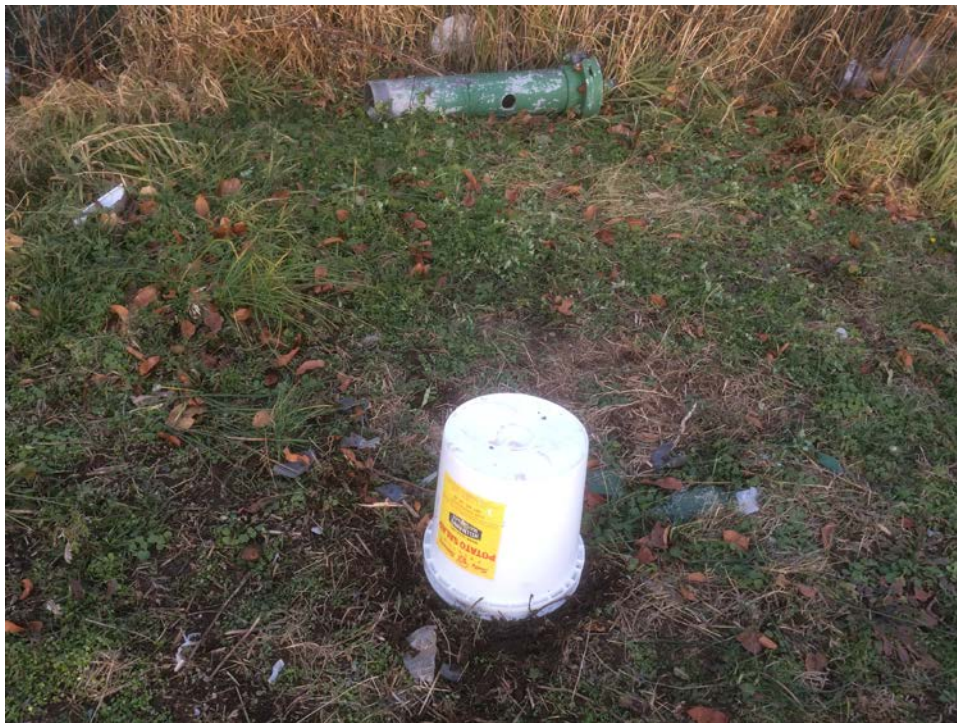
Well Casing Broken at Grade- NE16

Well Casing Broken at Grade – NE16

- Recommended that stockpiles not be placed within 25 feet of the ridge vent wells to prevent trucks from damaging the wells in the future. Well NE-16 should be repaired during the next well repair contract.
- Commencing in 2017, gas venting system inspections and perimeter/property line gas vent wells monitoring will be reduced from quarterly to semi-annually, as approved by the USEPA and NYSDEC.
