SYOSSET LANDFILL

2017 ANNUAL POST-CLOSURE SUMMARY REPORT

TOWN OF OYSTER BAY

June 2018

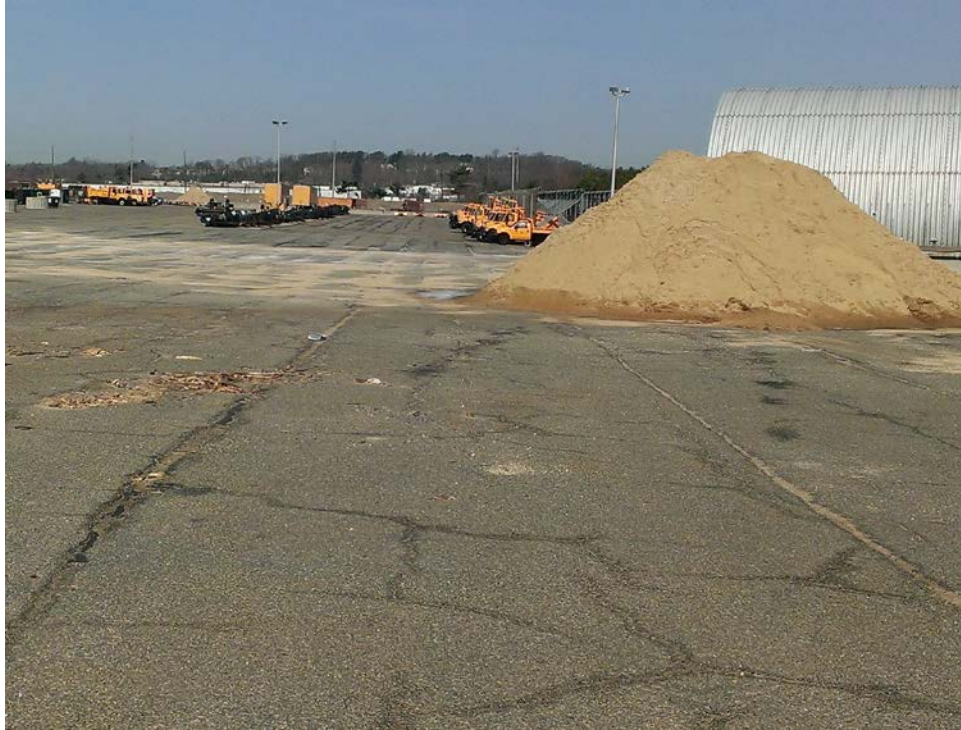
Asphalt Surface Cracks in in Area C

It is recommended that these areas continue to be repaired on a regular basis as part of routine yard maintenance. The joints should be cleaned and sealed to prevent further weathering damage in accordance with the New York State Department of Transportation (NYSDOT) Standard Specifications, Construction and Materials, Section 633-3.02, "Cleaning, Sealing and Filling Joints and Cracks". It is recommended that the cracks in the asphalt pavement be cleaned and sealed as per the NYSDOT Pay Item for Cleaning and Sealing Cracks in Hot Mix Asphalt Pavement using Hot Applied Sealant, ITEM 402.7602 08. Cracks in the concrete pavement should be cleaned and sealed as per the NYSDOT Pay Item for Crack Repair by Epoxy Injection (Restoration), ITEM 01555.8002 M.

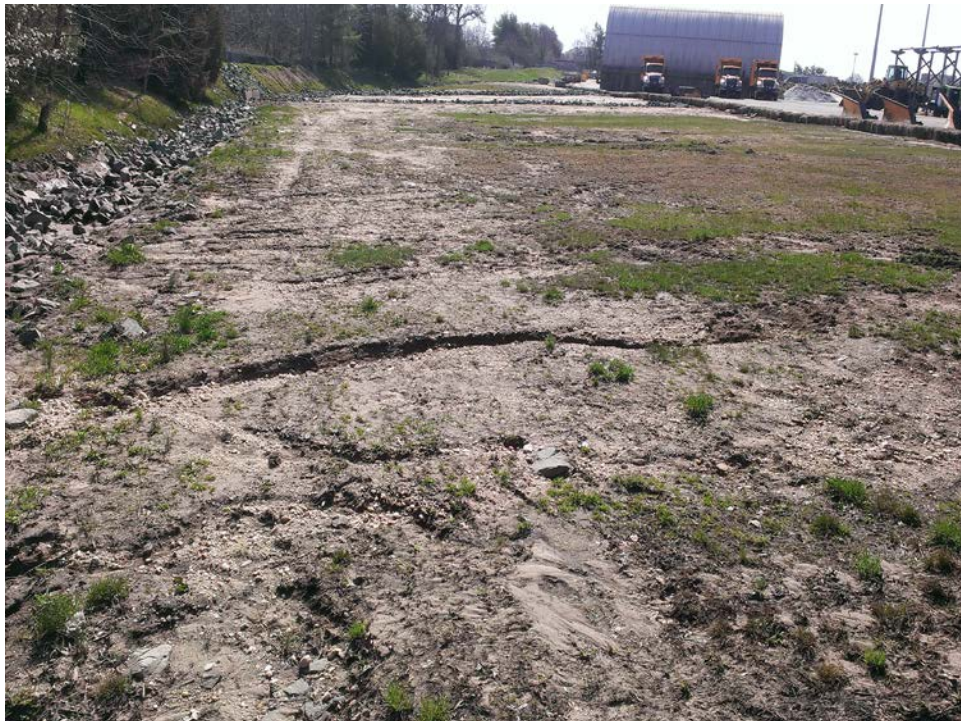
Surface Material Erosion in Area C

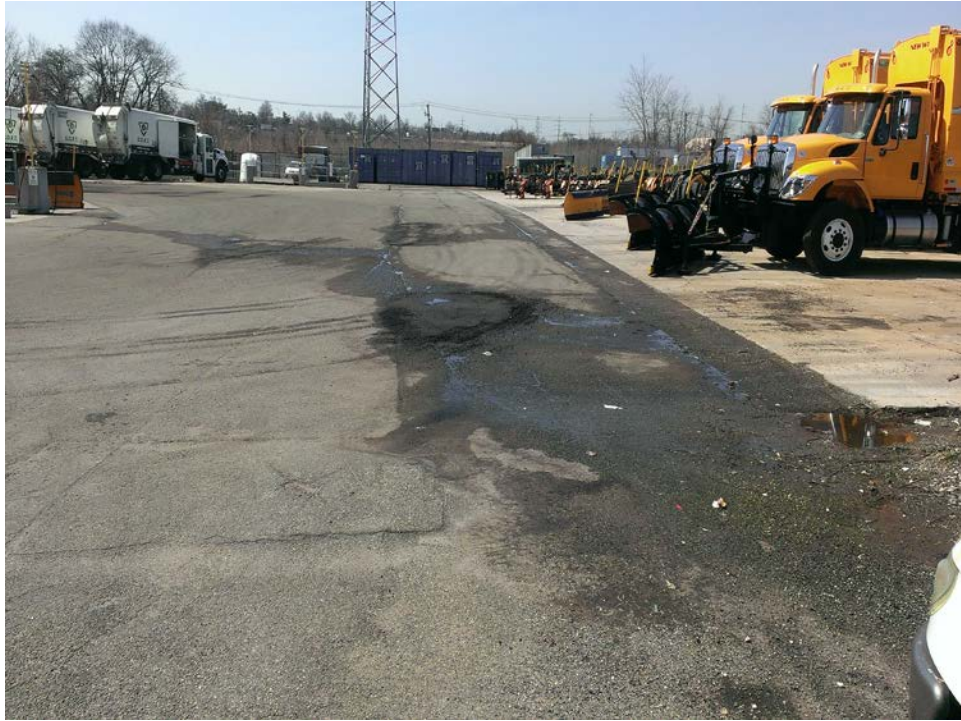
Minor ponding areas were observed in the paved areas within Area E during the first round of inspections during this reporting period due to uneven pavement and potholes. During the second round of inspections minor ponding areas were also observed in the RCA within Area A due to uneven grading and the pavement in Area C due to uneven pavement.

Minor Ponding in Area E

It is recommended that surface grading within the RCA material in Area A should be routinely adjusted to remove low points that occur. The asphalt section in Areas C and E experiencing ponding should be restored in accordance with the original Capping Contract specifications as discussed in Section 1.5 when routine pavement repairs are performed in the future in these areas.

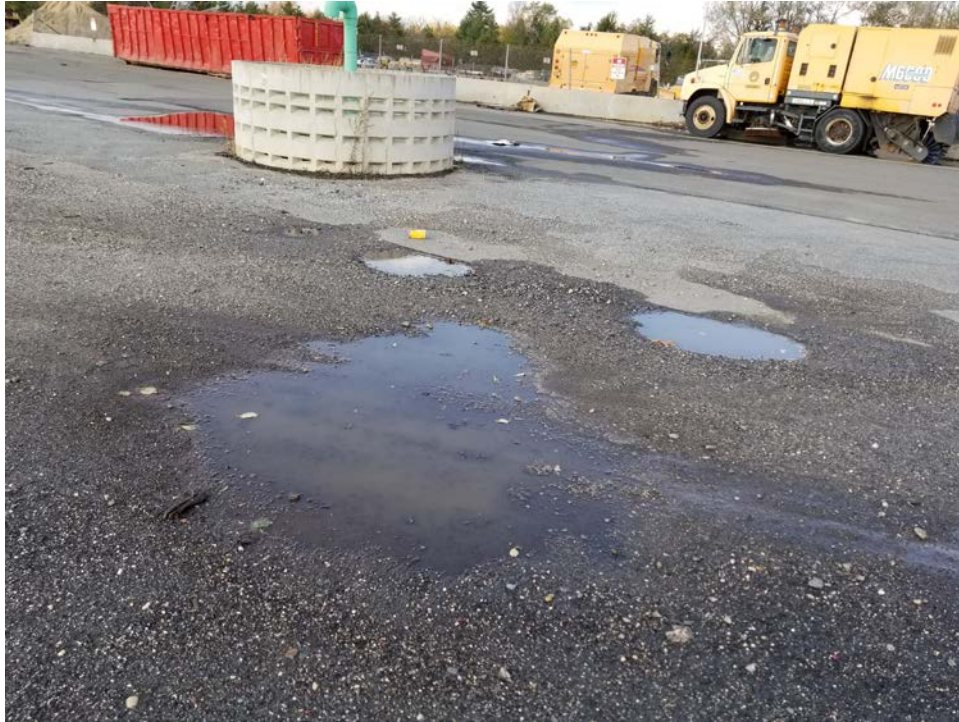
Ponding in Area A/C Border

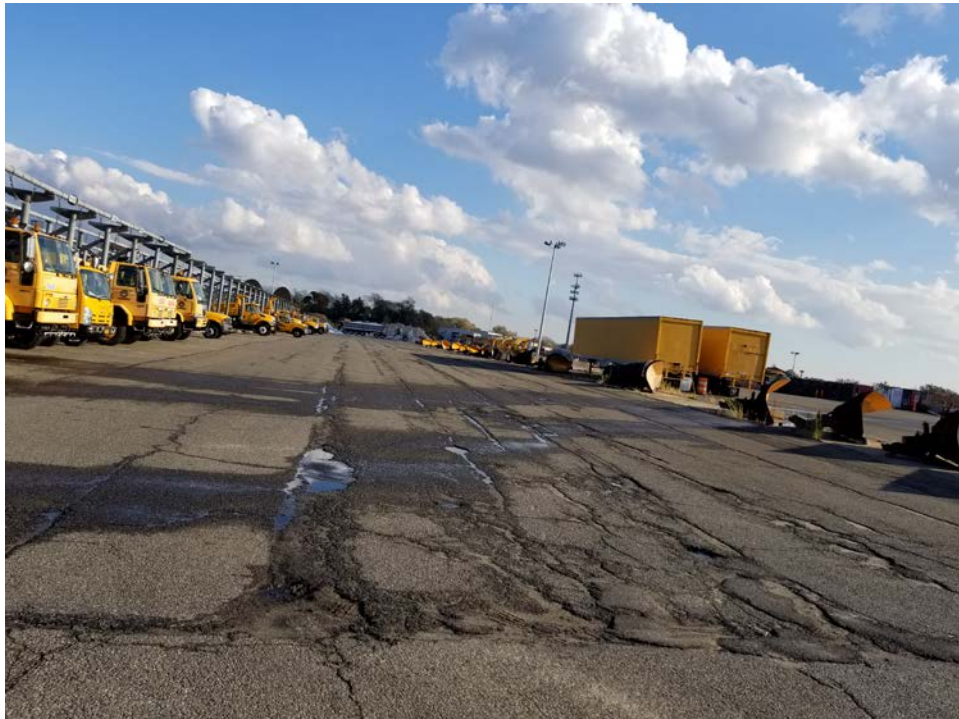
Asphalt Surface Cracks Area C

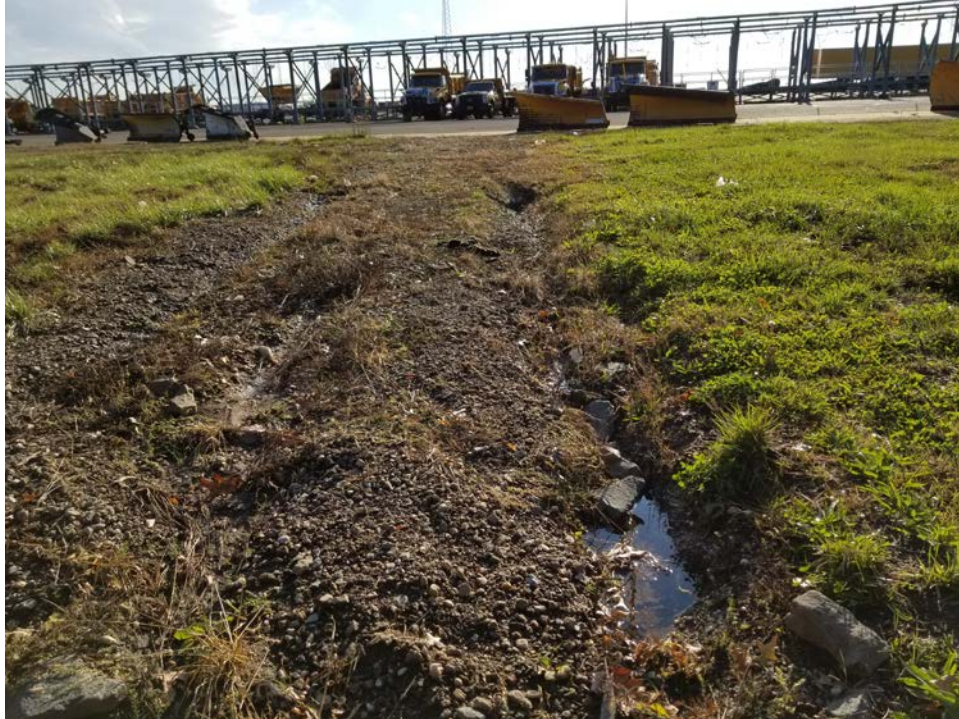
Areas of surface material erosion (i.e., ruts) were found in the vegetative cover buffer area of the Miscellaneous Equipment Storage Facility (Area B) and the Salt Storage Facility (Area C) during both rounds of inspections. These Areas are sloped toward the perimeter drainage ditches. The vegetative cover buffer area therefore receives runoff from both RCA and paved areas. Ruts form as a result of continued erosion of the surface material from stormwater runoff.

Vegetative Cover Erosion in Area C

It is recommended that ruts in the surface material be repaired by removing silt, filling/regrading the surface area to remove the ruts, replacing topsoil that may have eroded away and reseeding this area during the planting season to prevent further erosion problems.

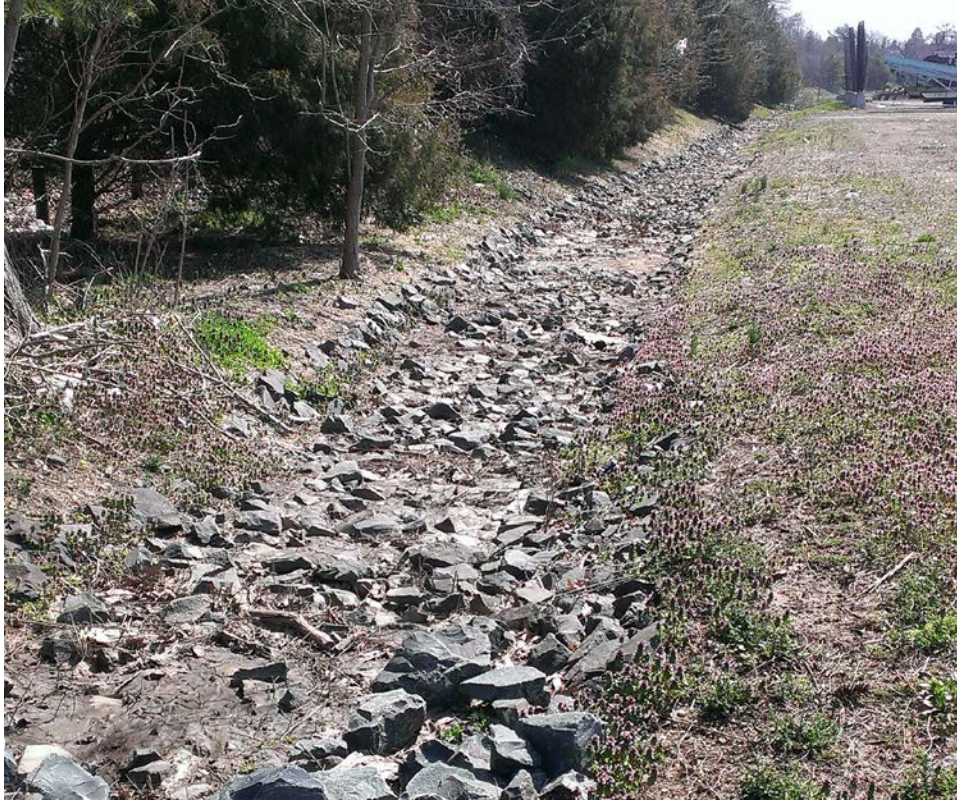
Siltation – DS#3

The drainage ditches should receive routine maintenance to prevent future sediment accumulation and vegetation growth conditions. The apparent

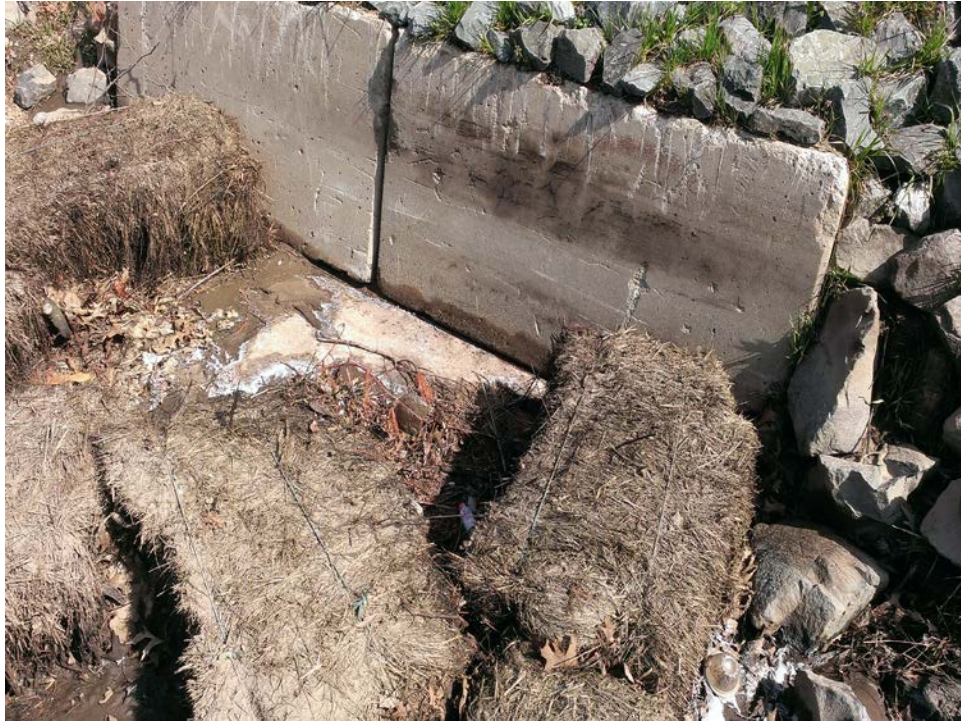
Siltation – Catch Basin #5

It is recommended that the silt and sediment be removed on a regular basis from catch basins and the area in the vicinity of the catch basin inlets and drainage ditches. The hay bales previously installed at the catch basin inlets should be replaced. The erosion control measures recommended in Section 2.1 should be implemented onsite to minimize the silt and sediment transport to the catch basin locations.

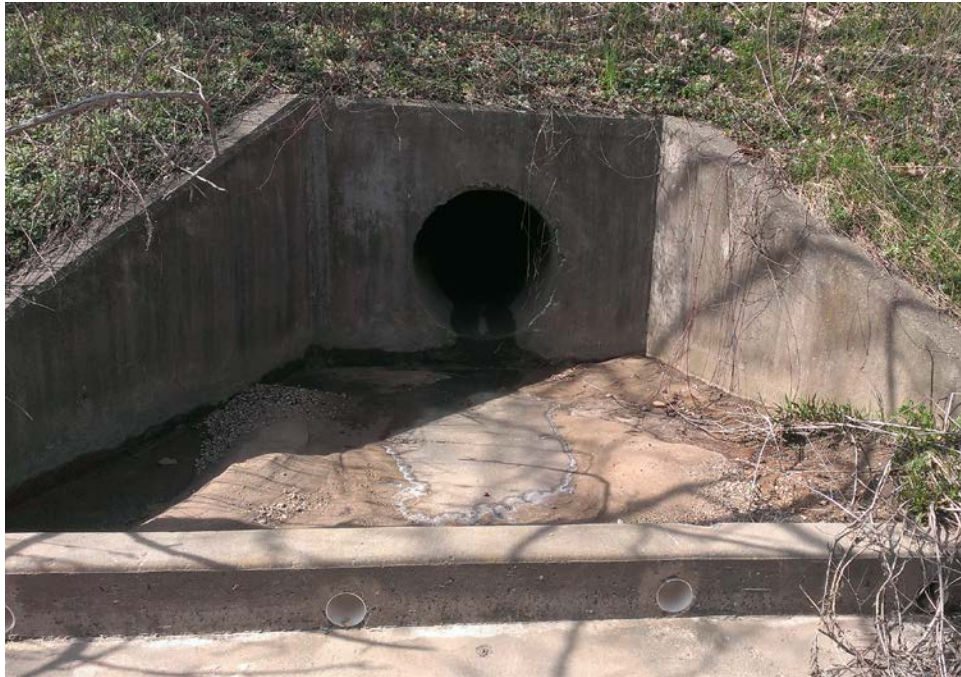
Minor Siltation – RB #284 (HW #3)

Although the silt/sediment deposits and vegetation are not impacting the performance of the headwalls, it is recommended that they be routinely removed. Routine maintenance of these Nassau County Basins is performed by Nassau County.

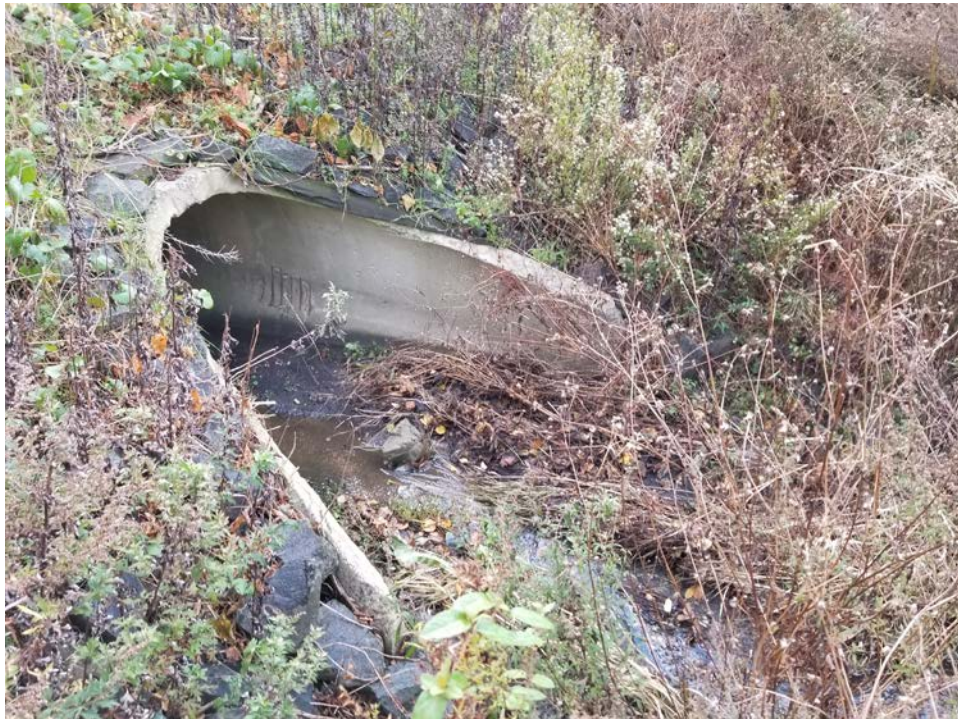
The storm drainage pipes were inspected at the drainage structure locations and only minimal sedimentation and some vegetative growth were noted at the entrance to the end section located adjacent to the Animal Shelter (ES #1, see Figure 2) during the 2017 reporting period.

Some Siltation and Vegetative Growth – ES#1 (DS#8)

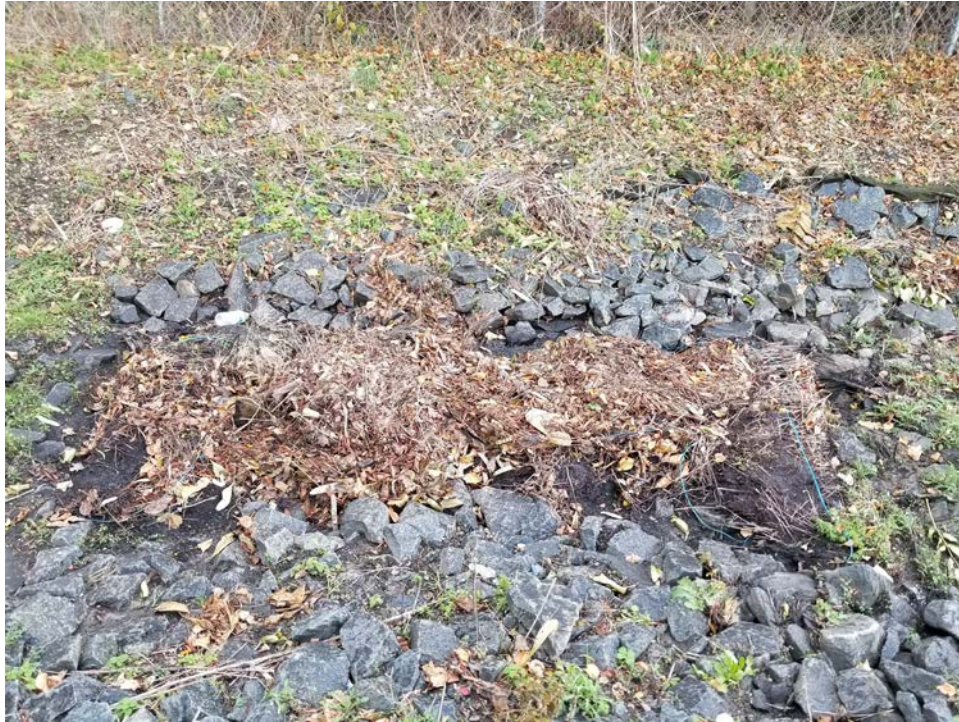
Siltation/Debris – Catch Basin #2

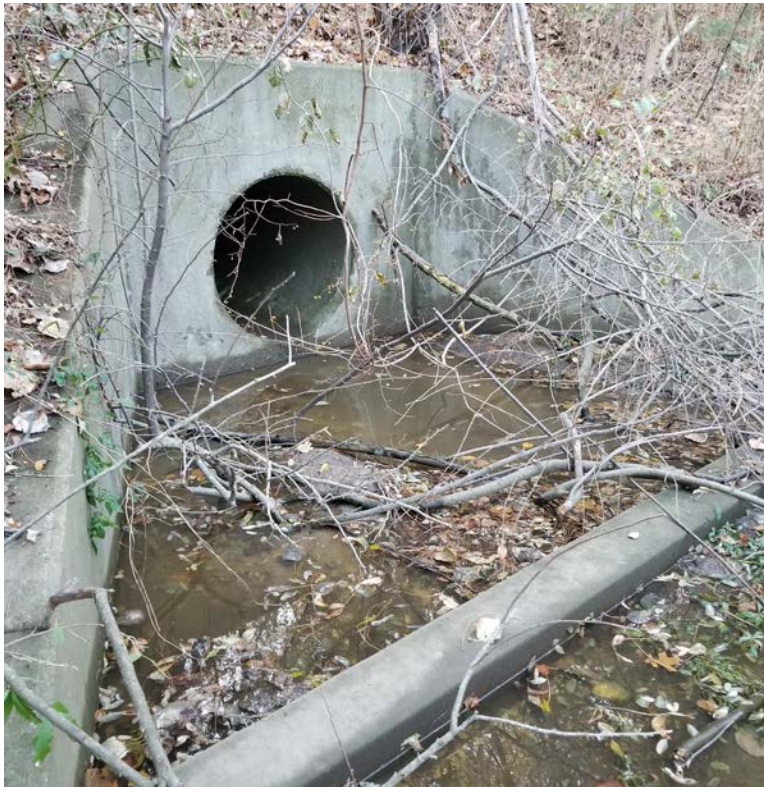
Minor Siltation/Debris – RB #358 (HW #4)

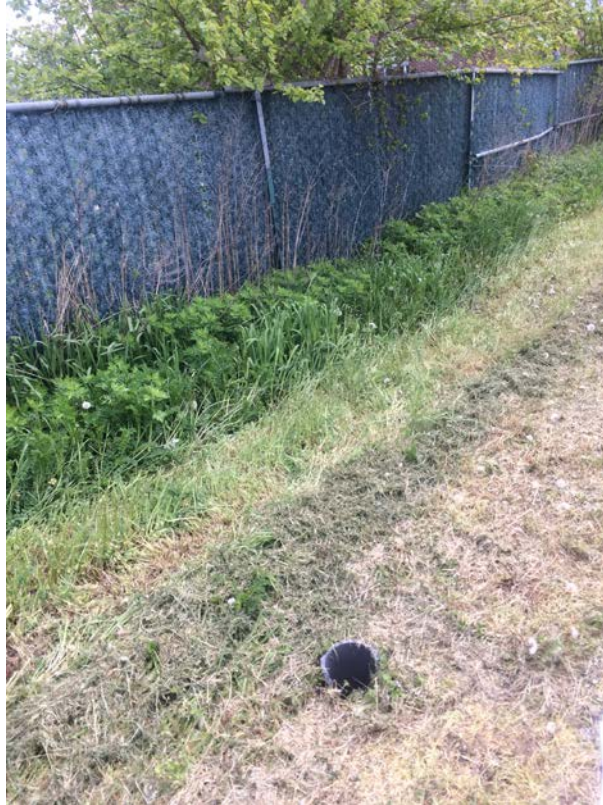
Inspection of each gas vent well was performed prior to each round of gas monitoring. Of the 54 property line and perimeter gas vent wells inspected in the first and second inspection rounds, only NE-16, NW-3, and SW-6 were damaged (the upper sections of the gas vent wells were detached from the well casing pipes at grade) during this reporting period. The three wells are secured with a temporary protective cover to prevent debris from entering the wells. Machinery used in this area combined with overgrown vegetation may have been the cause of the damage. During the post-closure period to date, methane has not been detected at Well NE-16, and has only been detected twice at Well NW-3 and four times at Well SW-6. However, these detections were all below the 6NYCRR Part 360 regulatory limit of 5% and no detections at these wells have occurred since the second quarter of 2013. While Well NE-16, NW-3, and SW-6 are still capable of venting and being monitored in their current condition, when necessary, it is recommended that the upper section of the casing pipe be reattached and the wells restored to their original configuration during the next well repair contract. It is recommended that vegetation near the gas vent wells be carefully maintained on a regular basis to improve visibility and help prevent damage to vent wells in the future.

Well Casing Broken at Grade – NE-16

- Recommended that stockpiles not be placed within 25 feet of the ridge vent wells to prevent trucks from damaging the wells in the future.
- Wells NE-16, SW-6, and NW-3 should be repaired during the next well repair contract.
- The damaged protective concrete rings at Ridge Vents R-6 and R-26 should be replaced.

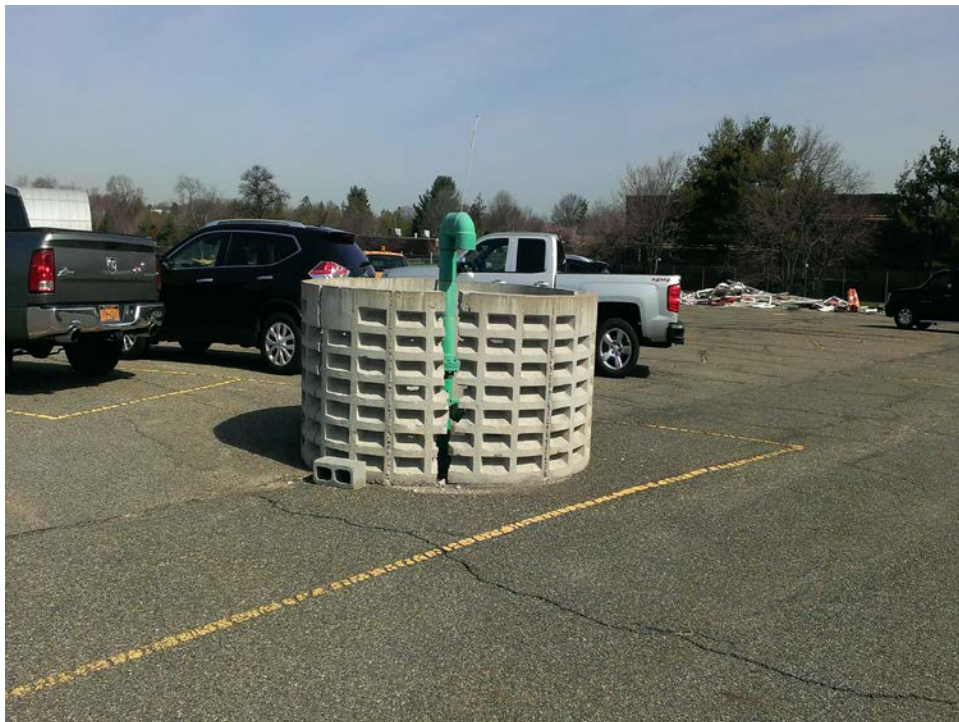
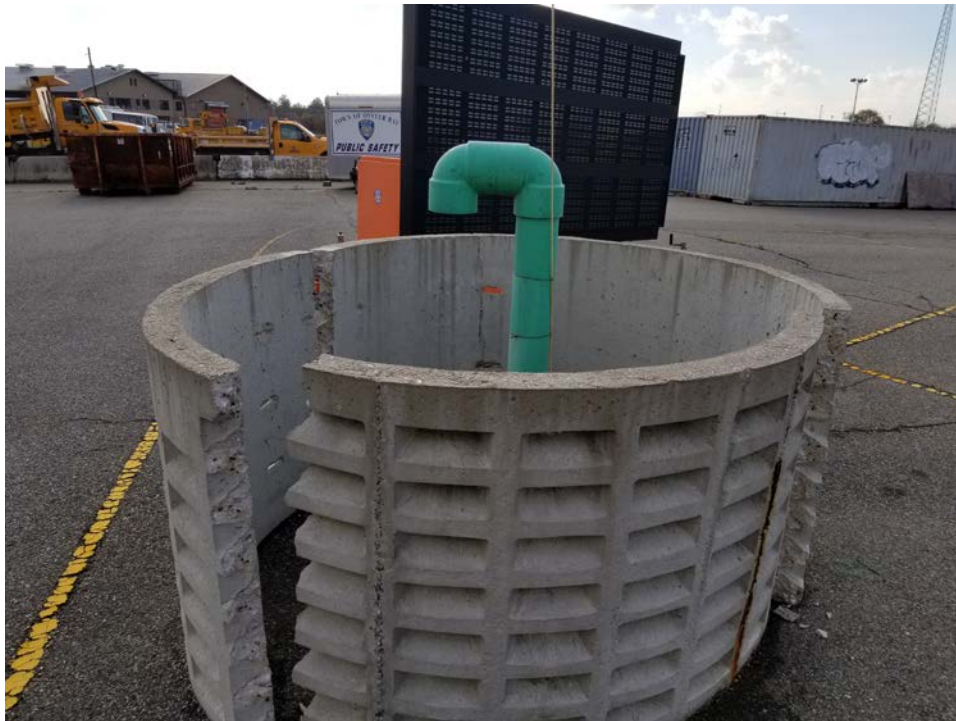
The 2017 ridge vent well inspections conducted during the first and second inspection rounds showed only damage to the Well R-6 and the Well R-26 ten foot diameter concrete ring. It is recommended that the damaged concrete rings be replaced with ten foot diameter concrete rings. Historically, the leading cause of damage to the ridge vent well casings and protective concrete rings has been attributed to impact with trucks or other vehicles used onsite. It is recommended that stockpiles not be placed within 25 feet of the ridge vent wells to prevent trucks from damaging the wells in the future.

Ridge Gas Vent Well Broken Ring – R-26

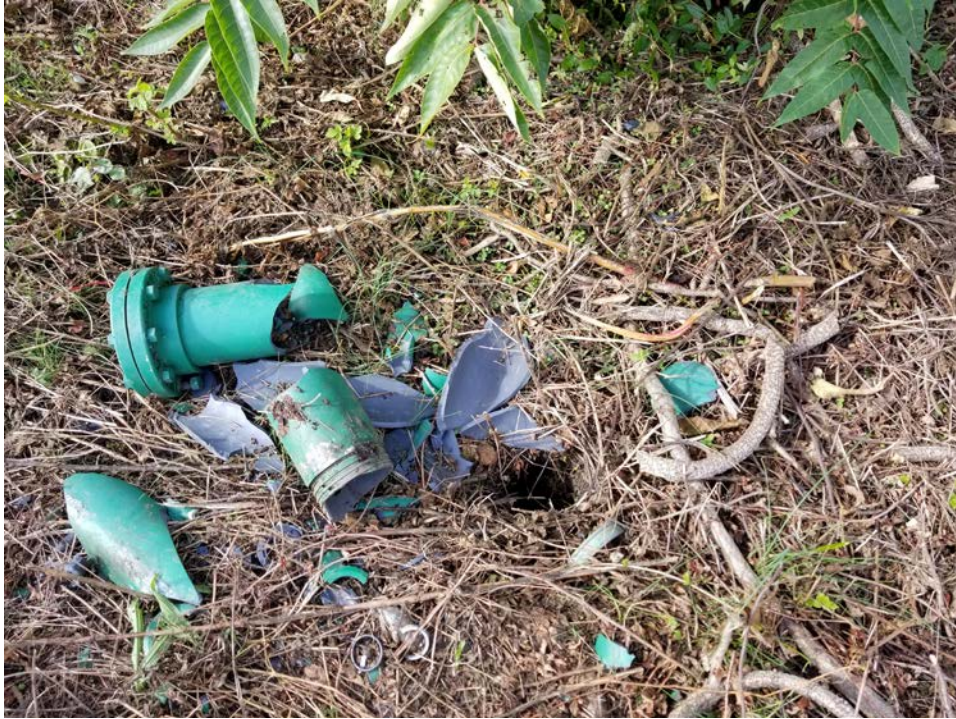
Well Casing Broken at Grade – NW-3

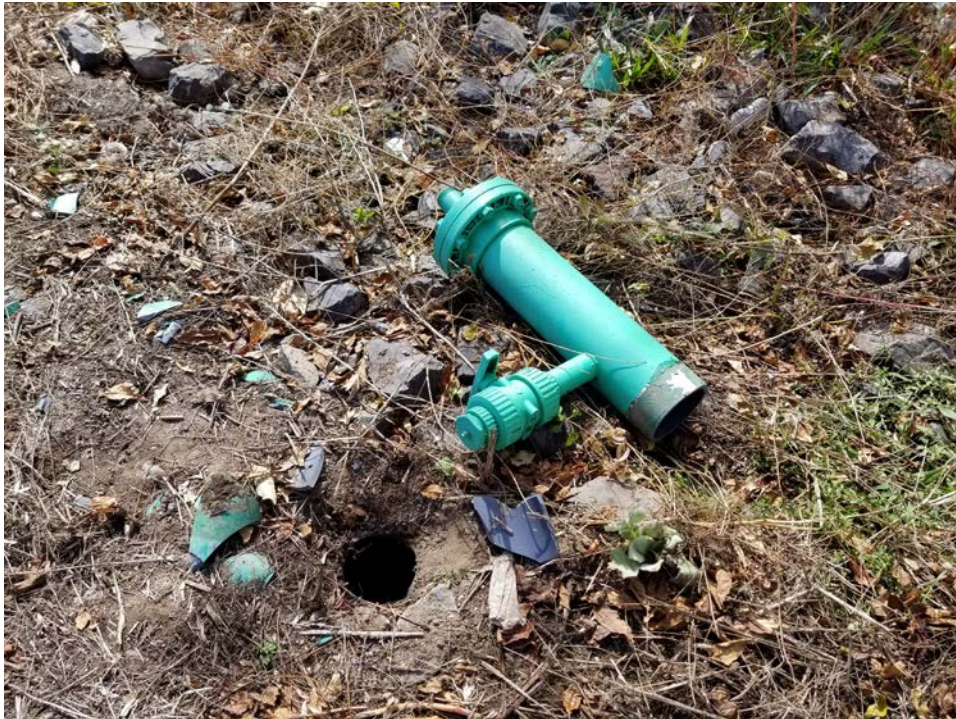
Well Casing Broken at Grade – SW-6

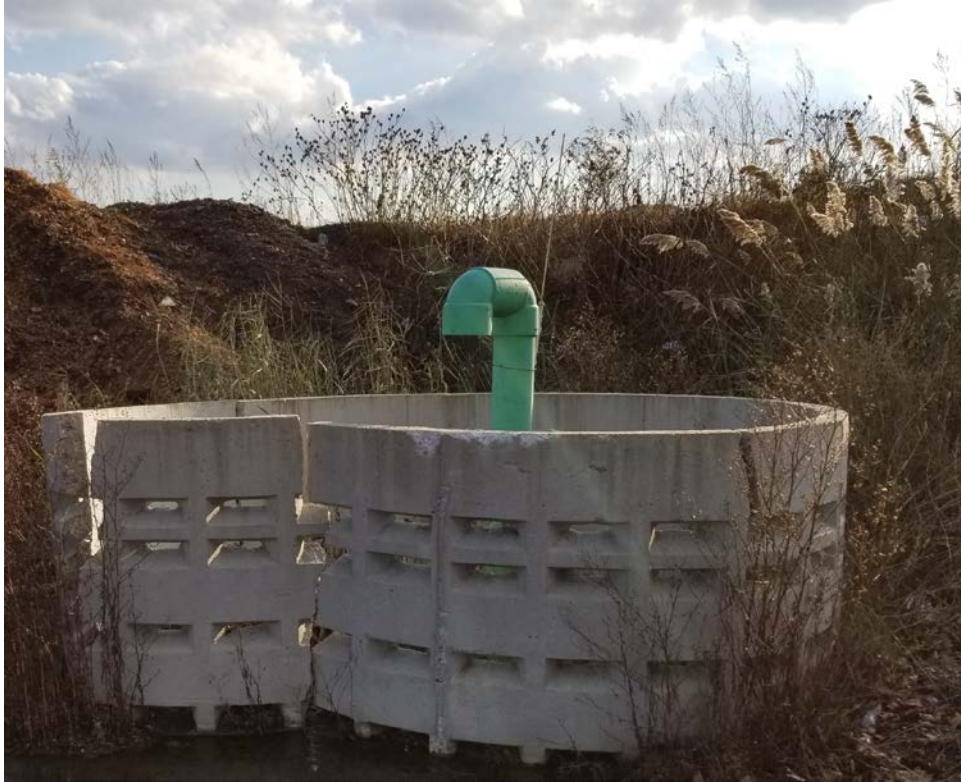
Ridge Gas Vent Well Broken Ring – R-6
