SYOSSET LANDFILL

2022 ANNUAL POST-CLOSURE SUMMARY REPORT

TOWN OF OYSTER BAY

June 2023

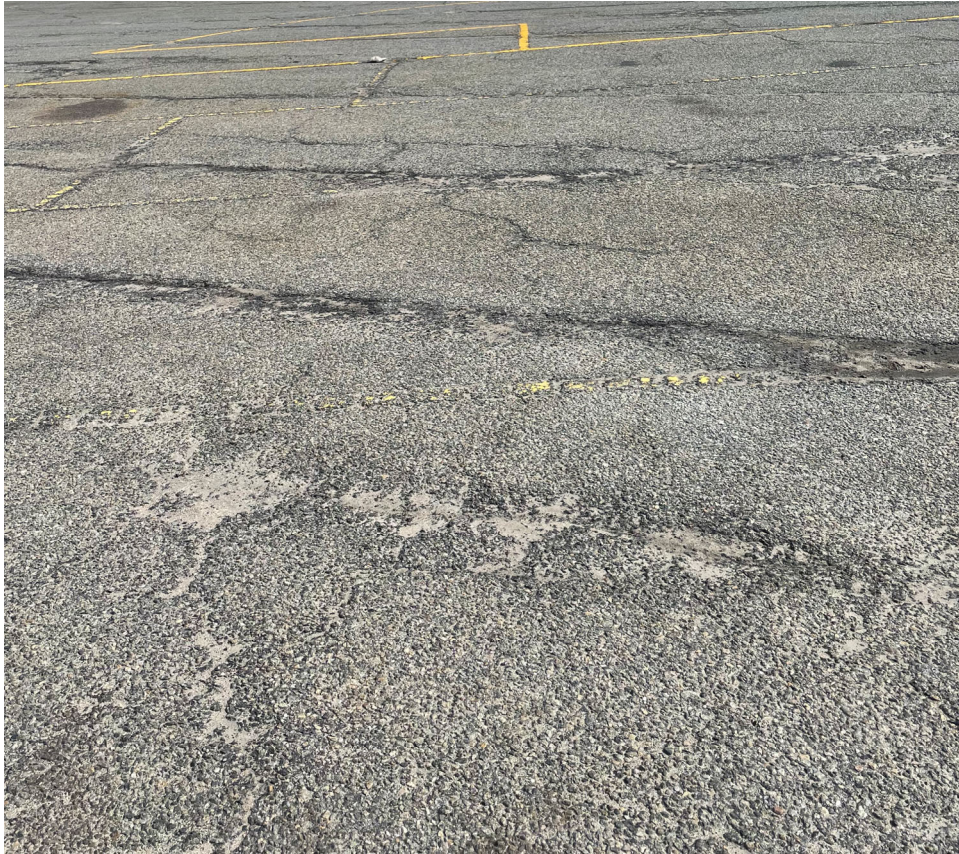
The condition of the concrete and asphalt pavement located in the Highway Division's Salt Storage Facility and Vehicle Parking Facility (Areas C & D) as well as the Town of Oyster Bay Sanitation Department's Vehicle Parking Facility (Area E), in general, continues to be good. Routine fracturing of pavement cracks occurs at construction joint locations and is likely occurring due to weathering. Minor cracks are inherent in these types of pavement materials. Some irregularly shaped pavement cracks also exist in Area E and are likely occurring due to a minor amount of settlement in the subsurface material in those areas. Their locations have been monitored/maintained throughout the post-closure period, the minor amount of settlement has not increased and is not necessarily attributable to the Landfill.

Minor Surface Cracks in Area D

It is recommended that these areas continue to be repaired on a regular basis as part of routine yard maintenance. The joints should be cleaned and sealed to prevent further weathering damage in accordance with the New York State Department of Transportation (NYSDOT) Standard Specifications, Construction and Materials, Section 633-3.02, "Cleaning, Sealing and Filling Joints and Cracks". It is recommended that the cracks in the asphalt pavement be cleaned and sealed as per the NYSDOT Pay Item for Cleaning and Sealing Cracks in Hot Mix Asphalt Pavement using Hot Applied Sealant, ITEM 402.7602 08. Cracks in the concrete pavement should be cleaned and sealed as per the NYSDOT Pay Item for Crack Repair by Epoxy Injection (Restoration), ITEM 01555.8002 M.

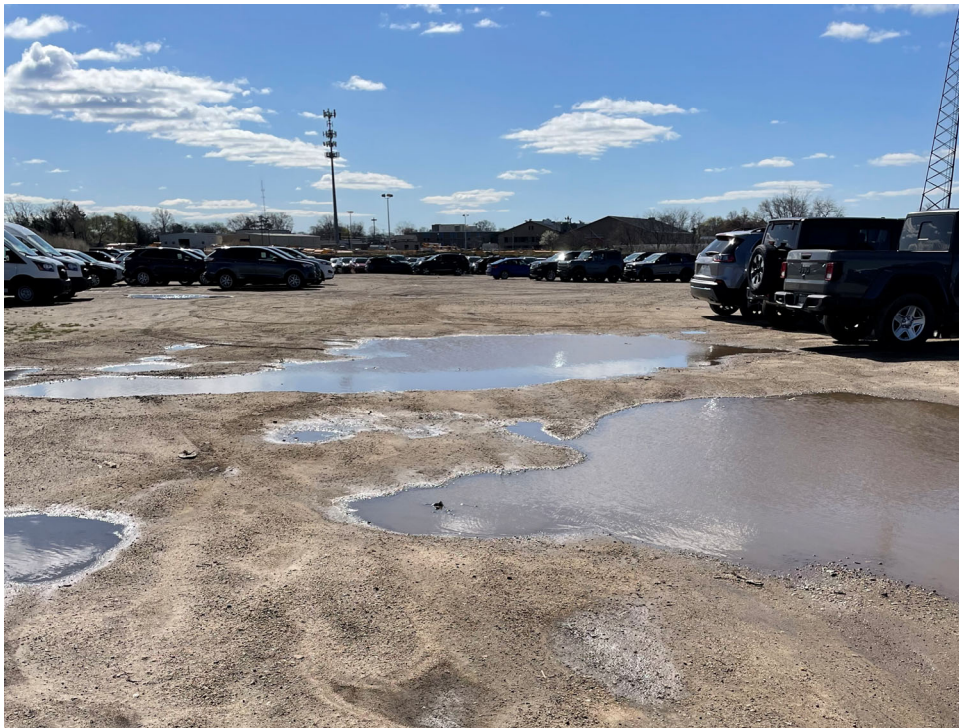
Ponding was observed in Areas A and B during both semi-annual inspection rounds. Minor ponding was noted in Area A at the edge of the vegetative cover bordering the access road. Some areas of ponding were also noted throughout Area B and in a few locations along the berm.

Ponding in Area A

In order to prevent ponding from occurring in the future, it is recommended that surface grading within the RCA material in Areas A and B should be routinely adjusted to remove low points that may occur. Should the asphalt section in Areas C and E experience ponding it should be restored in accordance with the original Capping Contract specifications as discussed in Section 1.5 when routine pavement repairs are performed in the future in these areas.

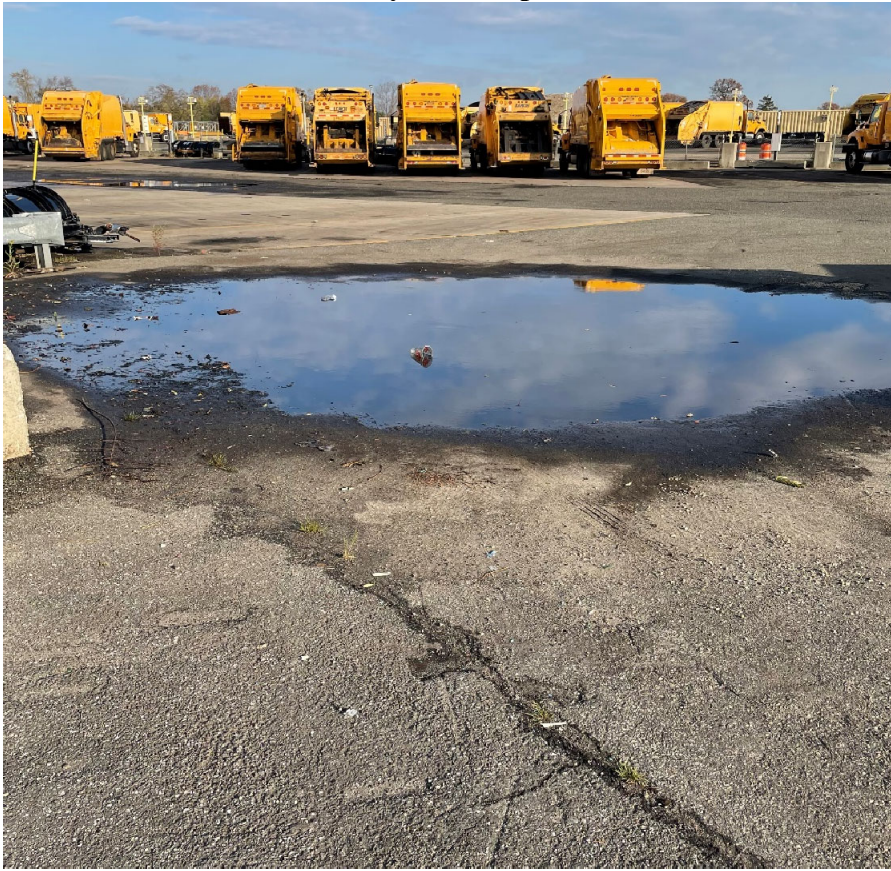
Ponding in Area E

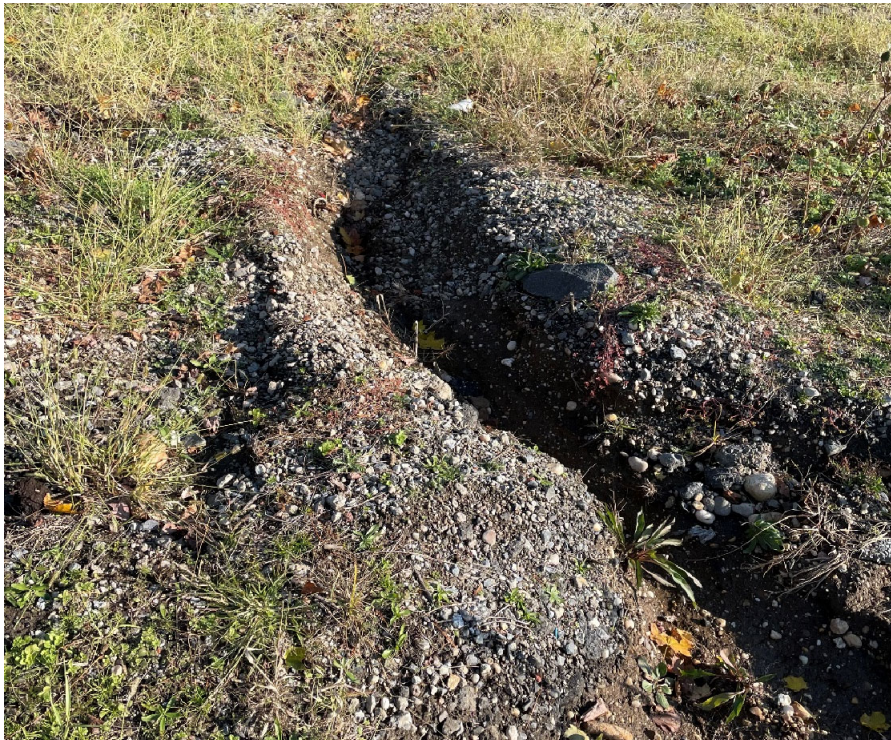
Areas of surface material erosion (i.e., ruts) were found in the vegetative cover buffer area of the Miscellaneous Equipment Storage Facility (Area B) and the Salt Storage Facility (Area C) during both rounds of inspections. These Areas are sloped toward the perimeter drainage ditches. The vegetative cover buffer area therefore receives runoff from both RCA and paved areas. Ruts form as a result of continued erosion of the surface material from stormwater runoff.

Vegetative Cover Erosion in Area B

It is recommended that ruts in the surface material be repaired by removing silt, filling/regrading the surface area to remove the ruts, replacing topsoil that may have eroded away and reseeding this area during the planting season to prevent further erosion problems.

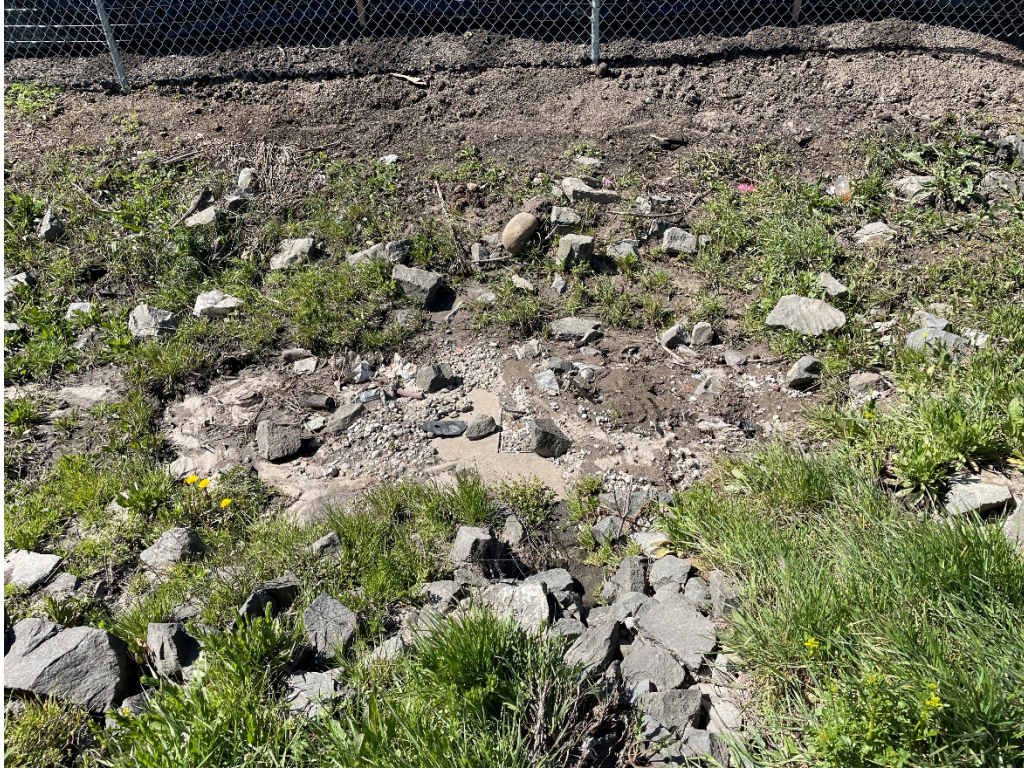
All of the catch basins onsite were inspected. During the first round of inspections of 2022, it was found that silting and debris completely covered Catch Basins #2 through #5. During the second round of inspections it was noted that the Catch Basins had been cleared, however Catch Basins #4 and #5 still had silting and debris present.

Grate Covered with Sediment and Debris – CB #2

It is recommended that the silt and debris be removed on a regular basis from catch basins and the area in the vicinity of the catch basin inlets and drainage ditches. It is also recommended to have silt protection around all of the catch basin inlets. The hay bales previously installed at the catch basin inlets should be replaced. The erosion control measures recommended in Section 2.1 should be implemented to minimize the silt and sediment transport to the catch basins.

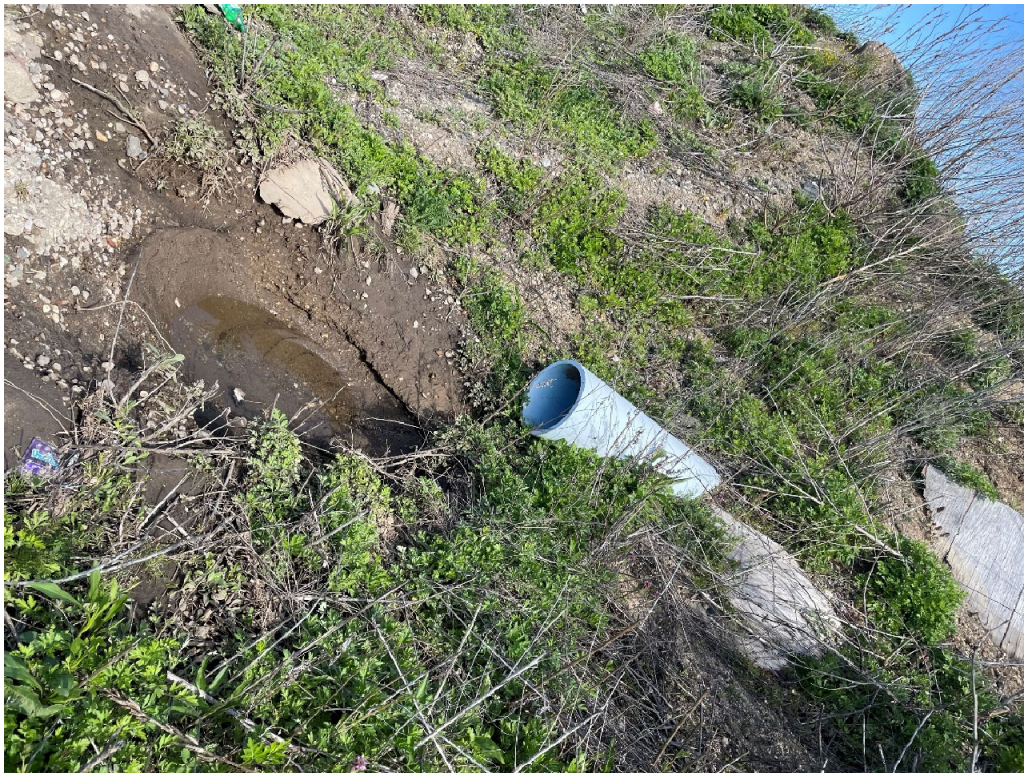
The drainage pipes located in the berm also did not contain defects. However, it was noted during both inspection rounds that stormwater discharging from some of these pipes has caused erosion resulting in ponding conditions and displacement of the stone that was placed at the pipe outlets. It is recommended that larger stone be placed between the pipe outlet and the perimeter ditches to control erosion.

Erosion from drainpipe in DS #6

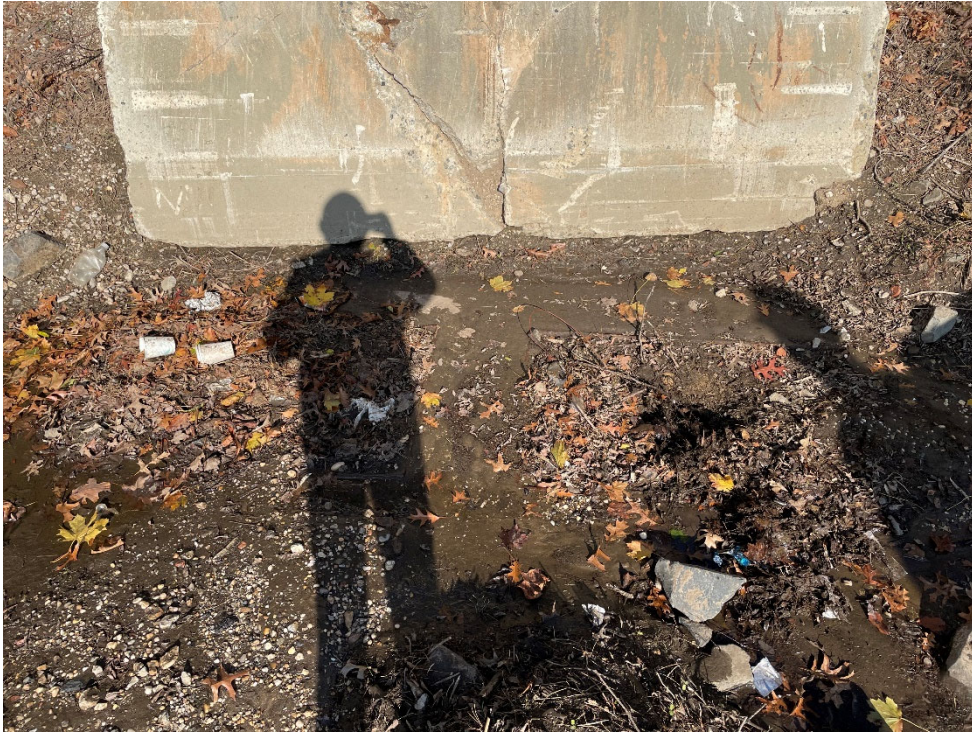
Catch Basin #5 Covered with Sediment and Debris

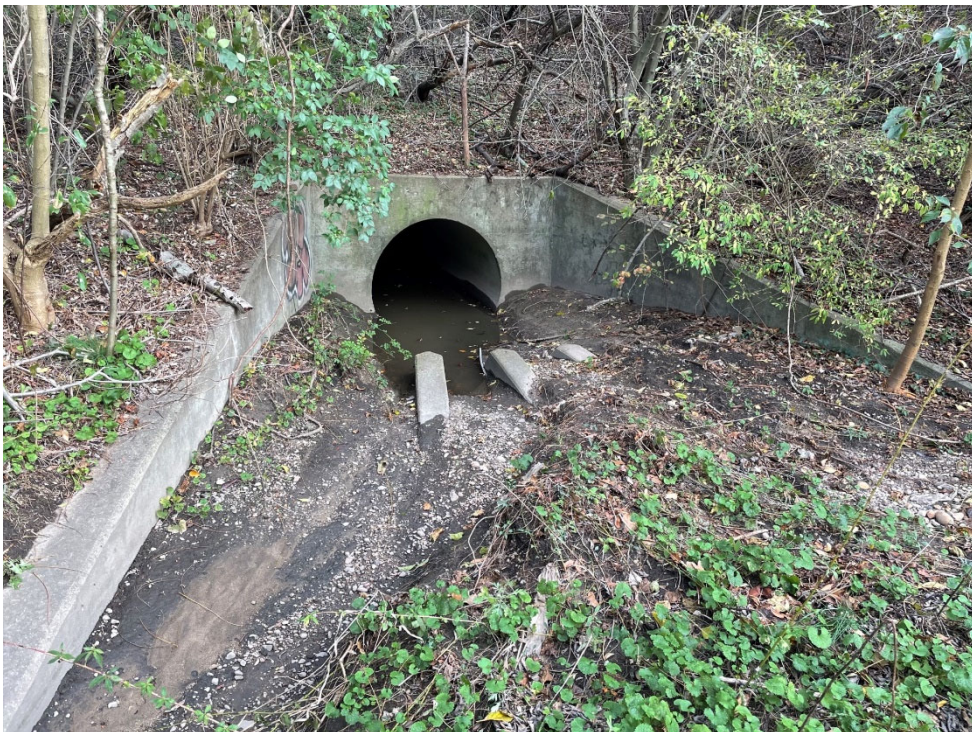
All four recharge basin headwalls discharging site stormwater runoff to three Nassau County Recharge Basins (#284, #358 and #571) were inspected and found to be operational. Each of the headwalls contained minor debris and vegetation during both monitoring rounds.

Siltation, Debris, and Vegetative Growth – HW#1 in RB#571

Although the silt/sediment deposits are not impacting the performance of the headwalls, it is recommended that they be routinely removed. Routine maintenance of these Nassau County Basins is performed by the Nassau County Department of Public Works.

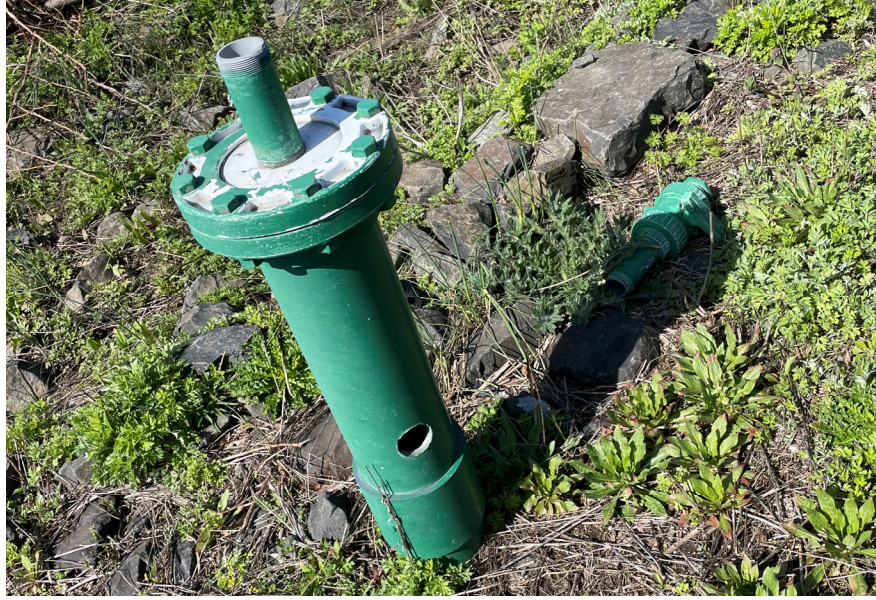
Detached Sampling Assembly – Well SW-7

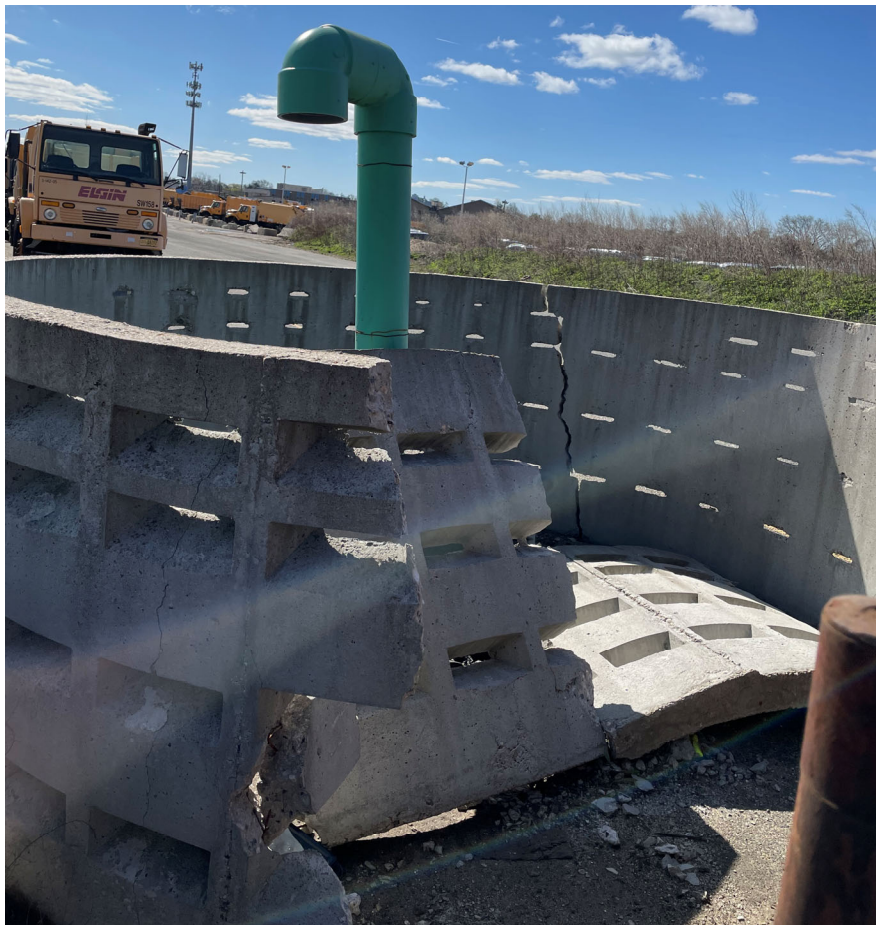
The first round of 2022 ridge vent well inspections showed damage to the protective concrete rings for ridge vent wells R-6, R-12, R-13, R-17, R-18, and R-26.

During the second inspection round, the same protective concrete rings remained damaged with the addition of ridge vent well R-22. It was also noted that ridge vent well R-22 was broken at grade and requires repair. Historically, the leading cause of damage to the ridge vent well casings and protective concrete rings has been attributed to impact with trucks or other vehicles used onsite.

Broken Protective Concrete Ring – R-13

- Recommended that stockpiles not be placed within 25 feet of the ridge vent wells and visibility of the gas vent wells be carefully maintained to prevent trucks from damaging the wells in the future.
- The protective concrete rings should be replaced at wells R-6, R-12, R-13, R-17, R-18, R-22, and R-26.
- Well R-22 is broken at grade and should be repaired during the next well repair contract.

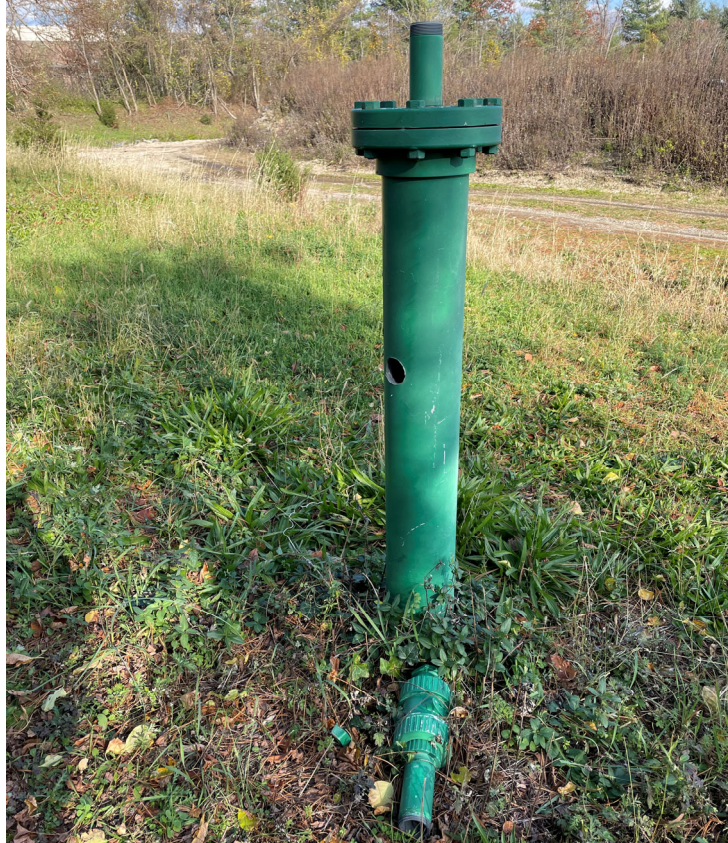
Detached Sampling Assembly – NW-5

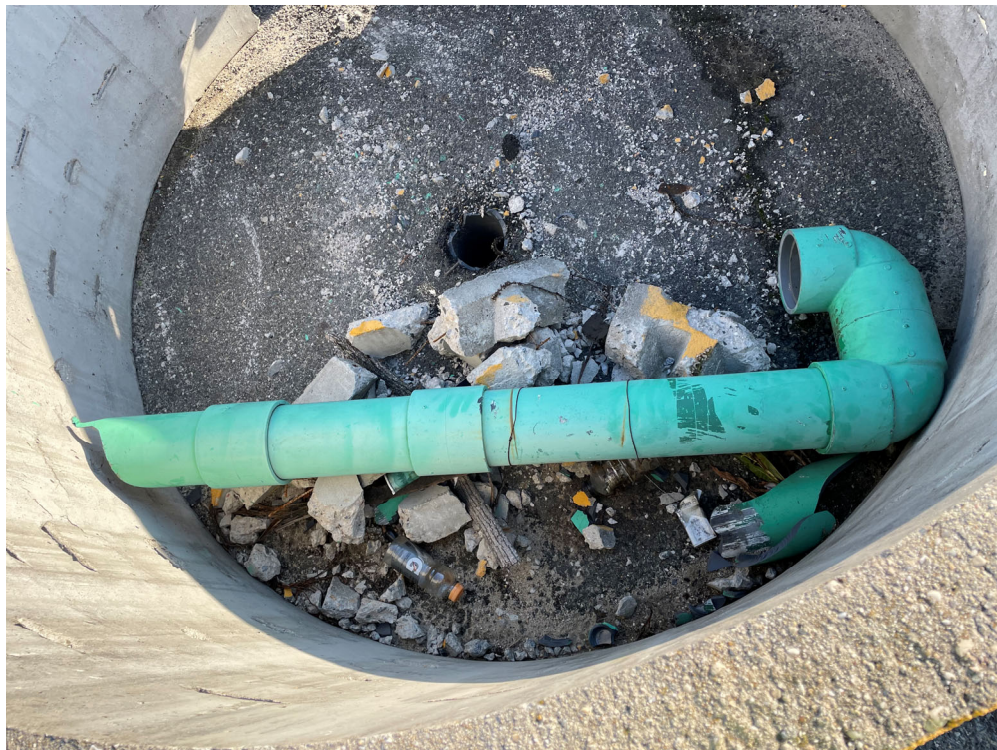
Well Casing Broken at Grade – R-22
