# *SYOSSET LANDFILL*

## *2023 ANNUAL POST-CLOSURE SUMMARY REPORT*

**TOWN OF OYSTER BAY**

Lockwood, Kessler and Bartlett, Inc.  
One Aerial Way  
Syosset, NY 11791

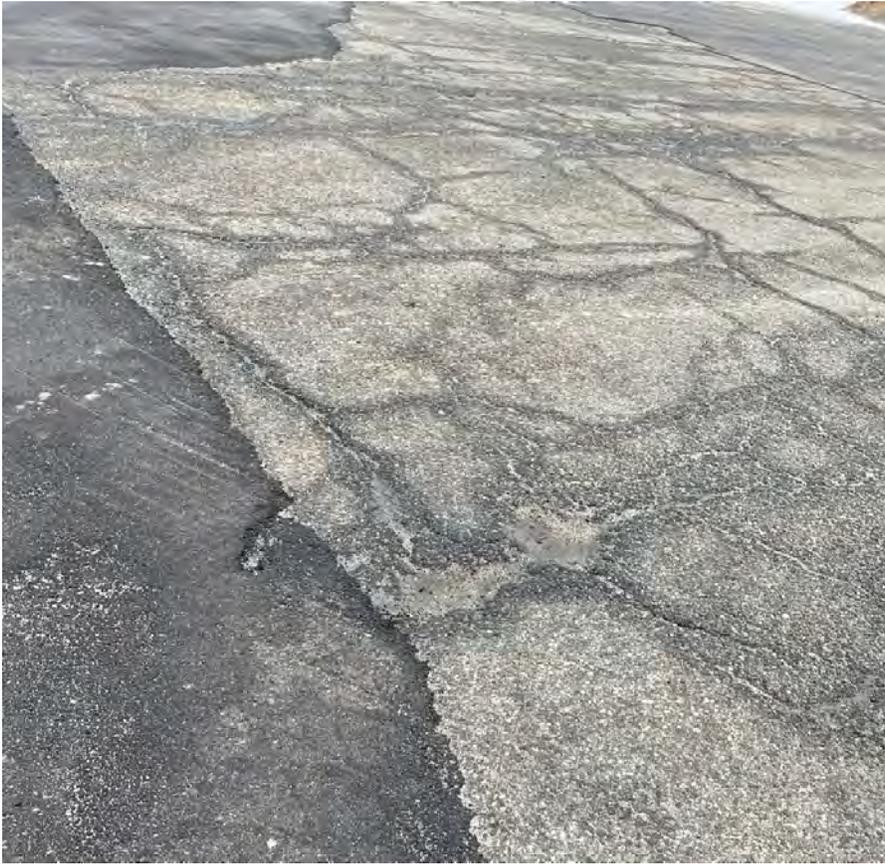
The condition of the concrete and asphalt pavement located in the Highway Division's Salt Storage Facility and Vehicle Parking Facility (Areas C & D) as well as the Town of Oyster Bay Department of Sanitation's (TOBDOS) Vehicle Parking Facility (Area E), in general, continues to be good. Routine fracturing of pavement cracks occurs at construction joint locations and is likely occurring due to weathering. Minor cracks are inherent in these types of pavement materials. Some irregularly shaped pavement cracks also exist in Area E and are likely occurring due to a minor amount of settlement in the subsurface material in those areas. Their locations have been monitored/maintained throughout the post-closure period, the minor amount of settlement has not increased and is not necessarily attributable to the Landfill.

Surface Cracks in Area C

It is recommended that these areas continue to be repaired on a regular basis as part of routine yard maintenance. The joints should be cleaned and sealed to prevent further weathering damage in accordance with the New York State Department of Transportation (NYSDOT) Standard Specifications, Construction and Materials, Section 633-3.02, "Cleaning, Sealing and Filling Joints and Cracks". It is recommended that the cracks in the asphalt pavement be cleaned and sealed as per the NYSDOT Pay Item for Cleaning and Sealing Cracks in Hot Mix Asphalt Pavement using Hot Applied Sealant, ITEM 402.7602 08. Cracks in the concrete pavement should be cleaned and sealed as per the NYSDOT Pay Item for Crack Repair by Epoxy Injection (Restoration), ITEM 01555.8002 M.

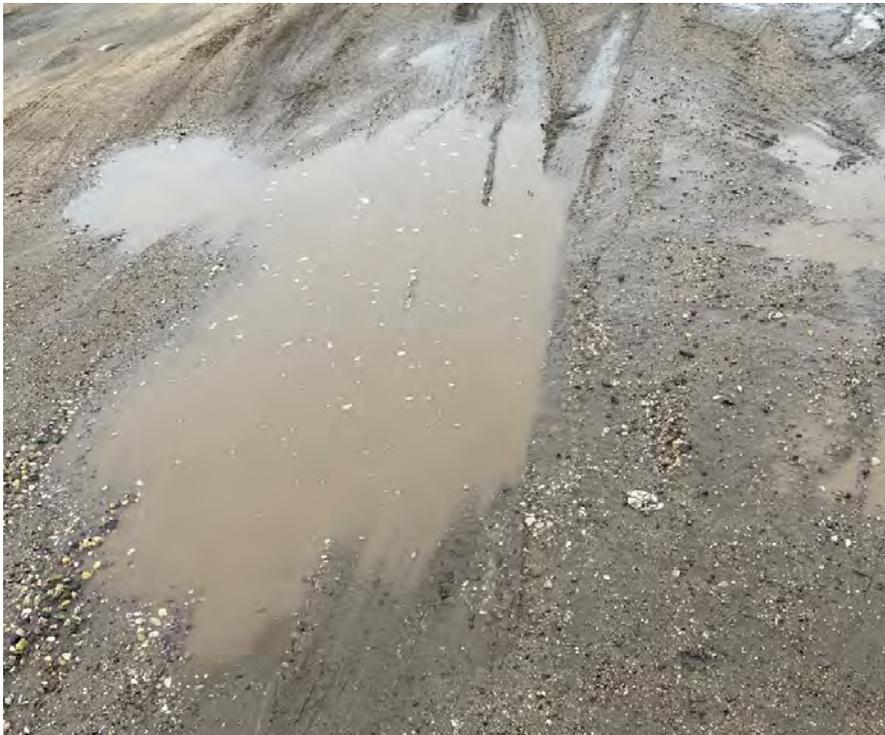
Ponding was observed in Areas A, B, and E during both semi-annual inspection rounds. Minor ponding was noted in Area A at the edge of the vegetative cover bordering the access road. Some areas of ponding were noted throughout Area B and in a few locations along the berm. Area E had some ponding in low points in the pavement near the sanitation truck parking.

Ponding in Area A

In order to prevent ponding from occurring in the future, it is recommended that surface grading within the RCA material in Areas A and B should be routinely adjusted to remove low points that may occur. Should the asphalt section in Areas C and E experience ponding it should be restored in accordance with the original Capping Contract specifications as discussed in Section 1.5 when routine pavement repairs are performed in the future in these areas.

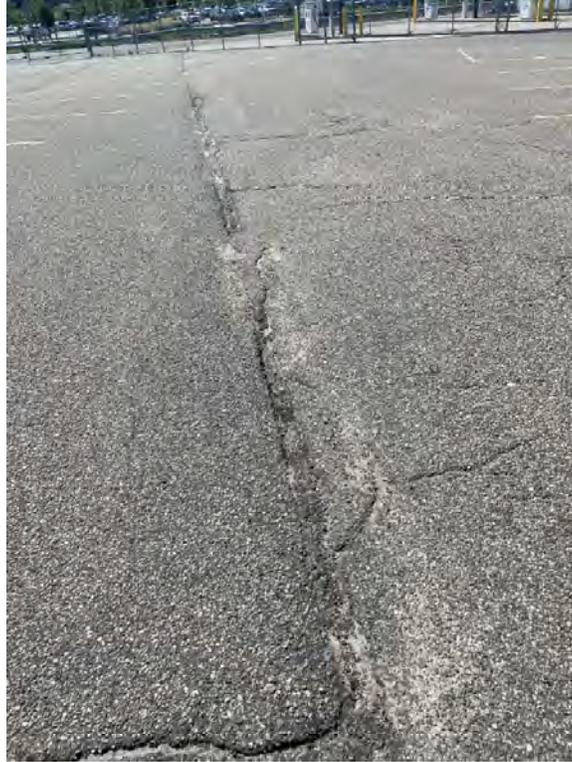
Surface Cracks in Area E

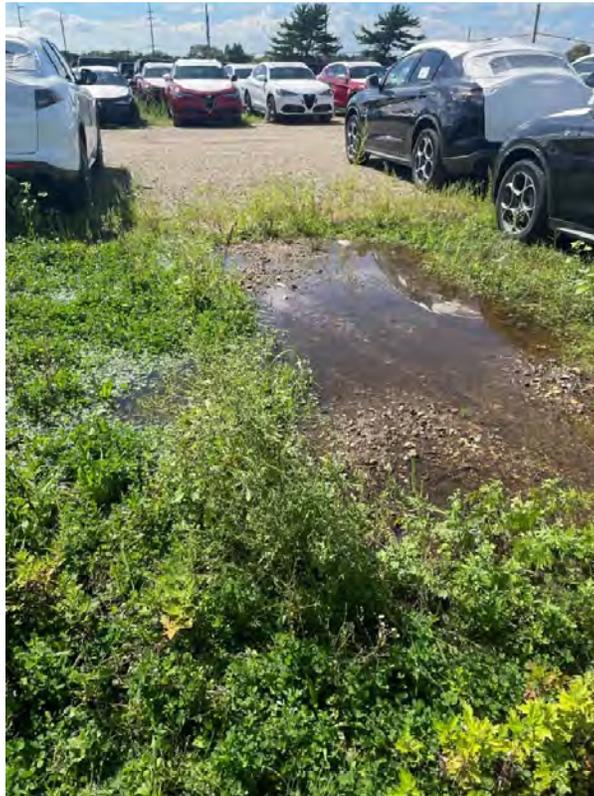
Ponding in Area A

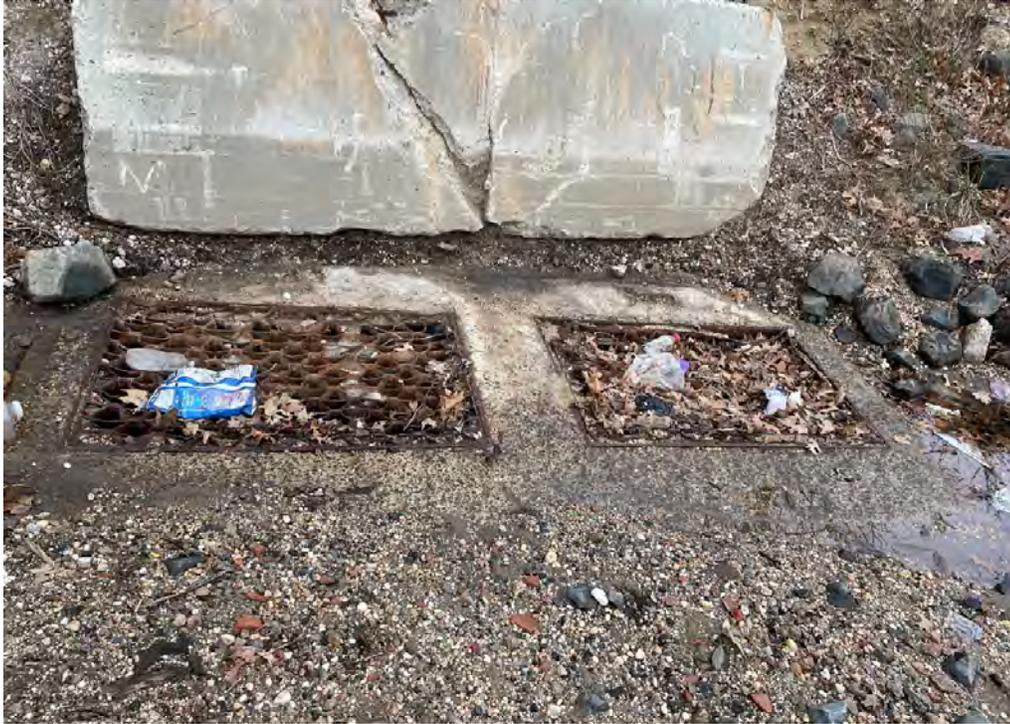
All of the catch basins onsite were inspected. During the first round of inspections of 2023, it was found that minor debris covered Catch Basins #4 and #5. During the second round of inspections, it was noted that Catch Basins #4 and #5 had accumulated more sediment and debris covering the tops of the grates.

Debris on Grate – CB #5

It is recommended that the silt and debris be removed on a regular basis from catch basins and the area in the vicinity of the catch basin inlets and drainage ditches. It is also recommended to have silt protection around all of the catch basin inlets. The hay bales previously installed at the catch basin inlets should be replaced. The erosion control measures recommended in Section 2.1 should be implemented to minimize the silt and sediment transport to the catch basins.

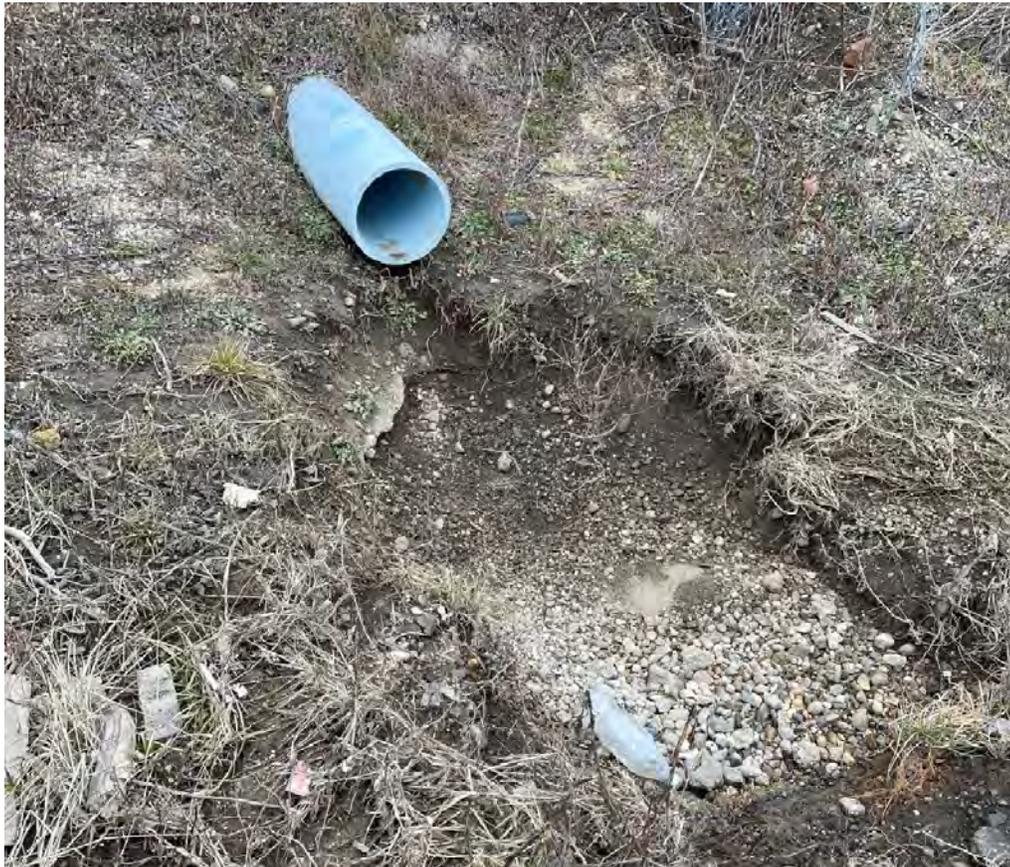
The drainage pipes located in the berm also did not contain defects. However, it was noted during both inspection rounds that stormwater discharging from some of these pipes has caused erosion resulting in ponding conditions and displacement of the stone that was placed at the pipe outlets. It is recommended that larger stone be placed between the pipe outlet and the perimeter ditches to control erosion.

Erosion from drainpipe in vicinity of DS #6

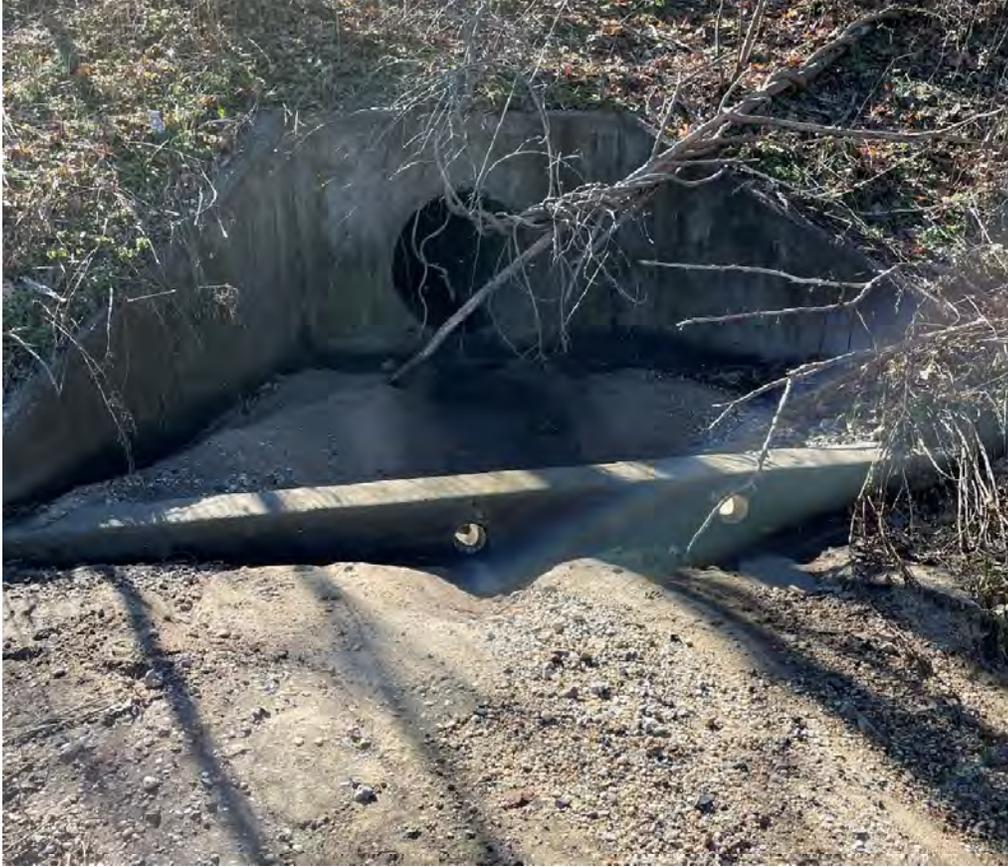
Each of the headwalls contained minor siltation and debris during that monitoring round. The headwalls were inaccessible during the second round of monitoring due to excessive vegetation growth throughout the recharge basin and could not be inspected. However, this is not considered an issue since the conditions encountered at these headwalls have been consistent throughout the years and the headwalls have always been operational.

Sediment Accumulation – RB# 284, HW #3

Although the silt/sediment deposits are not impacting the performance of the headwalls, it is recommended that they be routinely removed. Routine maintenance of these Nassau County Basins is performed by the Nassau County Department of Public Works.

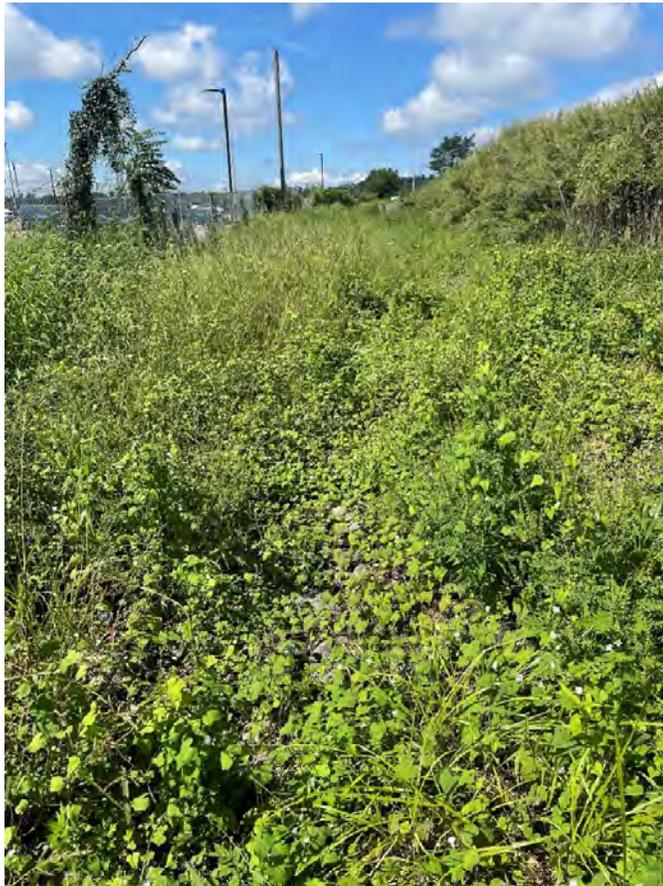
Overgrowth of Vegetation within Ditch Section #6

The drainage ditches should receive routine maintenance to prevent future sediment accumulation and vegetation growth conditions. The apparent

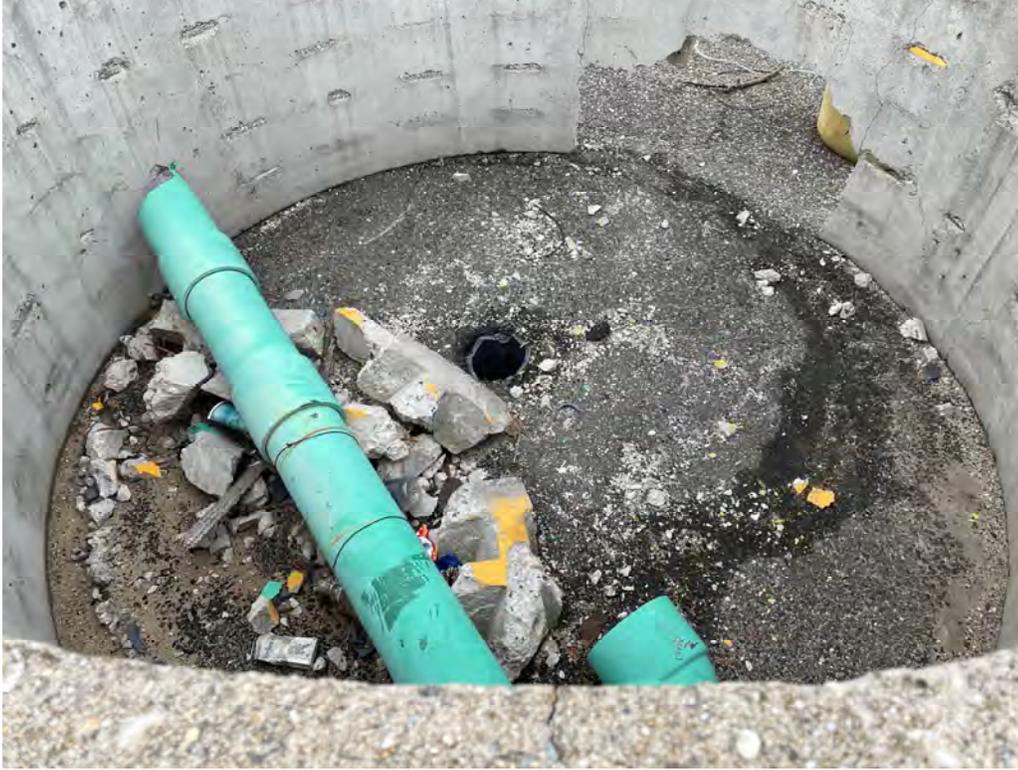
Both rounds of 2023 ridge vent well inspections showed damage to the protective concrete rings for ridge vent wells R-6, R-12, R-13, R-17, R-18, R-22 and R-26. Ridge vent well R-22 was broken at grade and requires repair. Historically, the leading cause of damage to the ridge vent well casings and protective concrete rings has been attributed to impact with trucks or other vehicles used onsite.

Well Head Casing Broken at Grade- R-22

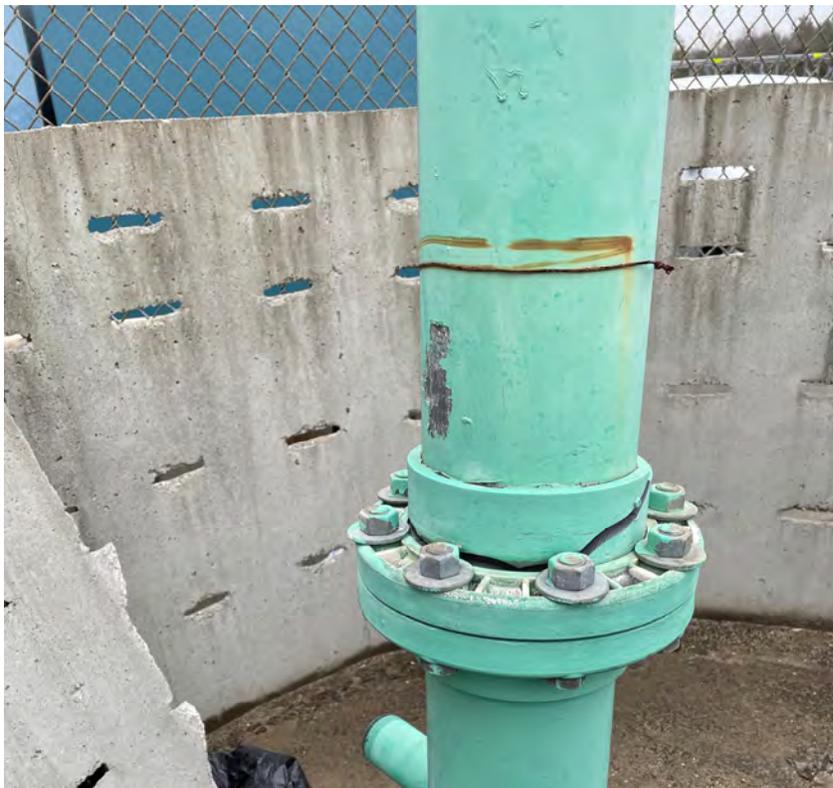
Crack in Ridge Vent Well – R-13

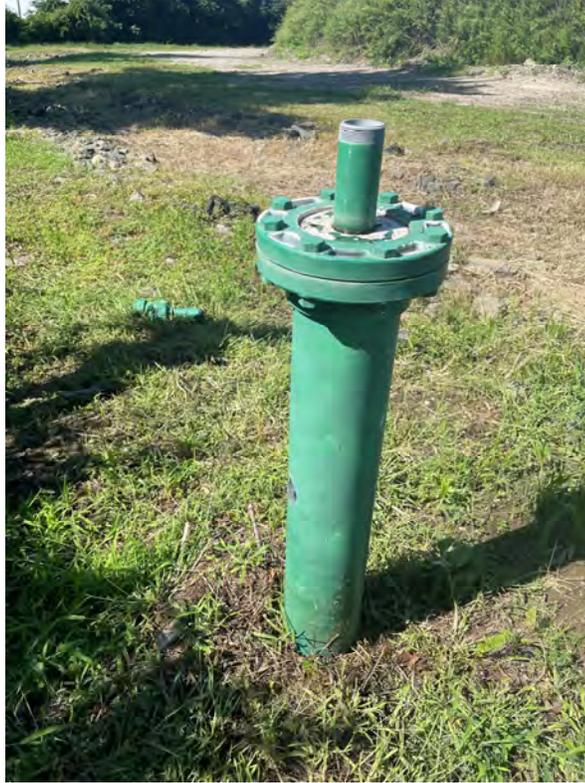
Broken Well NW-5

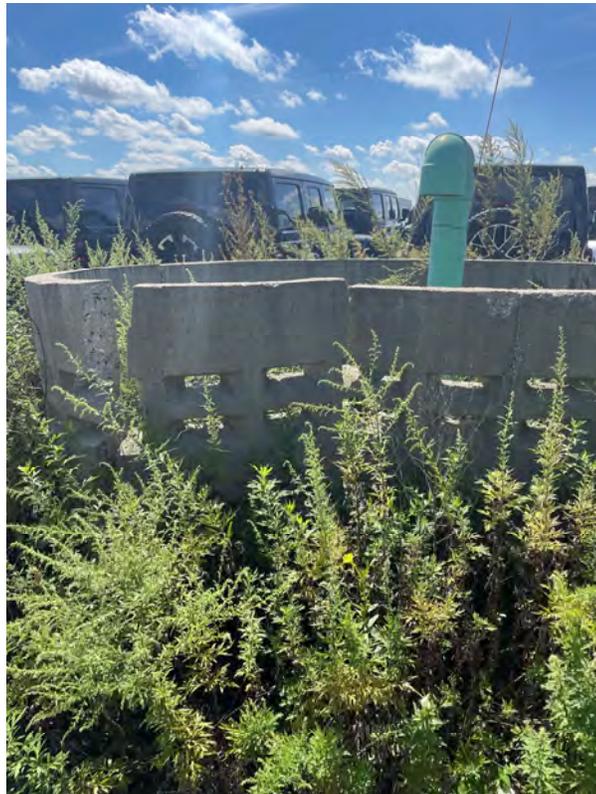
Broken Protective Concrete Ring – R-6

- Recommended that stockpiles not be placed within 25 feet of the ridge vent wells and visibility of the gas vent wells be carefully maintained to prevent trucks from damaging the wells in the future.
- The protective concrete rings should be replaced at wells R-6, R-12, R-13, R-17, R-18, R-22, and R-26.
- Well R-22 is broken at grade and should be repaired during the next well repair contract.
- The crack in the well head of ridge vent well R-13 should continue to be monitored and be repaired if conditions worsen significantly.
- Wells NW-5 and SW-7 have detached assemblies that can be reattached during the next well repair contract, if deemed necessary at that time.
