SYOSSET LANDFILL

2024 ANNUAL POST-CLOSURE SUMMARY REPORT

TOWN OF OYSTER BAY

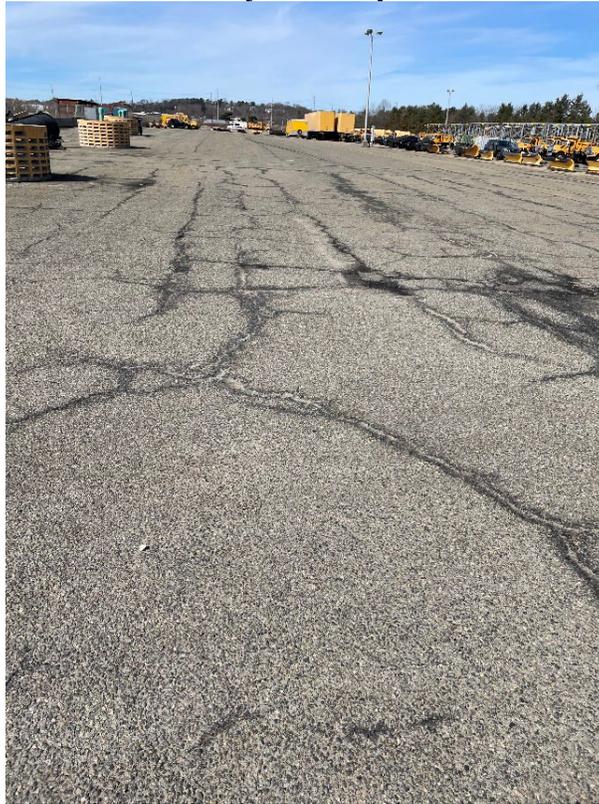
The condition of the concrete and asphalt pavement located in the Highway Division's Salt Storage Facility and Vehicle Parking Facility (Areas C & D) as well as the Town of Oyster Bay Department of Sanitation's (TOBDOS) Vehicle Parking Facility (Area E), in general, continues to be good. Routine fracturing of pavement cracks occurs at construction joint locations and is likely occurring due to weathering. Minor cracks are inherent in these types of pavement materials. Some irregularly shaped pavement cracks also exist in Area E and are likely occurring due to a minor amount of settlement in the subsurface material in those areas. Their locations have been monitored/maintained throughout the post-closure period, the minor amount of settlement has not increased and is not necessarily attributable to the Landfill.

Surface Cracks in Area C

It is recommended that these areas continue to be repaired on a regular basis as part of routine yard maintenance. The joints should be cleaned and sealed to prevent further weathering damage in accordance with the New York State Department of Transportation (NYSDOT) Standard Specifications, Construction and Materials, Section 633-3.02, "Cleaning, Sealing and Filling Joints and Cracks". It is recommended that the cracks in the asphalt pavement be cleaned and sealed as per the NYSDOT Pay Item for Cleaning and Sealing Cracks in Hot Mix Asphalt Pavement using Hot Applied Sealant, ITEM 402.7602 08. Cracks in the concrete pavement should be cleaned and sealed as per the NYSDOT Pay Item for Crack Repair by Epoxy Injection (Restoration), ITEM 01555.8002 M.

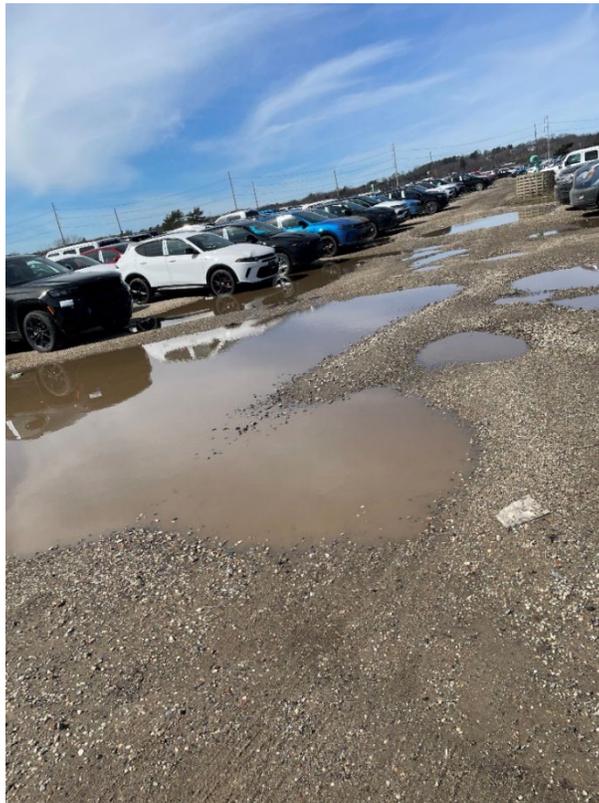
Ponding was observed in Areas A, B, and E during both semi-annual inspection rounds. Minor ponding was noted in Area A at the edge of the vegetative cover bordering the access road. Some areas of ponding were noted throughout Area B and in a few locations along the LVPF berm. Area E had some ponding in low points in the pavement near the sanitation truck parking.

Ponding in Area A

In order to prevent ponding from occurring in the future, it is recommended that surface grading within the RCA material in Areas A and B should be routinely adjusted to remove low points that may occur. Should the asphalt section in Areas C and E experience ponding it should be restored in accordance with the original Capping Contract specifications as discussed in Section 1.5 when routine pavement repairs are performed in the future in these areas.

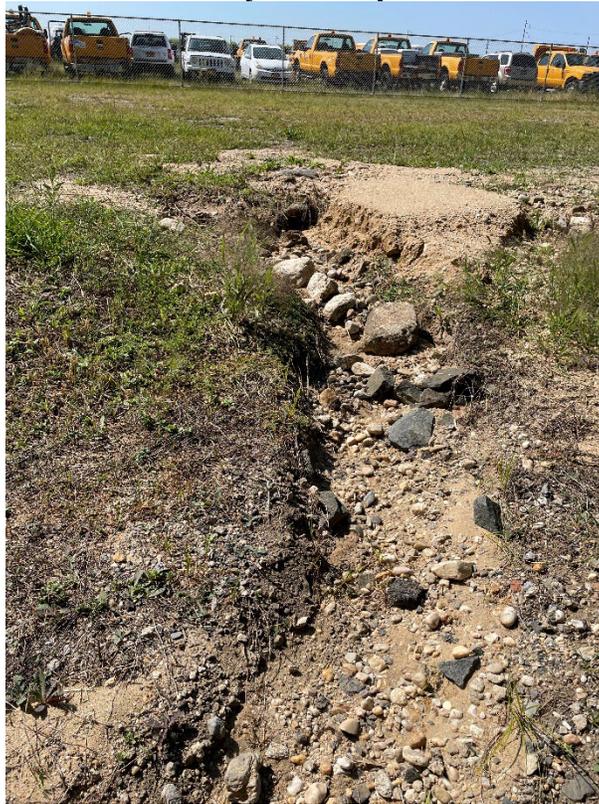
Areas of surface material erosion (i.e., ruts) were found in the vegetative cover buffer area of the Miscellaneous Equipment Storage Facility (Area B) and the Salt Storage Facility (Area C) during both rounds of inspections. These Areas are sloped toward the perimeter drainage ditches. The vegetative cover buffer area therefore receives runoff from both RCA and paved areas. Ruts form as a result of continued erosion of the surface material from stormwater runoff.

Erosion in Area C

It is recommended that ruts in the surface material be repaired by removing silt, filling/regrading the surface area to remove the ruts, replacing topsoil that may have eroded away and reseeding this area during the planting season to prevent further erosion problems.

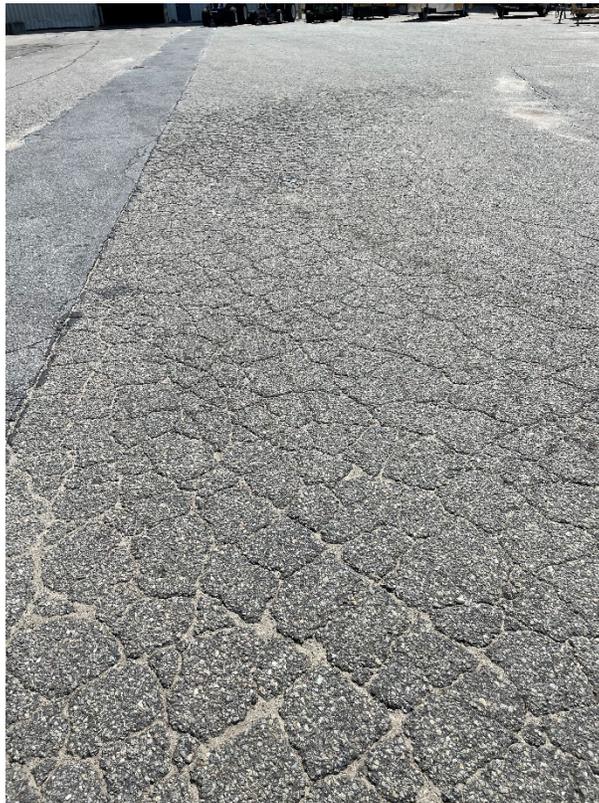
Surface Cracks in Area D

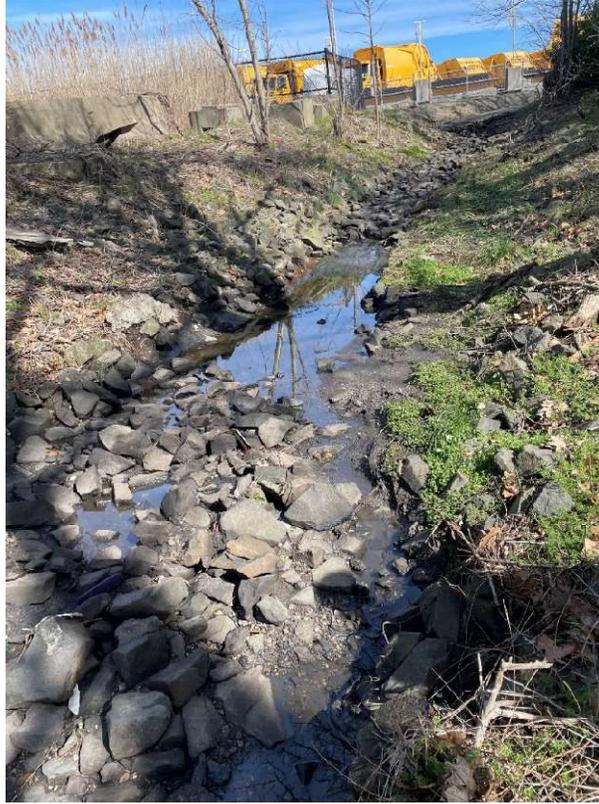
Erosion within the Drainage Ditch Section at ES #1

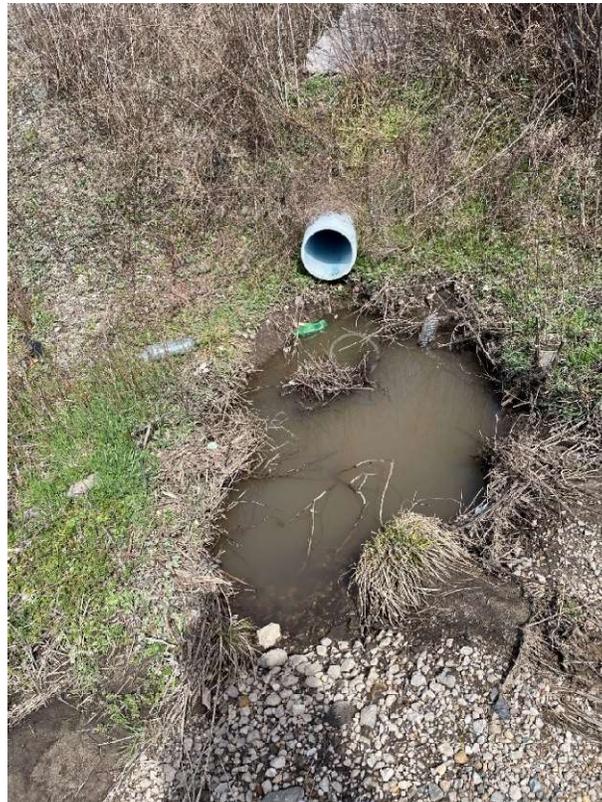
The drainage pipes located in the LVPF berm also did not contain defects. However, it was noted during both inspection rounds that stormwater discharging from some of these pipes has caused erosion resulting in ponding conditions and displacement of the stone that was placed at the pipe outlets. It is recommended that larger stone be placed between the pipe outlet and the perimeter ditches to control erosion.

Erosion from drainpipe in DS #6

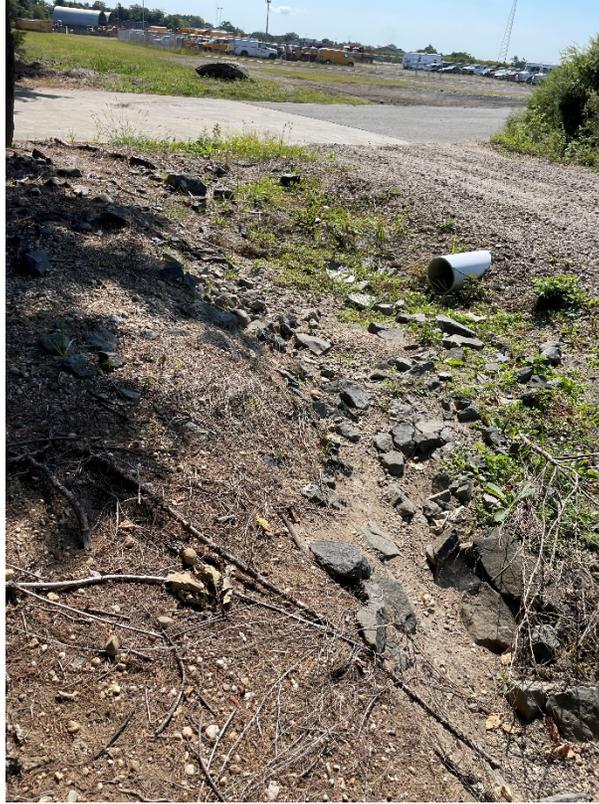
Siltation in Drainage Section #4

The drainage ditches should receive routine maintenance to prevent future sediment accumulation and vegetation growth conditions. The apparent cause of most of the ditch siltation appears to be from the erosion of surface materials. Erosion control techniques should be implemented to protect the eroded surface materials transported to the drainage ditches. However, only erosion control devices that can be installed on the ground surface or anchored above the cap elevation should be utilized.

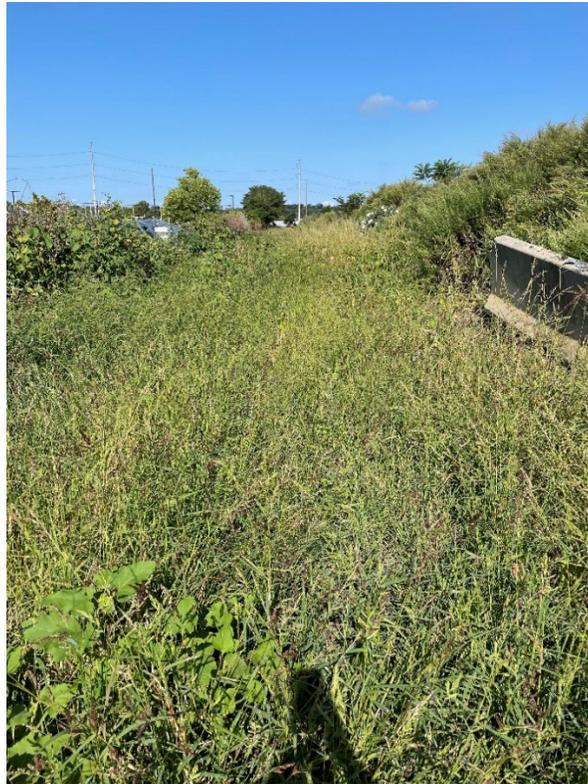
Overgrowth of Vegetation within Ditch Section #6

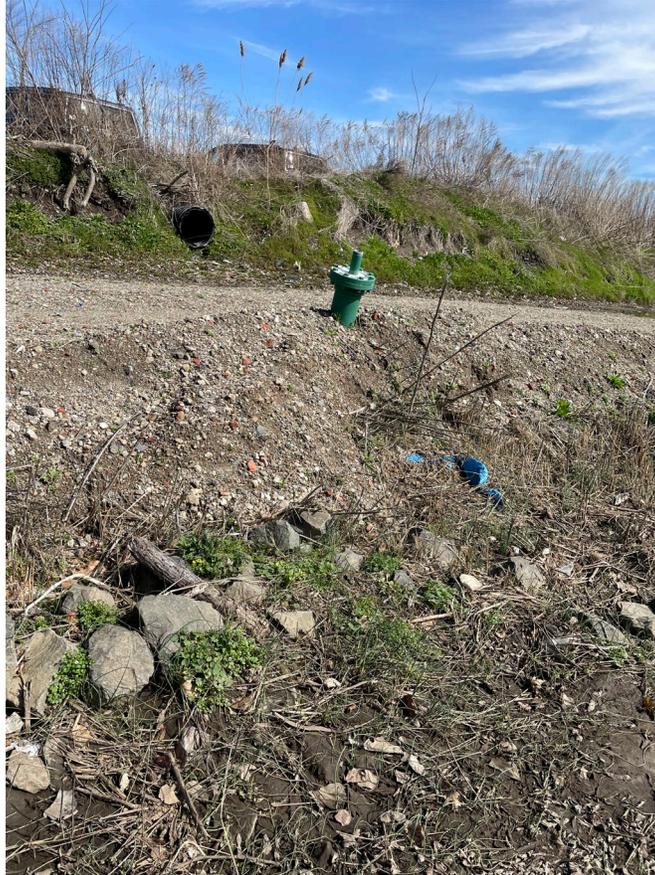
Two rounds of gas vent well inspections were performed during 2024. Perimeter gas monitoring well SE-2 was decommissioned in 2019. Of the remaining 53 property line and perimeter gas vent wells inspected in both rounds of inspections, sampling assemblies at NW-5 and SW-7 were broken off. It is recommended that vegetation near the gas vent wells be carefully maintained on a regular basis to improve visibility and help prevent damage to vent wells in the future. It was also noted that well SW-7 was partially buried at the edge of a newly constructed access road during both inspection rounds. It is recommended that protection be provided around well SW-7 to prevent vehicular damage.

Partially buried Property Line Gas Vent Well (SW-7)

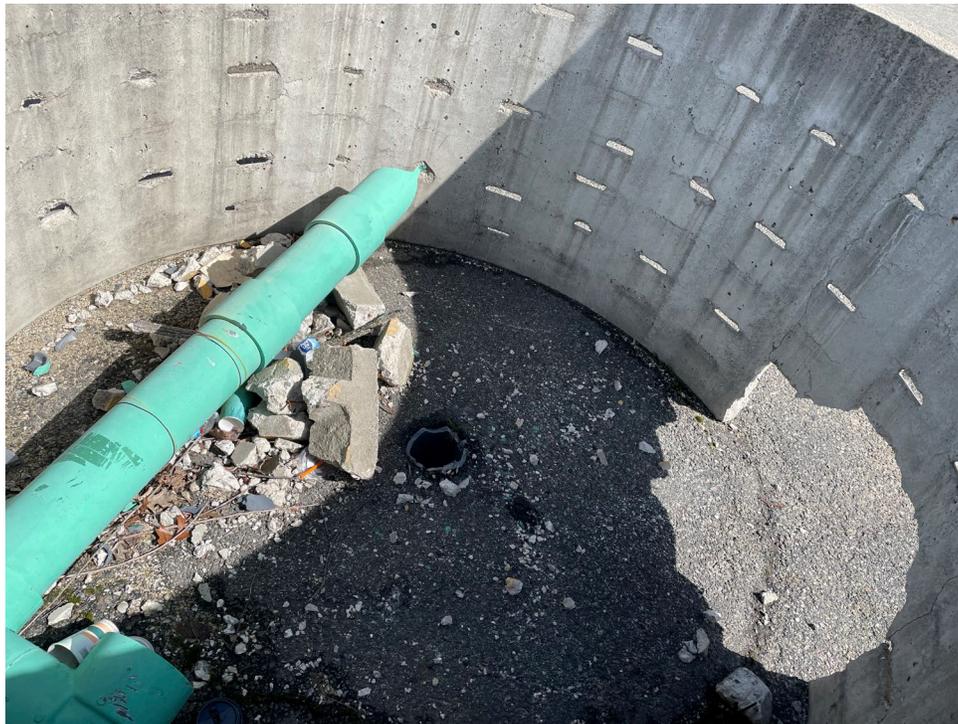
Well Head Broken at Grade (R-22)

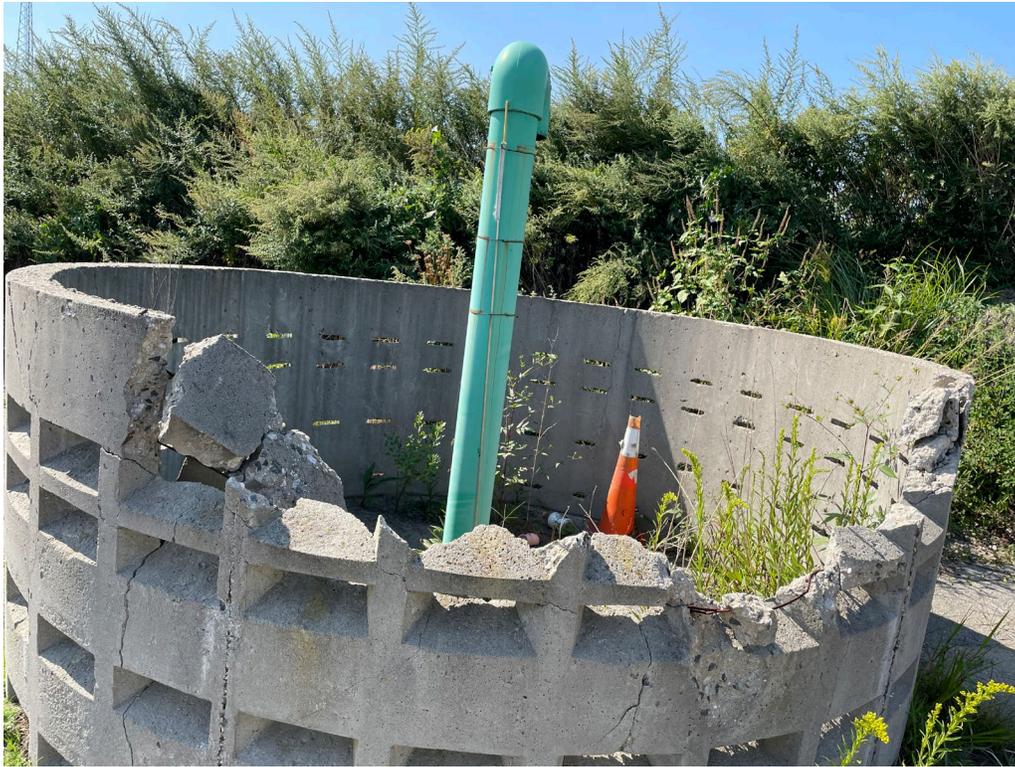
Both rounds of 2024 ridge vent well inspections showed damage to the protective concrete rings for ridge vent wells R-6, R-12, R-13, R-17, R-18, R-22 and R-26. Ridge vent well R-13 is cracked near the coupling and should be monitored and repaired if its condition worsens. Ridge vent well R-22 was broken at grade and requires repair. During the second inspection, it was noted that well R-21 had cracking in the protective ring. Historically, the leading cause of damage to the ridge vent well casings and protective concrete rings has been attributed to impact with trucks or other vehicles used onsite.

Broken Protective Concrete Ring (R-12)

- Recommended that stockpiles not be placed within 25 feet of the ridge vent wells and visibility of the gas vent wells be carefully maintained to prevent trucks from damaging the wells in the future.
- The protective concrete rings should be replaced at wells R-6, R-12, R-13, R-17, R-18, R-22, and R-26.
- Well R-22 is broken at grade and should be repaired during the next well repair contract.
- The crack on the flange coupling of ridge vent well R-13 should continue to be monitored and repaired if conditions worsen significantly.
- Wells NW-5 and SW-7 have detached assemblies that can be reattached during the next well repair contract, if deemed necessary at that time.

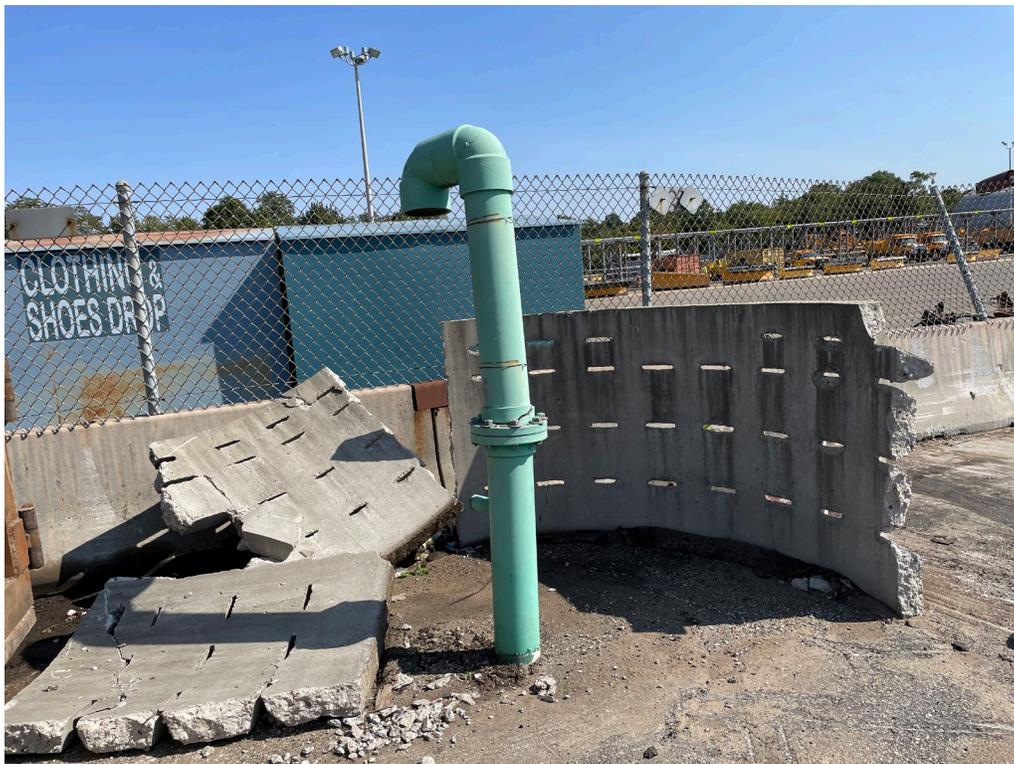
Broken Protective Concrete Ring (R-13)
