# Monthly Report of the Operations & Maintenance Activities

Claremont Polychemical Operable Unit 5  
Groundwater Treatment System

*Old Bethpage, New York*  
June 2020

NYSDEC Standby Engineering Contract  
Work Assignment #D0076025-28

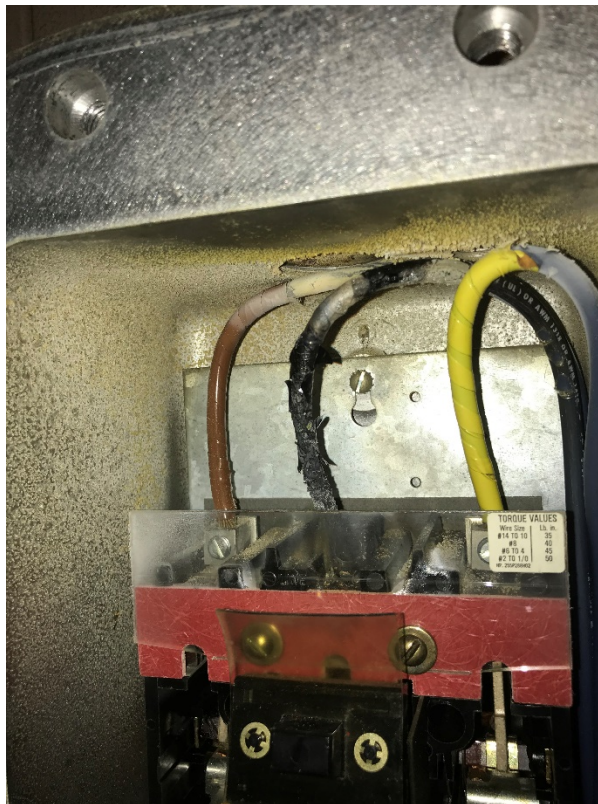
Electrical engineers onsite to troubleshoot operational issue with the AS blower. Burnt wires inside of the disconnect switch enclosure were discovered.

The input side of the motor disconnect on the Phase B wire melted off the terminal. The wire was no longer connected, and charring and burn marks on the wire, tape, and insulation were observed. This occurred inside of an explosion proof disconnect, therefore there was no indication of excessive heat on the outside due to the thickness of the housing.

This scenario typically occurs overtime as a progression of deterioration. What caused the initial deterioration is unknown, however it could have been as simple as a nicked wire during initial insulation stripping, a wire lug not being as tight, or dirt getting into the disconnect. As the wire heats up due to the current flowing there was a hot spot that caused either the insulation or dirt to burn or the copper to arc slightly.

This incident is fairly common and usually does not cause a big issue. In this case, the starting current of the blower is pretty high and over the years, this caused slight arcs. Every time the cable arced, no matter how small of an arc, the copper melts ever so slightly. As the cross section of the cable decreases, the heat at that one point increases and the size of the arcs increase. This increases the rate of deterioration. The final deterioration happened when the cable was basically completely disconnected and the current flowed through a larger arc which charred the top of the terminal, melted/burned some of the insulation and tape, and disconnected the wire completely.
