Page 1 of 9 Alsy Manufacturing, Inc. Site, Site No. 130027 Date: 01/09/2024

NEW YORK NYSDEC Department of STATE OF OPPORTUNITY Environmental Division of Environmental Remediation

Contract No. D009812

Site Location: 270 & 280 Duffy Avenue, Hicksville, New York

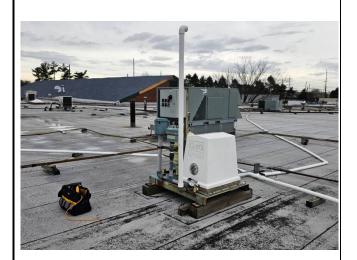
Operational SSDS-1 (270 Duffy Avenue) system blower.

Operational SSDS-2 (280 Duffy Avenue) system blower.

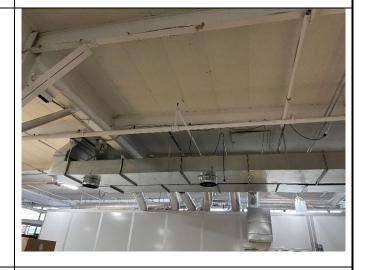
Manometer used to gauge vacuum at vapor monitoring point, VMP-10.

View of portion of exhaust system for Clean Room located in 280 Duffy Avenue Site building.

Roux noted exhaust systems located within the Site buildings may be interfering with vapor monitoring point vacuum readings. Roux suggested that readings would be more accurate if taken during non-operational hours (when exhaust systems are not running).
