ADDITIONS/CHANGES TO REGISTRY: SUMMARY OF APPROVALS

TE NAME: Pass & Seymour

DEC I.D. NUMBER 130053A

**ENGINEERING INVESTIGATIONS AT
INACTIVE HAZARDOUS WASTE SITES
PRELIMINARY SITE ASSESSMENT**

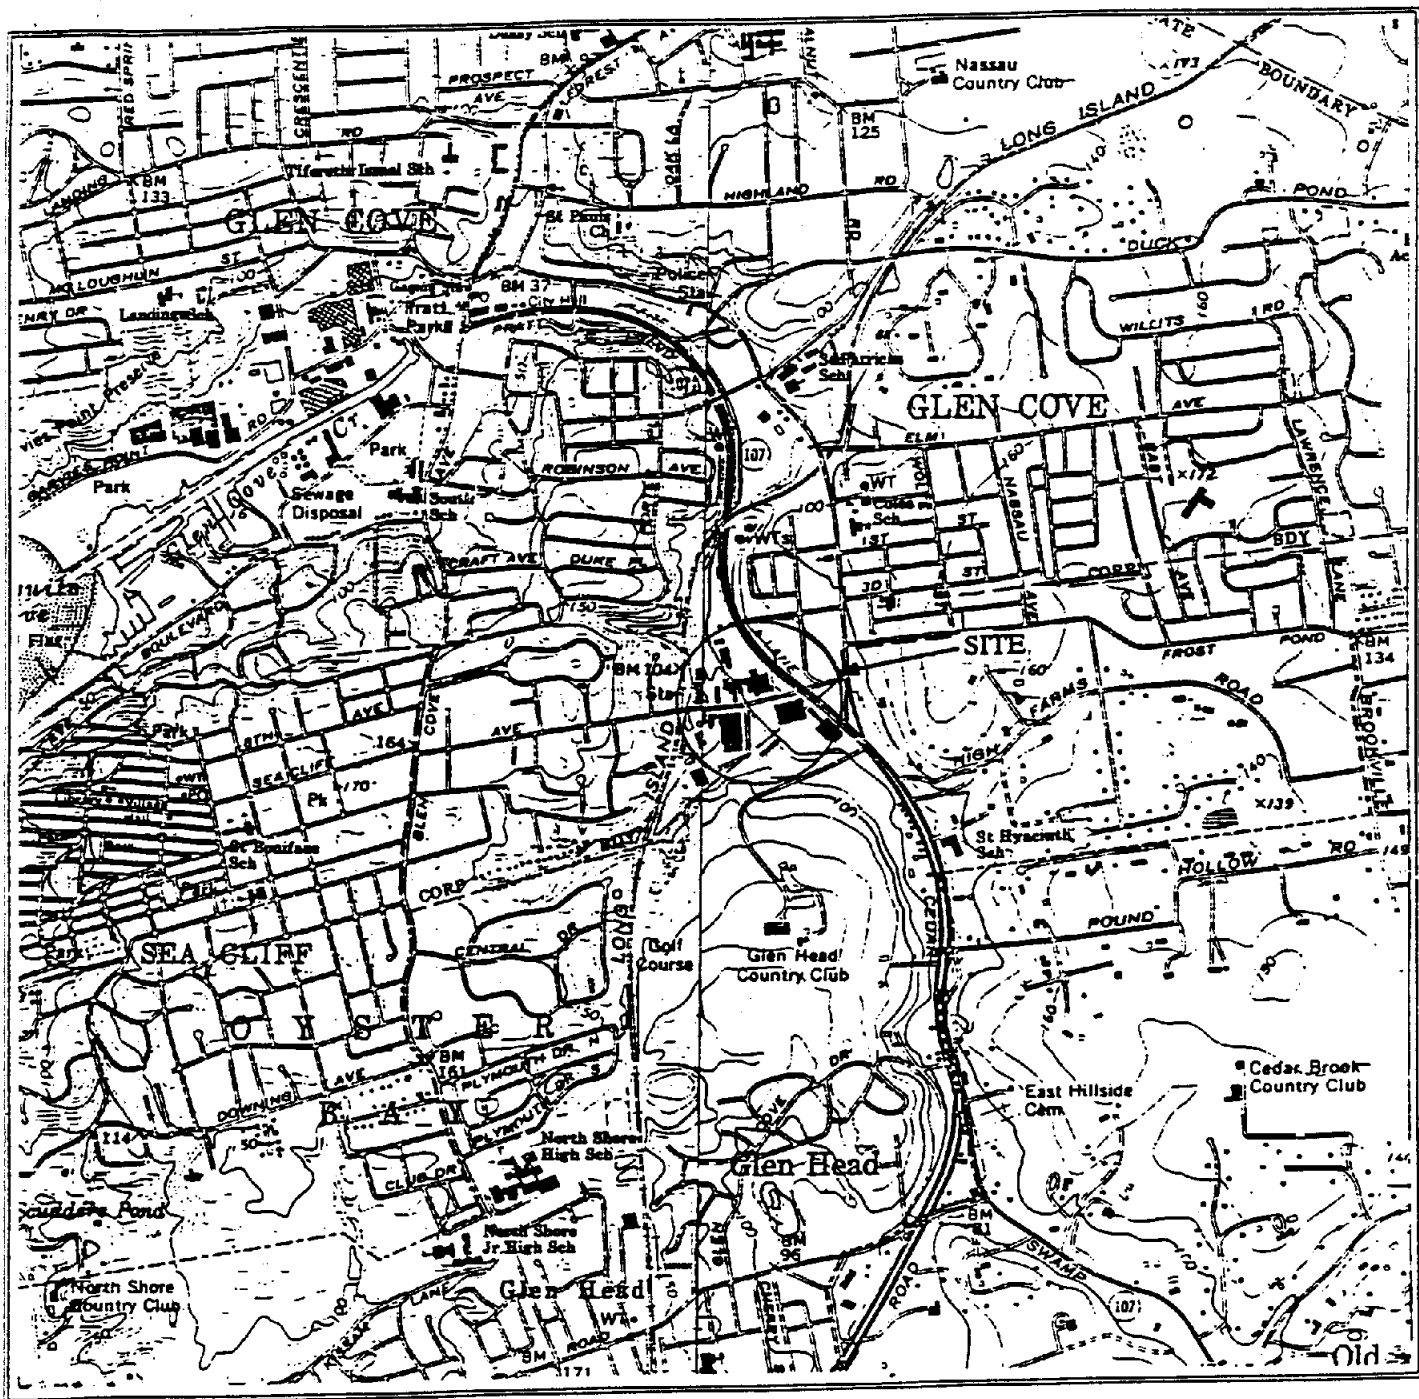
FIGURE A - SITE TOPOGRAPHY

The Sea Cliff Avenue Industrial Area is located within an area of glacial moraine and is characterized by a variable surface topography (Figure A). Specifically, the study area is situated in a north-south trending valley that runs parallel to Glen Cove Creek, elevations rise rapidly to the east and west of the study area from 40-60 feet above sea level (ASL) to over 175 feet ASL. The geology of the study area is comprised of three hydrostratigraphic units, an upper glacial till of generally low permeability, a sand and gravel unit of moderate to high permeability and the areally extensive Port Washington confining clay unit which forms the base of the glacial aquifer in the study area.

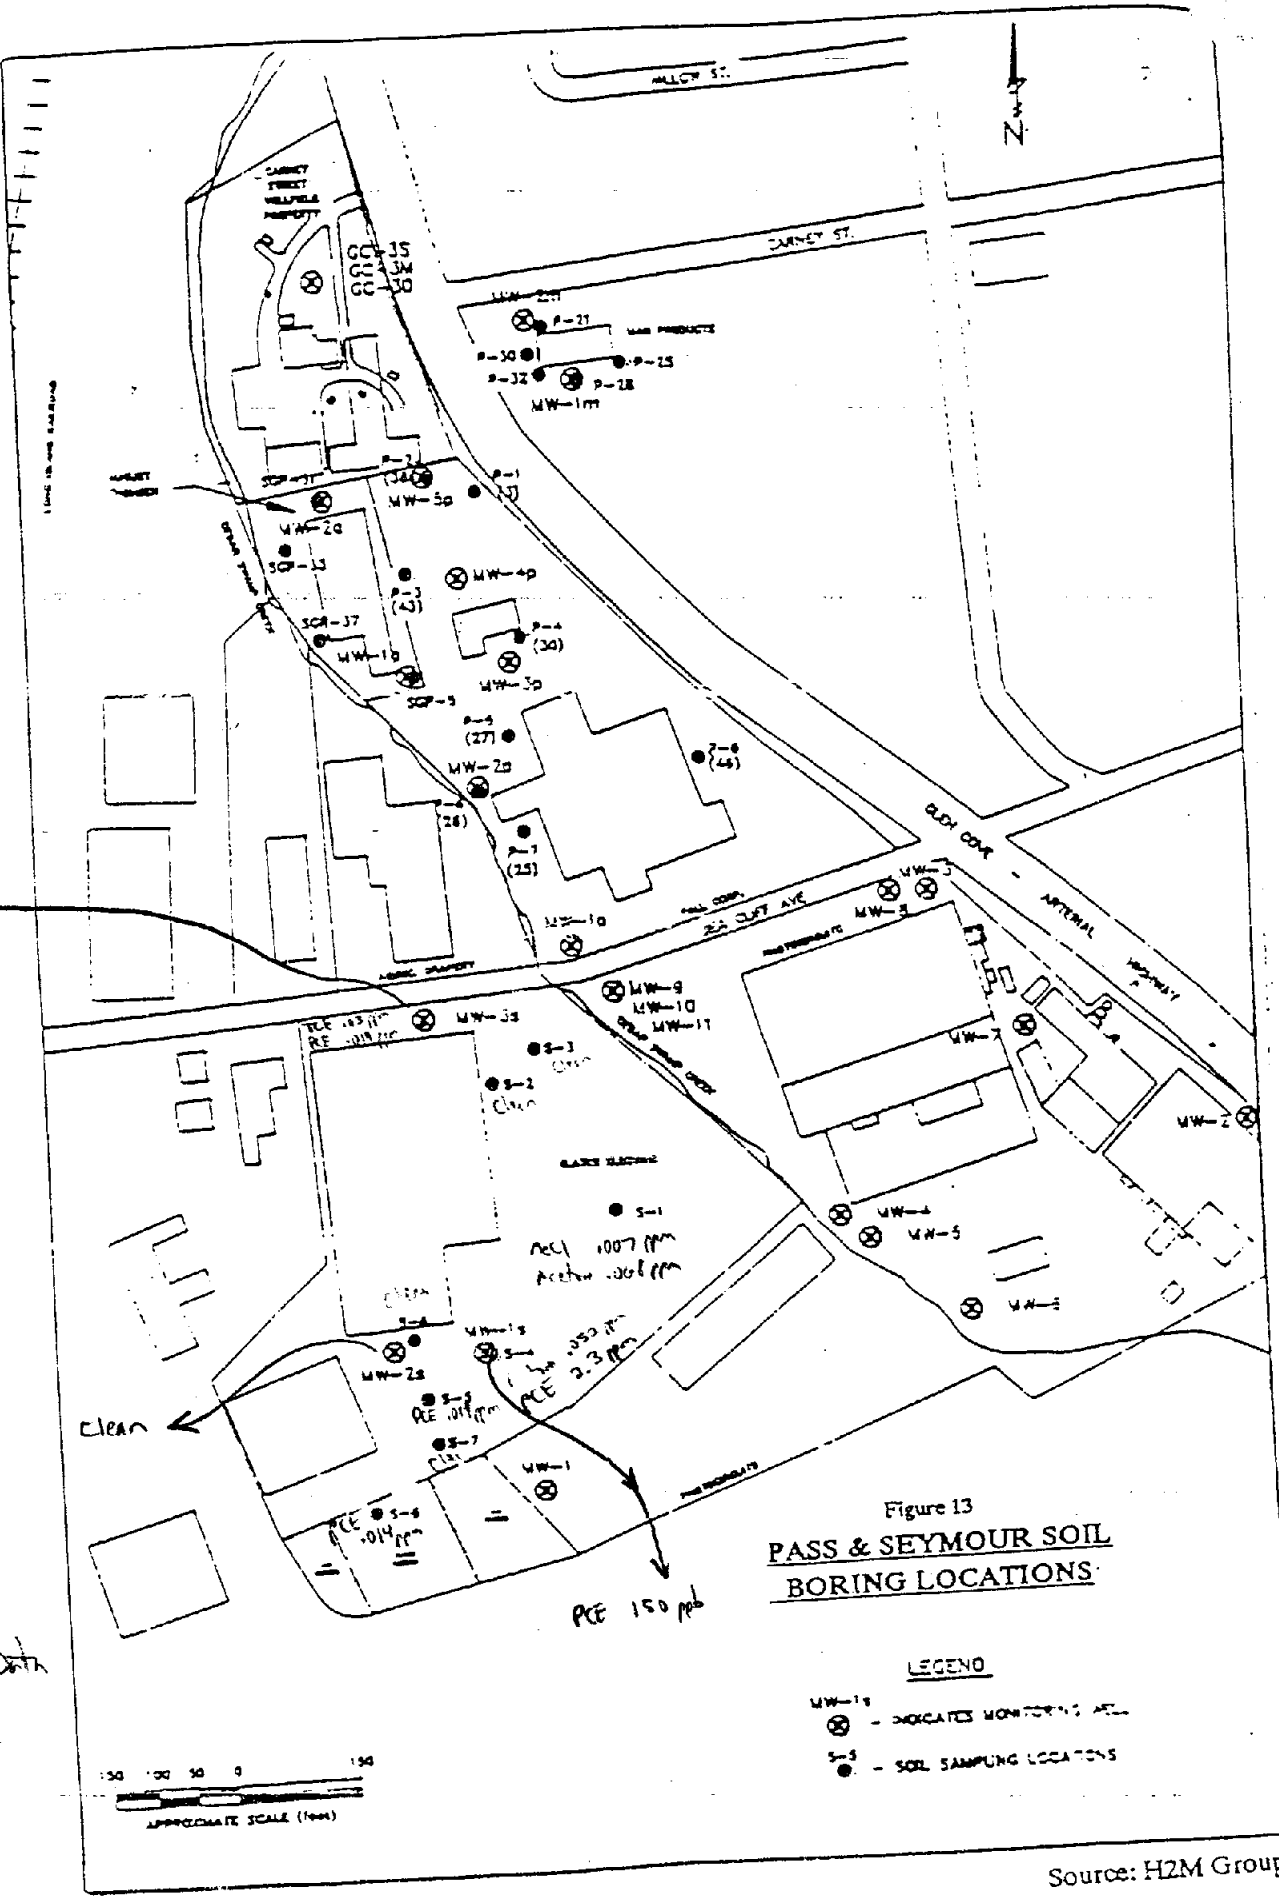
Figure 13
**PASS & SEYMOUR SOIL
BORING LOCATIONS**

the locations were individual soil boring ("S" designations), while three were borings for groundwater monitoring wells MW-1, 2 and 3. The locations of all wells and borings are shown in Figure 13.

The results of the December, 1991 sampling event for the 1992 Source-Area Investigation are presented in Table 8. Review of this data indicates that volatile organic compounds were present in soils on the Pass and Seymour site. Low levels of halogenated volatile organic compounds were detected in samples collected from borings S-1, S-5, S-8 and MW-3S. Total VOC's in borings S-5, S-8 and MW-3S were less than 0.05 ppm and less than 0.10 ppm in boring S-1.

High levels of halogenated volatile organics were detected in soils collected from boring S-4. The total VOC concentration was approximately 2.35 ppm, the majority of this total consisted of 2.3 ppm of Tetrachloroethene. It should be noted that this concentration was flagged with an "E" by H2M Laboratories. The "E" indicates a positive detection which was above the calibration standard and is therefore estimated.

The concentrations of the four volatile organic compounds identified in soils at the Pass and Seymour site were compared to the recommended soil cleanup objectives specified by the NYSDEC (DHWR) in its November 16, 1992 Technical Administrative Guidance Memorandum (TAGM), Determination of Soil Cleanup Objectives and Cleanup Levels. Three of the four compounds, Acetone, Trichloroethene and Methylene Chloride were an order of magnitude below their respective standards. The only compound which exceeded its cleanup objective (1.4 ppm) was Tetrachloroethene, which was found at an estimated concentration of 2.3 ppm.

PCE 21 ppb
100 ppb
13 ppb
