# VAPOR MITIGATION SYSTEM COMPLETION REPORT

Former TransTechnology Corporation Facility, Glen Head, New York

09/26/13

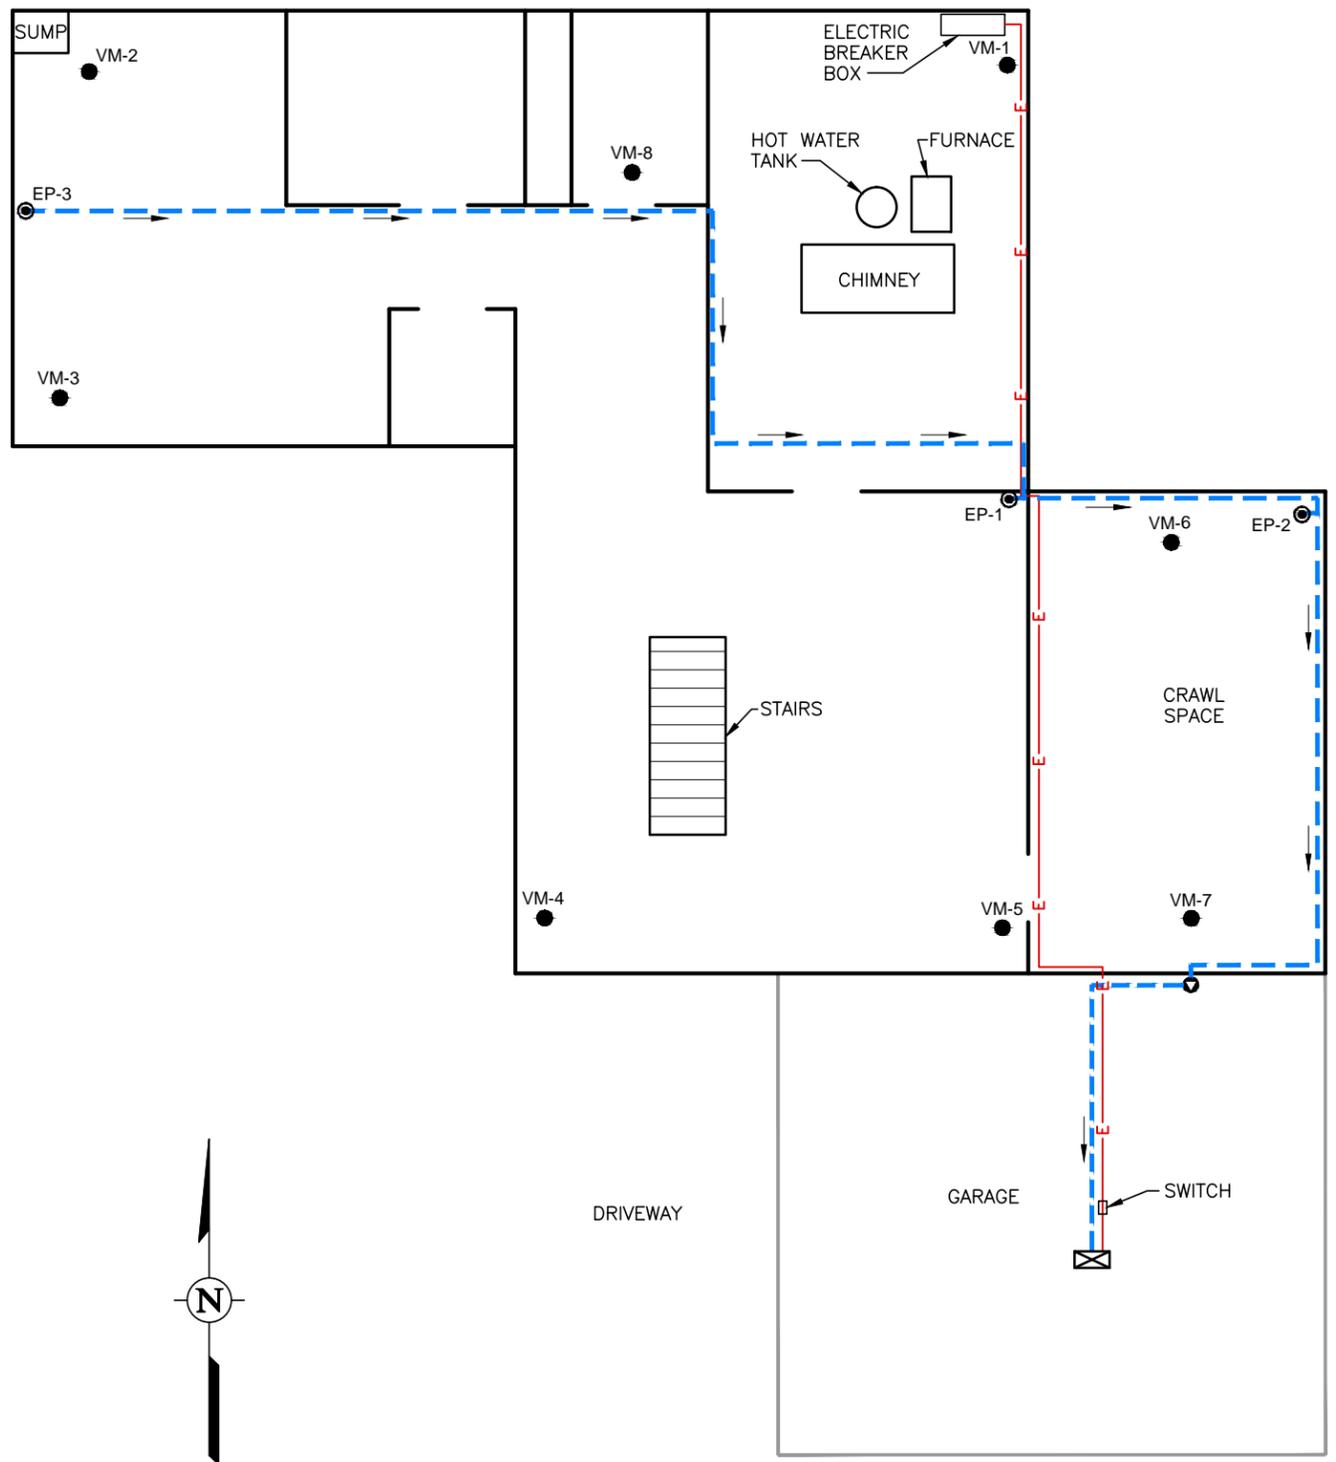
**FIGURE 2**  
**AS-BUILT VAPOR MITIGATION SYSTEM**  
**HOME #21**

The initial site visit for home #21 was performed on September 13, 2012. An inspection of the home revealed a full-height (approximately 8 feet-high) L-shaped basement beneath the original footprint of the home (Figure 2). The foundation walls appeared to be poured concrete and were matched with a contiguous concrete pad that covered the entire basement. Several small openings were noted in the floor, including a dry sump in the northwest corner of the basement, and around drainage pipes along the north wall. The basement was partially framed with a utility room, containing the furnace, hot water tank, and the home's main electrical breaker box located in the northeast corner. The basement also included a relatively small, elevated crawl space attached to the southeast corner of the basement underlying an addition to the home. The crawl space was approximately 3.5 feet in height and included a poured foundation wall and a contiguous poured concrete floor. Access to the crawl space was through an opening in the main foundation wall near the southeast corner of the basement.

Communication testing was performed initially using five vacuum monitoring locations, designated VM-1 through VM-5, positioned within the main basement with VM-5 used as the vacuum extraction point for the test (Figure 2). The vacuum was applied using a portable wet/dry vacuum capable of generating a vacuum of approximately 60 inches of WC. The vacuum was introduced to the subsurface by holding the hose over the opening in the concrete. Vacuum measurements, collected at each of the VM locations using a digital manometer, ranged between -0.014 and -0.406 inch of WC at VM-4 and VM-1, respectively, indicating that vacuum influence was present beneath the entire basement floor. No communication testing was performed within the crawl space due to access issues during the initial site visit. WSP assumed that construction beneath the crawl space would have a similar response to that of the main basement and deferred communication testing in this area to post construction testing.

The vapor mitigation system designed for home #21 initially included just two vacuum extraction points based on the communication testing results: EP-1, located in the main basement, and EP-2, located within the crawl space (Figure 2). Extraction point EP-2 was included to ensure vacuum coverage under the crawl space, the floor of which is at a different elevation than the main basement. A third extraction point, EP-3, was added in the northwest corner of the basement after the post-installation vacuum measurements at VM-02 showed relatively weak response (-0.009 inch of WC), only slightly above the minimum vacuum response criteria of -0.004 inch of WC. All three extraction points were created by coring a 5-inch diameter hole through the basement floor using a concrete

Post-installation testing of the system (with all three extraction points) was conducted on June 18, 2013, by opening the gate valves on each extraction point riser, turning on the fan, and running the system continuously for approximately 15 minutes (to allow the vacuum field to propagate outward from each extraction point beneath the concrete slab). Vacuum measurements collected from the VM points installed during the pre-installation activities and three new VM points, installed in the crawl space (VM-6 and VM-7) and along the north wall of the basement (VM-8), showed good response with vacuums ranging between -0.097 and -0.460 inch of WC (Figure 2). Differential pressure readings at the exhaust stack indicated that the system was generating a vacuum of approximately 2.5 inches of WC.

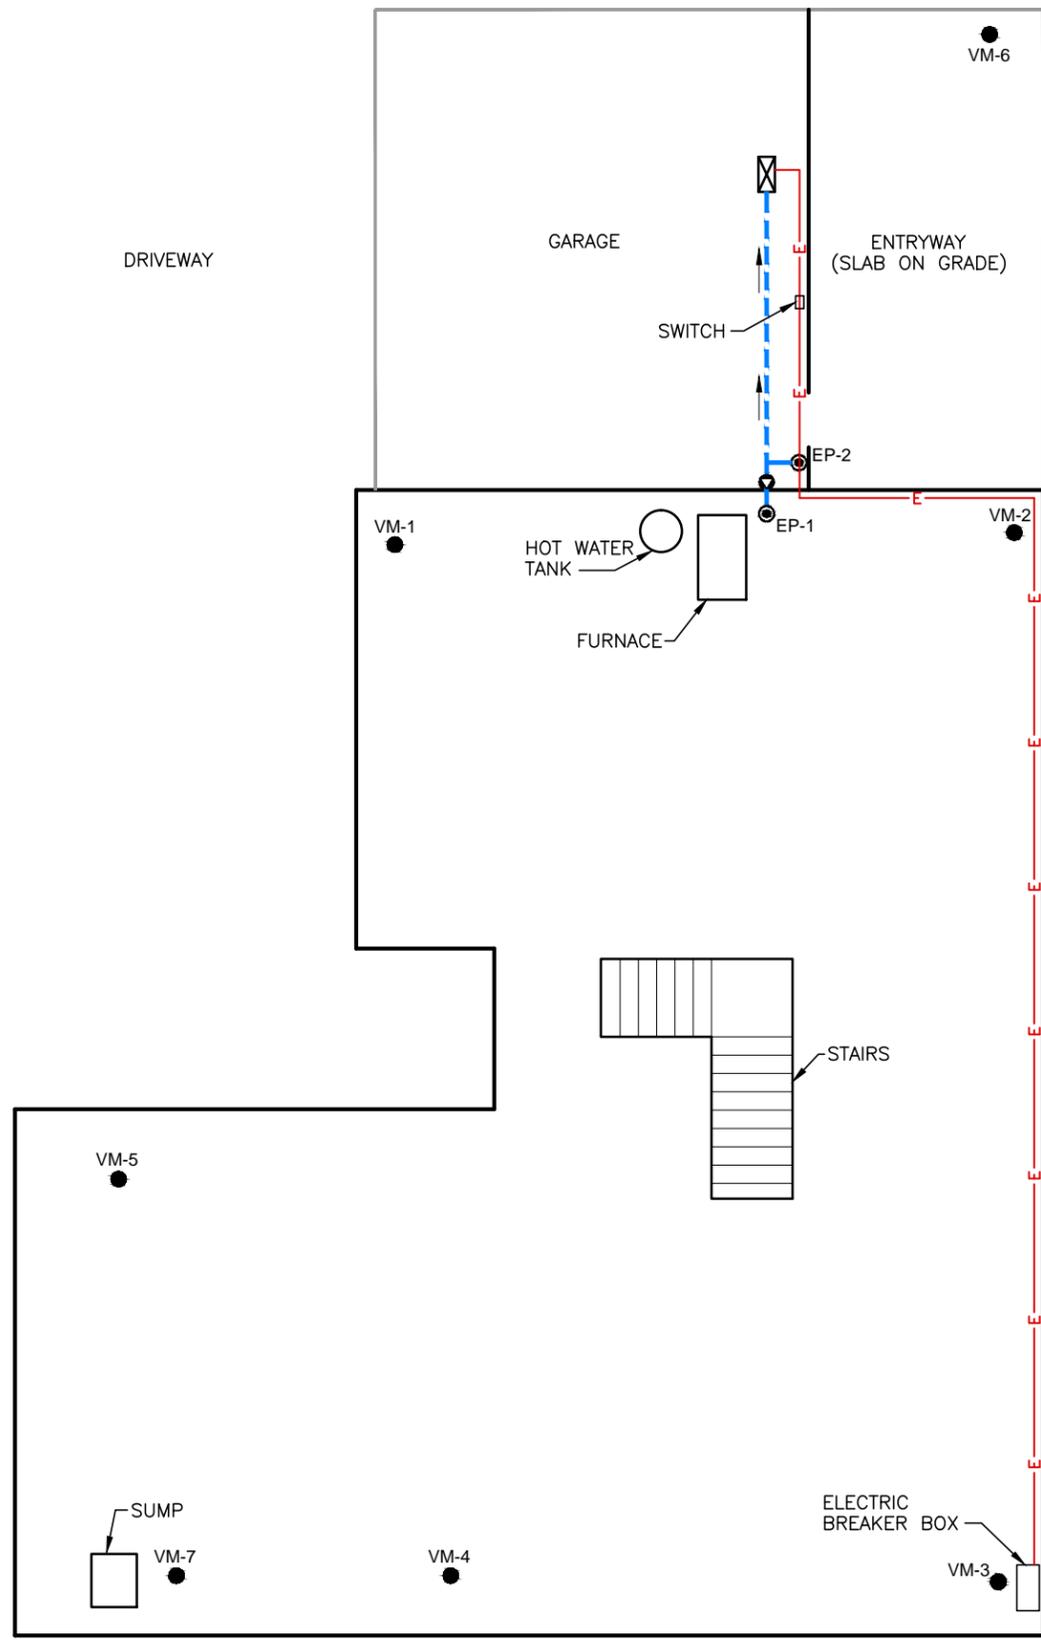
FIGURE 3  
 AS-BUILT VAPOR MITIGATION SYSTEM  
 HOME #22

The initial site visit for home #22 was also performed on September 13, 2012. The inspection revealed a full-height (approximately 8 feet-high) L-shaped basement beneath the original footprint of the house (Figure 3). Like home #21, the foundation walls appeared to be poured concrete and were matched with a contiguous concrete pad that covered the entire basement. Only one small opening was noted in the floor for a dry sump in the southwest corner of the basement. The basement did not have any internal partitions or framed areas (i.e., it was a single large room). The furnace and hot water tank were located near the north wall of the basement with the main electrical breaker box located in the southeast corner. The home did not have any attached crawl spaces, but did have an addition built over an adjacent slab on grade east of the garage. The addition, an entryway for the home, was not occupied on a regular basis; however, the space was open to the main home and, thus, was included in the mitigation design.

Pre-installation communication testing was performed using four vacuum monitoring locations, designated VM-1 through VM-4, positioned within the main basement with VM-1 used as the vacuum extraction point for the test (Figure 3). The vacuum was applied to the subsurface and measured using the same equipment and procedures as those detailed above. Vacuum measurements ranged between -0.009 and -0.040 inch of WC at VM-4 and VM-3, respectively, showing that there was vapor communication beneath the entire basement floor. No communication testing was performed for the entryway, which was part of the living space for the home. WSP assumed that construction beneath this portion of the house would have a similar response to that of the main basement.

The vapor mitigation system designed for home #22, based on the communication testing results included two vacuum extraction points: EP-1, located in the main basement, and EP-2, installed at ground level through the concrete floor of the garage. Extraction point EP-2 was designed to generate a vacuum beneath the adjacent slab-on-grade entryway, but was located in the garage (instead of through the entryway itself) to minimize the impact to the homeowners (Figure 3). Both extraction points were created by coring 5-inch diameter holes through the concrete slab, constructing 4-inch ID extraction point risers fitted with PVC gate valves and manometers using the

Post-installation testing of the system was conducted on June 18, 2013 by opening the extraction point valves, turning on the fan, and running the system continuously for approximately 15 minutes to establish the sub-slab vacuum field. WSP installed three additional vacuum measurement points (beyond those used for the pre-installation testing) to verify: that the Plexiglas cover installed over the sump had sealed the opening (VM-7); that the vacuum field extended to the northwest corner of the basement (VM-5); and that the second riser installed in the garage was effective at generating a vacuum field beneath the adjacent slab-on-grade entryway (VM-6; Figure 3). The vacuum measurements indicated good response with vacuums ranging between -0.017 and -0.28 inch of WC for the main basement, and -0.027 inch of WC for the slab-on-grade entryway. Differential pressure readings at the extraction points indicated that the system was generating a vacuum of approximately 2.5 inches of WC.
