February 18, 2025

Re: 2024 Annual System Status Report  
Sub-Slab Depressurization System  
Former United Stellar Industries Site (#130115)  
131 Sunnyside Boulevard, Plainview, New York

**2024 Annual System Status Report**  
***Former United Stellar Industries Site (#130115)***  
***131 Sunnyside Boulevard, Plainview, New York***

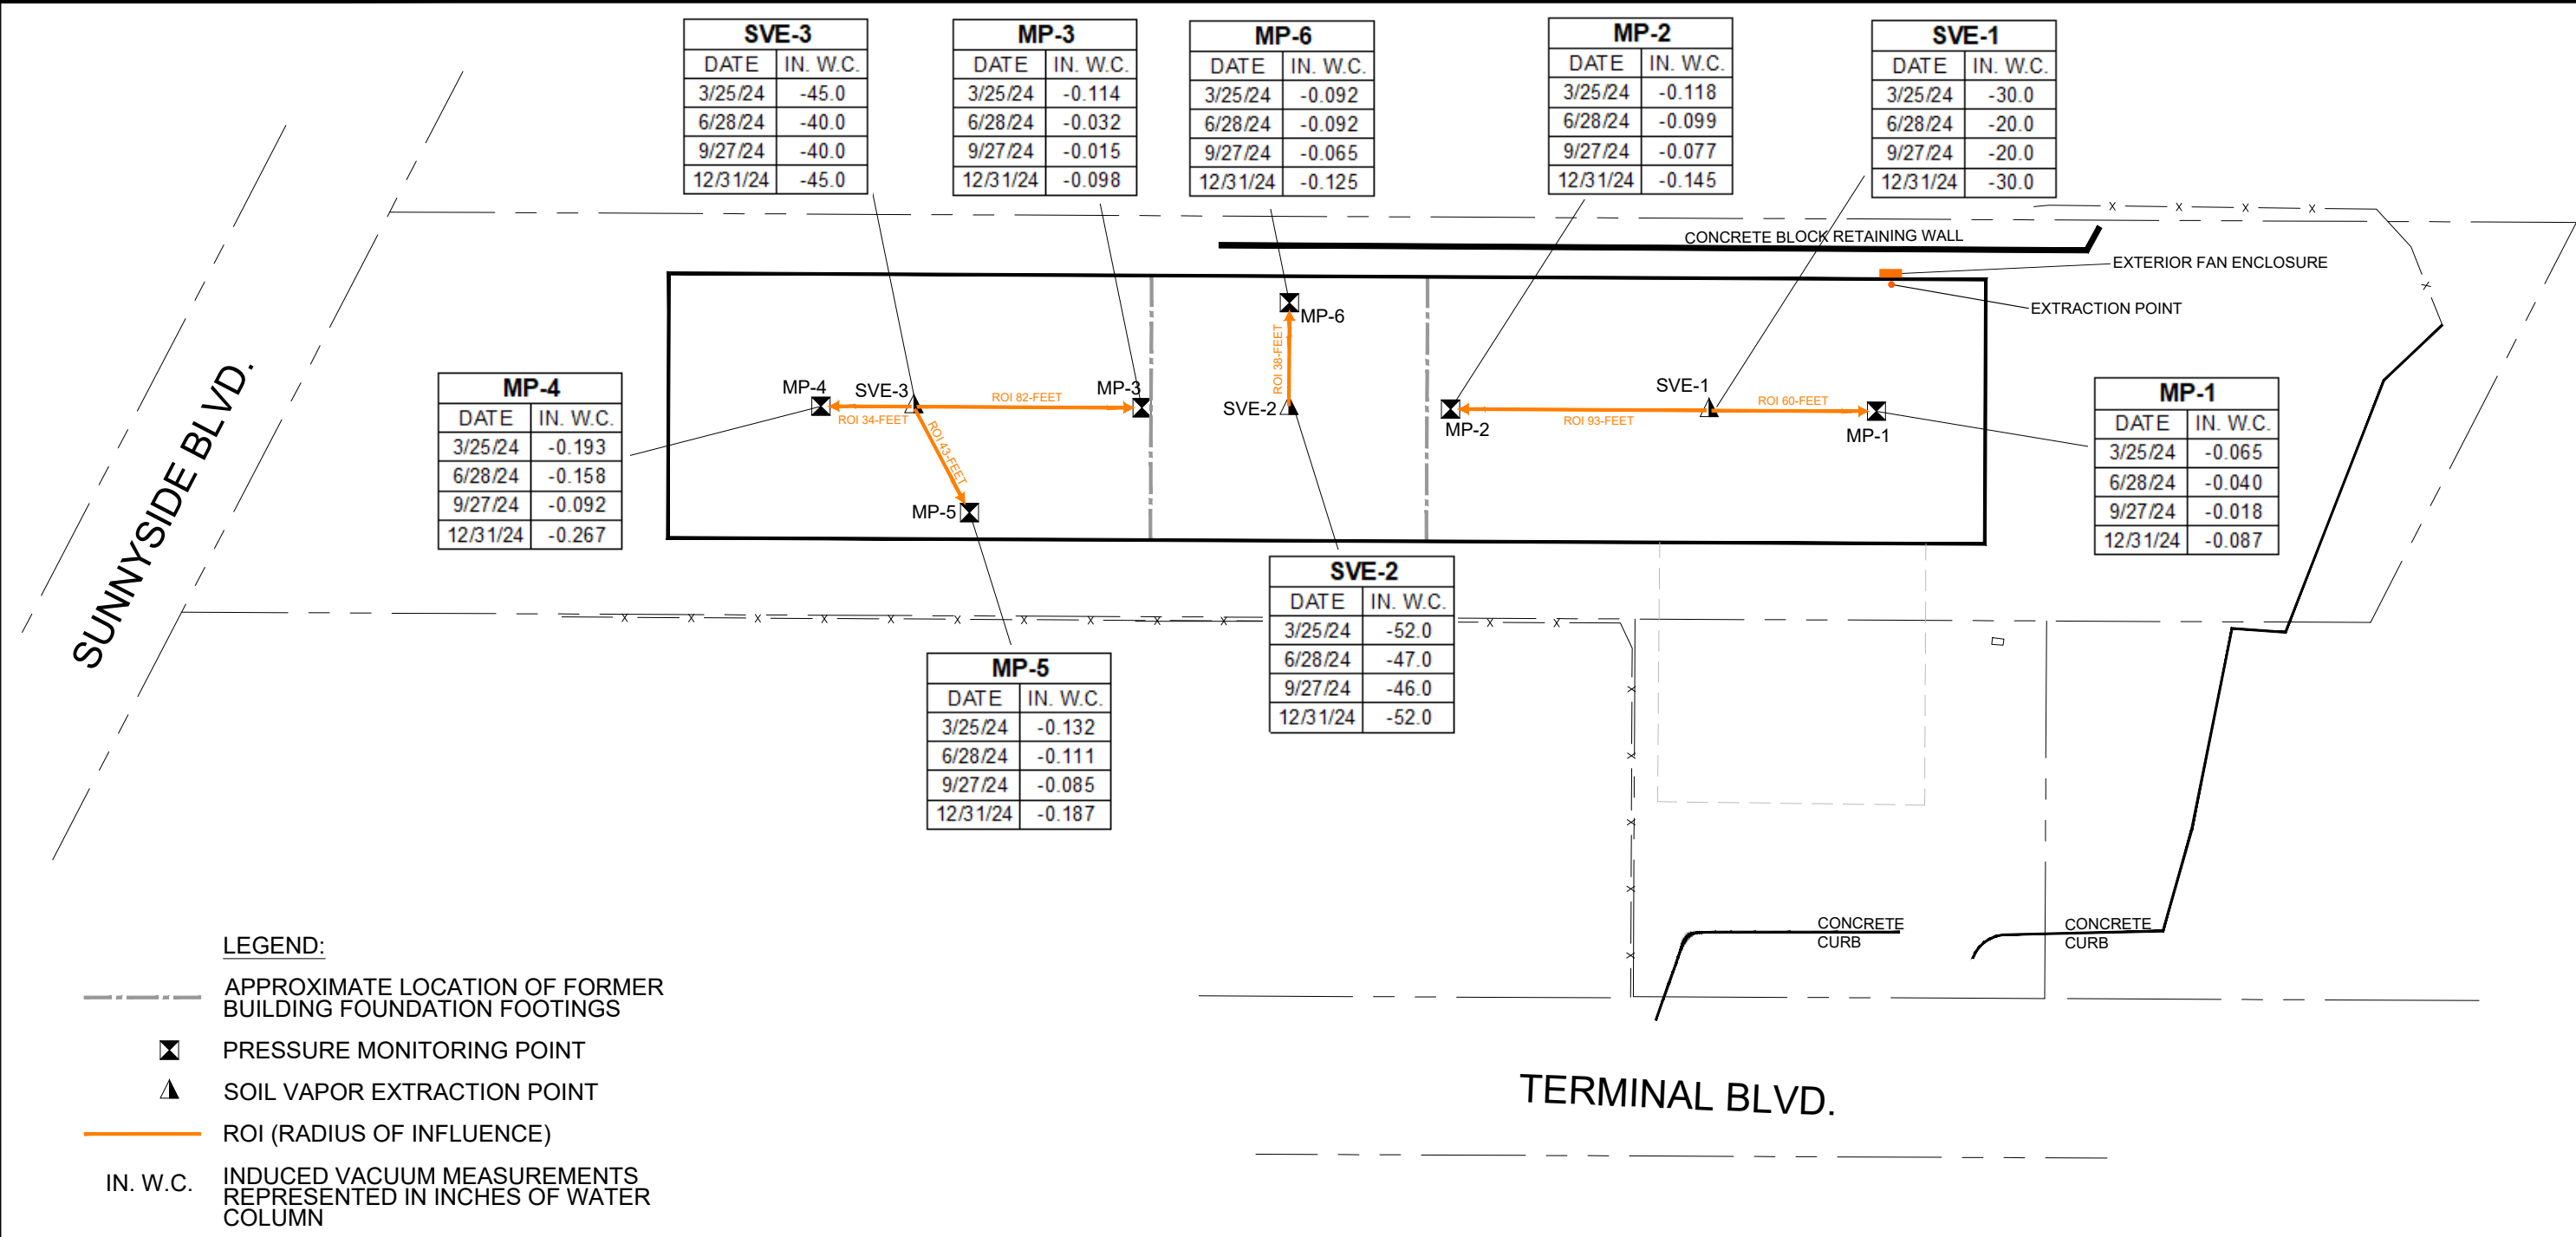
FIGURE  
1

Operational measurements including applied vacuum levels at each extraction point and extraction air flow rates are summarized in Table 1. Figure 1 depicts locations of the vacuum extraction wells, vacuum/vapor monitoring points, and associated measurements collected during the 2024 reporting period.

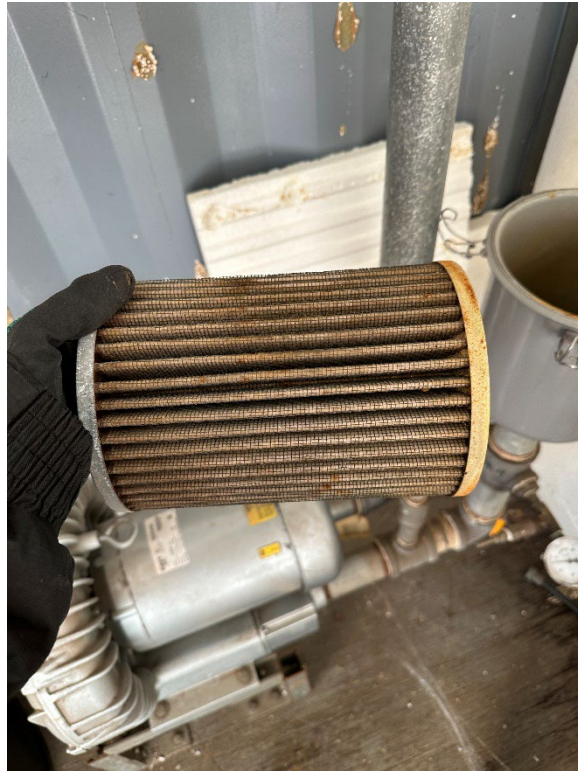
| SUB-SLAB DEPRESSURIZATION SYSTEM OPERATIONS AND MAINTENANCE FORM | | | | | |
|---|---|---|---|---|---|
| Is the vacuum filter in good condition? | | | ___ | X | Needs replacement |

**Photograph 5: View of the air filter from the blower.**
