Re: 2025 Annual System Status Report
Sub-Slab Depressurization System
Former United Stellar Industries Site (#130115)
131 Sunnyside Boulevard, Plainview, New York

2025 Annual System Status Report
Former United Stellar Industries Site (#130115)
131 Sunnyside Boulevard, Plainview, New York

SSDS Operations and Maintenance Forms and
Photos of System Components

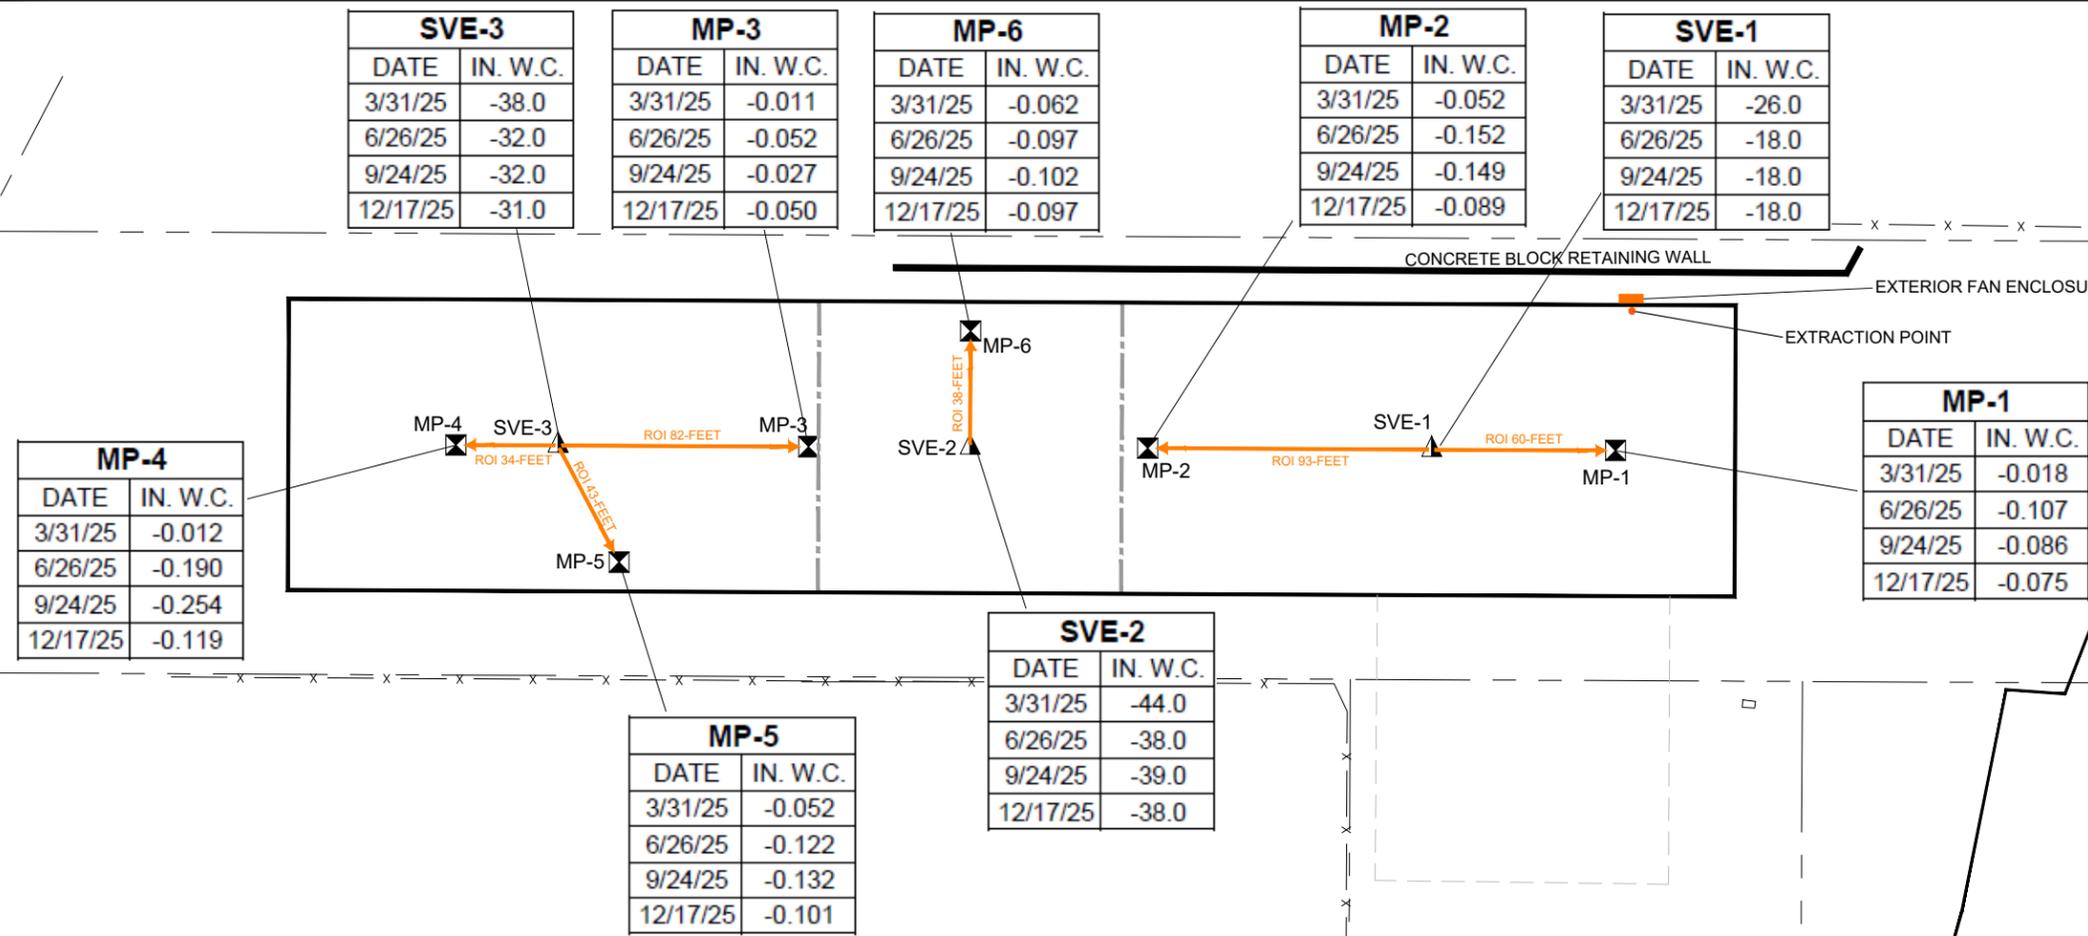
Compiled by: J.L. Date: 01/08/2026 FIGURE
Project Mgr: J.L. Scale: AS SHOWN 1

Operational measurements including applied vacuum levels at each extraction point and extraction air flow rates are summarized in Table 1. Figure 1 depicts locations of the vacuum extraction wells, vacuum/vapor monitoring points, and quarterly measurements collected during the 2025 reporting period.

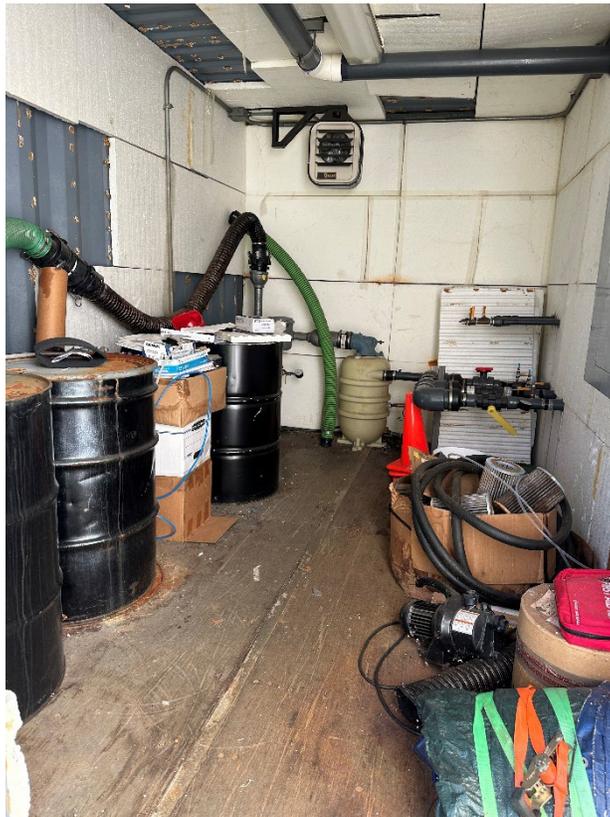
Photograph 1: Overall view of the system container.

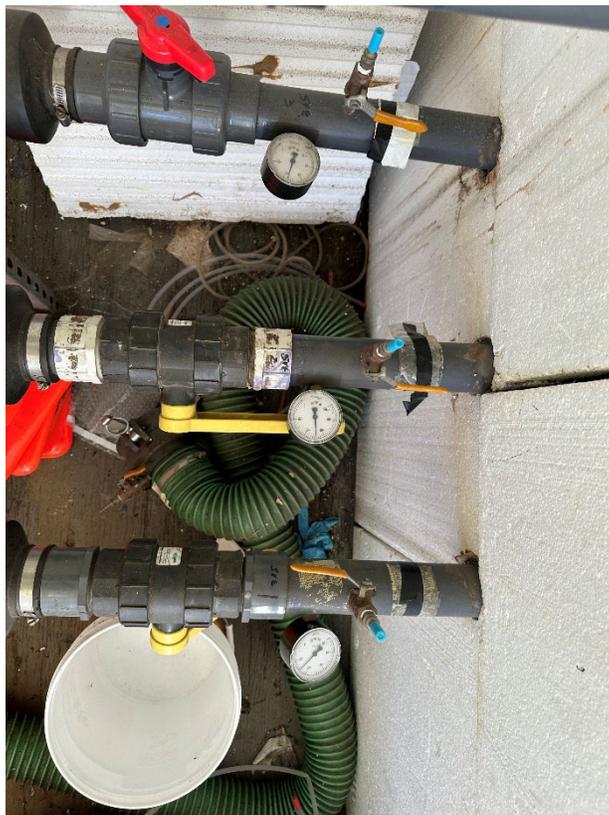
Photograph 2: View of the SVE vacuum gauges.

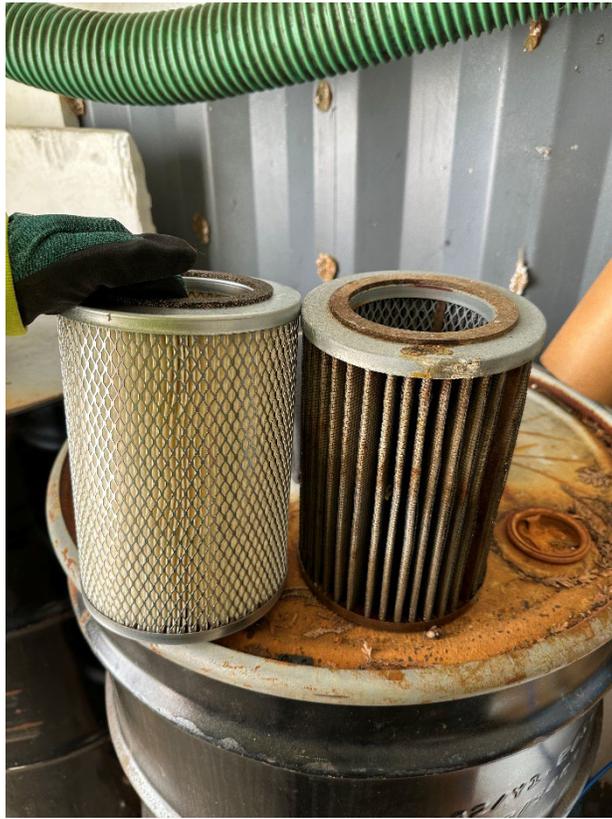
Photograph 3: View of vacuum filter replacement.

List maintenance activities that were performed or _____ the interior and exterior piping, blower, knock-out tank, vacuum/pressure gauges, and valves were inspected.
 other comments about the system: _____ the vacuum filter was replaced.

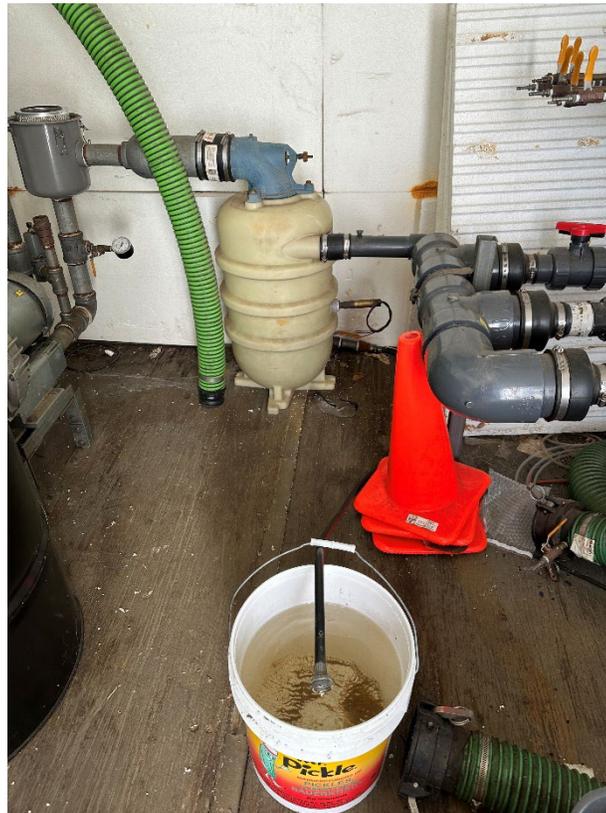
Photograph 4: View of condensate drained from the knockout tank.

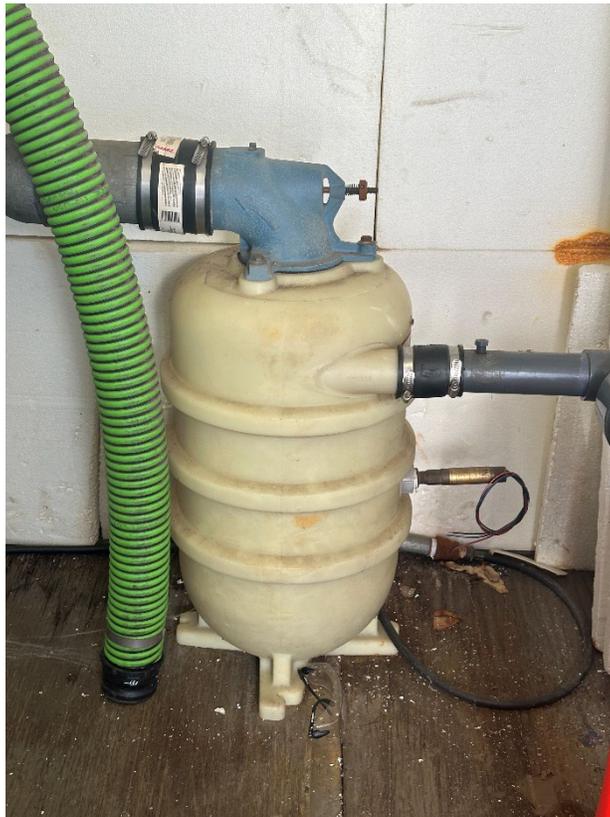
Photograph 1: View of the knockout tank.

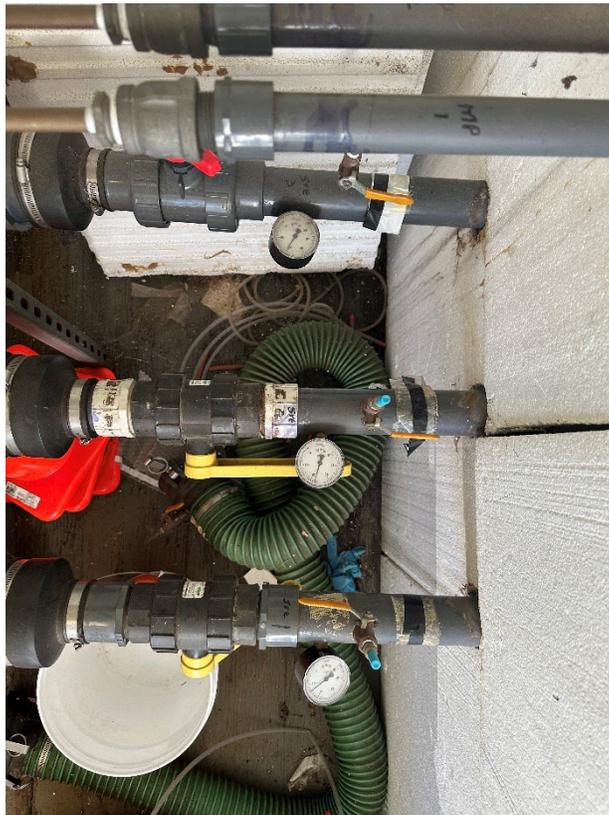
Photograph 2: View of the SVE vacuum gauges.

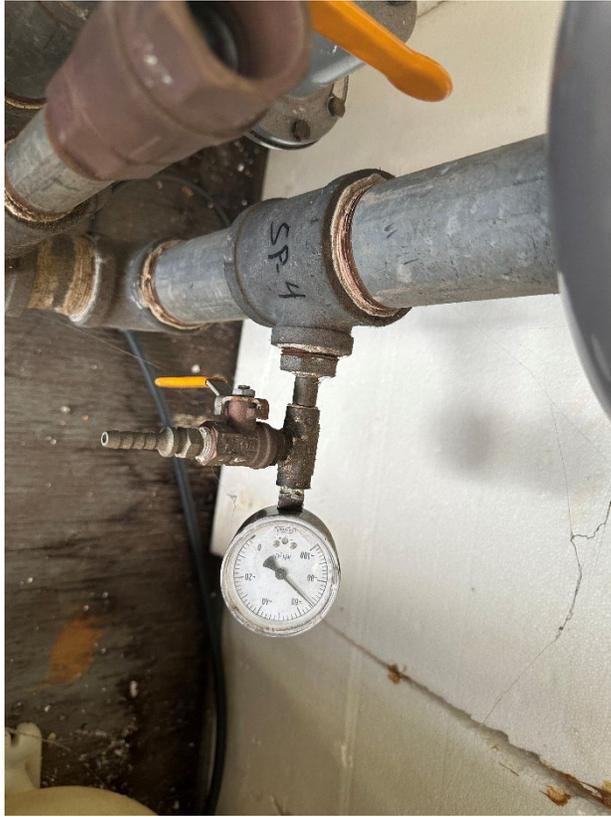
Photograph 3: View of the blower vacuum gauge.

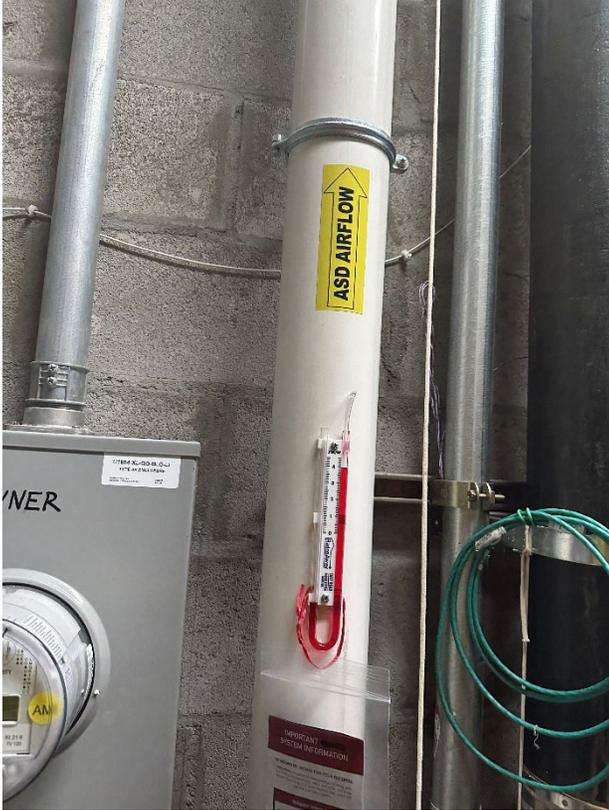
Photograph 4: View of the u-tube reading associated with the GP-501 fan.

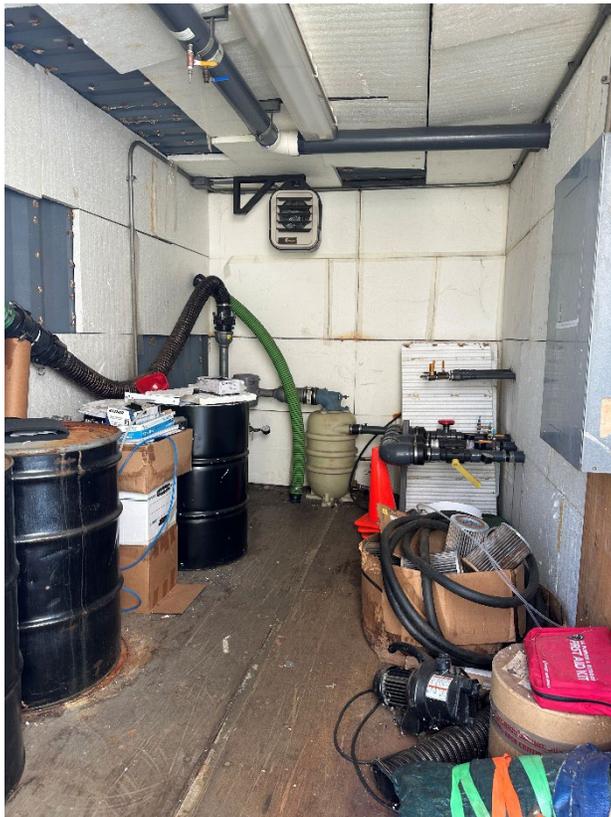
Photograph 1: Overall view of the system container.

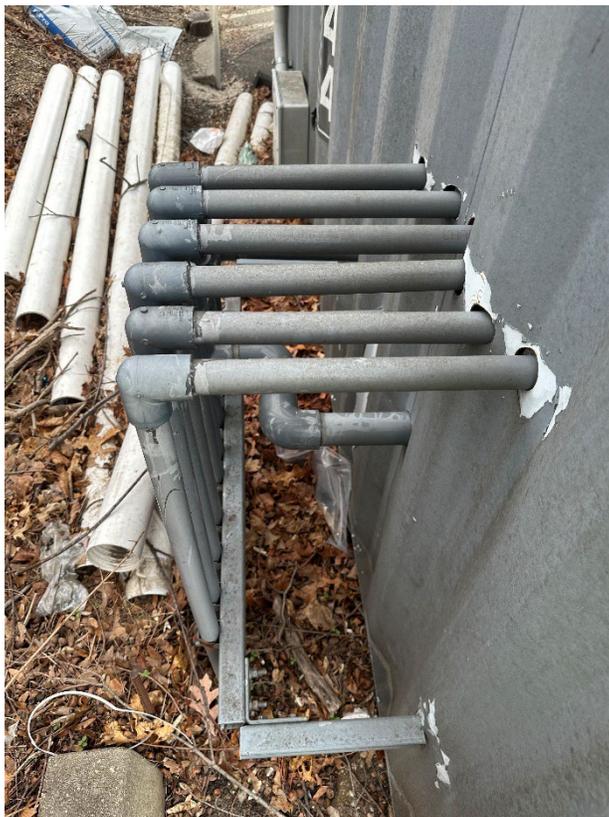
Photograph 2: View of the exterior piping.

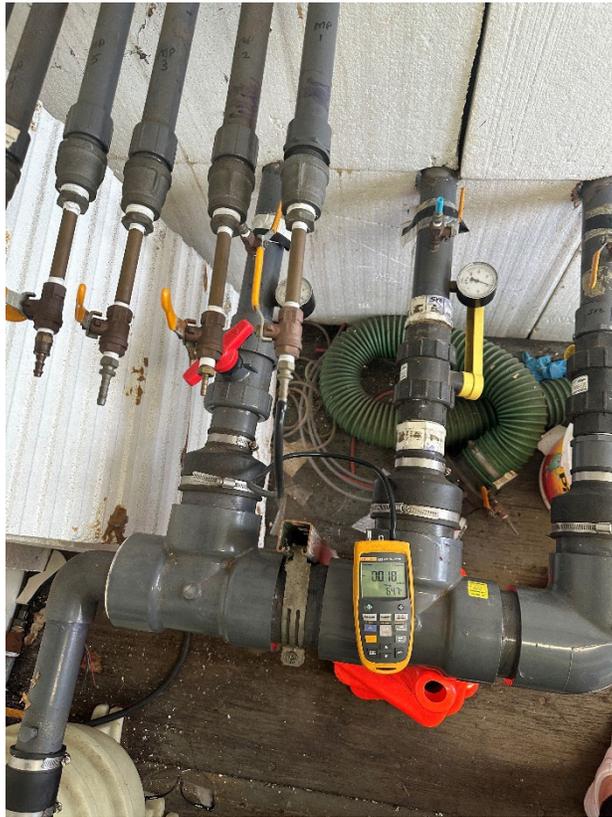
Photograph 3: View of the vacuum measurement from MP-1.

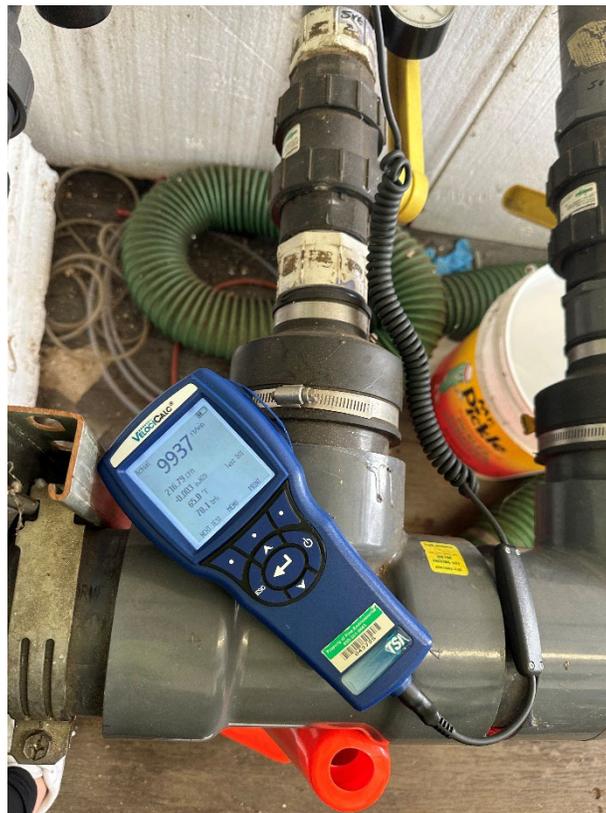
Photograph 4: View of the velocity measurement from SVE-3.

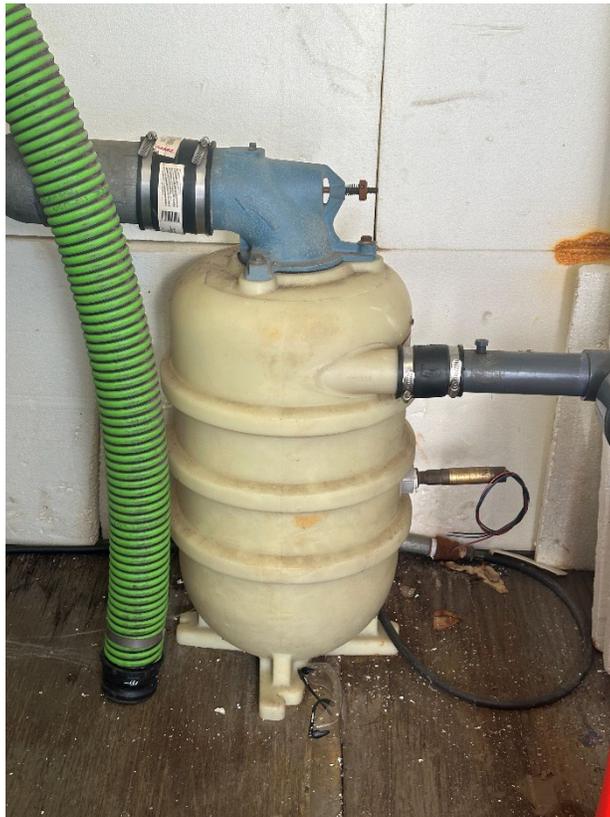
Photograph 1: View of the knockout tank.

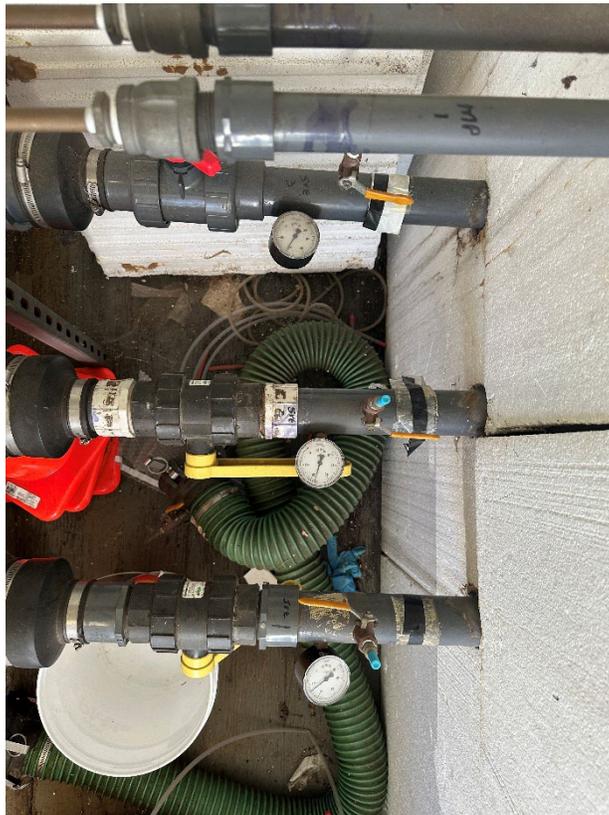
Photograph 2: View of the SVE vacuum gauges.

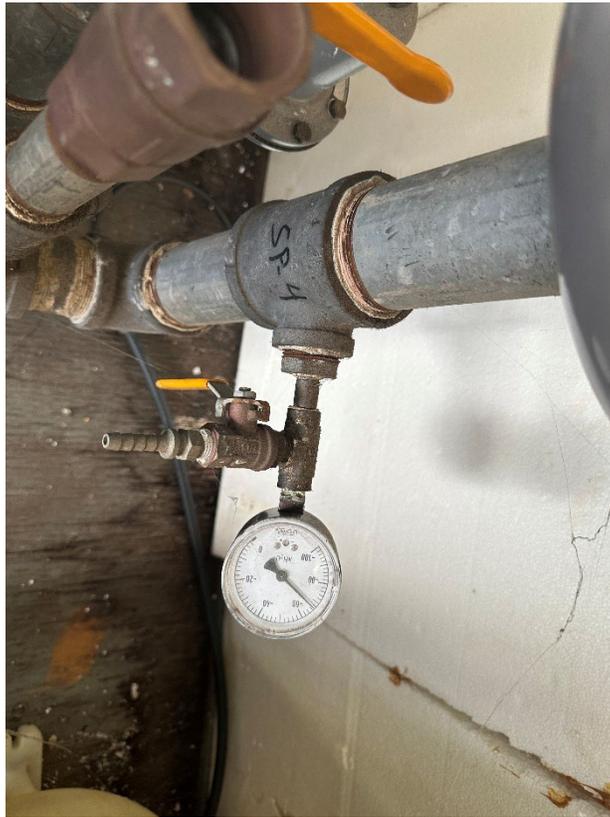
Photograph 3: View of the blower vacuum gauge.

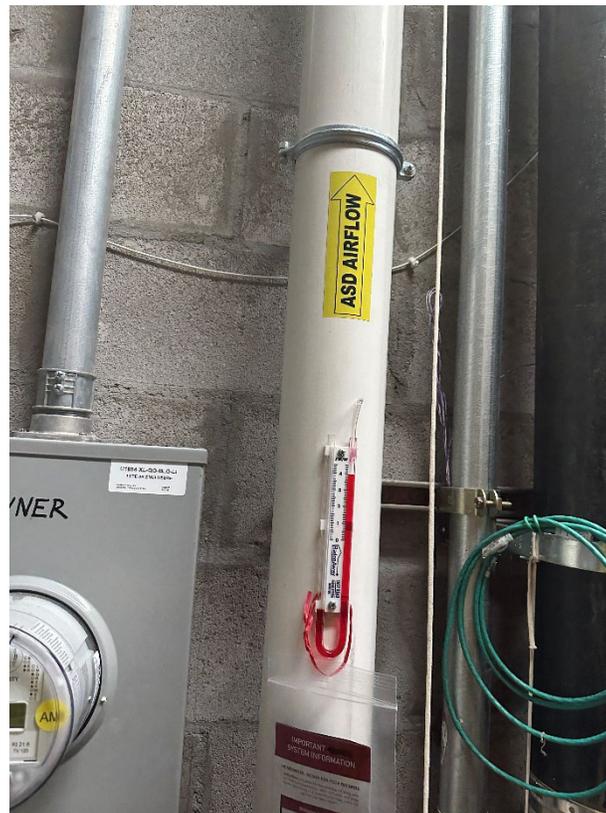
Photograph 4: View of the u-tube reading associated with the GP-501 fan.

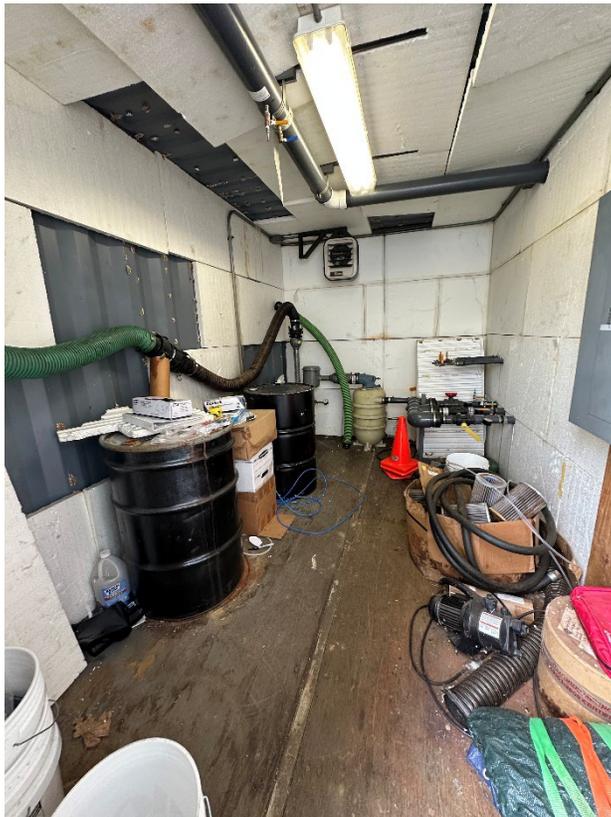
Photograph 1: Overall view of the system container.

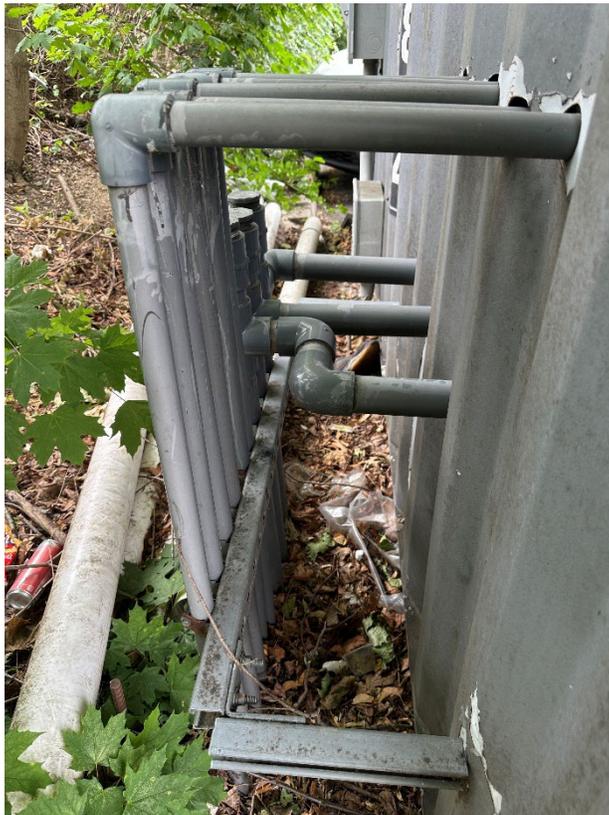
Photograph 2: View of the exterior piping.

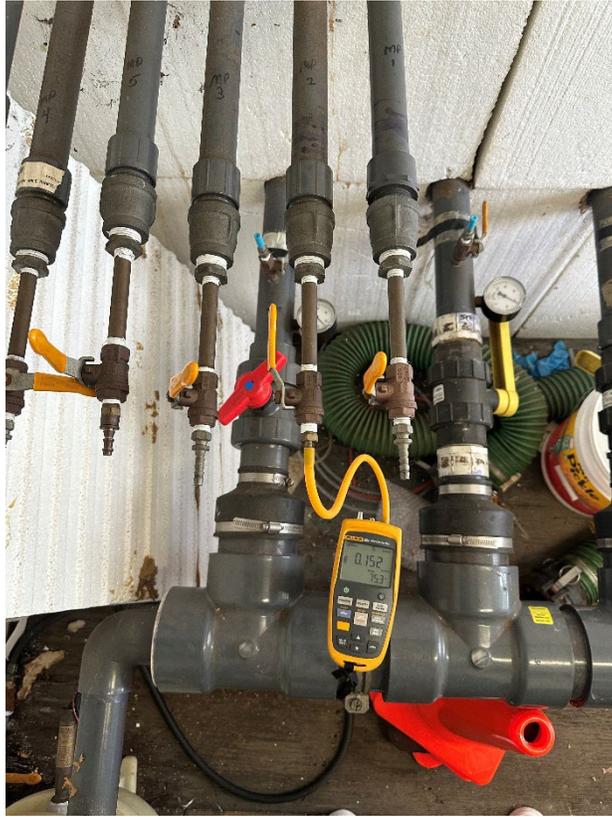
Photograph 3: View of the vacuum measurement from MP-2.

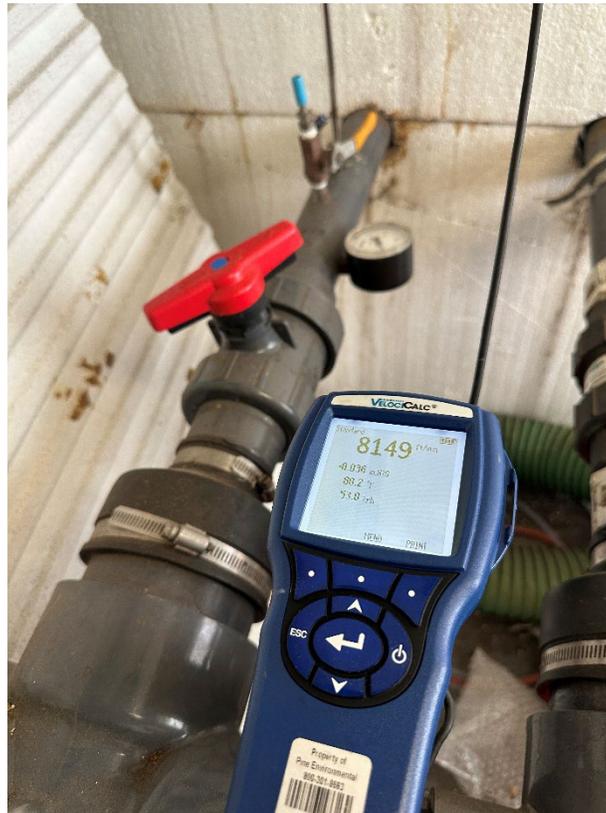
Photograph 4: View of the velocity measurement from SVE-3.
