Re: Report of Vapor Mitigation System Observation & Testing Services
COSTCO Wholesale (Oceanside, NY)
Daly Boulevard & Hampton Road
Town of Hempstead, Nassau County, New York
MC Project No. 12000271A

March & April 2017 Inspection of Liquid Boot Application and Smoke Testing

Attachment #1
Vapor Barrier Testing Log

Attachment #2
Site Photographs

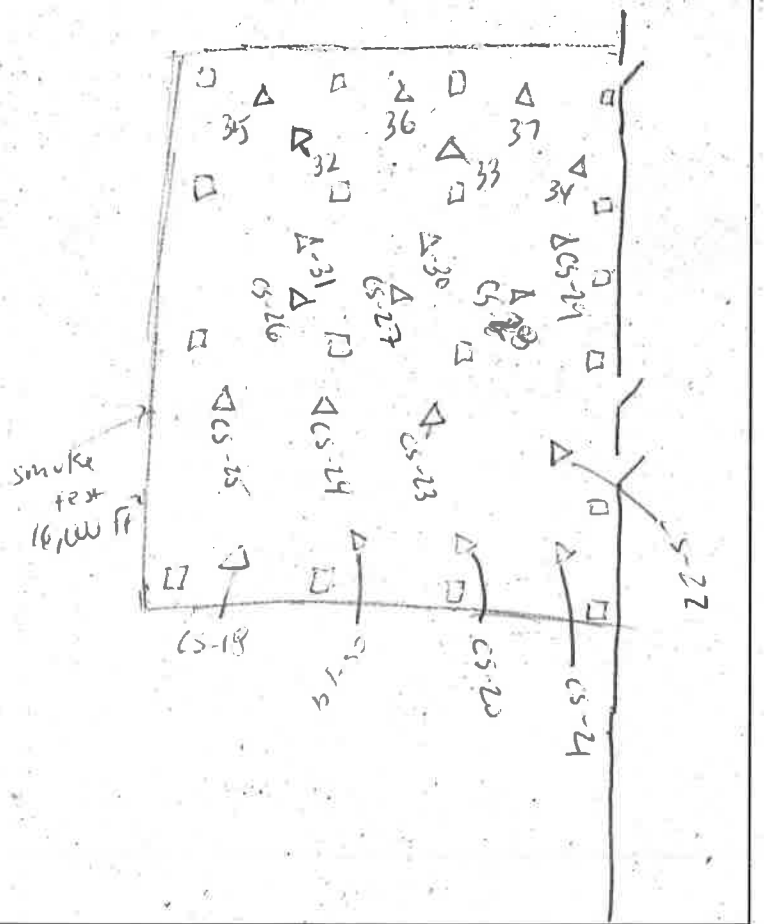
Coupon Samples Taken	15 20
Coupon Samples Under the Specified Thickness	3
Coupon Sample Marked for Repair	3

Smoke Test Conducted	Yes
Duration of Smoke Test	
Number of Areas Needing Repair	3

↑N	CS-18	79.5	
	CS-19	39.5	
	CS-20	62.5	
	CS-21	157	→ respunged low fabric
	CS-22	62	
	CS-23	92	
	CS-24	95	
	CS-25	75	
	CS-26	66	
	CS-27	74	respunged
	CS-28	77	respunged
	CS-29	81	
	CS-30	72	
	CS-31	118	
	CS-32	71	
	CS-33	103	
	CS-34	61	
	CS-35	81	
	CS-36	78	
	CS-37	82

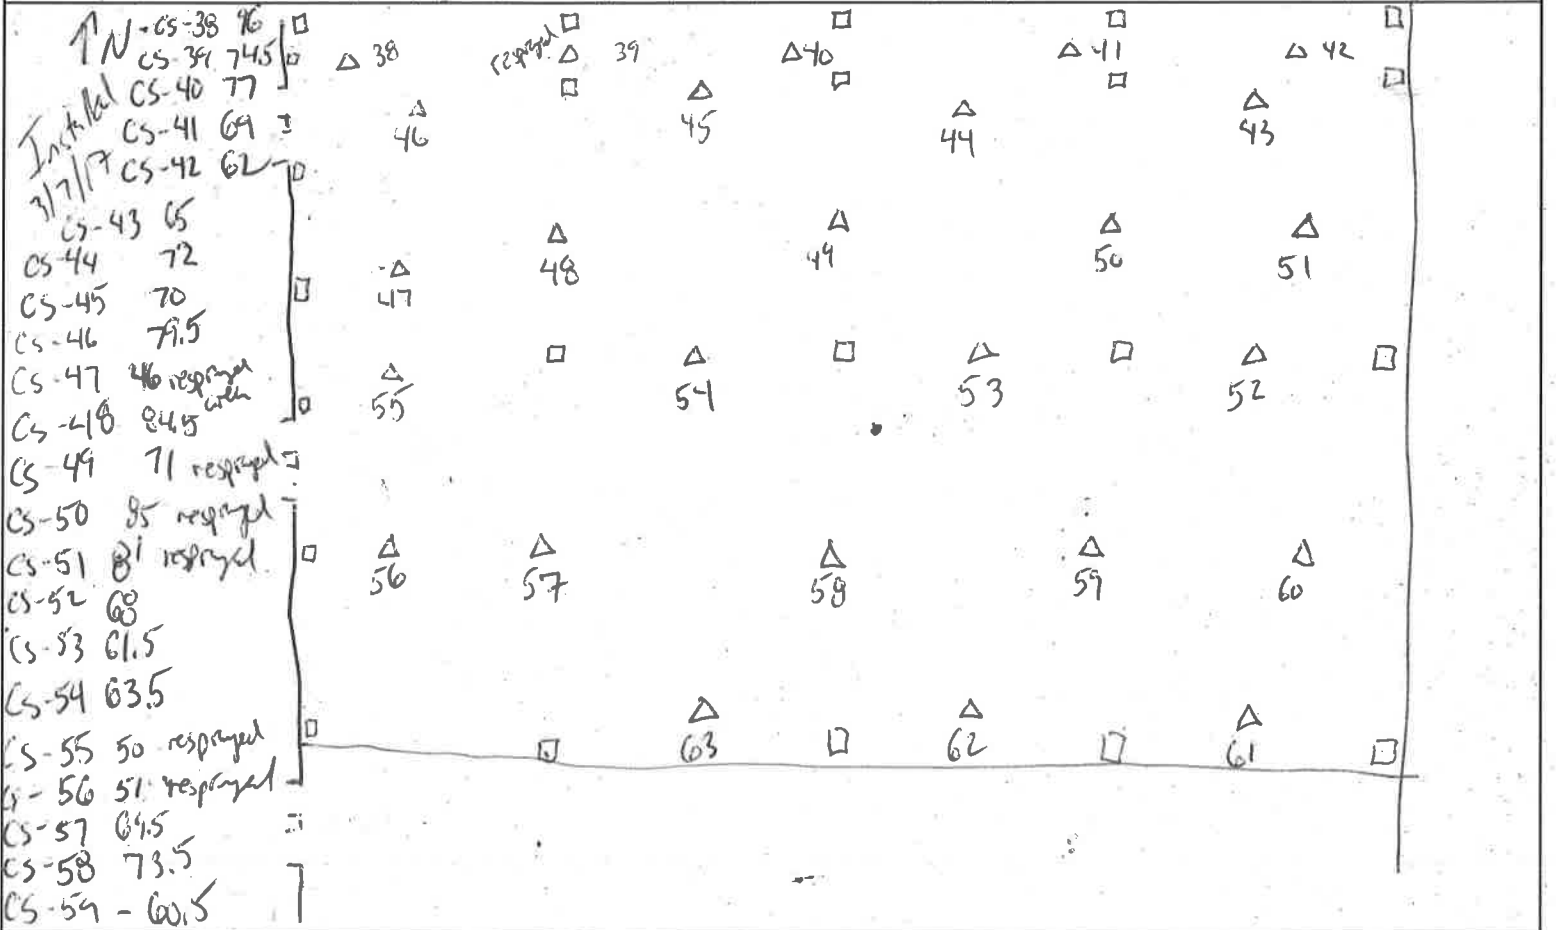
Coupon Samples Taken	26
Coupon Samples Under the Specified Thickness	6
Coupon Sample Marked for Repair	6

CS-60 65.5
 CS-61 65.5
 CS-62 70.5
 CS-63 60.2
 CS-64 65.5

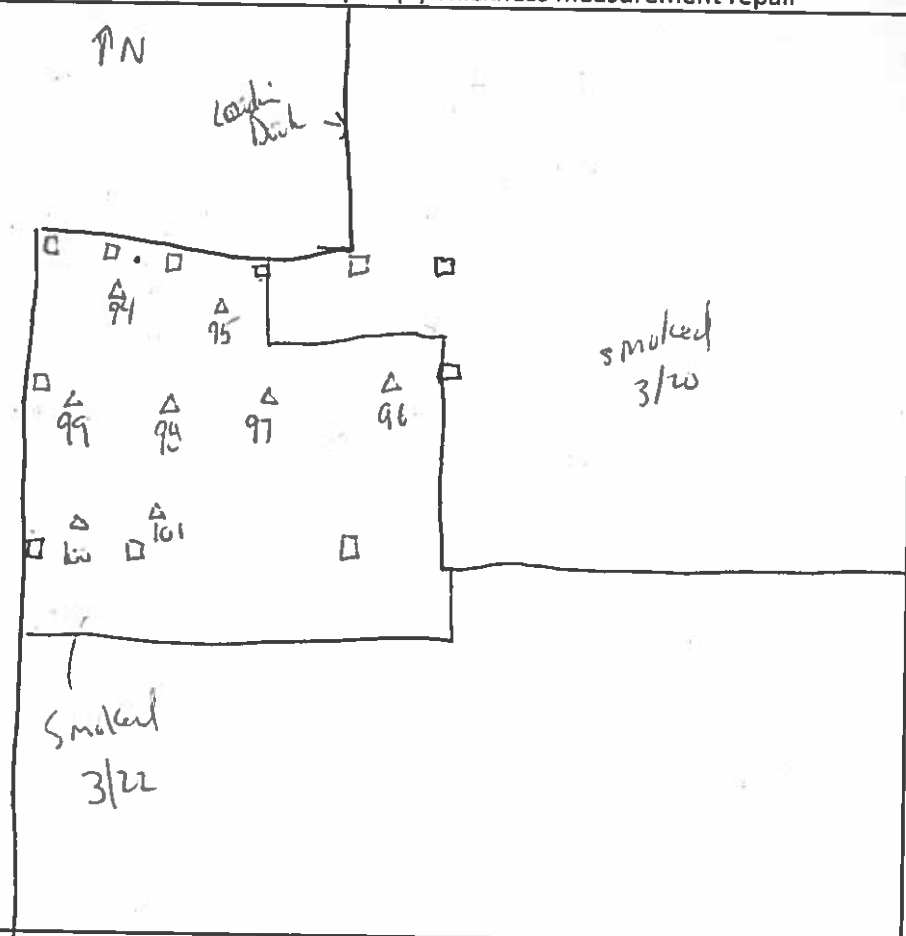
Coupon Samples Taken	<u>9</u>
Coupon Samples Under the Specified Thickness	<u>1</u>
Coupon Sample Marked for Repair	<u>1</u>

- CS-94 90
- CS-95 115
- CS-96 65.5
- CS-97 51 *
- CS-98 97.5
- CS-99 90
- CS-100 14.5
- CS-101 81
- CS-102 90

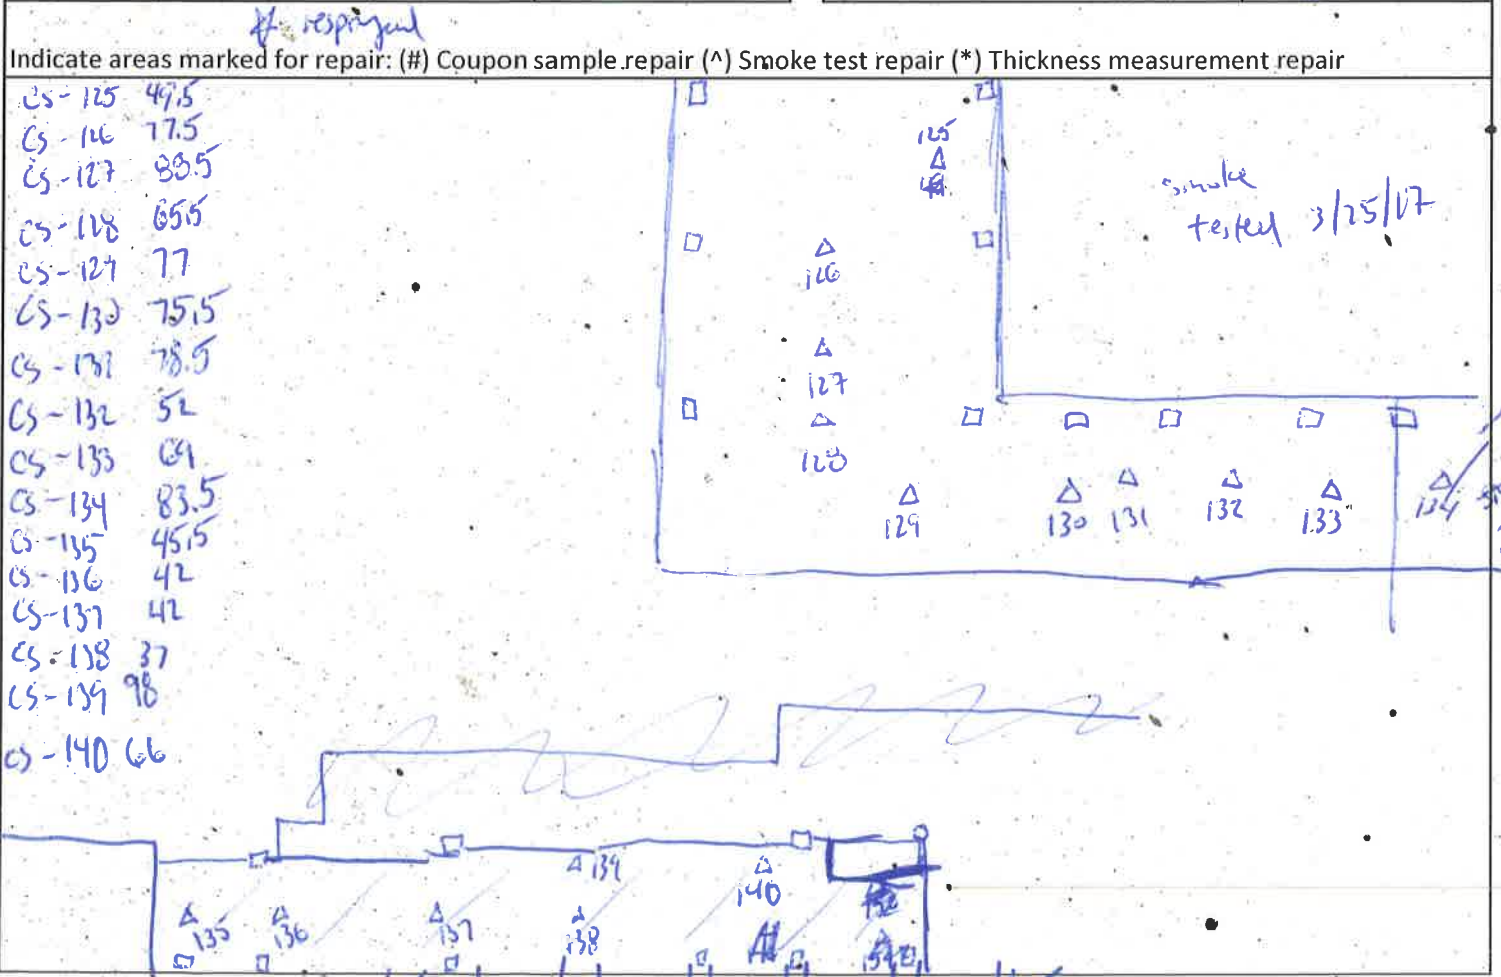
Coupon Samples Taken	<u>16</u>	Smoke Test Conducted	<u>3/28/17</u>
Coupon Samples Under the Specified Thickness	<u>6</u>	Duration of Smoke Test	<u>3 L/s</u>
Coupon Sample Marked for Repair	<u>6</u>	Number of Areas Needing Repair	<u>6</u>

- CS-125 47.5
- CS-126 77.5
- CS-127 83.5
- CS-128 65.5
- CS-129 77
- CS-130 75.5
- CS-131 78.5
- CS-132 52
- CS-133 69
- CS-134 83.5
- CS-135 45.5
- CS-136 42
- CS-137 42
- CS-138 37
- CS-139 98
- CS-140 66

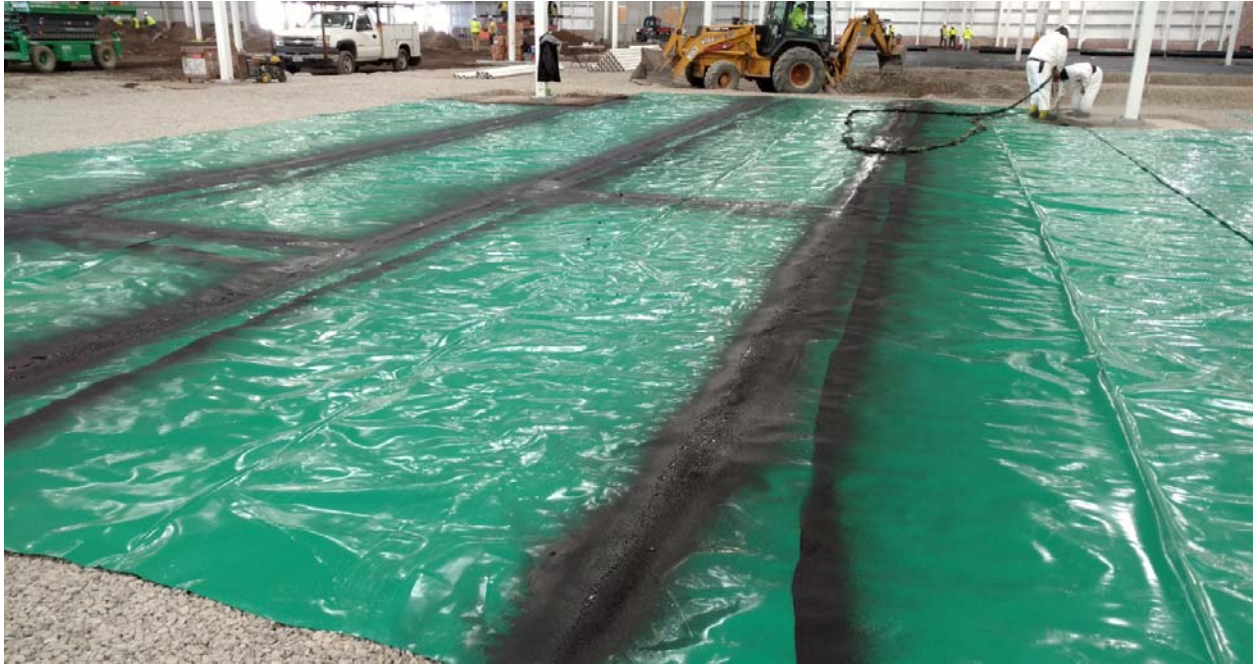
Photo #1: Depicts installation of vapor barrier system.

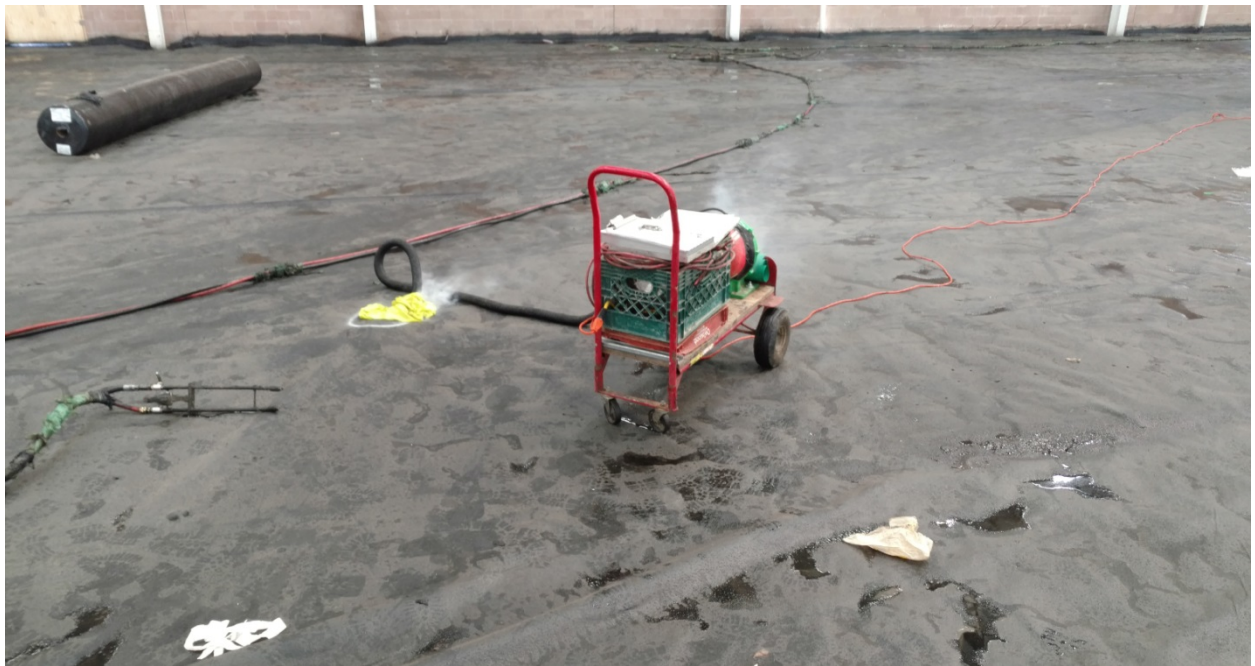
Photo #2: Depicts smoke testing of Liquid Boot Membrane.

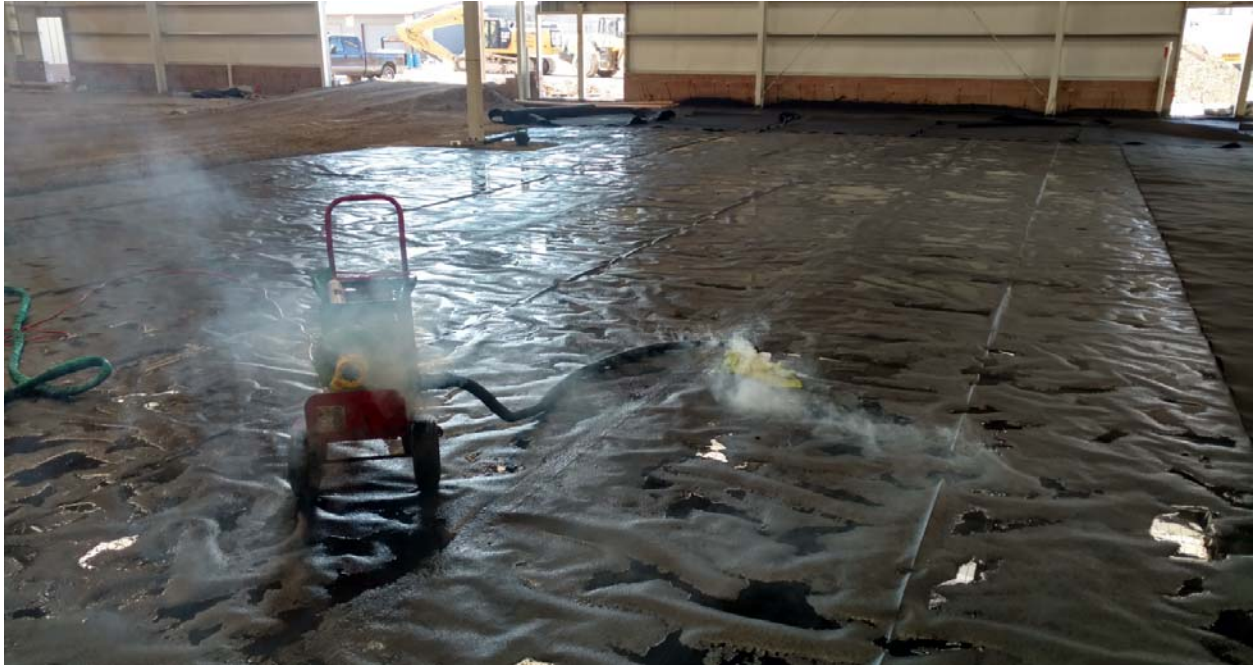
Photo #3: Depicts smoke testing of Liquid Boot Membrane.

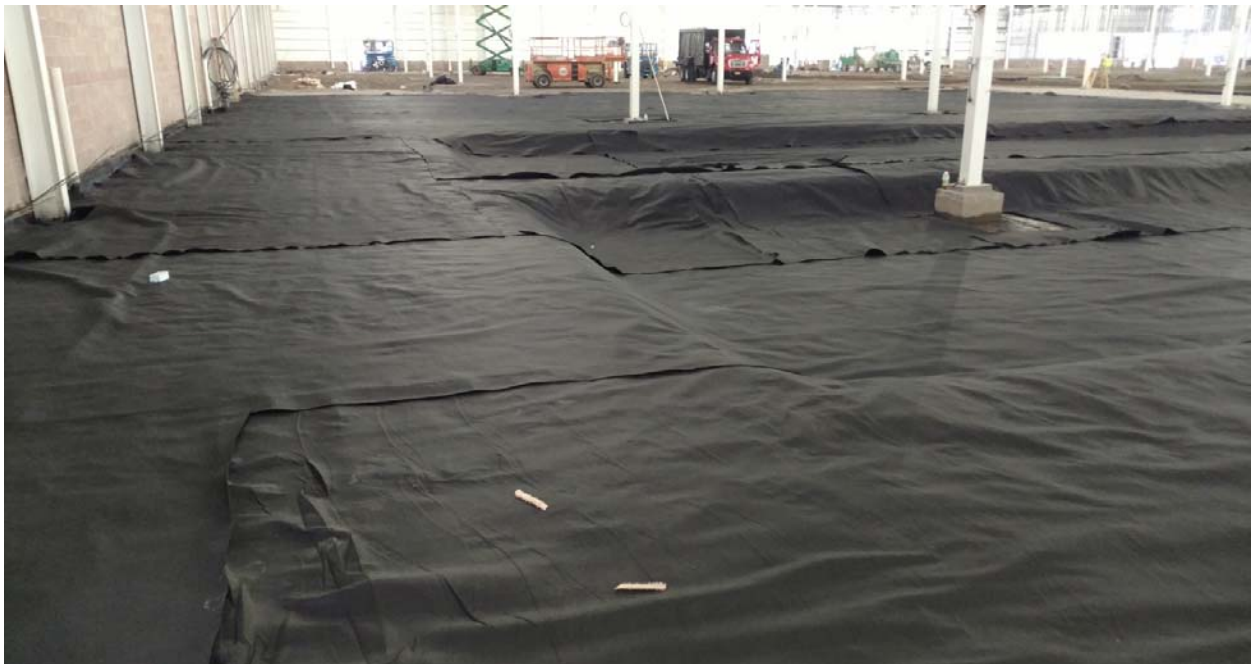
Photo #4: Depicts G-1000 protective layer.
