# Advanced Cleanup Technologies, Inc.

### PHASE I/PHASE II ENVIRONMENTAL SITE ASSESSMENT

1-3 Manorhaven Boulevard  
Port Washington, New York 11050

October 30, 2006

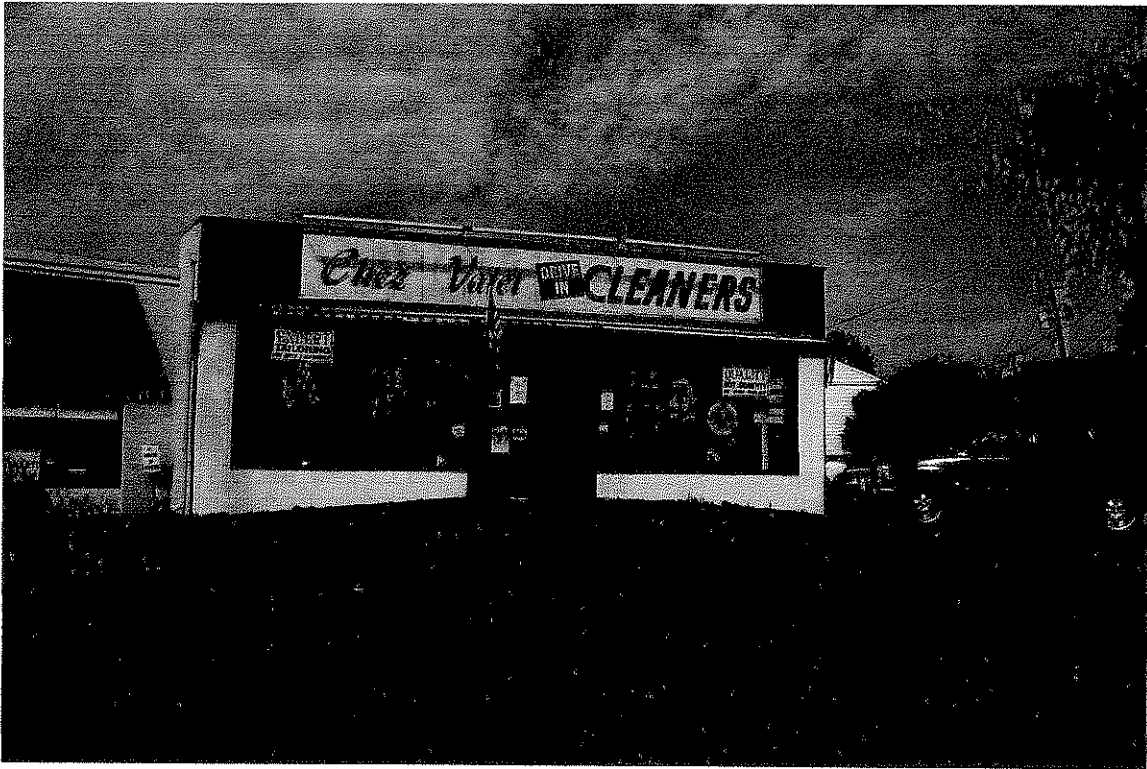
**Photograph #1: Dry Cleaner Looking West**

The subject property consists of two adjoining one-story commercial buildings. The buildings are constructed on concrete slabs. The northern building contains Chez Valet Dry Cleaners located at 1 Manorhaven Boulevard ("dry cleaner") and has a partial basement (Photograph 1). The southern building contains The Breakfast Room, a kitchen and bath showroom located at 3 Manorhaven Boulevard ("kitchen and bath showroom") with no basement (Photograph 2).

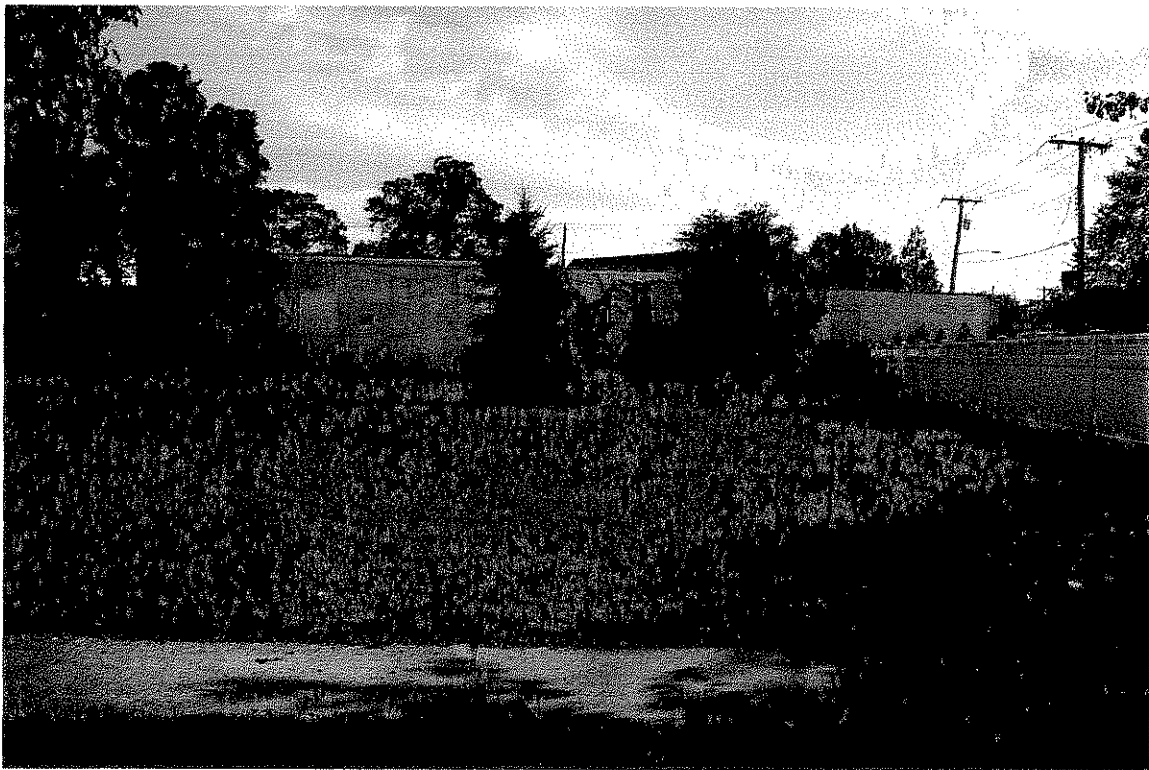
The exterior of the dry cleaner is surrounded by asphalt parking lots along its north and east sides and the kitchen and bath showroom to the south. The western wall of the dry cleaner abuts a vacant lot owned by the Village of Manorhaven (Photograph 8). The vacant lot contained two stand

**Photograph #8: Vacant Lot West of Subject Property**

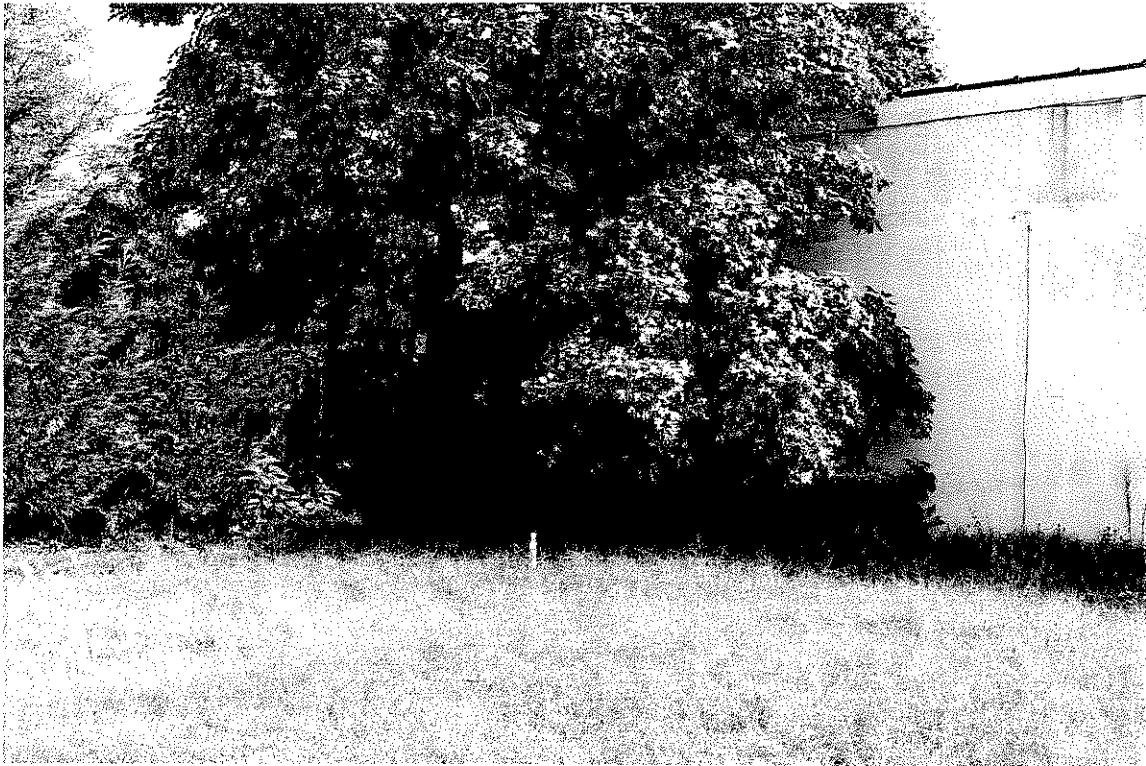
pipes for monitoring wells located along its eastern and southern boundaries adjacent to the subject property (Photographs 9 and 10). This lot will be discussed further in the Phase II portion of the Assessment.

**Photograph #9: Monitoring Well on Eastern Boundary of Vacant Lot**

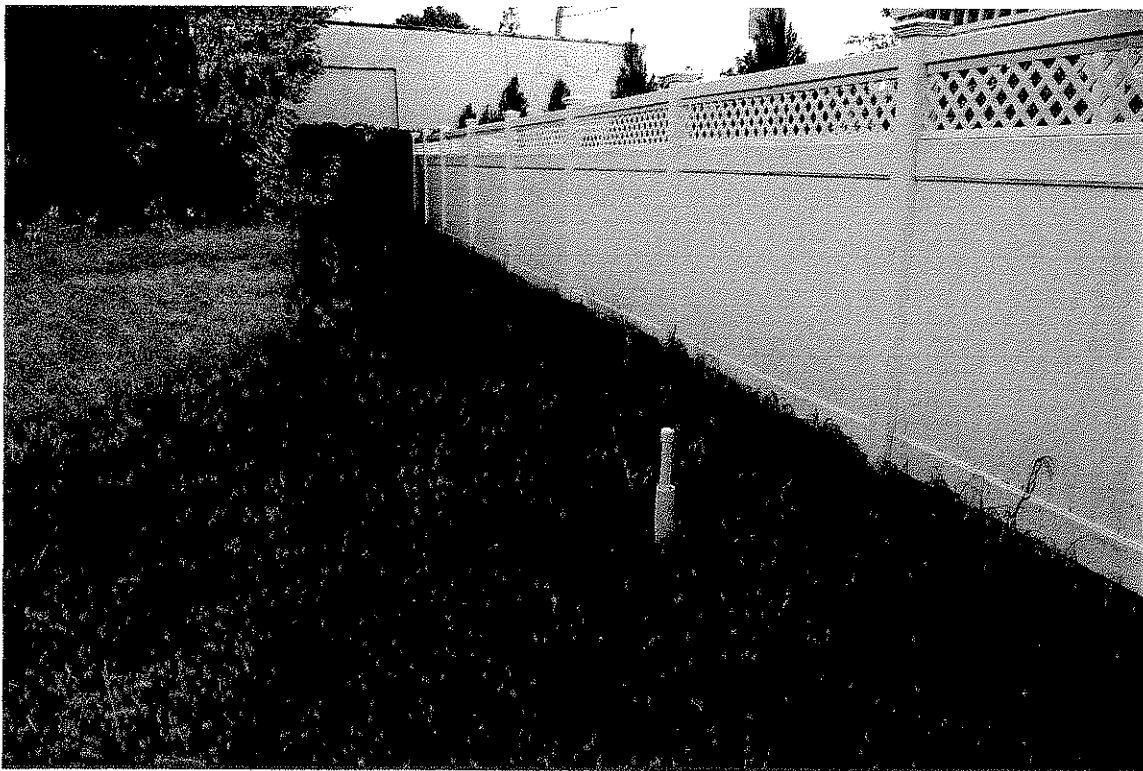
**Photograph #10: Monitoring Well on Southern Boundary of Vacant Lot**
