## **PHASE I ENVIRONMENTAL SITE ASSESSMENT**

**1-3 Manorhaven Boulevard  
Port Washington, New York 11050**

**December 19, 2007**

**ACT File #: 5621-PWNY**

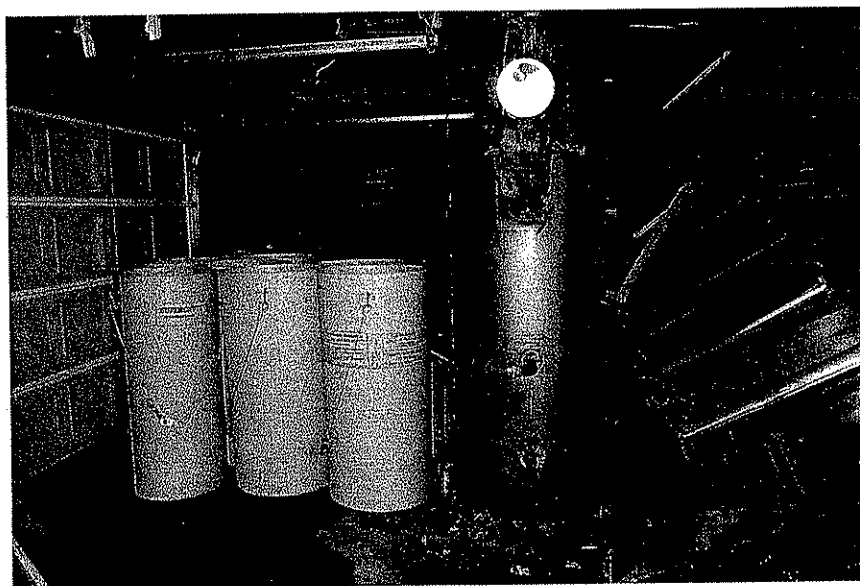
Inactive Heating Equipment in Garage

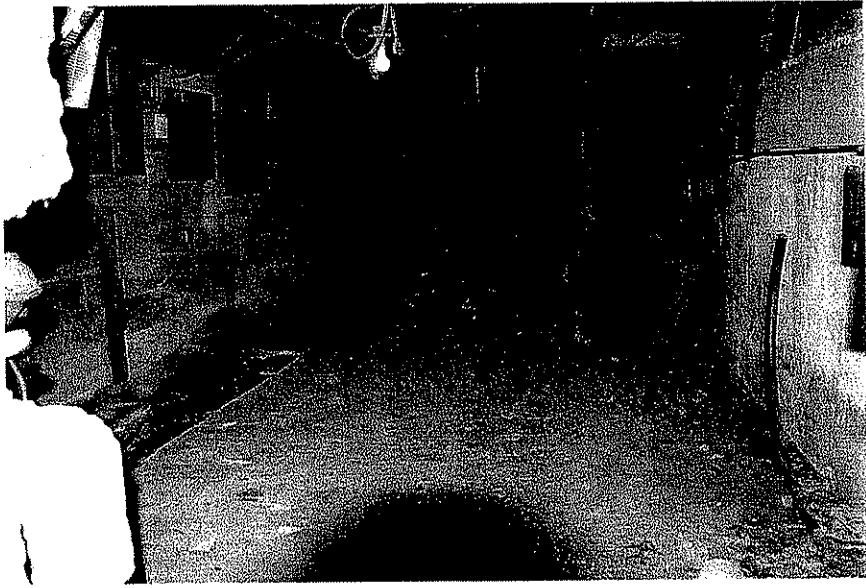
Partial Basement in Northern Building

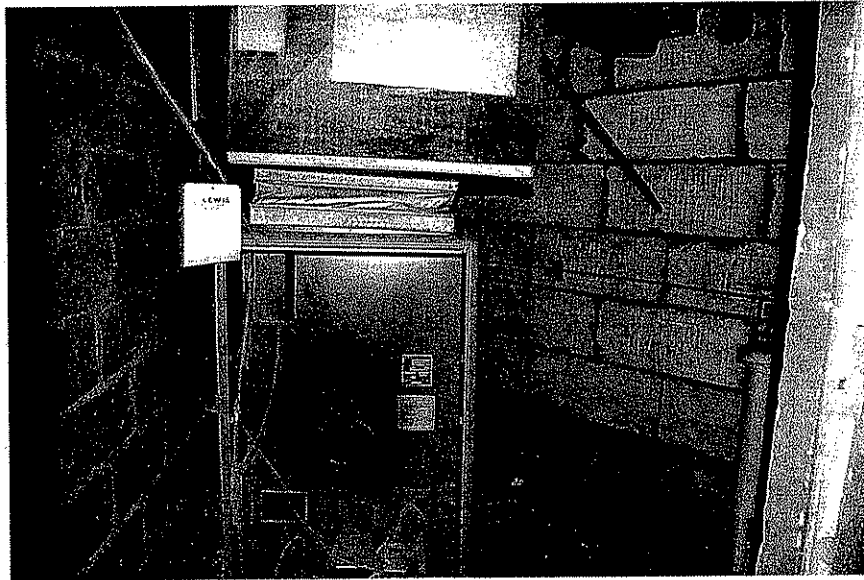
The northern building is provided heat by an oil-fired furnace located in the garage. The northern building is not provided with hot water. No stains or odors were identified in the vicinity of the heating equipment. The southern building is provided heat and hot water by a natural gas-fired furnace located in a utility closet. No stains, odors or evidence of spills were identified in the vicinity of the heating equipment.

Fuel Oil Fired Heating Equipment in the Northern Building

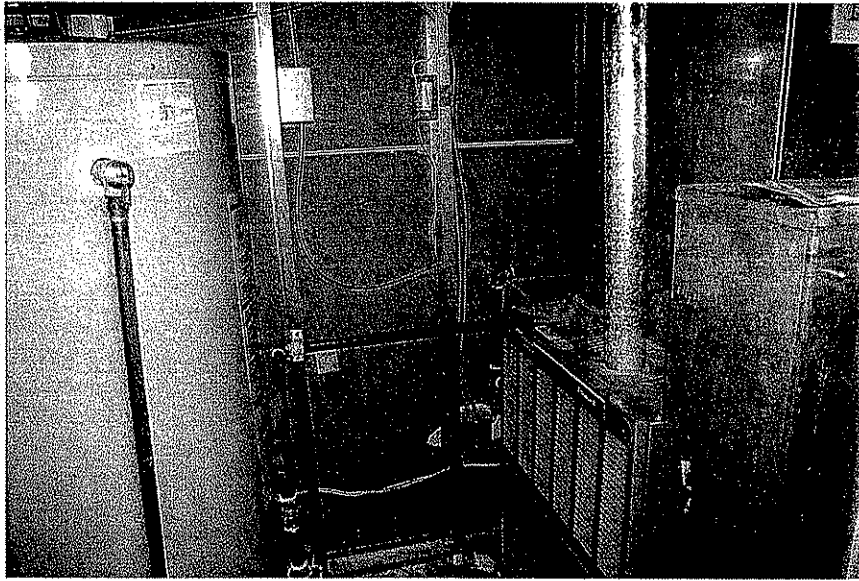
Natural Gas Fired Heating Equipment in the Southern Building
