Subject: Chez Valet Dry Cleaners – NYSDEC Site Number 1-03-169  
Revised Progress Report For Time Period 4/9/2013 through 1/29/2015

**SSD/SVE SYSTEM  
NYSDEC Site Number 1-03-169  
Former Chez Valet Dry Cleaners  
1-3 Manorhaven Boulevard  
Port Washington, NY 11050**

**Progress Report**

**Time Period  
4/9/2013 to 1/29/2015**

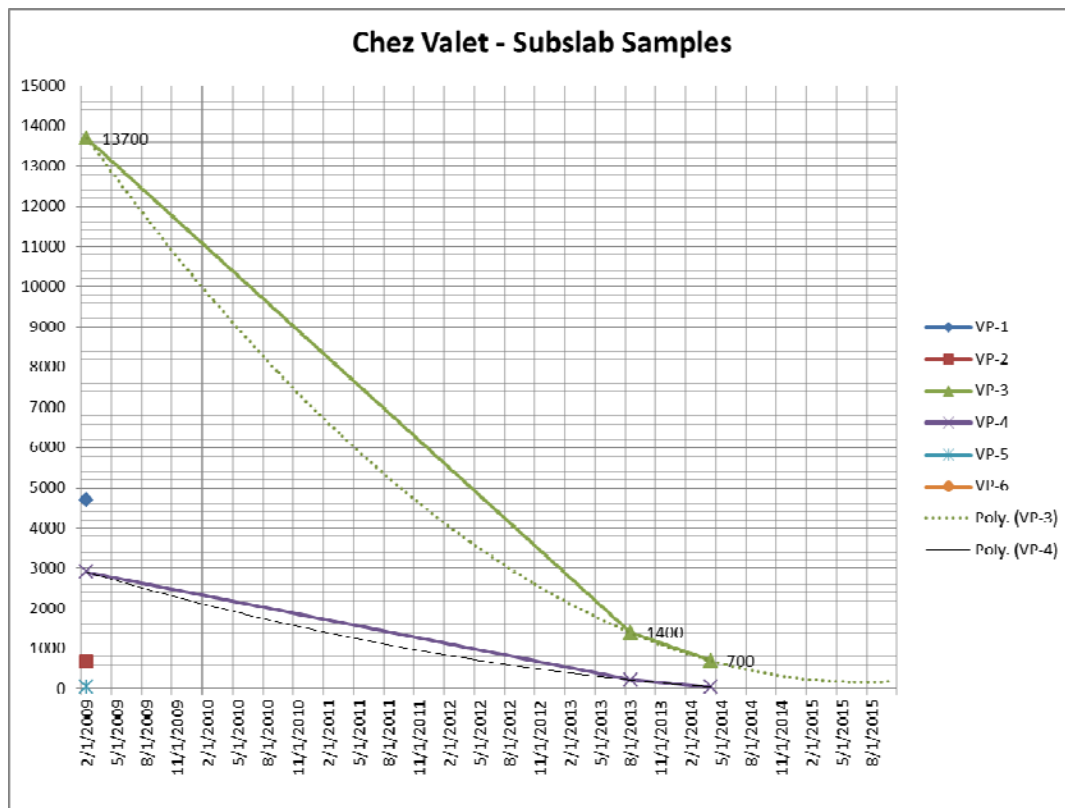
The site's , most recent (April 2014), highest recorded subslab vapor concentration is 700  $\mu\text{g}/\text{m}^3$  which is not far from the 100  $\mu\text{g}/\text{m}^3$  target value. For this reason the engineer recommended to continue operating the SVE/SSD through the 2014/2015 winter heating season, in an effort to further reduce the sub slab vapor concentrations. The basis for this recommendation is further represented in the following graph.

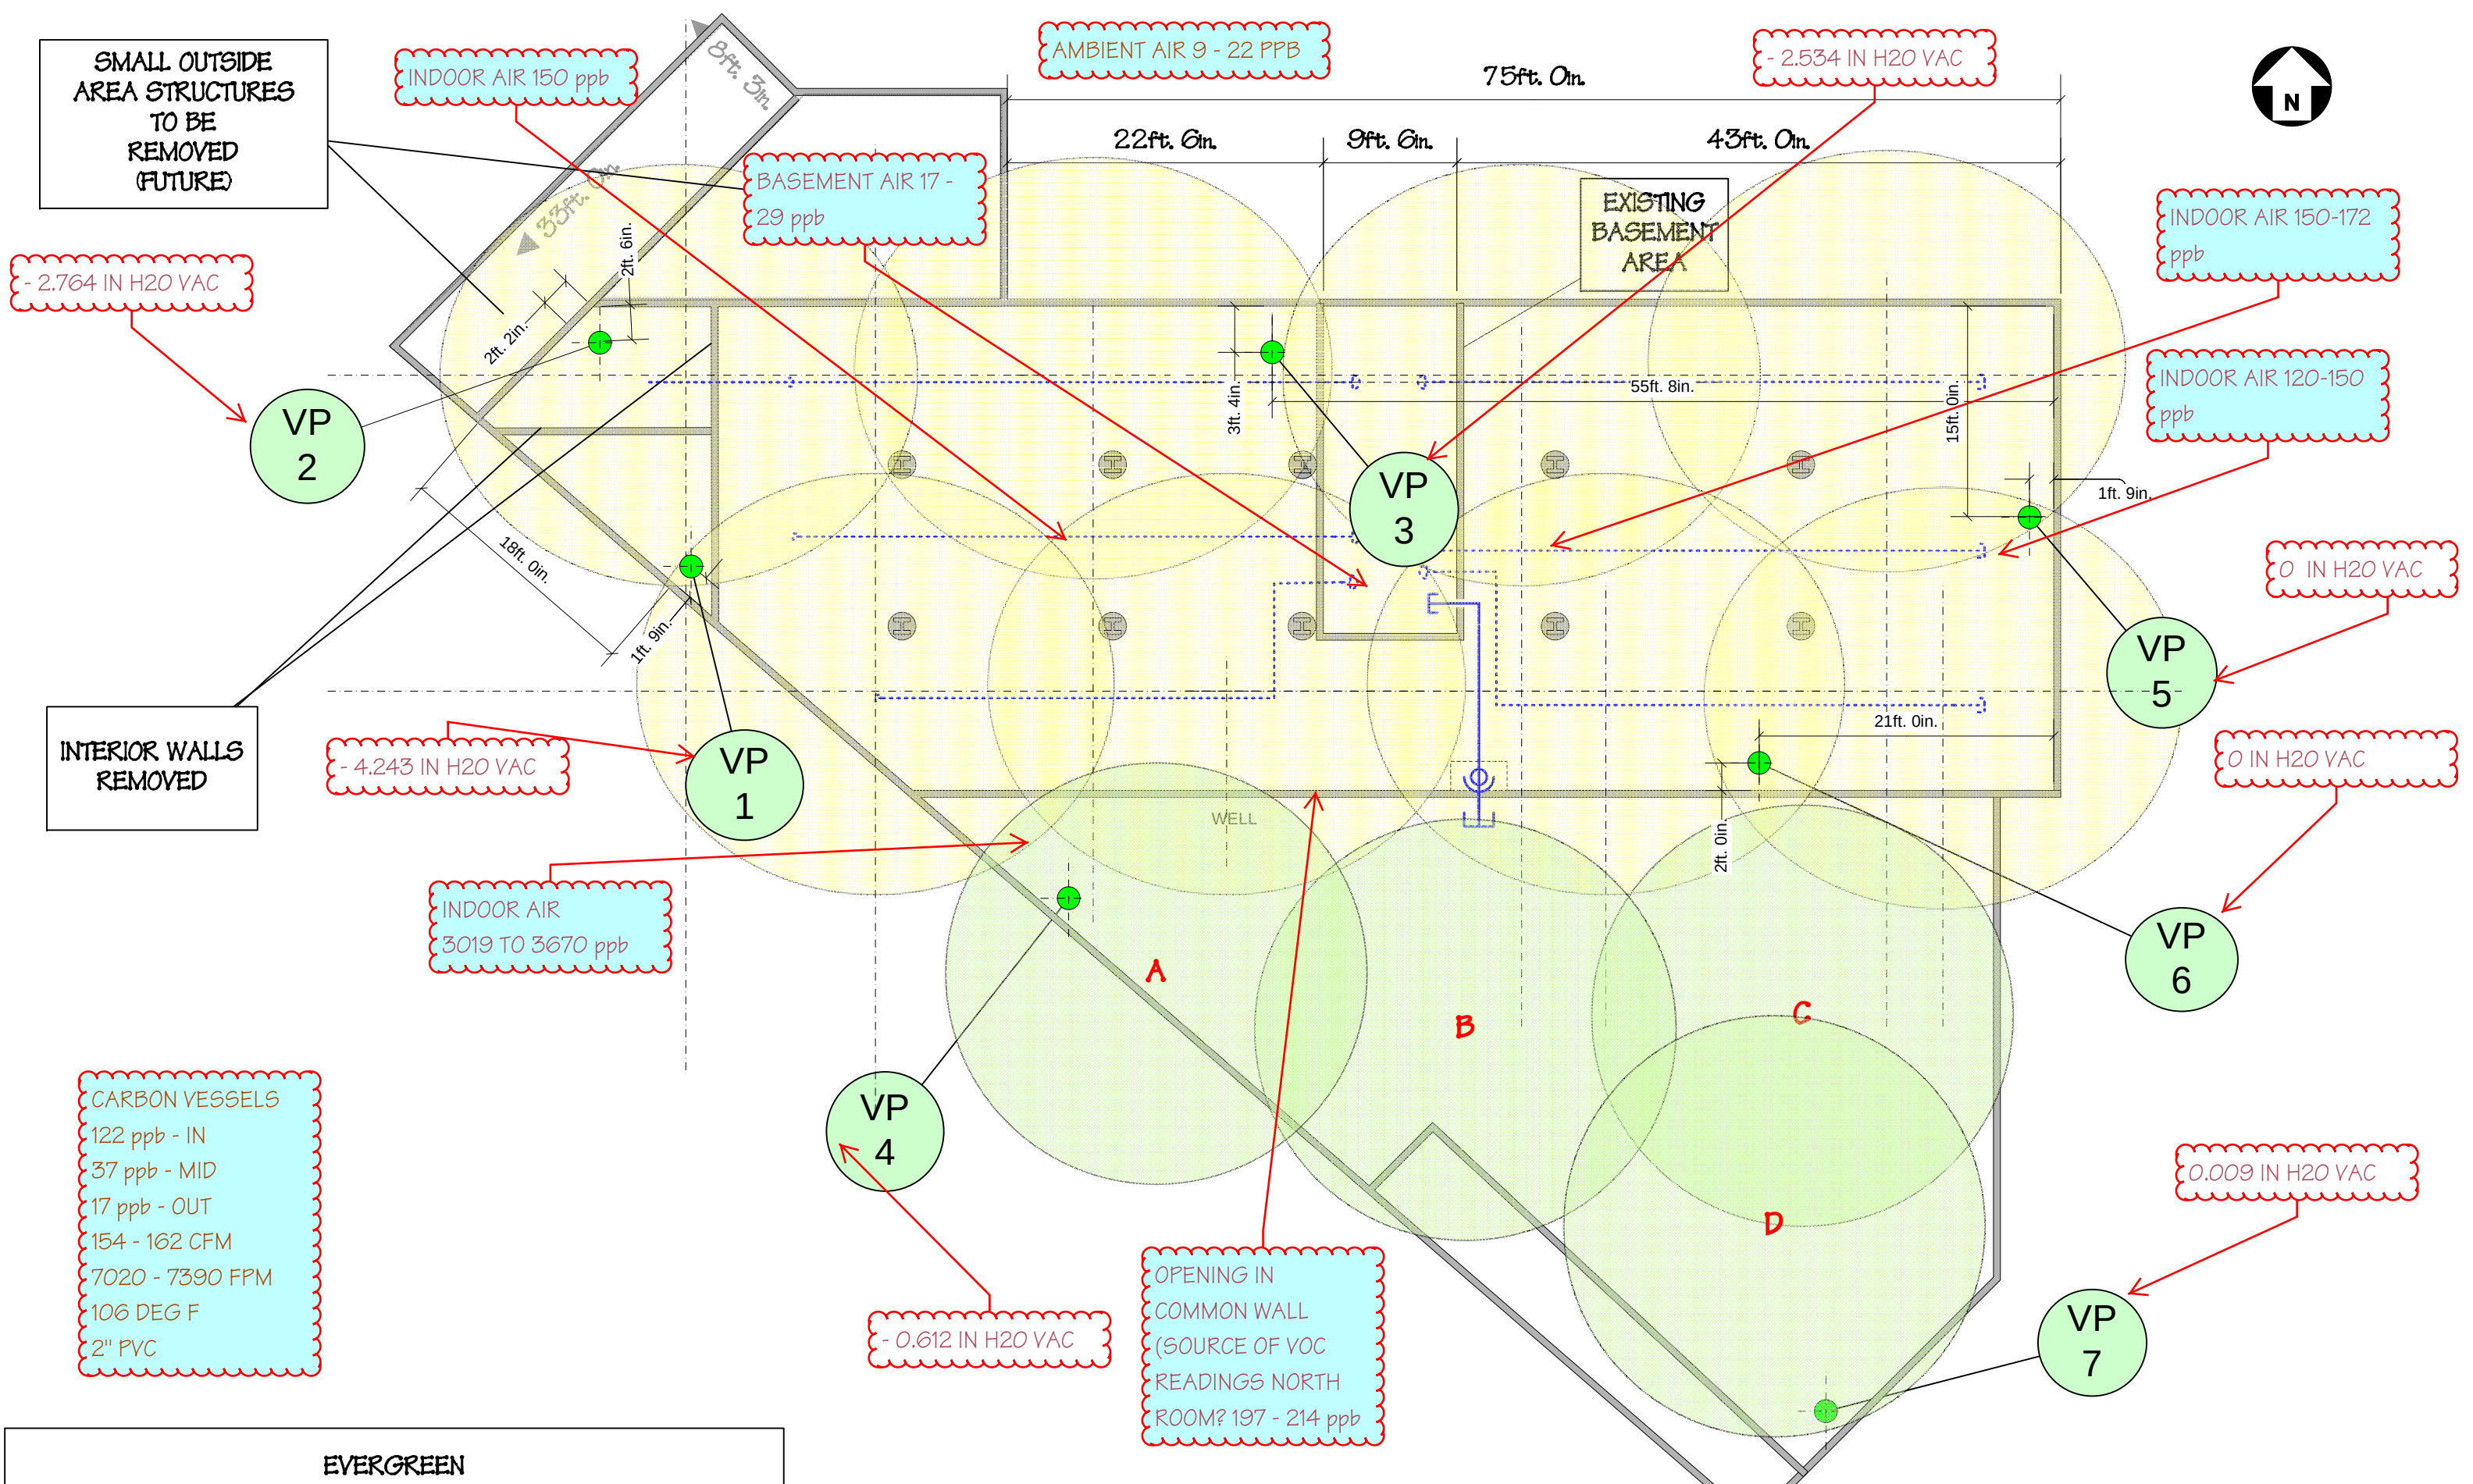
| DRAWN | ANDRIS LEDINS | | | EXISTING VAPOR POINT LOCATIONS | |

| PID Readings | | | | | |
|---|---|---|---|---|---|
| <p>Engineer and I collected several PID readings - detailed on attached figure. Valves 1 through 8 were closed on September 27th when the system was re-started.</p> | | | | | |

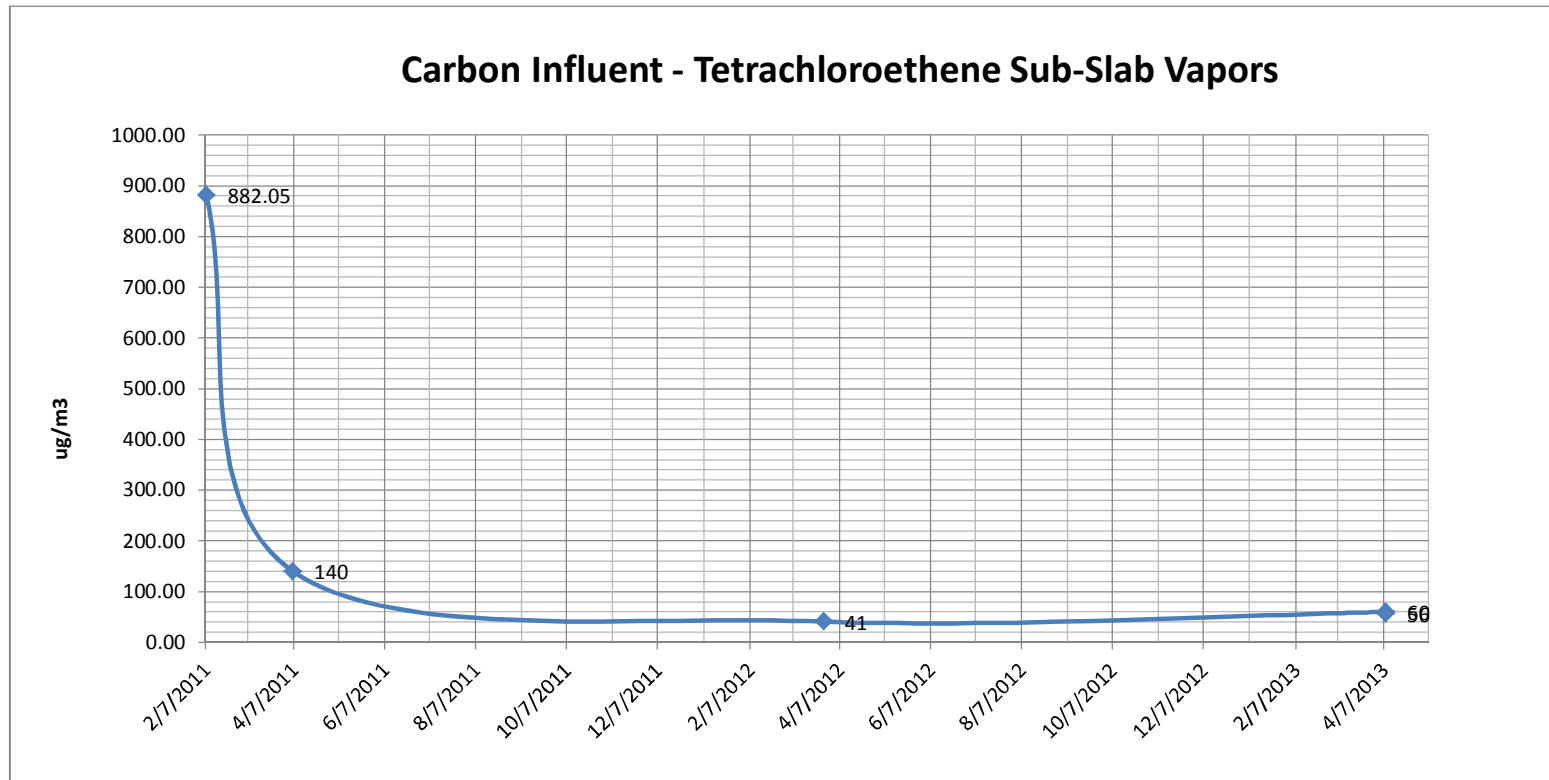
**Soil Vapor Extraction - Sub Slab Depressurization System VOC Sampling Results (Laboratory)**

| Compound Analyzed | Carbon Influent | | | | | | | |
|---|---|---|---|---|---|---|---|---|
| <b>Tetrachloroethene</b> | <b>882.05</b> | <b>140</b> | 4.6 | <b>41</b> | <b>60</b> | 6.8 | <b>56</b> | 4.5 |
