**DAILY OBSERVATION REPORT**

**Day: Tuesday Date: 7-14-09**

**Pendaflex Site Characterization****NYSDEC Site # 1-30-185****Contract # D-004368-35****Garden City, New York**

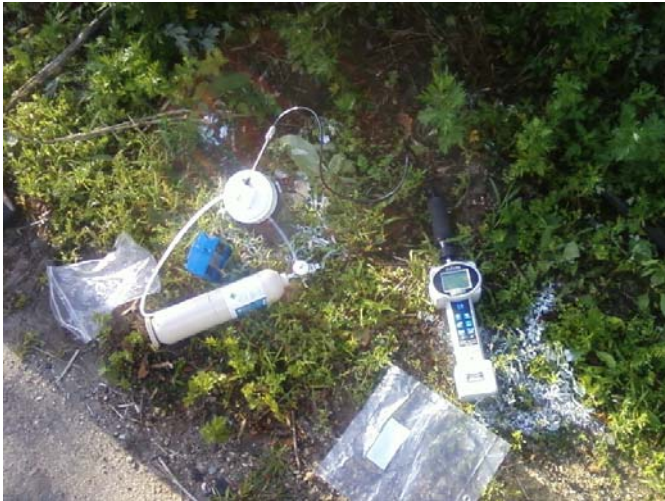
Arrival on site at 700am, when Aztech prepped for the day, leak test performed on 2 soil vapor points (SV04 and SV03) and other points purged.

Leak Test on soil vapor points.

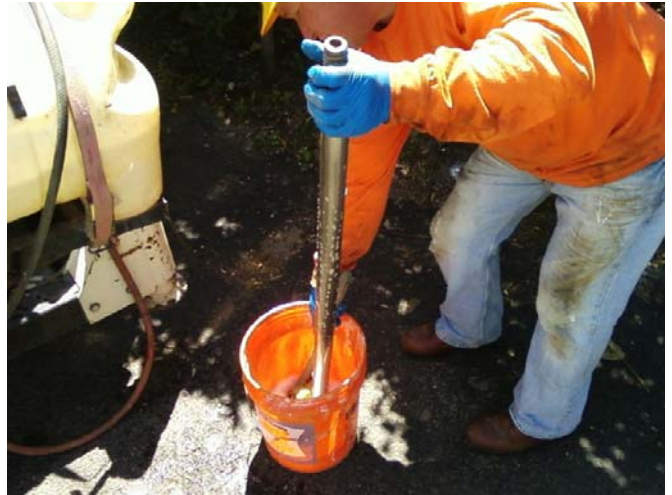
Decon procedure

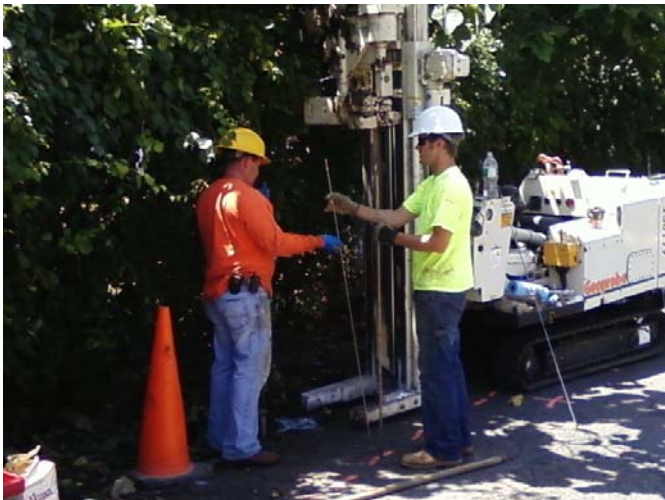
Collected additional subsurface soil samples to the water table. Once soil samples were collected and depth to water table was known, hydropunch points could be driven to depth, retracted to expose screen. Samples collected at 25-30 ft bgs for VOC, SVOC, Metals, Pesticides, PCBs initially at GP-01, GP-02, GP-04, GP-05.

Hydropunch install

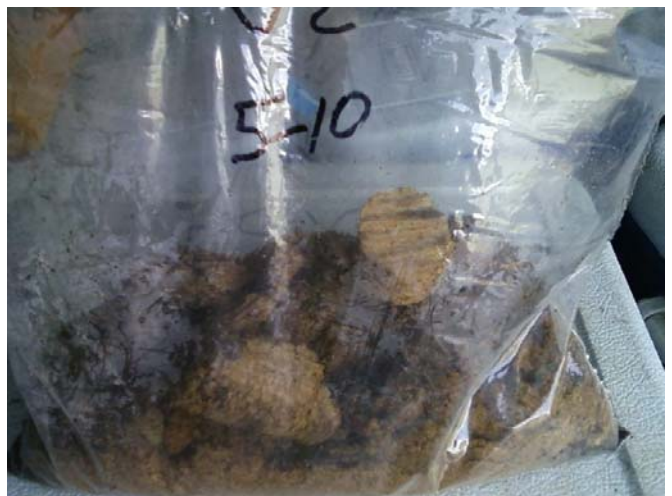
SBO2 – 5-10 ft. interval had wood (possible railroad tie) that was clearly soaked in creosol or other treatment. Skewed PID readings were thrown out. sample collected from next lower lever (10-15 ft)

Wood in SB02 sample(5-10 interval) – high PID reading

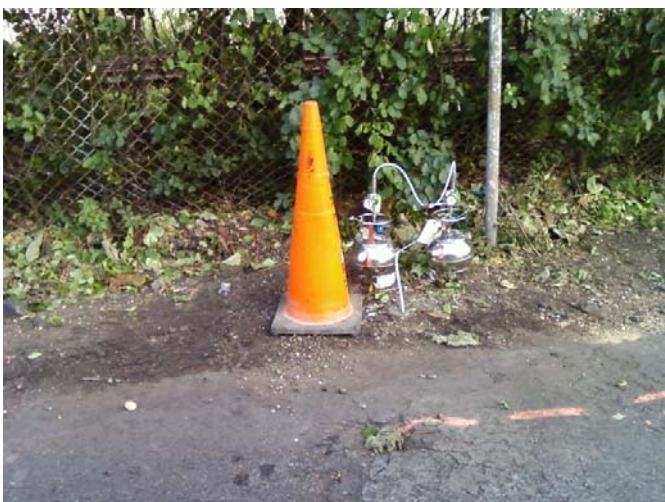
Soil Vapor Duplicate sample collection.

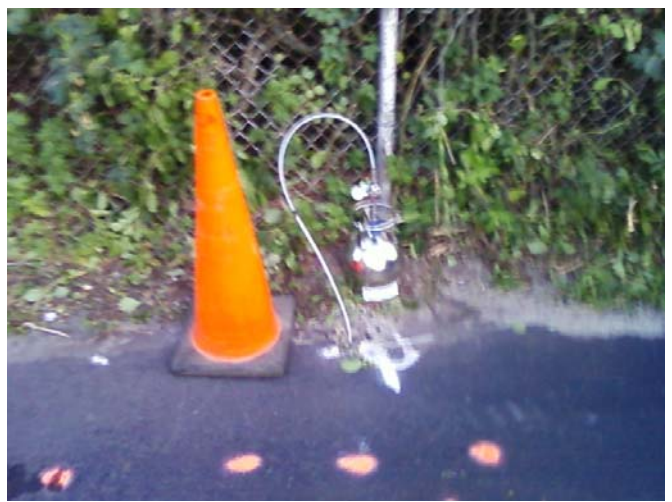
Following completion of soil and groundwater samples for the day, drillers left at 600pm. Soil vapor samples were then collected in the evening, so busy parking lot would not cause damage to SUMMA Canisters.

Soil vapor sample collection.
