DAILY OBSERVATION REPORT

Day: Thursday Date: 7-16-09

Pendaflex Site Characterization**NYSDEC Site # 1-30-185****Contract # D-004368-35****Garden City, New York**

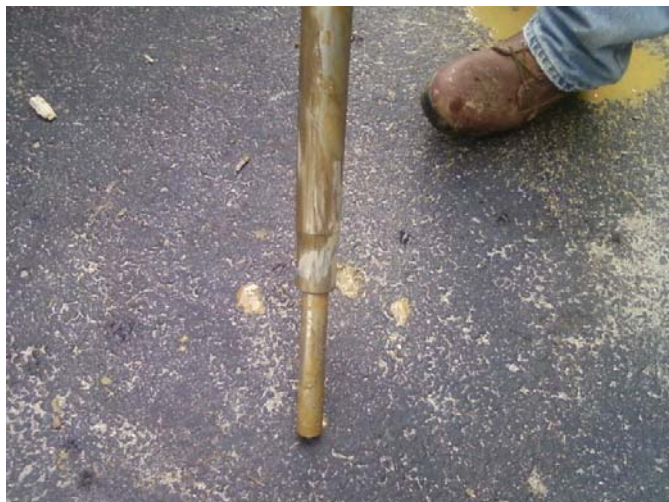
Arrival on site at 600am, began driving hydropunch sampler to 100 feet, exposed screen by pushing out with spaghetti rods extended into drive rods. Tubing equipped with check valve would not collect water as sand/silt infiltrated screen and clogged tubing and check valve repeatedly. Pulled out all rods and re-drove point to 100 feet with same results. Attempted to pull up to 85 feet and 70 ft and attempt collecting samples, with sand/silt still clogging tubing and screen. Attempted driving slotted rod to 40 feet to see if samples could be collected utilizing another technique, sand/silt infiltrated slotted rod at 40 feet. No Sample Collected.

Sand jamming hydropunch rod/screen

Based on discussions with driller/EA PM, proposed alternate method to collect samples where hydro punch was determined that could be attempted week of 7/20. Proposed method to drive 2 1/4" rods to depth and install 1-in pvc screen with sand pack, collect sample at depth with bailer and pull PVC out to desired depths. At request of EA PM along with DEC PM, attempted Hyrdopunch collection at GP07 (Up gradient point located in grass, not pavement).

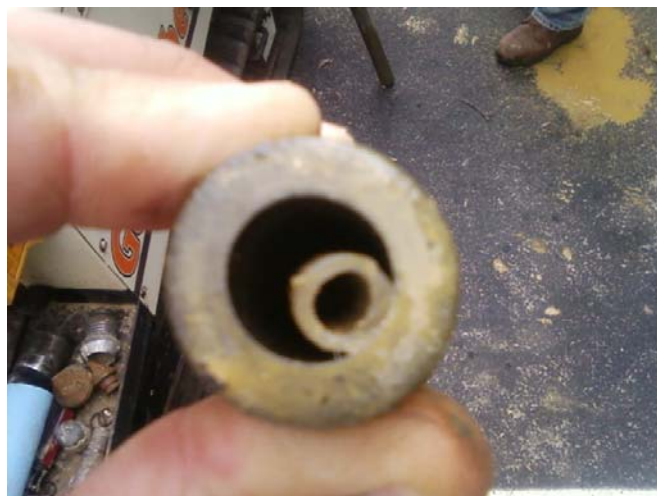
Sand and tubing stuck within drive rod

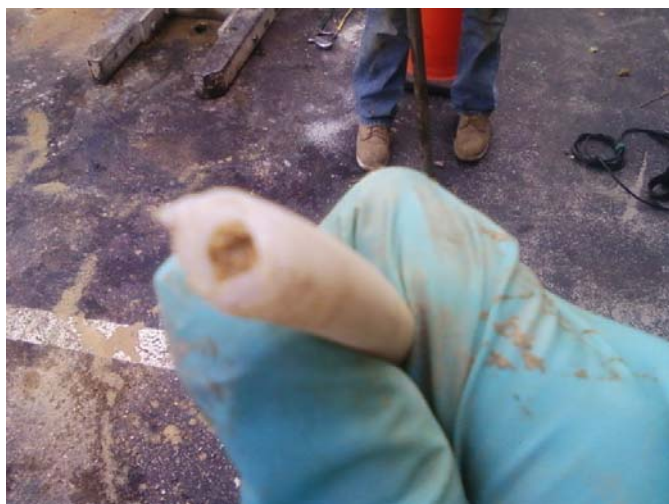
Sand clogging sample tubing

Driller thought that new check valves and a water pump may aid in sample collection, new valves and pump brought onsite by Pine Environmental (Driller Rental). Water acts by raising and lowering tubing automatically to draw water with use of check valve.

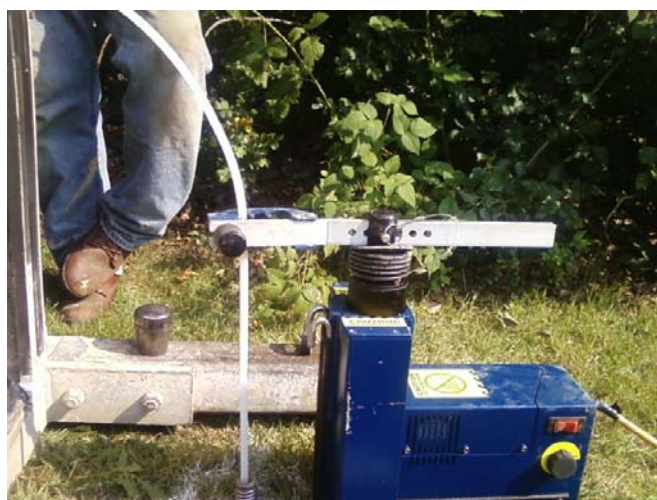
Waterra Pump used to collect water samples.
