**Re: Town of Islip
Blydenburgh Road Landfill Post Closure Monitoring**

TO: Anthony J. Varrichio, P.E., Chief Engineer
FROM: Fazil Rahaman, Acting Ground Water Treatment Plant Operator
DATE: August 9, 2017
RE: **Blydenburgh Rd. L.F. 2017 1st Half Semi-Annual Post Closure
Monitoring and Maintenance Report**

**POST CLOSURE MONITORING AND MAINTENANCE REPORT
FOR THE BLYDENBURGH ROAD M.S.W. LANDFILL
FORMER ASH MONOFILL
AND GROUNDWATER REMEDIATION**

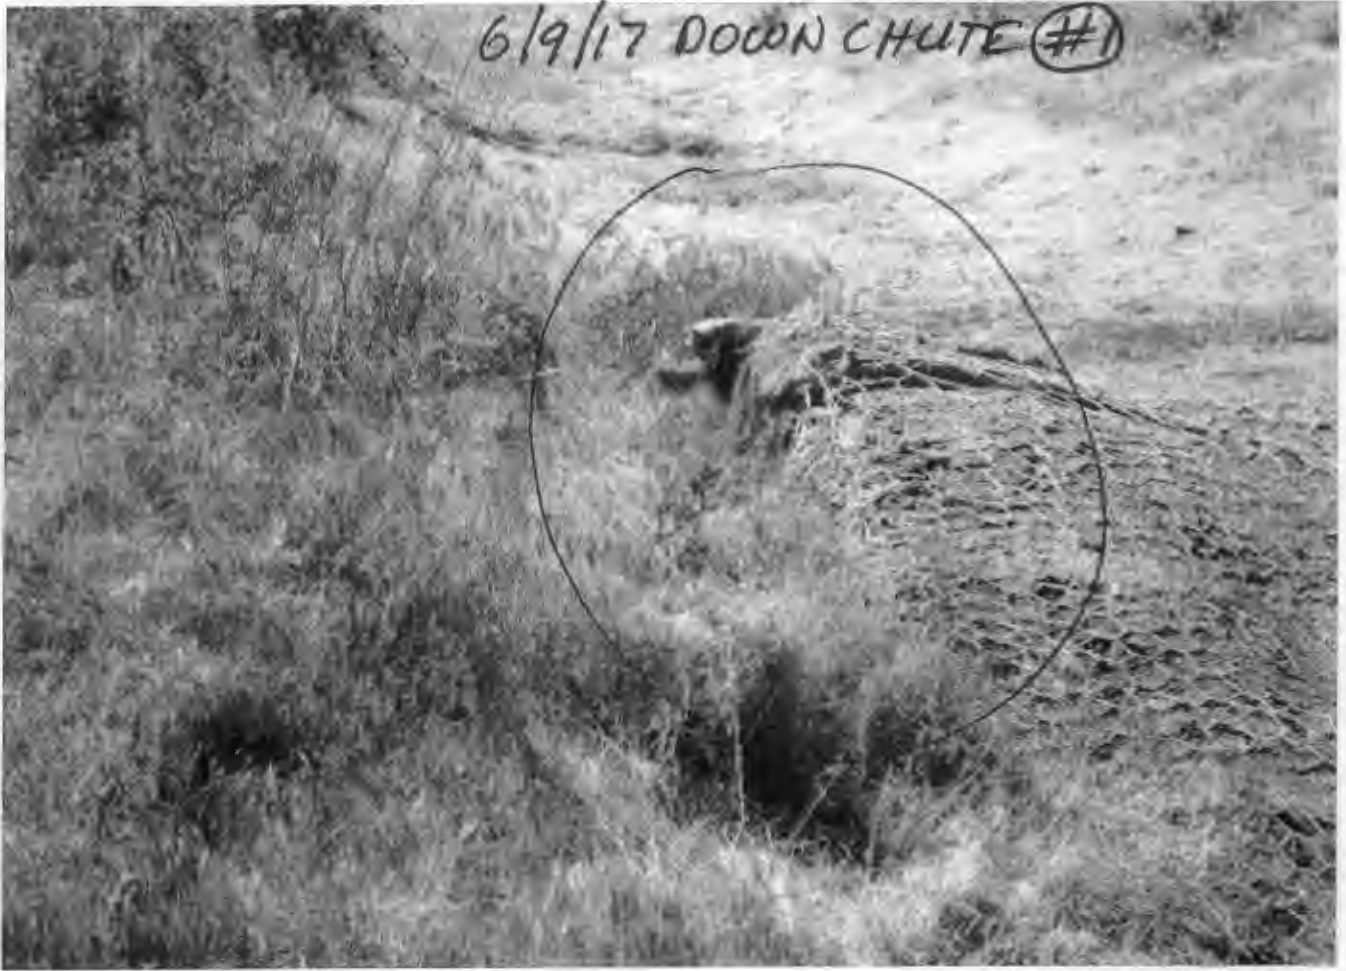
6/9/17 DOWN CHUTE (#1)

| ITEM | ADEQUATE (or YES) | NEEDS ATTENTION (or NO) | COMMENTS/ REMARKS <small>(Note if repair/maintenance is recommended and describe its location/extent)</small> |
|---|---|---|--|
| P-5 | ADEQUATE <input type="checkbox"/> YES <input type="checkbox"/> | NEEDS ATTENTION <input checked="" type="checkbox"/> NO <input type="checkbox"/> | Cracking/spalling, etc. just north of downchute #1, Photo attached. |

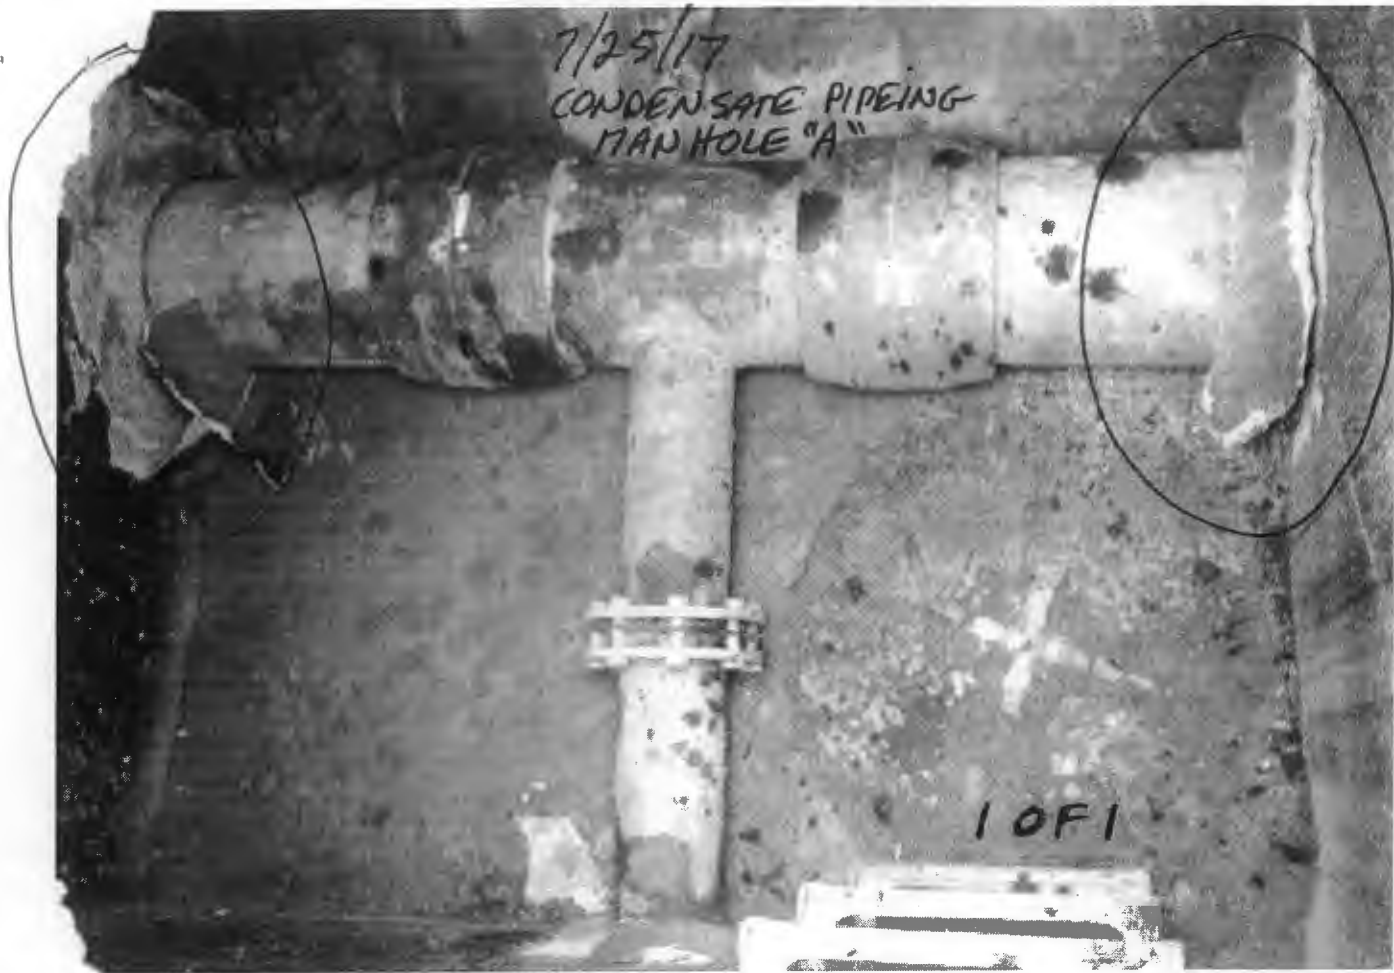
7/25/17
CONDENSATE PIPEING
MAN HOLE "A"

| ITEM | ADEQUATE (or YES) | REQUIRES MAINTENANCE | COMMENTS/ REMARKS <small>(Note if repair/maintenance is recommended and describe its location/extent)</small> |
|---|---|--|--|
| | | | Craig D., Landfill Personell Present for inspection of N.V.Structure. |

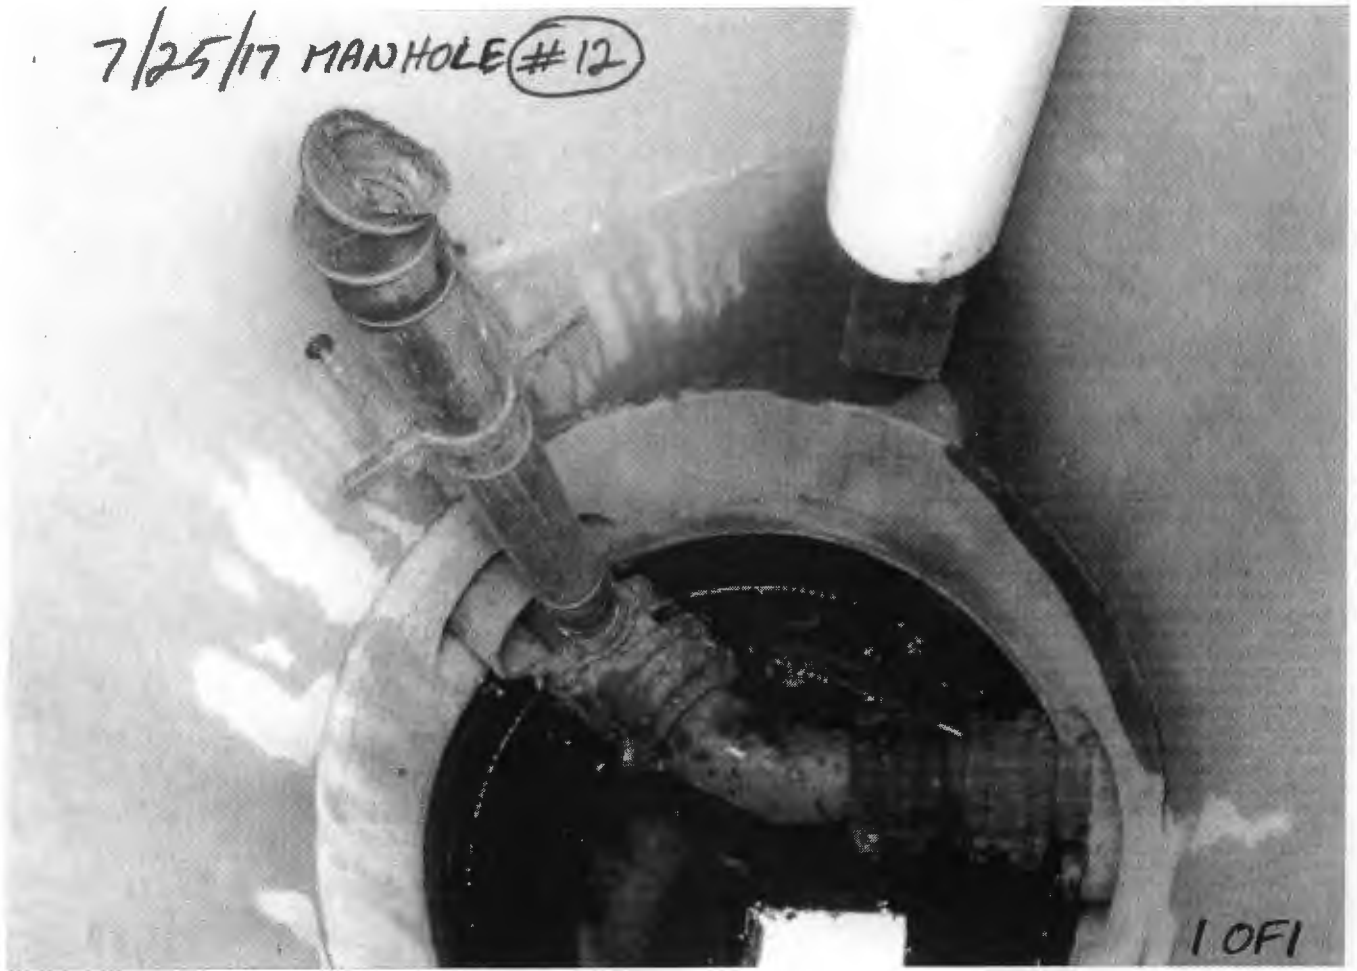
7/25/17 MANHOLE #12

| ITEM | ADEQUATE (or YES) | NEEDS ATTENTION (or NO) | COMMENTS/ REMARKS <small>(Note if repair/maintenance is recommended and describe its location/extent)</small> |
|---|---|---|--|
| Manhole No. 12 | ADEQUATE <input type="checkbox"/> YES <input type="checkbox"/> | NEEDS ATTENTION <input checked="" type="checkbox"/> NO <input type="checkbox"/> | Repair Vent. Will be addressed in closure of C&D, Photo attached. |
