**Re: Town of Islip
Blydenburgh Road Landfill 2018 1st Half Semi-Annual Post Closure Monitoring and
Maintenance Report**

ASH MONOFILL INSPECTION REPORT

**POST CLOSURE MONITORING AND MAINTENANCE REPORT
FOR THE BLYDENBURGH ROAD M.S.W. LANDFILL
FORMER ASH MONOFILL
AND GROUNDWATER REMEDIATION**

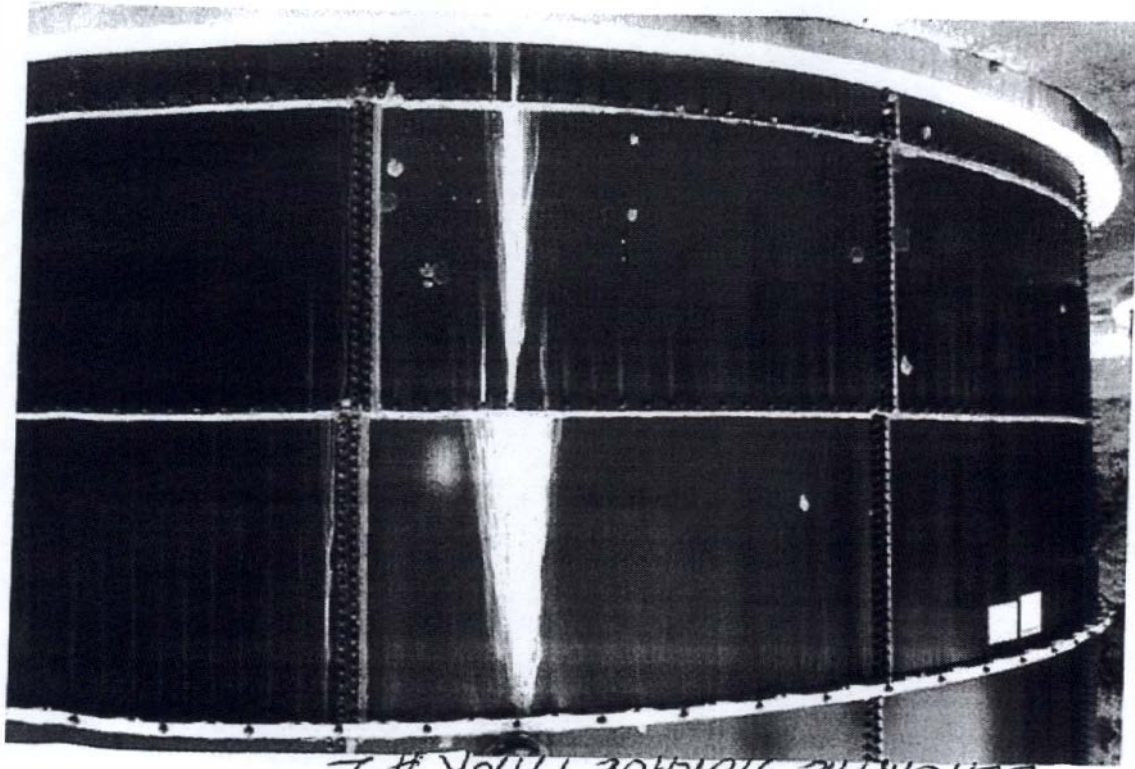
LEACHATE STORAGE TANK #2

2.0 LEACHATE STORAGE TANKS			
Leachate Storage Tank No. 1 Level/Condition	ADEQUATE <input checked="" type="checkbox"/> YES <input type="checkbox"/>	NEEDS ATTENTION <input type="checkbox"/> NO <input type="checkbox"/>	11 Feet.
Leachate Storage Tank No. 2 Level/Condition	ADEQUATE <input type="checkbox"/> YES <input type="checkbox"/>	NEEDS ATTENTION <input checked="" type="checkbox"/> NO <input type="checkbox"/>	Not ck., No sample tube & Tank Stain on west side Photo attached.
Leachate Storage Tank No. 3 Level/Condition	ADEQUATE <input checked="" type="checkbox"/> YES <input type="checkbox"/>	NEEDS ATTENTION <input type="checkbox"/> NO <input type="checkbox"/>	11 Feet.
Leachate Storage Tank No. 4 Level/Condition	ADEQUATE <input checked="" type="checkbox"/> YES <input type="checkbox"/>	NEEDS ATTENTION <input type="checkbox"/> NO <input type="checkbox"/>	11 Feet.
Cathodic Protection System Operation	ADEQUATE <input type="checkbox"/> YES <input type="checkbox"/>	NEEDS ATTENTION <input type="checkbox"/> NO <input type="checkbox"/>	Not inspected. Due to product containment.
