**Re: Town of Islip  
Blydenburgh Road Landfill 2018 2<sup>nd</sup> Half Semi-Annual Post Closure Monitoring  
and Maintenance Report**

**RE:** **Blydenburgh Rd. L.F. 2018 2nd Half Semi-Annual Post Closure Monitoring and Maintenance Report**

**POST CLOSURE MONITORING AND MAINTENANCE REPORT  
FOR THE BLYDENBURGH ROAD M.S.W. LANDFILL  
FORMER ASH MONOFILL  
AND GROUNDWATER REMEDIATION**

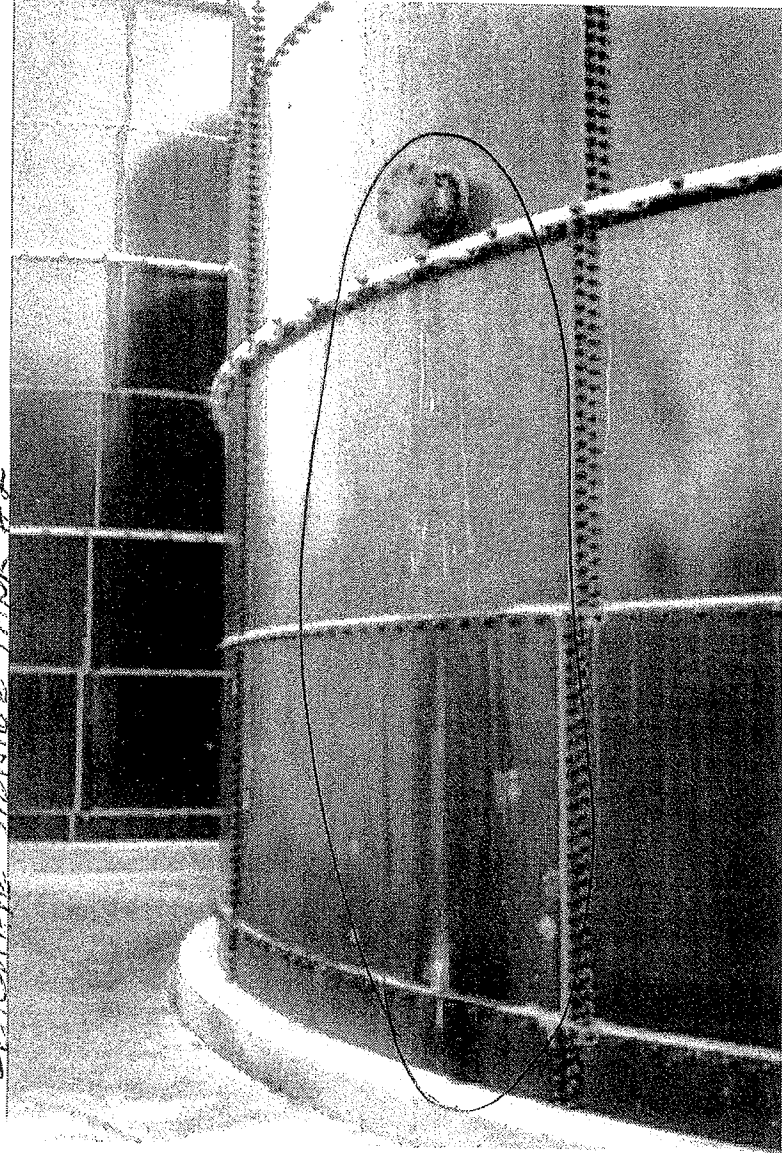
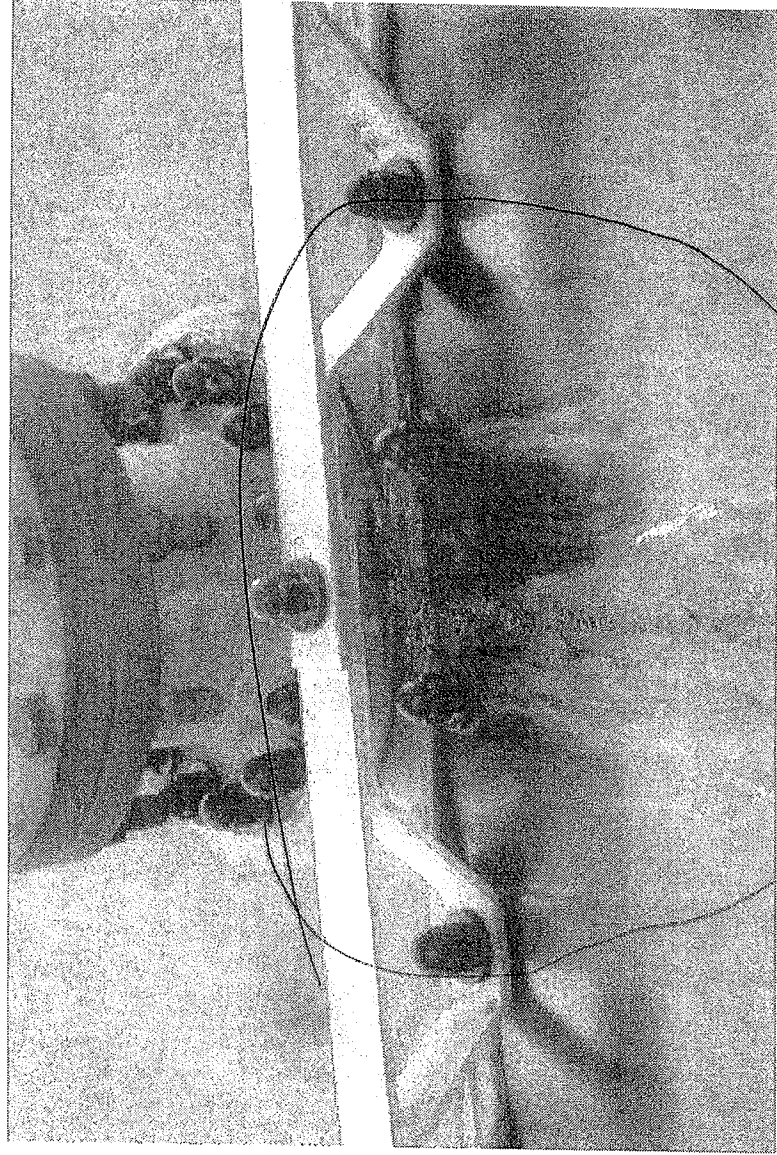
LEACHATE STORAGE TANK #2

19 Feet, Leak concerns on west side below blind flange. Photo att.
