RE: Blydenburgh Rd. L.F. 2019 2nd Half Semi-Annual Post Closure
Monitoring and Maintenance Report

2019, 2nd Half
POST CLOSURE MONITORING AND MAINTENANCE REPORT
FOR THE BLYDENBURGH ROAD M.S.W. LANDFILL,
FORMER ASH MONOFILL
AND
GROUNDWATER REMEDIATION FACILITY

**FIELD INSPECTION FORM NO. 1 FOR
MSW LANDFILL/ ASH MONOFILL COVERS AND SURFACE WATER MANAGEMENT SYSTEM**

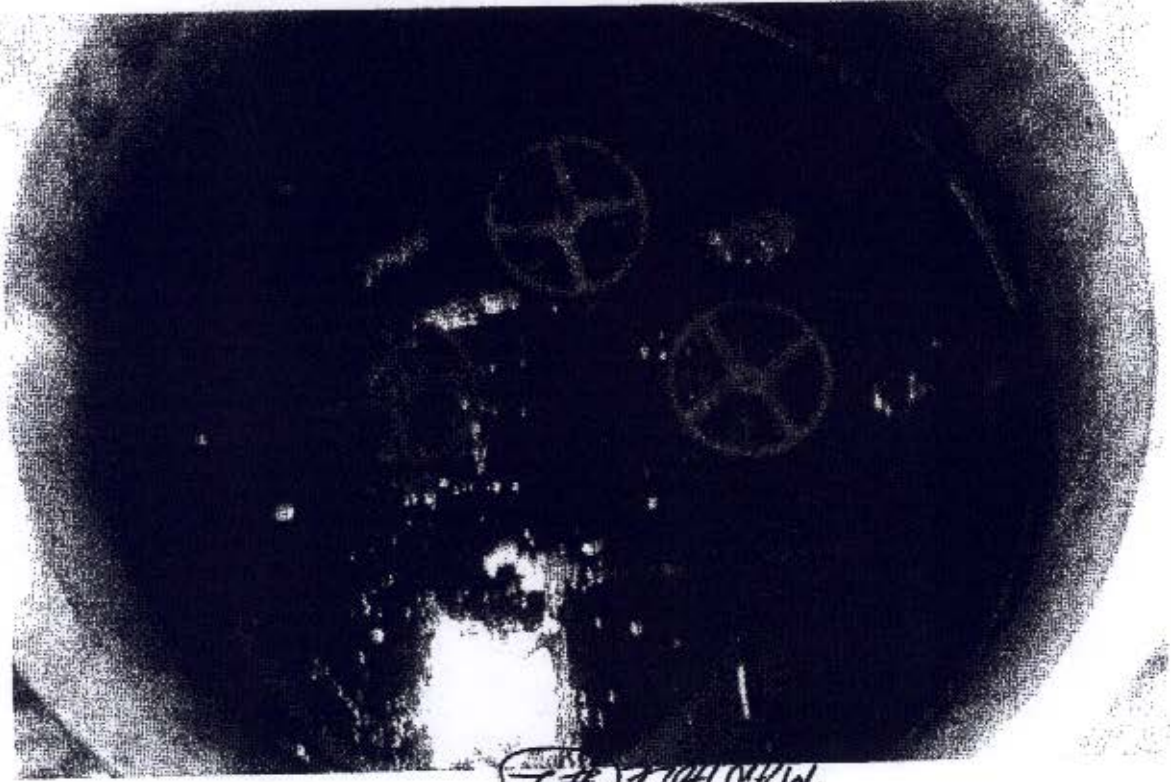
3/19/20
MANHOLE #2

1.0 MUNICIPAL SOLID WASTE LANDFILL (Cont'd)			
1.3 Manholes and Piping (both primary and secondary systems)			
Manholes No. 2 Condition	ADEQUATE <input type="checkbox"/> YES <input type="checkbox"/>	NEEDS ATTENTION <input checked="" type="checkbox"/> NO <input type="checkbox"/>	Piping submerged by liquid, Photo attached.
Manholes No. 3 Condition	ADEQUATE <input type="checkbox"/> YES <input type="checkbox"/>	NEEDS ATTENTION <input checked="" type="checkbox"/> NO <input type="checkbox"/>	Reconnect band, Photo attached.
Manholes No. 4 Condition	ADEQUATE <input checked="" type="checkbox"/> YES <input type="checkbox"/>	NEEDS ATTENTION <input type="checkbox"/> NO <input type="checkbox"/>	
Manholes No. 5 Condition	ADEQUATE <input type="checkbox"/> YES <input type="checkbox"/>	NEEDS ATTENTION <input checked="" type="checkbox"/> NO <input type="checkbox"/>	Reconnect band and re paint No. 5, Photo attached.
