RE: **Blydenburgh Rd. L.F. 2020 1st Half Semi-Annual Post Closure
Monitoring and Maintenance Report**

POST CLOSURE MONITORING AND MAINTENANCE REPORT

FOR THE BLYDENBURGH ROAD M.S.W. LANDFILL

GROUNDWATER REMEDIATION FACILITY

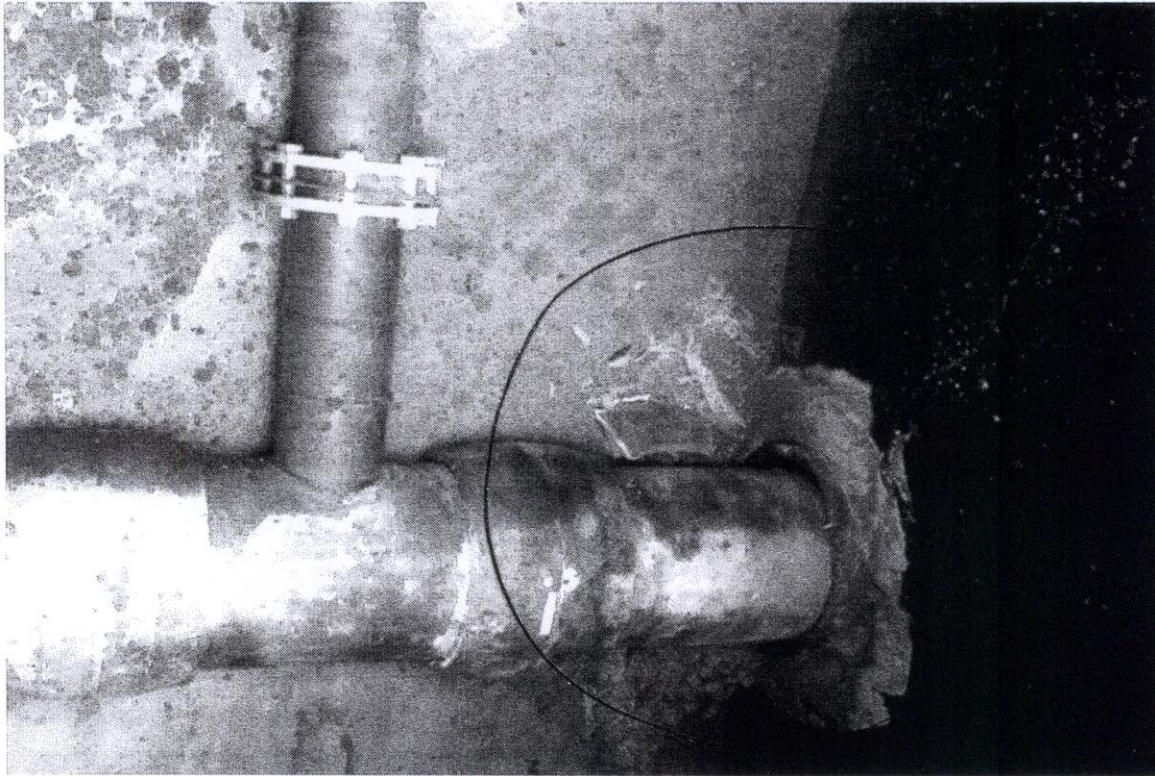
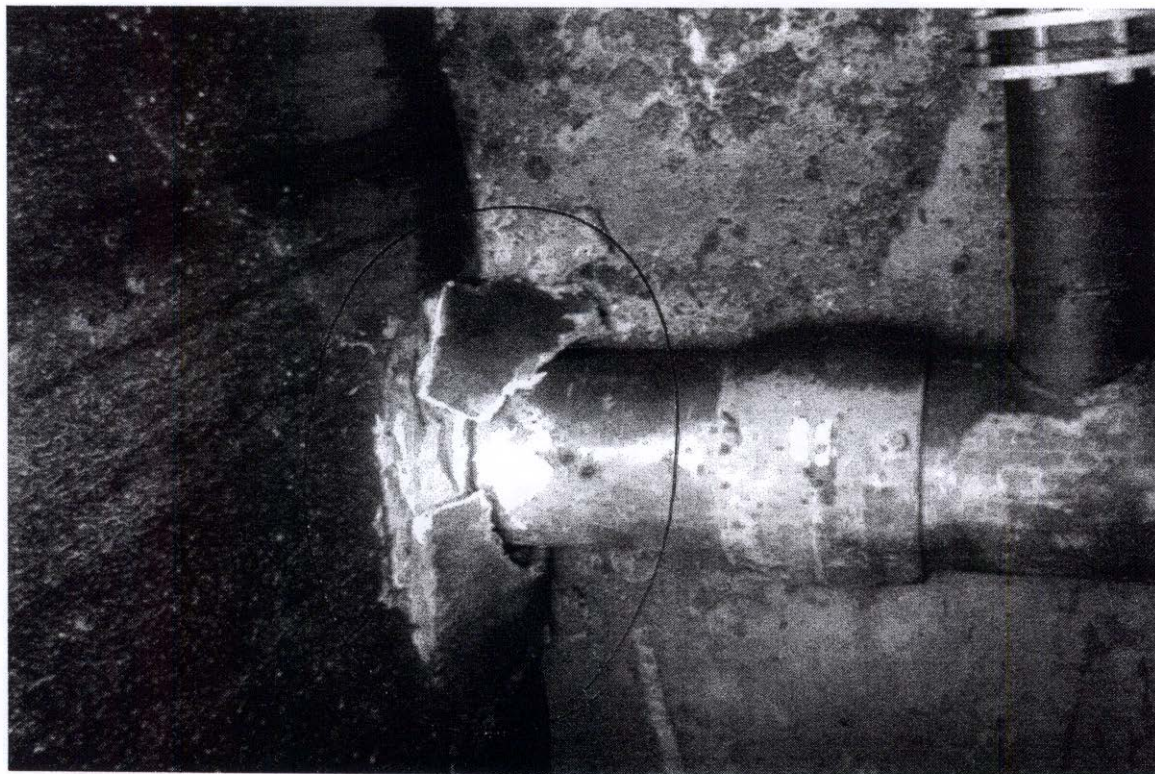
CONDENSATE PIPING HANDHOLE "A"

Comments	Craig D., L.F. Personell Present for inspection of N.V.Structure.		
	9/2 Chris D., L.F. Personell Present for valve`s, repaired inspection.		
	RE: To previous reports.

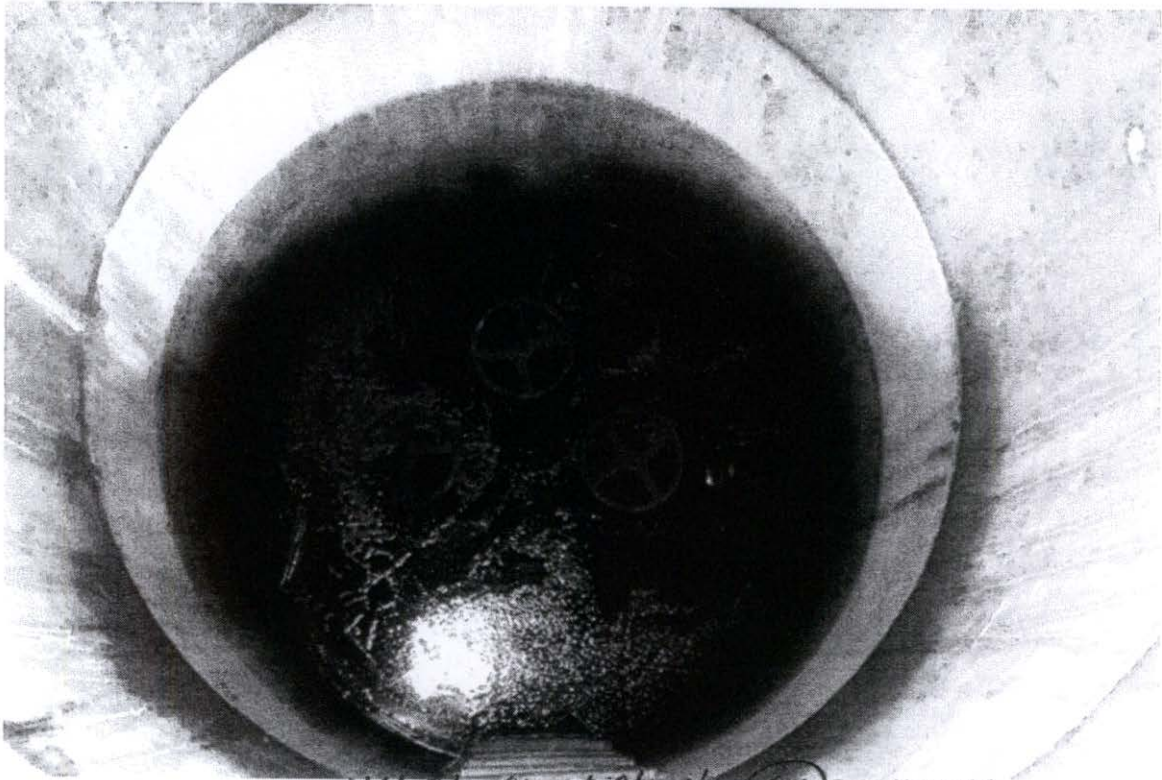
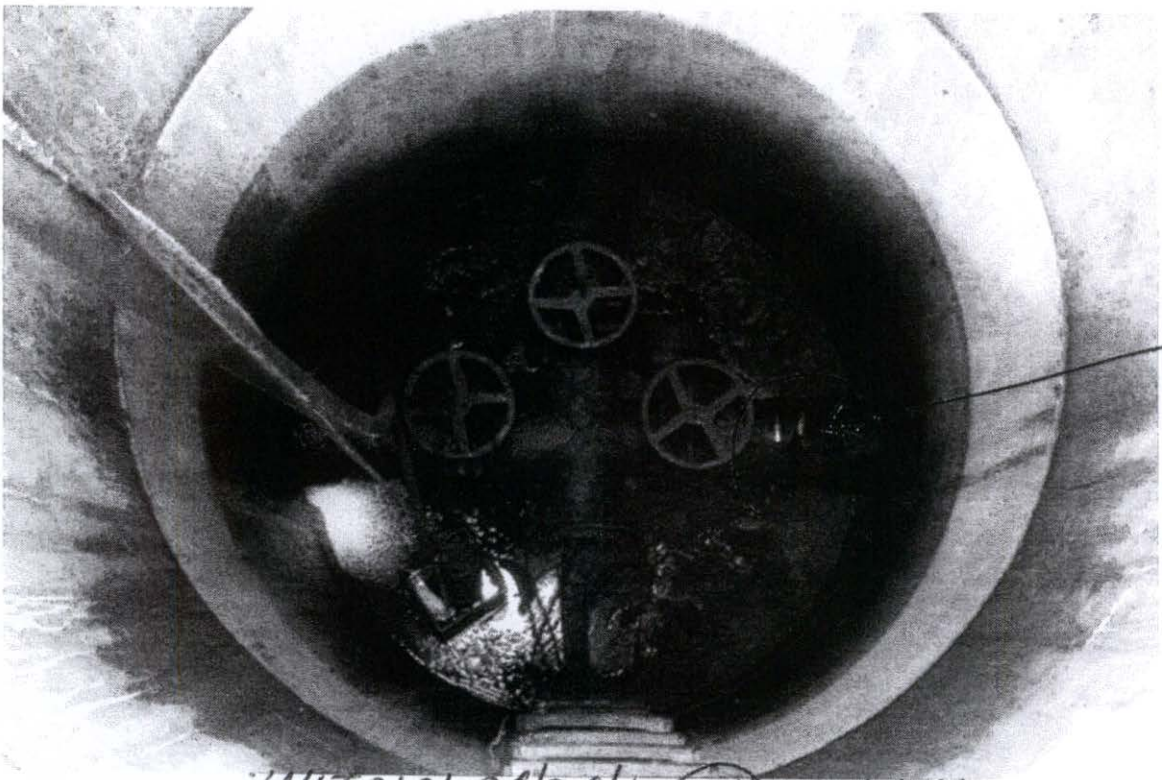
MANHOLE #2 7/24/20 - 12:45 PM

Manholes No. 2 Condition	ADEQUATE <input type="checkbox"/> YES <input type="checkbox"/>	NEEDS ATTENTION <input checked="" type="checkbox"/> NO <input type="checkbox"/>	Reconnect band, 2 Photo attached.
Manholes No. 3 Condition	ADEQUATE <input checked="" type="checkbox"/> YES <input type="checkbox"/>	NEEDS ATTENTION <input type="checkbox"/> NO <input type="checkbox"/>	
Manholes No. 4 Condition	ADEQUATE <input checked="" type="checkbox"/> YES <input type="checkbox"/>	NEEDS ATTENTION <input type="checkbox"/> NO <input type="checkbox"/>	
Manholes No. 5 Condition	ADEQUATE <input checked="" type="checkbox"/> YES <input type="checkbox"/>	NEEDS ATTENTION <input type="checkbox"/> NO <input type="checkbox"/>	
Manholes No. 6 Condition	ADEQUATE <input checked="" type="checkbox"/> YES <input type="checkbox"/>	NEEDS ATTENTION <input type="checkbox"/> NO <input type="checkbox"/>	
Manholes No. 7 Condition	ADEQUATE <input checked="" type="checkbox"/> YES <input type="checkbox"/>	NEEDS ATTENTION <input type="checkbox"/> NO <input type="checkbox"/>
