**Re: Town of Islip
Blydenburgh Road Landfill 2020 2nd Half Semi-Annual Post Closure Monitoring
and Maintenance Report**

TO: Anthony J. Varrichio, P.E., Chief Engineer
FROM: Fazil Rahaman, Acting Ground Water Treatment Plant Operator
DATE: April 9th, 2021
RE: **Blydenburgh Rd. L.F. 2020 2nd Half Semi-Annual Post Closure
Monitoring and Maintenance Report**

POST CLOSURE MONITORING AND MAINTENANCE REPORT

FOR THE BLYDENBURGH ROAD M.S.W. LANDFILL

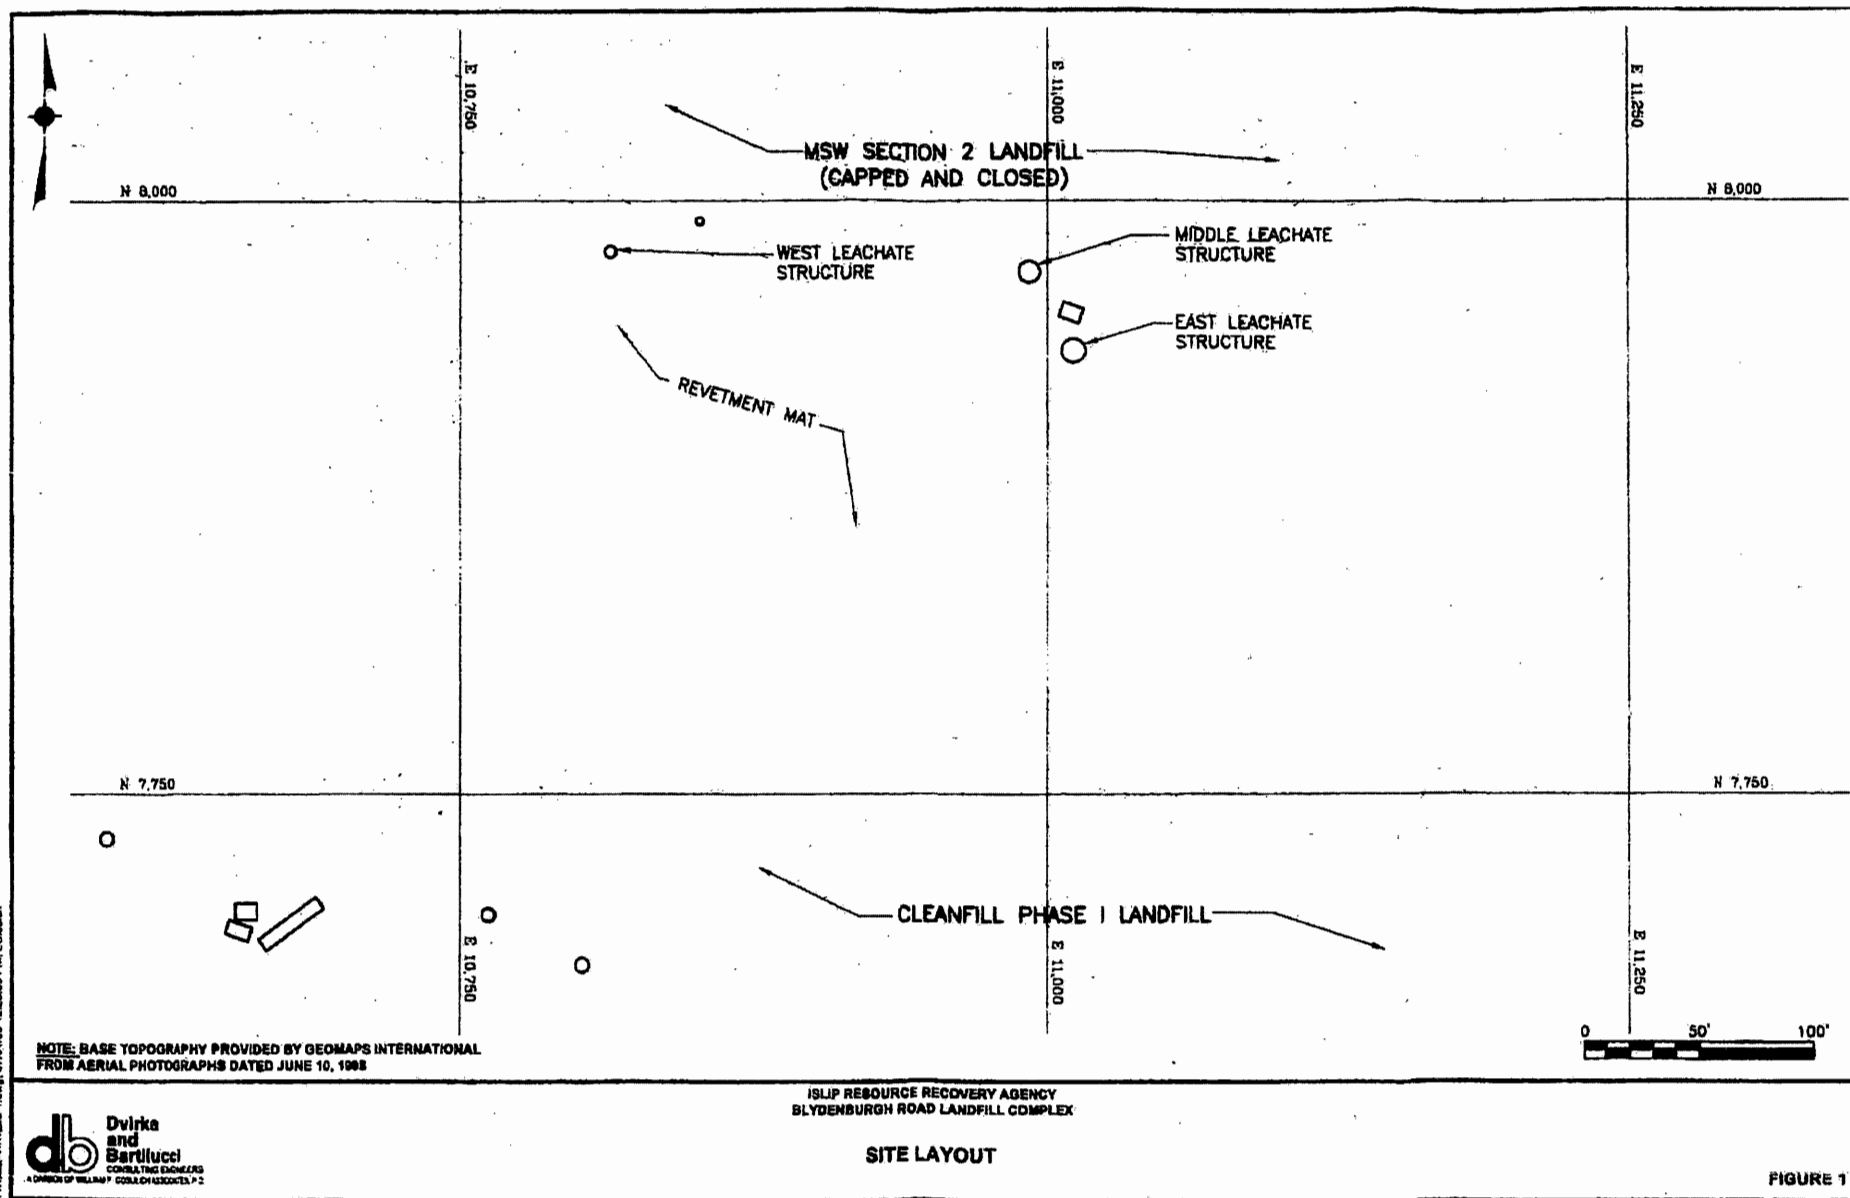
Note : No action to be taken by operation personnel.
with landfill settlement the protruding ring
should be removed
