Re: Sonia Road Landfill Remediation Program
Site Registry No. 152013
Post Closure Program

**SONIA ROAD LANDFILL
WEST BRENTWOOD, NEW YORK
SITE REGISTRY NO. 152013**

**POST CLOSURE
MONITORING AND MAINTENANCE REPORT**

**JANUARY THROUGH JUNE
2011**

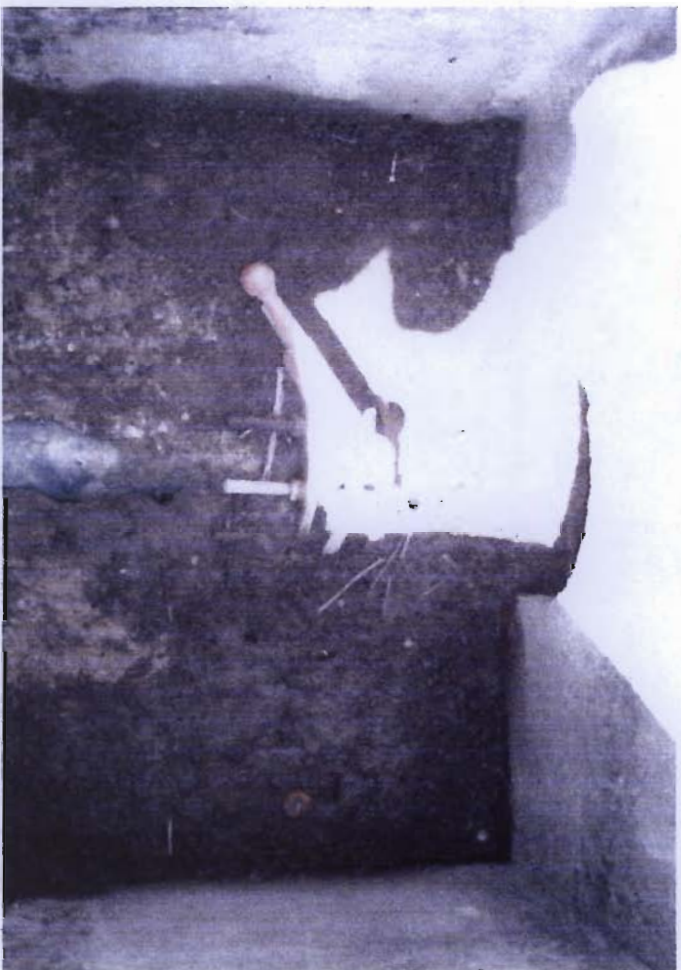
G.V. # 11

ITEM I.D.	PROBLEM CODE	PRIORITY CODE	PHOTO TAKEN	COMMENTS
LFG Recovery Wells / Valve Vaults				<u>SEE PG. 14</u>
<u>11</u>	<u>OK</u>	<u>3</u>	<u>(Y) N #</u>	<u>ON GOING, (CORRECTED)</u>
<u>12</u>	<u>0</u>	<u>3</u>	<u>(Y) N #</u>	<u>SAME</u>
<u>18</u>	<u>OK</u>	<u>3</u>	<u>(Y) N #</u>	<u>SAME</u>
			Y / N #	
LFG Collection Wells (GC1 - GC16)				<u>SEE PG. 14</u>
<u>5</u>	<u>0</u>	<u>MONITORING</u>	<u>Y (N) #</u>	<u>SAND/DIRT PERCOLATING UP-WARD</u>
			Y / N #	<u>THROUGH SUB-OPENING</u>
			Y / N #	
			Y / N #
