**DAILY INSPECTION REPORT - No. 211**  
**(Lawrence Aviation), Site No. 152016**

Page 1 of 8  
 Date: 02/05/2025

| <b>Site Location: NYSDEC Lawrence Aviation, Port Jefferson Station, NY</b> | | | | | |

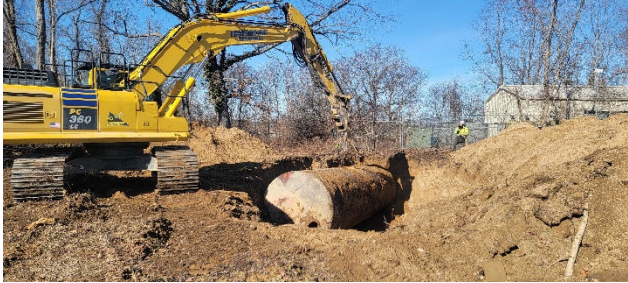
| Site Photographs (Descriptions Below) | |
|---|---|
| Photo 1 – Excavation of UST-1 cooling water tank behind former electro-melt building. | Photo 2- Soil conditions after UST-1 was pulled. Bottom samples were collected. |

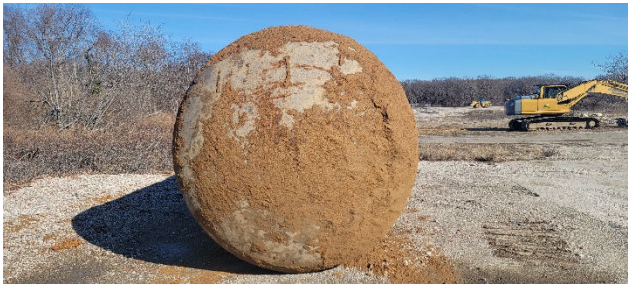
| Site Photographs (Descriptions Below) | |
|---|---|
| Photo 3 – 33x8ft single steel wall UST looking at the western end cap. | Photo 4- UST-1 top of the tank. |

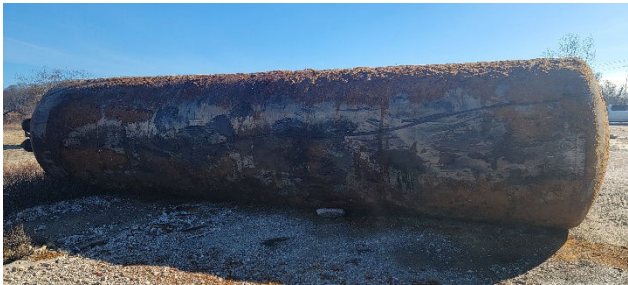
| Site Photographs (Descriptions Below) | |
|---|---|
| Photo 5 – UST-1 bottom of the tank. No holes or pitting observed. | Photo 6 – Retrieval of “pushed in” temporary fencing from P-1. |

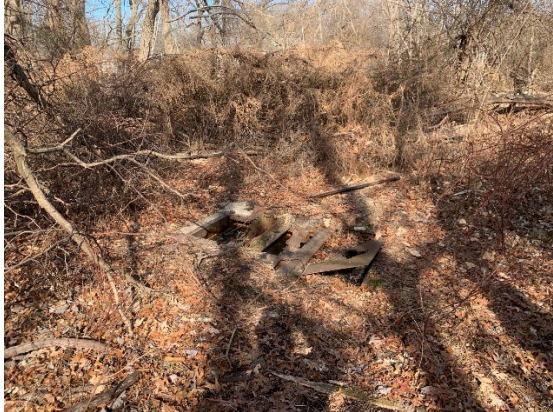
| <p>Photo 7 – Pit (anomaly) structure observed in the wooded area north of DW-2, 2A and 2C.</p> | <p>Photo 8 – Outfall-02 discovered south of the former hazardous waste storage building. (View facing north).</p> |
