State Superfund OM&M Sites on Long Island

Trip date, 5/25-26/2005

Photos with Notes

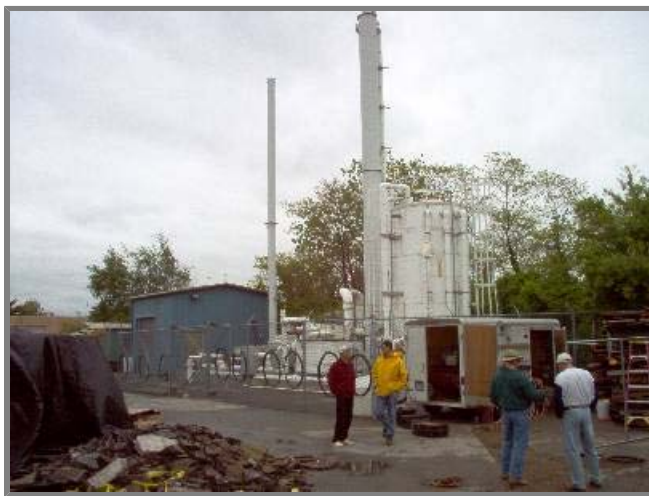
Photo left. View of USEPA's remedial system in the background. We will own the white towers and piping plus the treatment plant building. EarthTec, an EPA contractor, owns the yellow trailer, and at the time of the visit was performing bioremediation focused on a "hot spot."

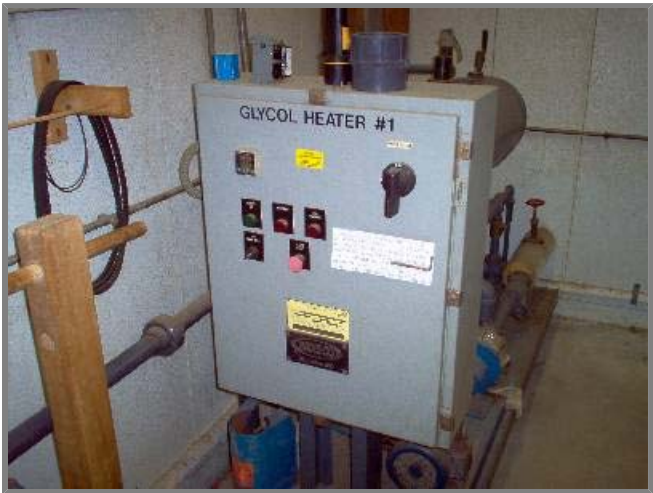
Photo left. View of the "glycol heater." This unit warms the air discharging from the airstripper before it enters the carbon filters.

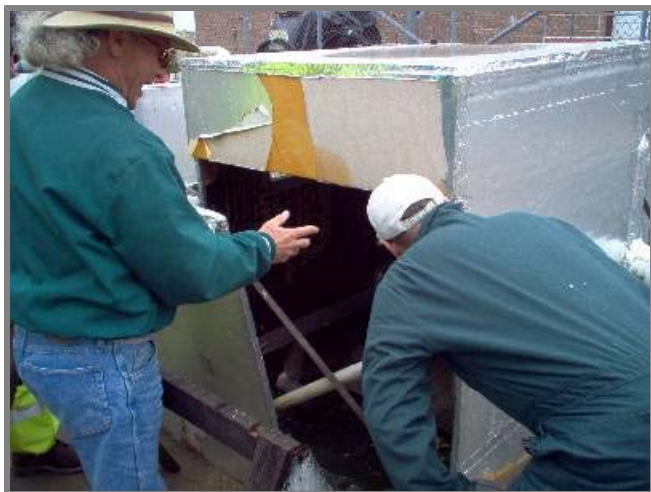
Photo left. Looking into one of the insulated boxes in the treatment compound. Kenn has thoroughly insulated all outdoor piping and pumps that might be prone to freezing. This box is placed over the sump pump and has a heater as well.

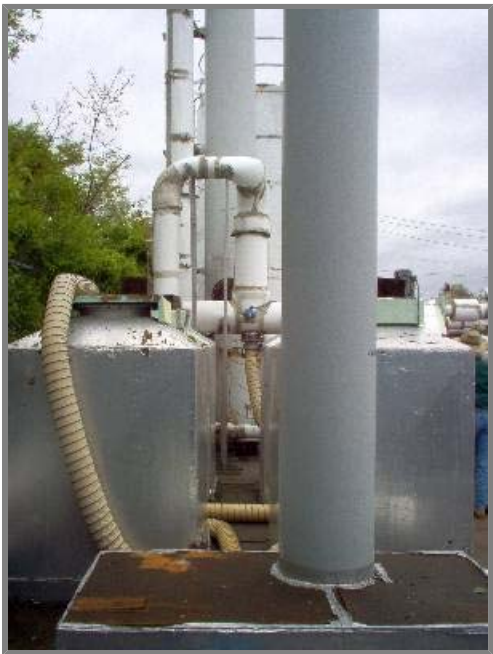
Photo left. Towers and tank. Descriptions from front to back: (1) air exhaust stack, (2) air discharge tower leading from the top of air stripper down to heater and carbon filters, (3) air stripping tower, and (4) the wide, padded water intake tank.

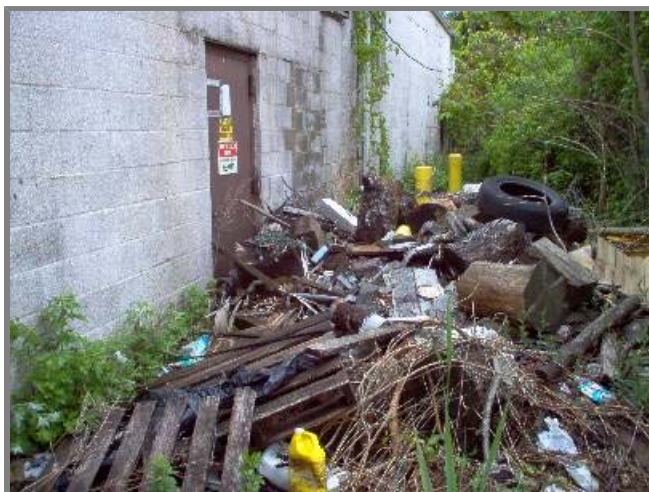
Photo left. NYSDEC-owned plant at Site No. 152077, ServAll Laundry, 8 Drayton Avenue, Bayshore, NY 11706. We wish to dismantle this plant. The first step in decommissioning would be garbage removal! We couldn't gain access through the door on 5/26-- our key didn't work plus debris was piled deep against the door.

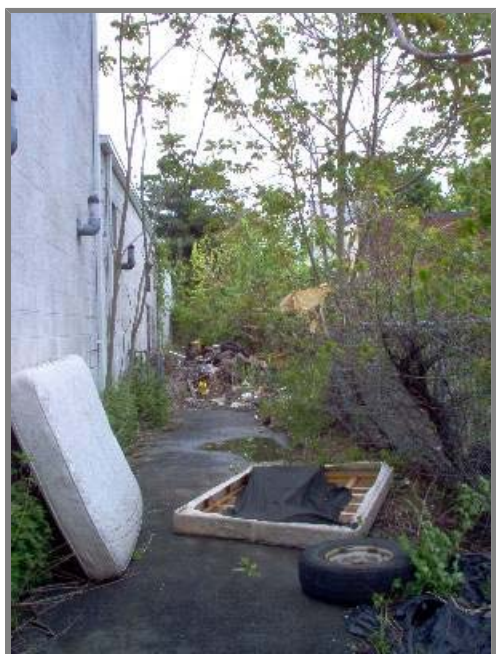
Photo left. Backing out further; More trash.

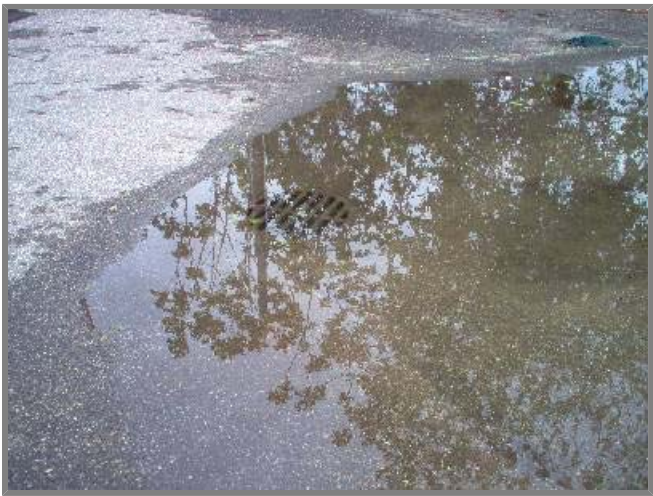
Photo left. Plugged drain in front of the plant.

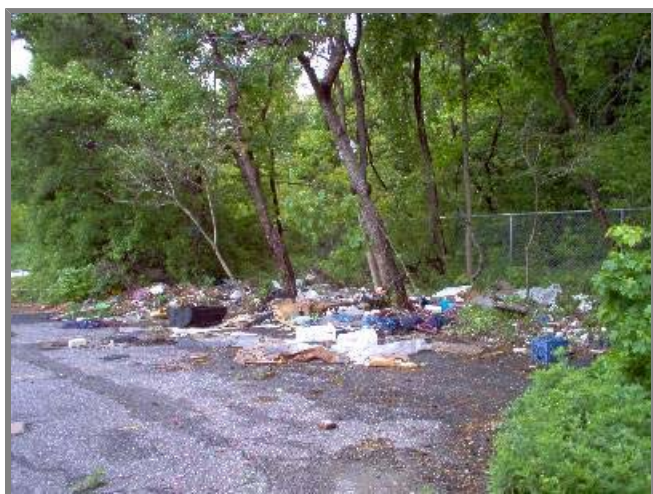
Photo left. Trash along the entrance way to the site. The gate is broken and people are dumping here.

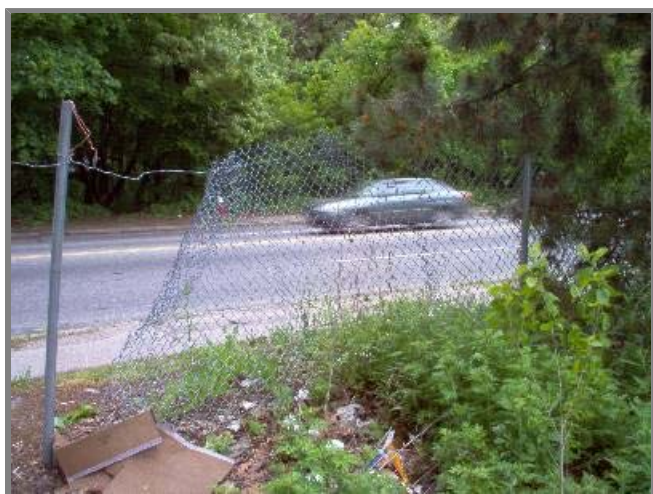
Photo left. Liberty Industrial site, broken gate.

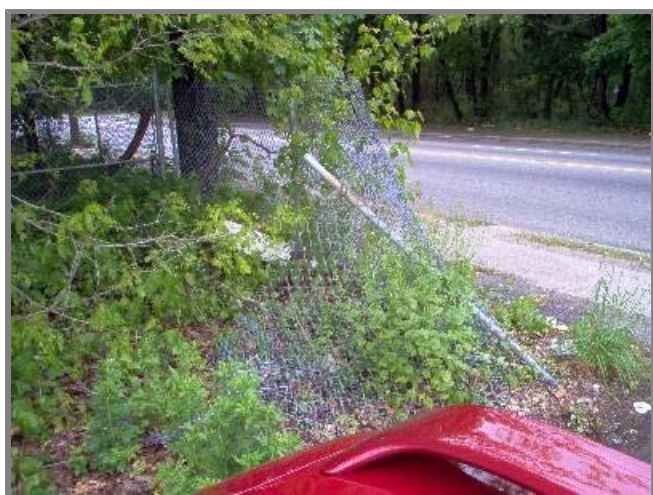
Photo left. Liberty Industrial site, broken gate.

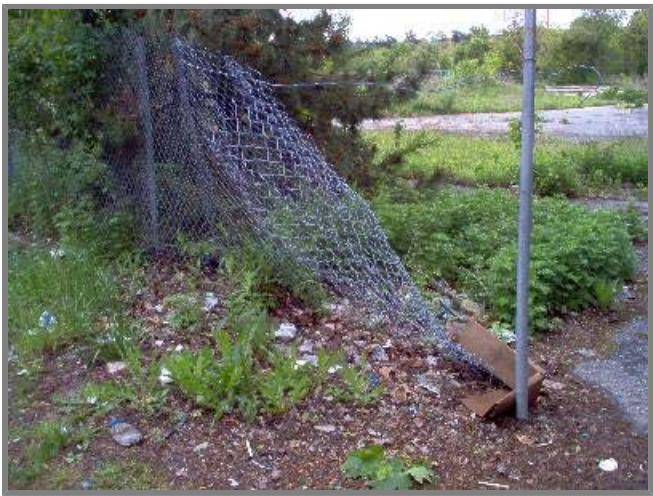
Photo left. Liberty Industrial site, broken gate.

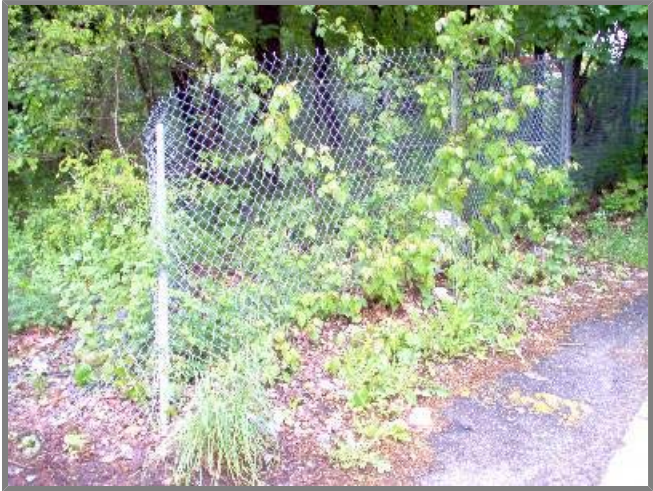
Photo left. Liberty Industrial site, broken gate.
