Project: Spectrum Finishing - Remedial Action
 Contractor: EnviroTrac Environmental Services
 CDM Job No: D-006956 Site No. 1-52-029
 CDM Project Manager: John Blaum

DAILY REPORT

Date: 17-Mar-09
 REPORT No. 101
 PAGE No. 1

Spectrum Finishing Remedial Action

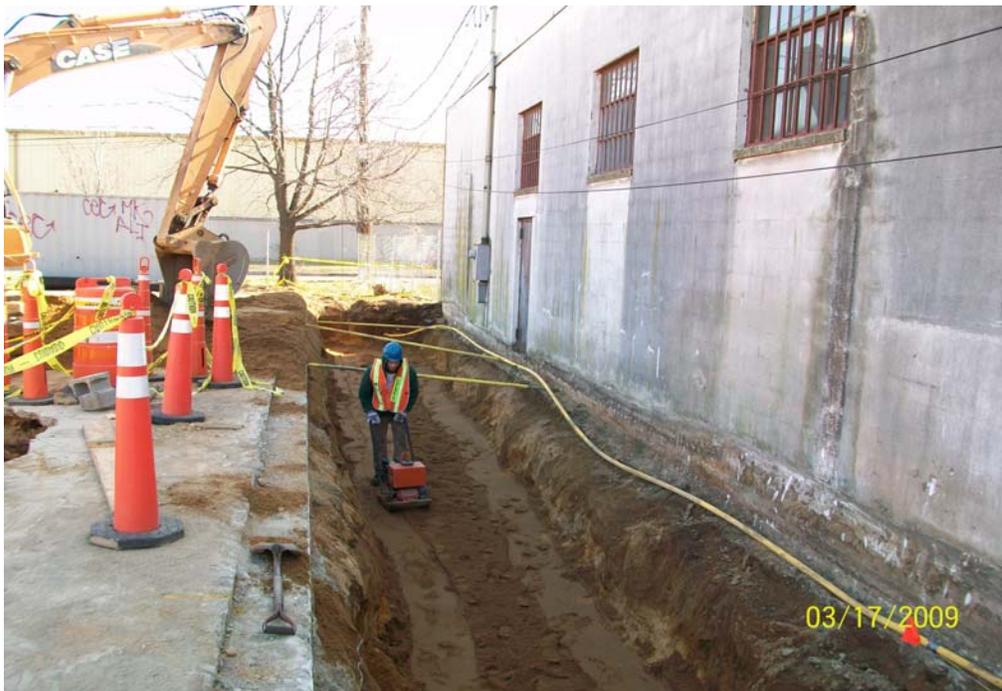
100_00128.jpg - Compacting east alleyway, looking east.

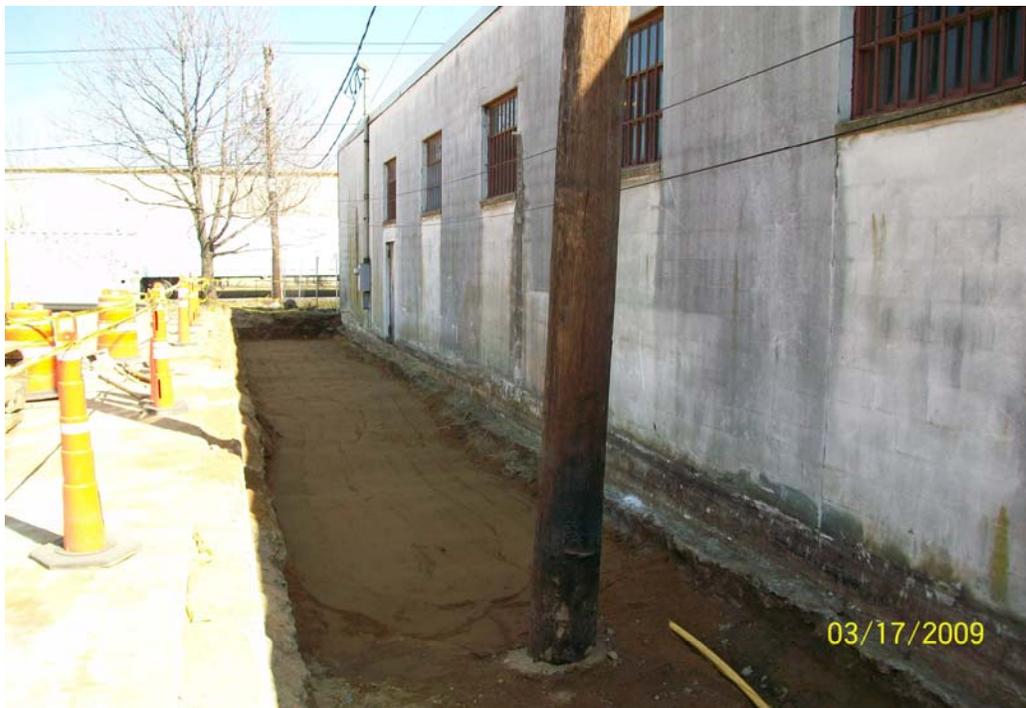
100_00130.jpg - Backfilling and compaction completed for the day at the east alleyway, looking east.

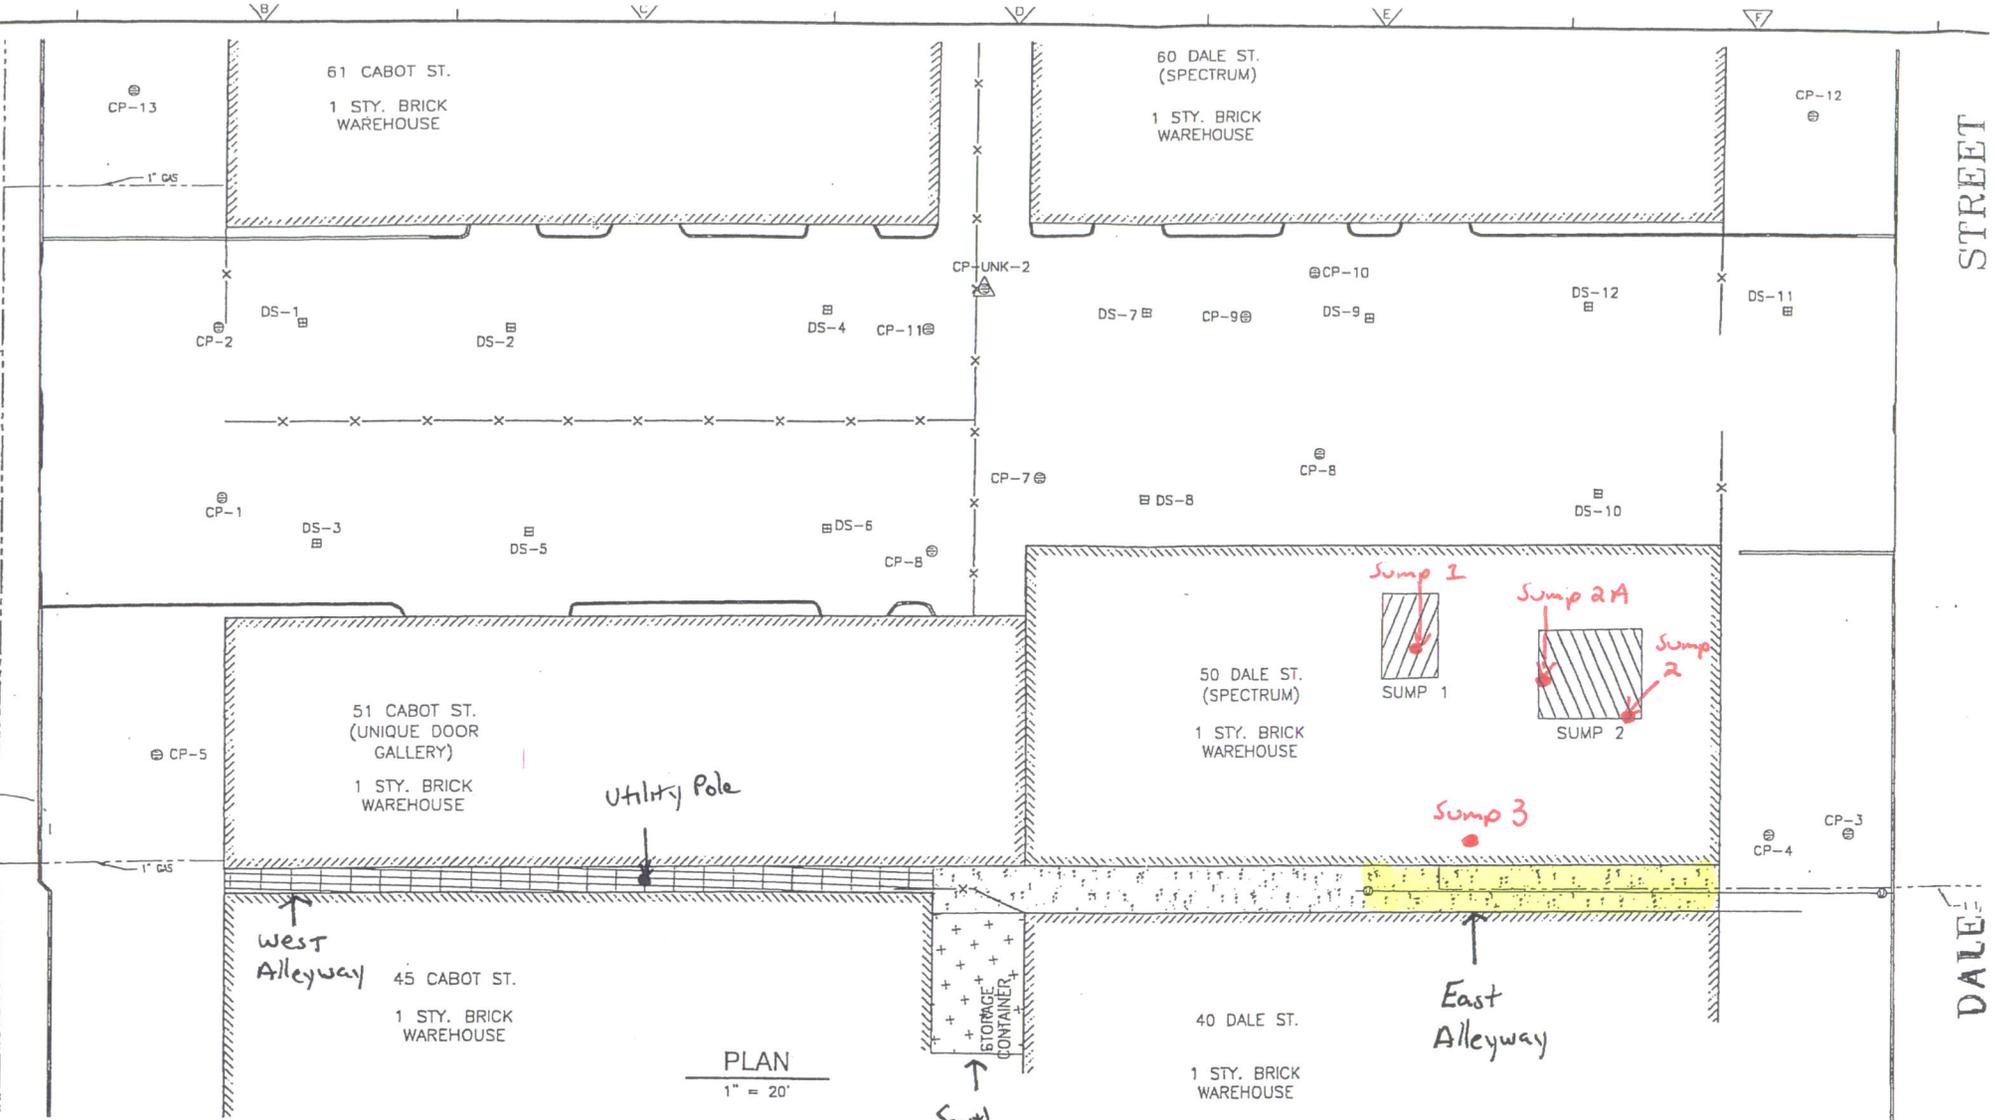
PLAN
1" = 20'

- Work Areas
Backfill and Compacting
