Project: Spectrum Finishing - Remedial Action  
 Contractor: EnviroTrac Environmental Services  
 CDM Job No: D-006956 Site No. 1-52-029  
 CDM Project Manager: John Blaum

### DAILY REPORT

Date: 23-Mar-09  
 REPORT No. 105  
 PAGE No. 1

**Spectrum Finishing Remedial Action**

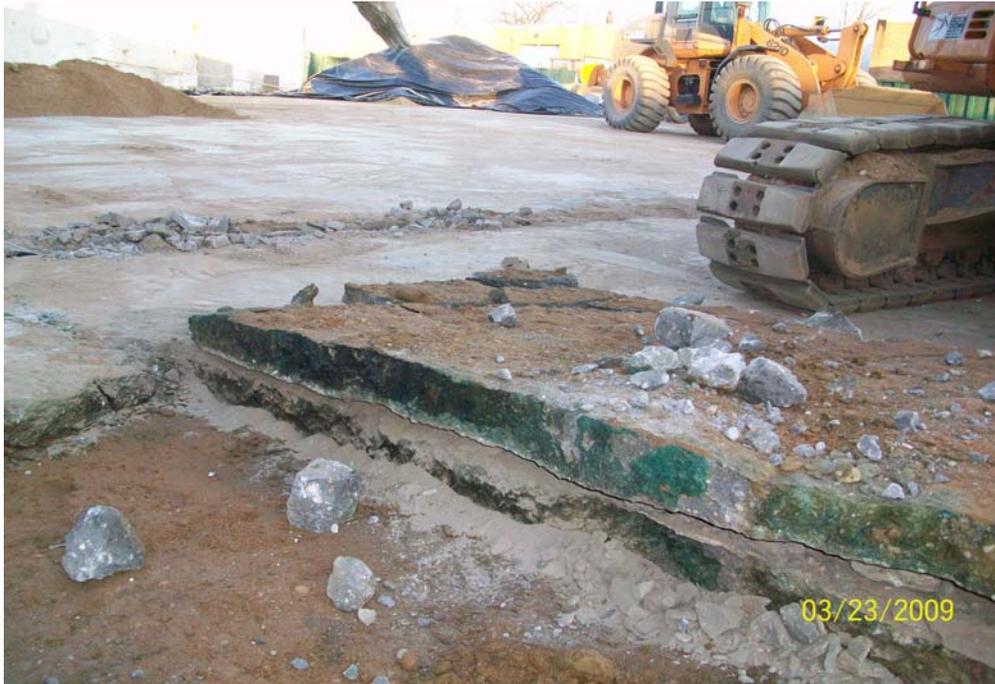
100\_00144.jpg - Green stained concrete near sump-3.

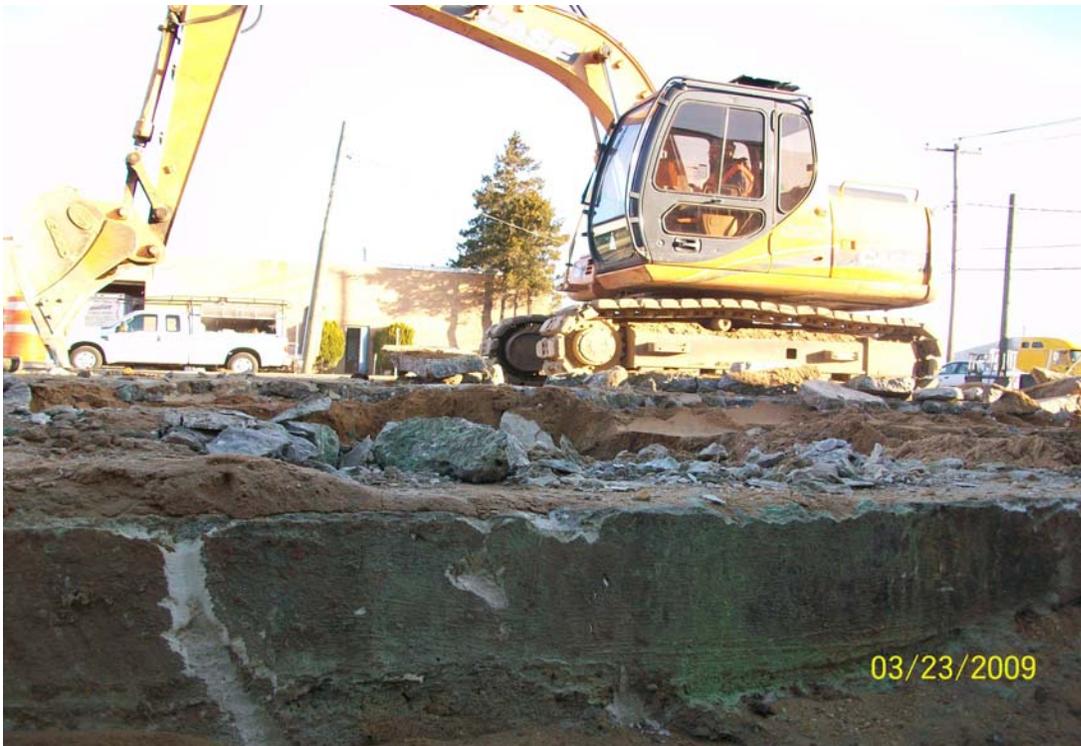
100\_00149.jpg - Green staining on south foundation wall.

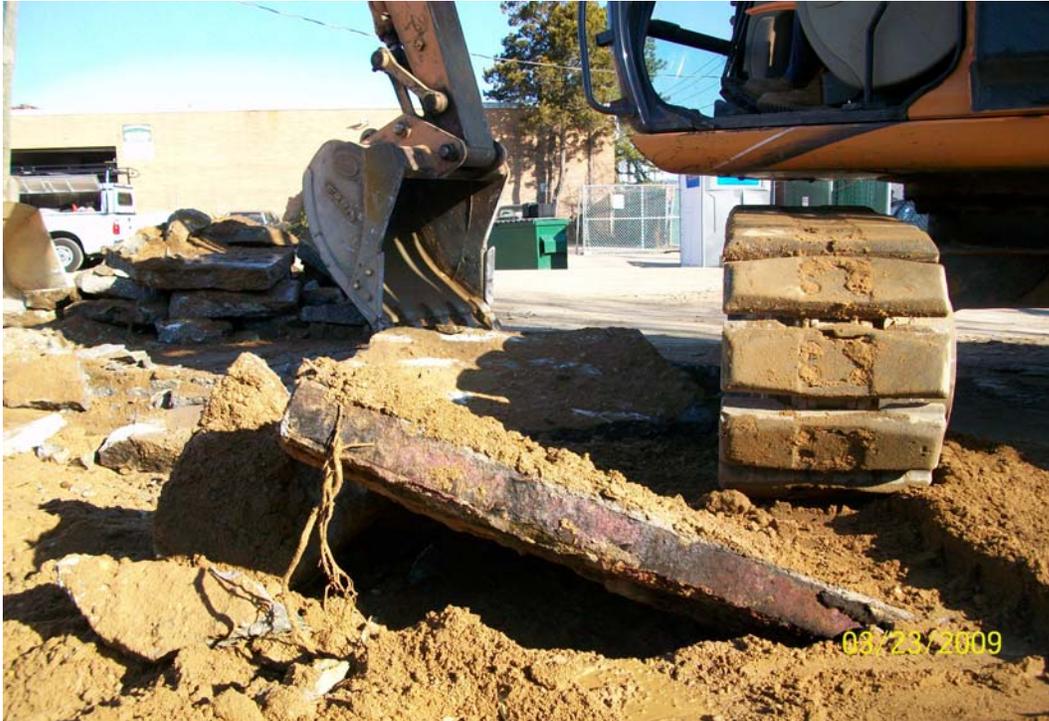
**100\_00155.jpg - Red stained concrete from around sump-2.**

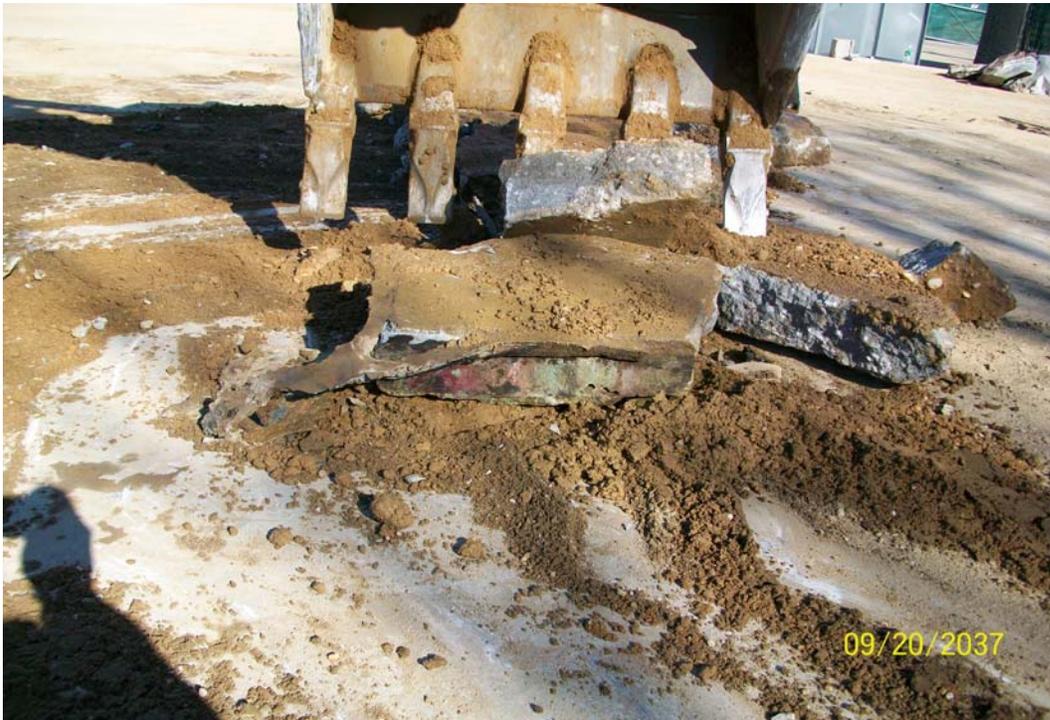
**100\_00157.jpg - Red/purple stained concrete from around sump-2.**

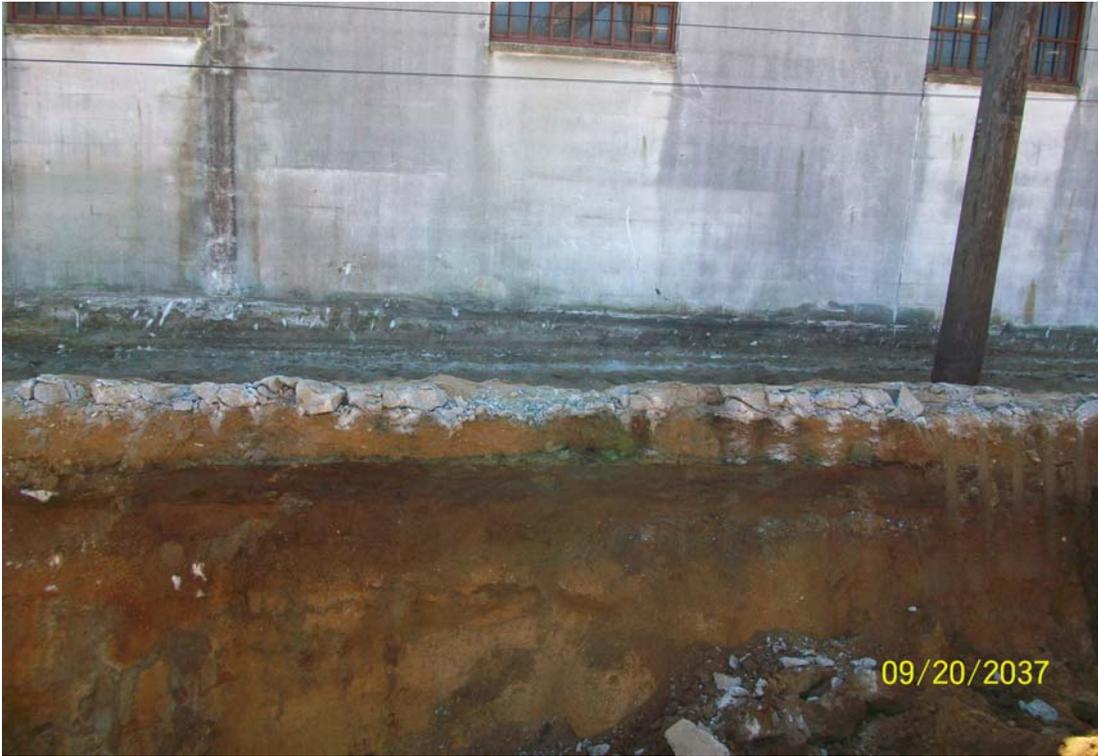
**100\_00159.jpg - Green/red stained soil by foundation wall.**

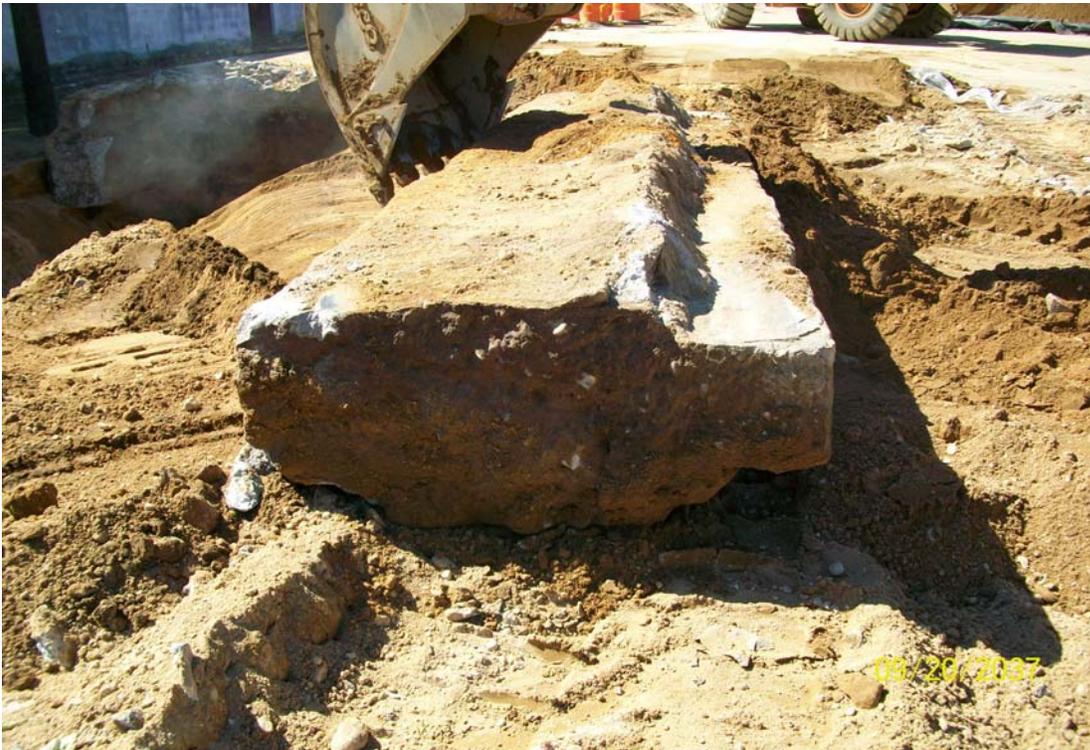
**100\_00166.jpg - Red stained concrete foundation wall, stained completely through.**

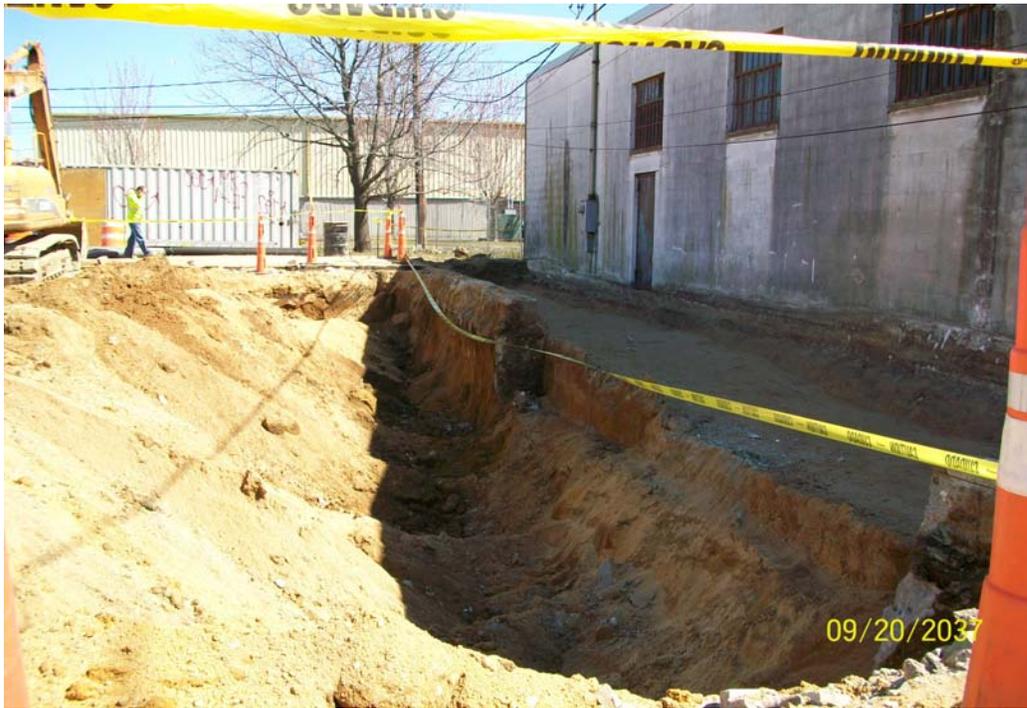
100\_00167.jpg - Excavation at the end of the day.
