Project: Spectrum Finishing - Remedial Action
 Contractor: EnviroTrac Environmental Services
 CDM Job No: D-006956 Site No. 1-52-029
 CDM Project Manager: John Blaum

DAILY REPORT

Date: 25-Mar-09
 REPORT No. 107
 PAGE No. 1

PHOTOGRAPHIC LOG
25-Mar-09
CDM Job No. D-006956
Spectrum Finishing Remedial Action
SITE No. 1-52-029

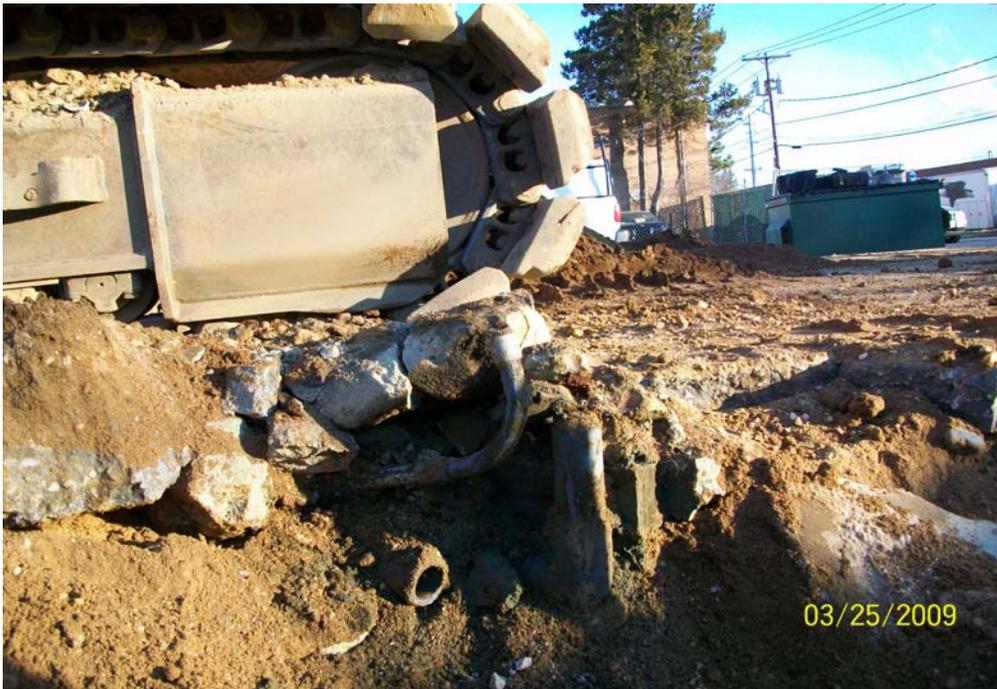
100_00190.jpg - 3 PVC pipes found just below the slab. See drawing for location.

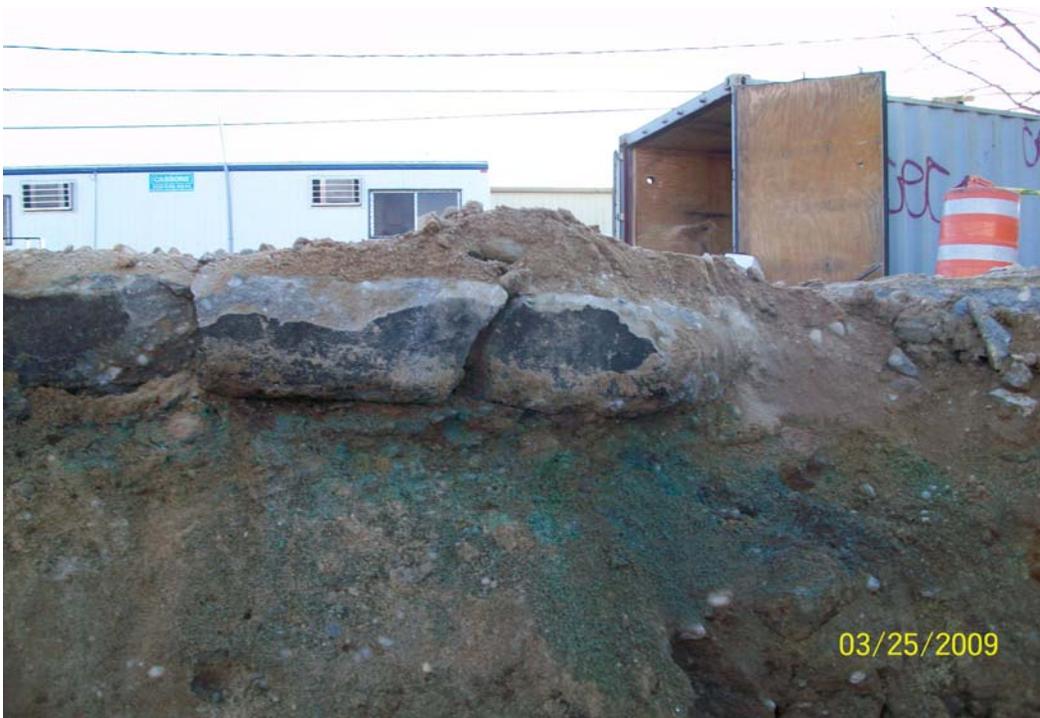
100_00191.jpg - Green stained soil on east side of excavation

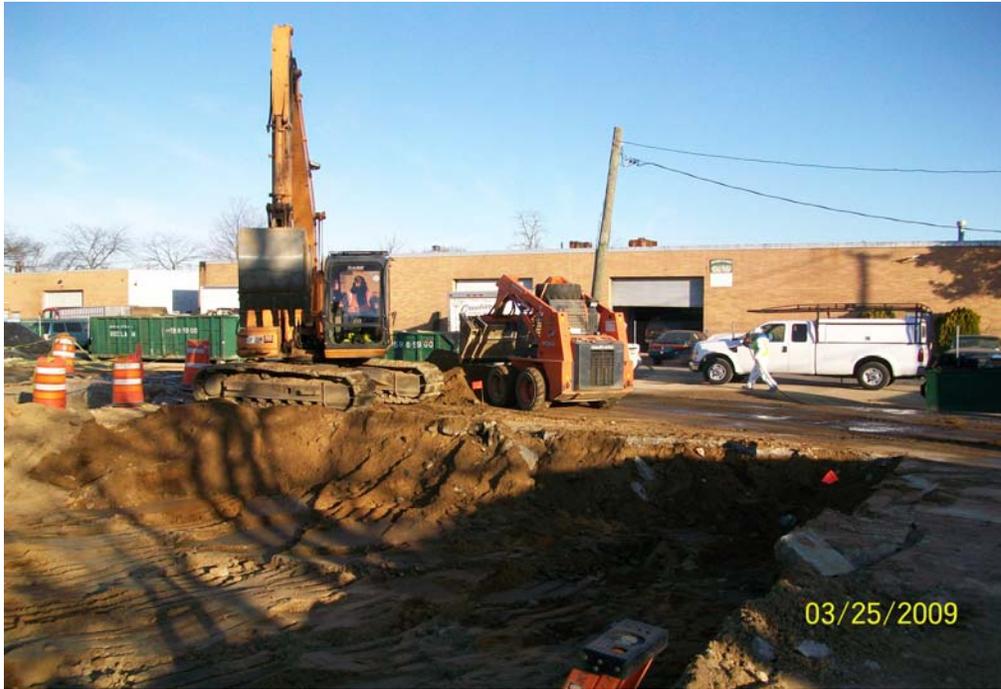
100_00192.jpg - Excavating soil from the excavation.

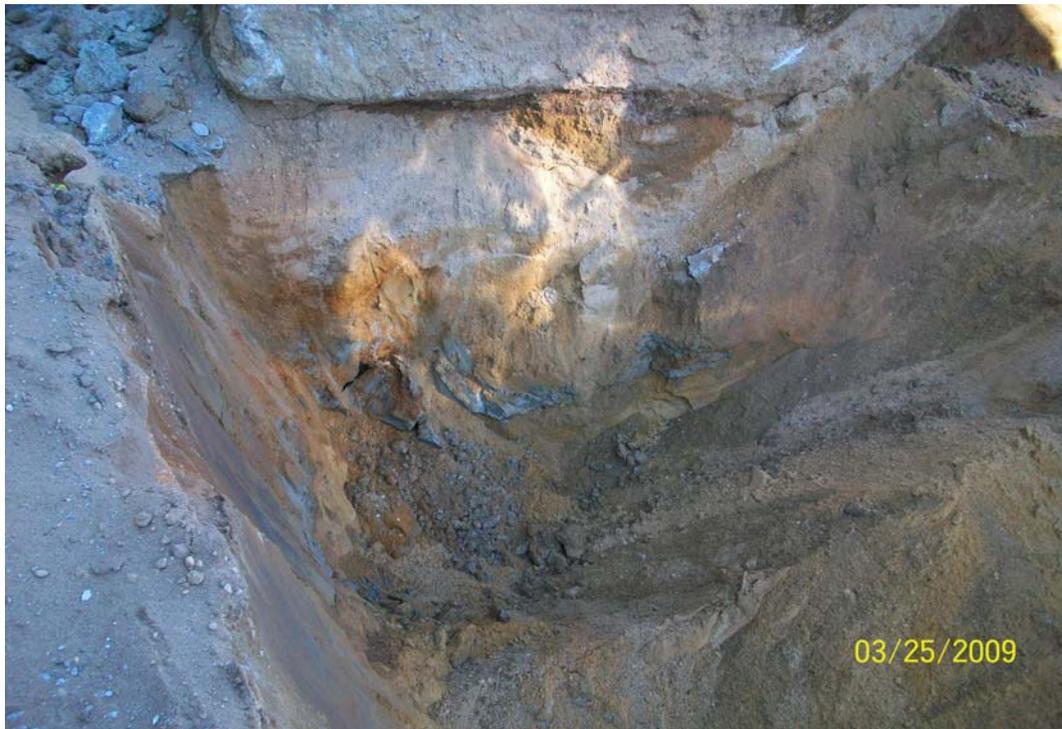
100_00195.jpg - Green clay like material at SW corner of excavation

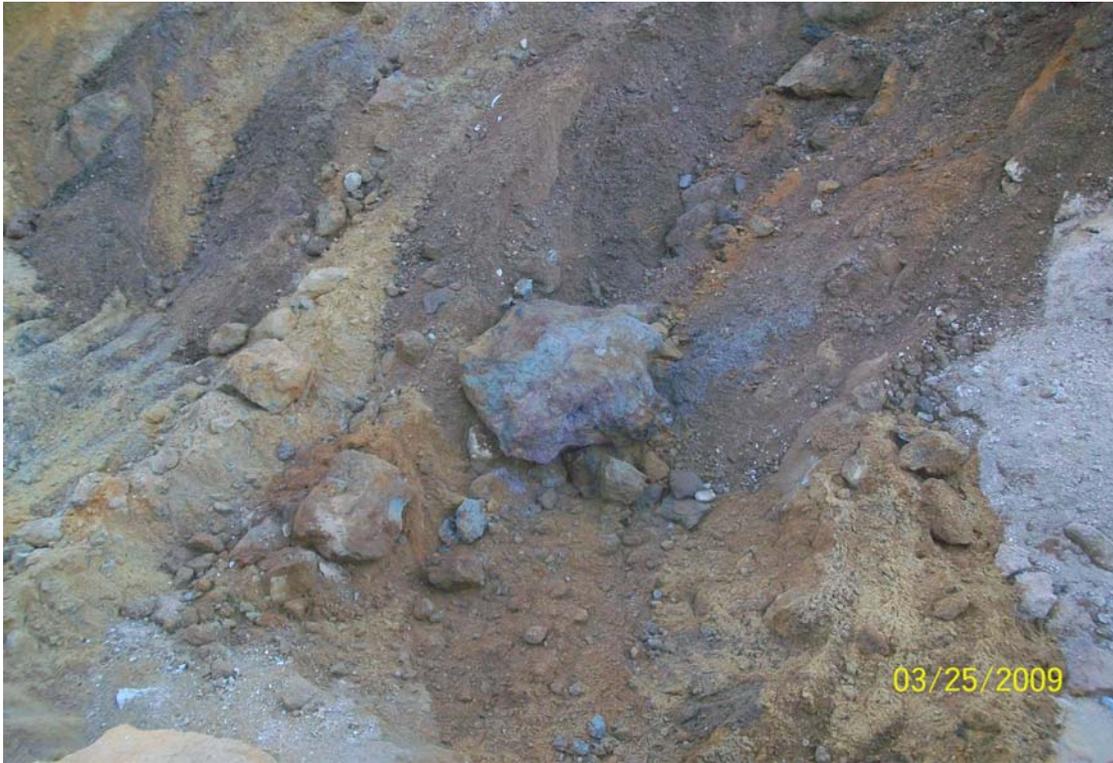
100_00201.jpg - Chunks of green/red hard material from north side of sump-3

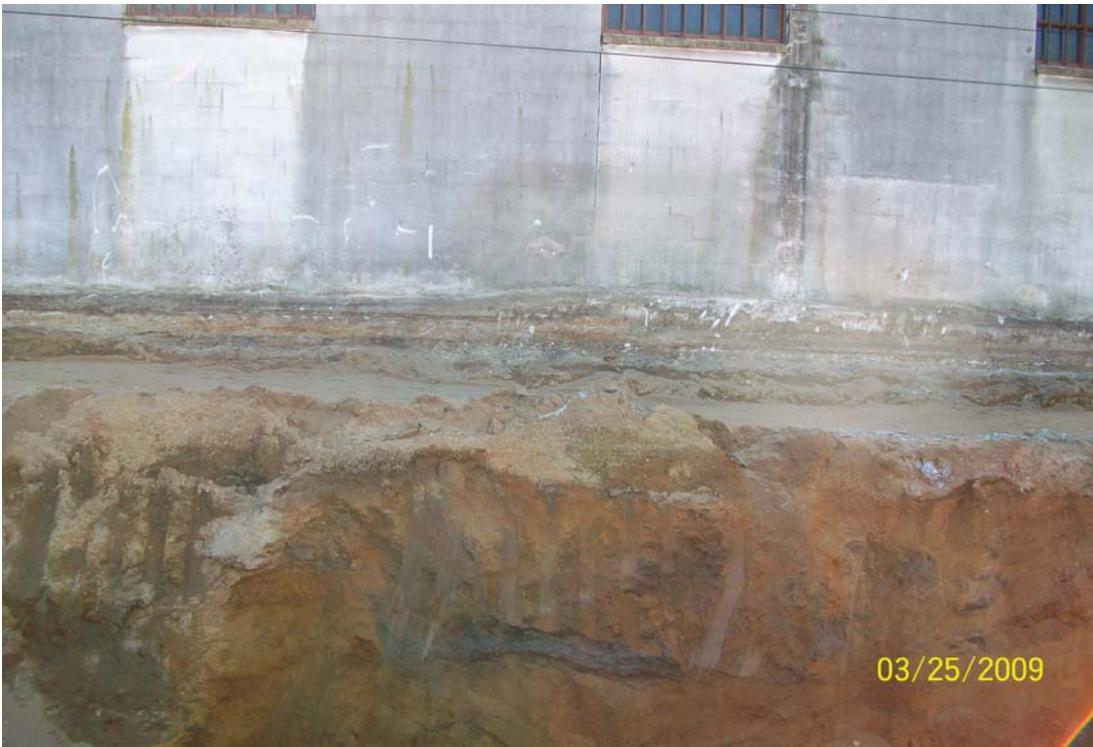
100_00203.jpg - Green clay like material with red crust around, south side of excavation.

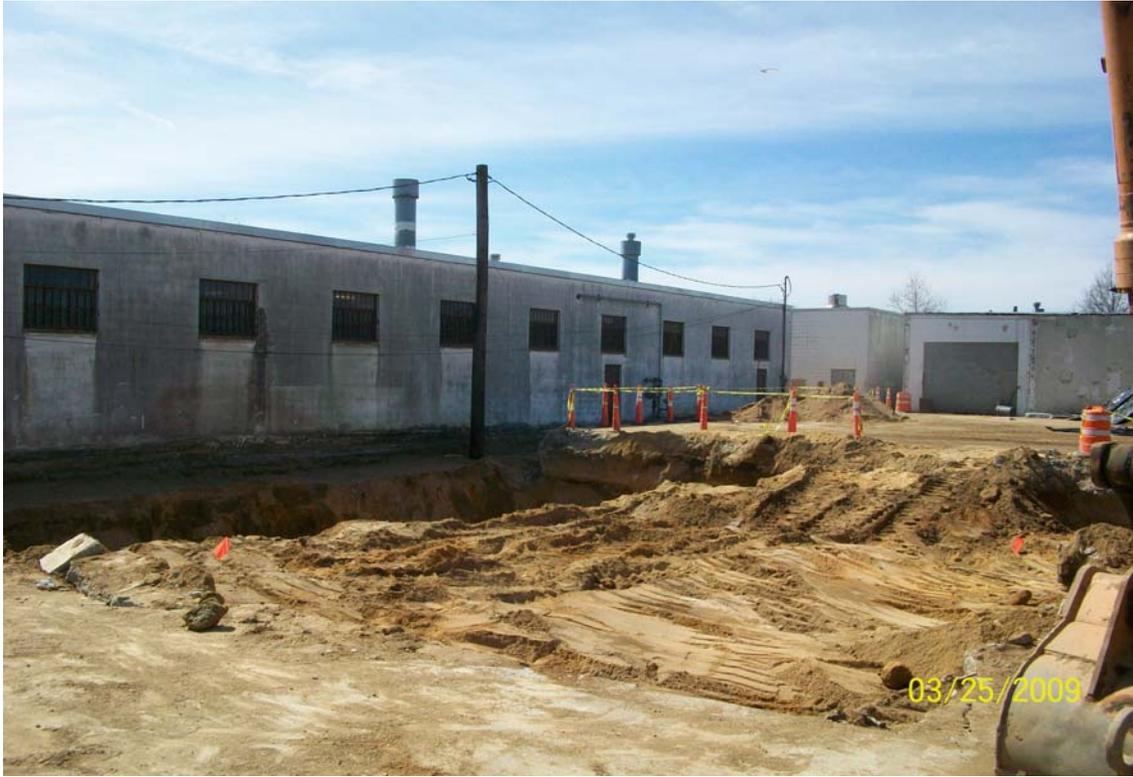
100_00206.jpg - Excavation at the end of the day.

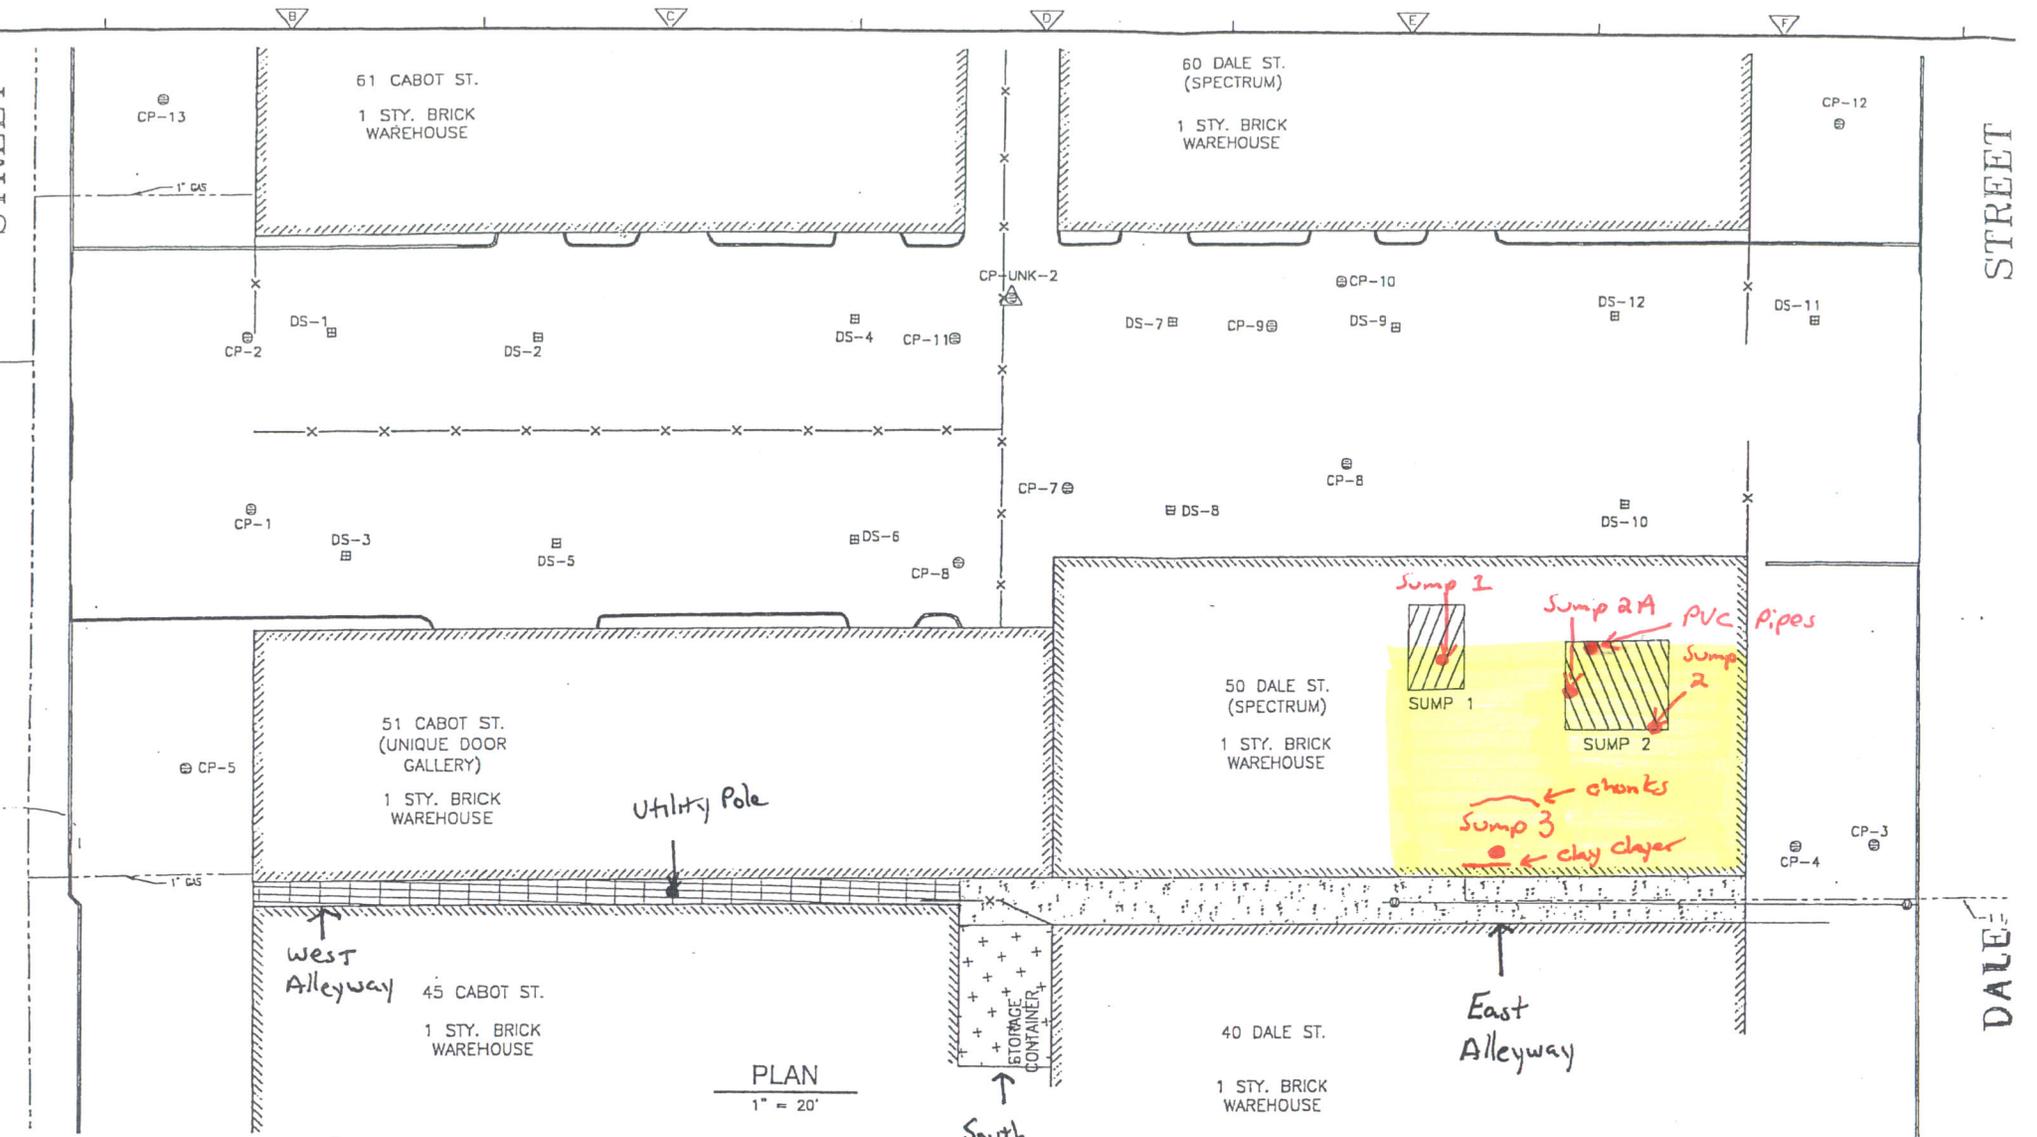
PLAN
1" = 20'

Site Representative: Frank Robinson - CDM
Health and Safety Site Officer: N/A
DESCRIPTION OF WORK PERFORMED AND OBSERVED
1-Tailgate H&S meeting performed before the start of the work day. 2-Air monitoring for dust and VOC's (2 stations) were set up.
3-14 trucks loads (10 wheel) of hazardous waste soil were transported to the disposal facility, Clean Earth, by ETGI Trucking.
4-Continue to excavate the area down to ~4 that was started yesterday. Excavating down to ~10 along where the foundation wall was and where sump-3 used to be. Found hard grayish clay layers with green veins of material going through it. Also hard chunks of green and red material, almost like concrete north of where sump-3 was.
5-Found 3 PVC pipes just below the slab with green soil and concrete soil around them. See drawing for location.
6-Sprayed water on slab for dust control.
