Project: Spectrum Finishing - Remedial Action
 Contractor: EnviroTrac Environmental Services
 CDM Job No: D-006956 Site No. 1-52-029
 CDM Project Manager: John Blaum

DAILY REPORT

Date: 27-Mar-09
 REPORT No. 109
 PAGE No. 1

PHOTOGRAPHIC LOG
27-Mar-09
CDM Job No. D-006956
Spectrum Finishing Remedial Action
SITE No. 1-52-029

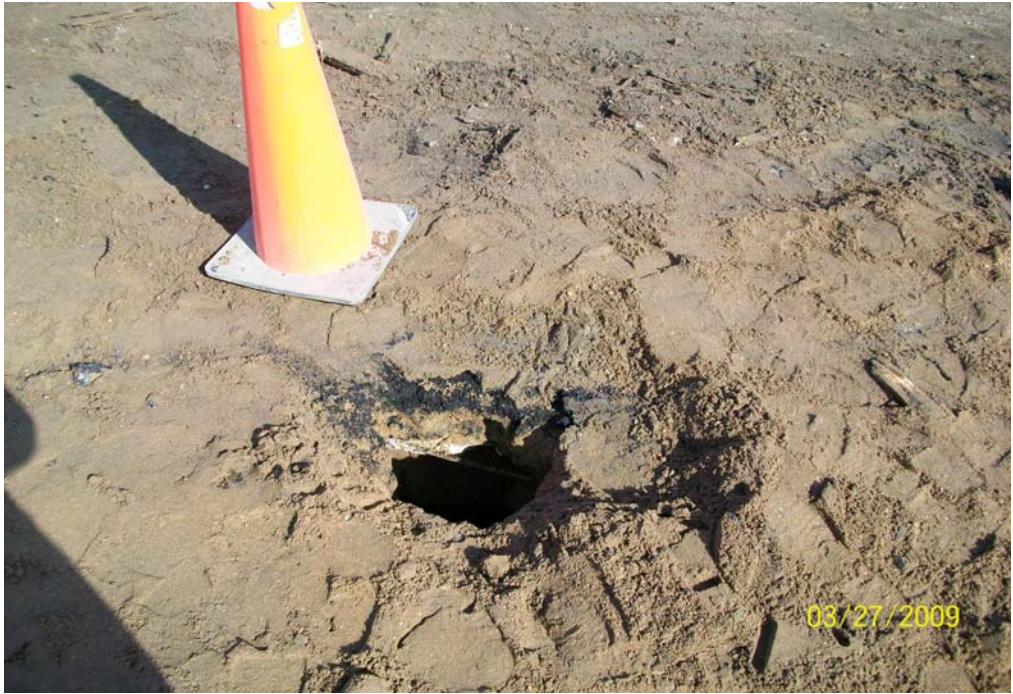
100_00229.jpg - Sinkhole on top of CP-8

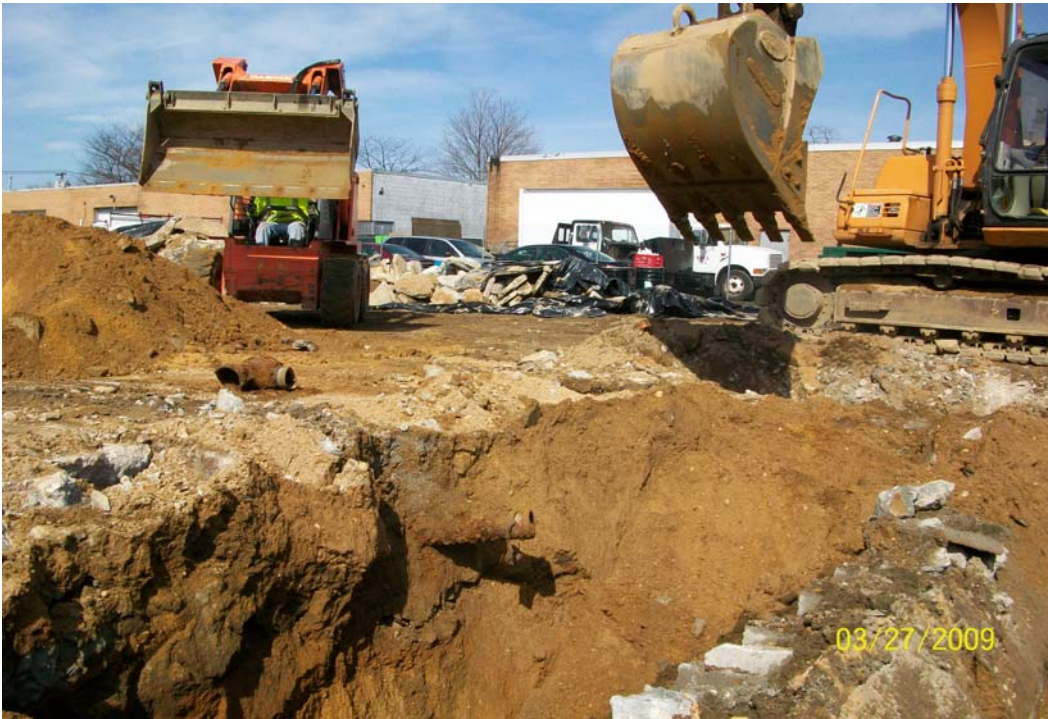
Site Representative: Frank Robinson - CDM
Health and Safety Site Officer: N/A
DESCRIPTION OF WORK PERFORMED AND OBSERVED
1-Tailgate H&S meeting performed before the start of the work day. monitoring for dust and VOC's (2 stations) were set up. 2-Air
3-The foundation wall around sump-1 was broken up and removed. A trench was excavated around the foundation wall to undermine the wall, and the soil on the outside wall down to ~7 does not appear to be stained.
4-A small sinkhole developed, ~1' in diameter, above CP-8 due to the heavy equipment traffic in that area. A road plate has been ordered to cover this area.
5-A cast iron sewer pipe was found while excavating sump-1 to the west, pipe is heading to the SW.

100_00233.jpg - Cast iron sewer pipe found to the west of sump-1, heading SW

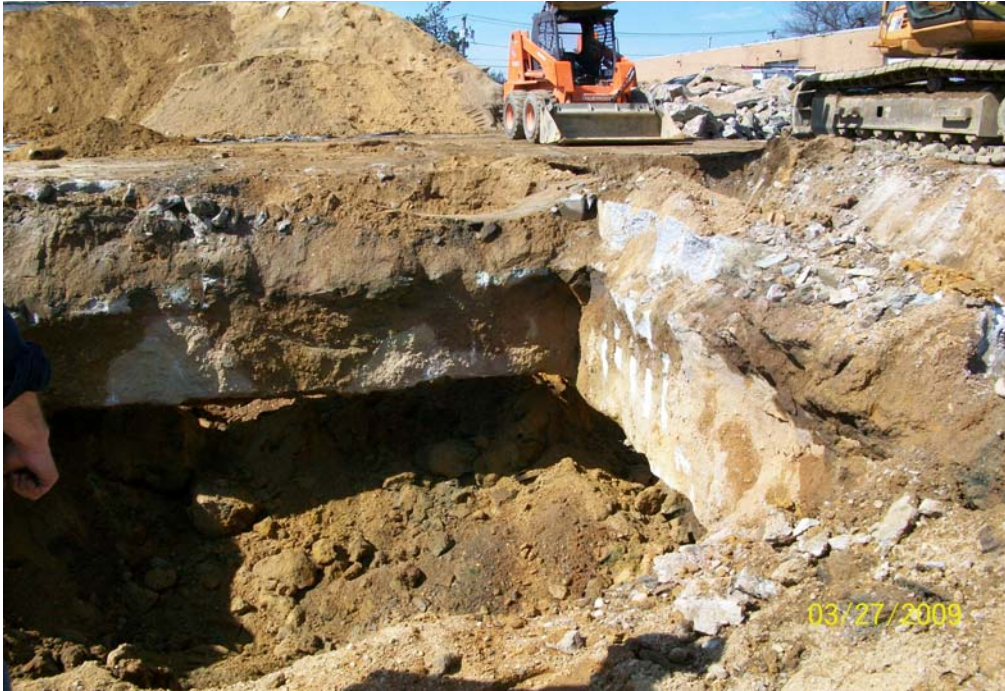
100_00236.jpg - Undermined foundation wall, NW corner of sump-1.

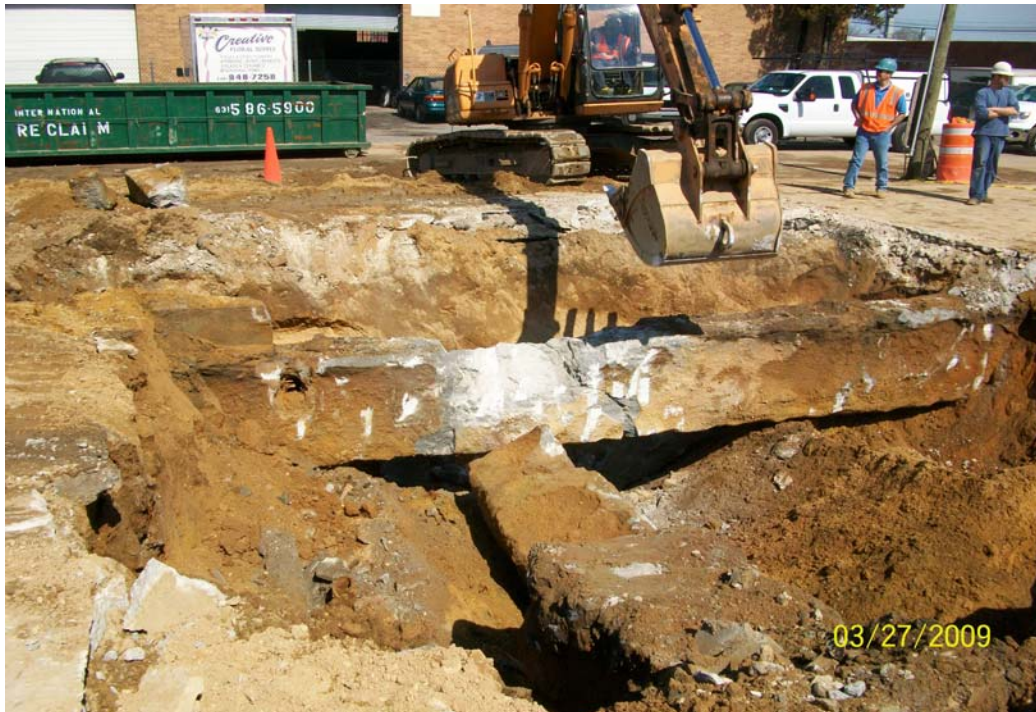
100_00238.jpg - Foundation wall partially demolished.

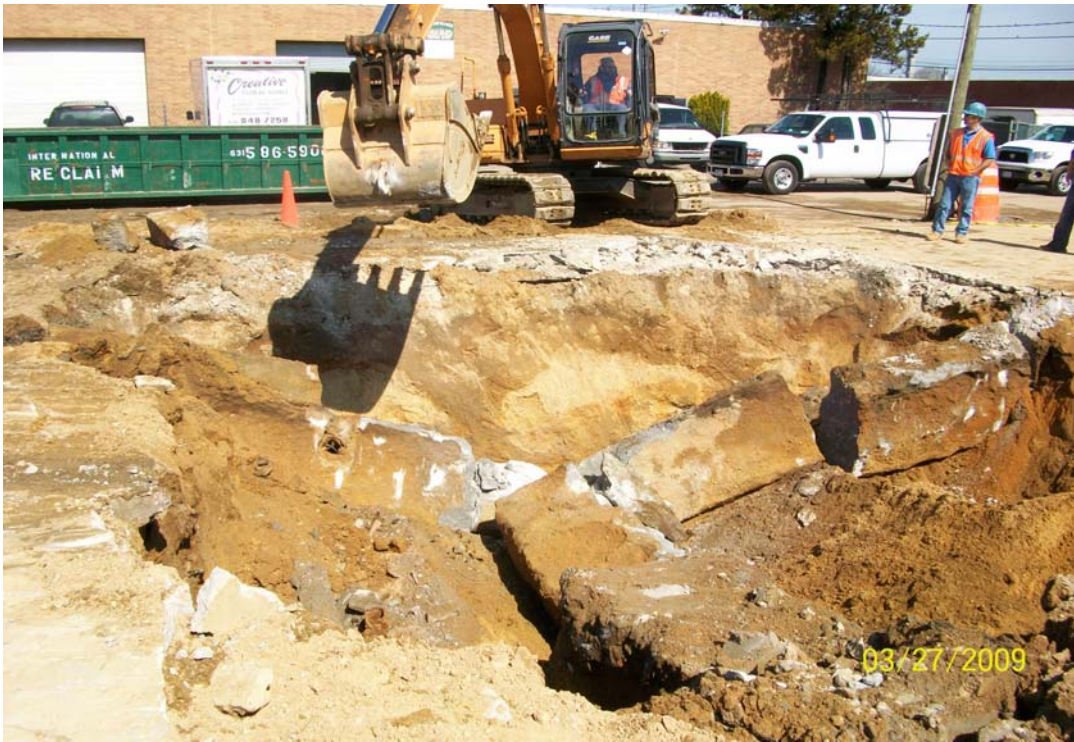
100_00239.jpg - Foundation wall completely demolished.

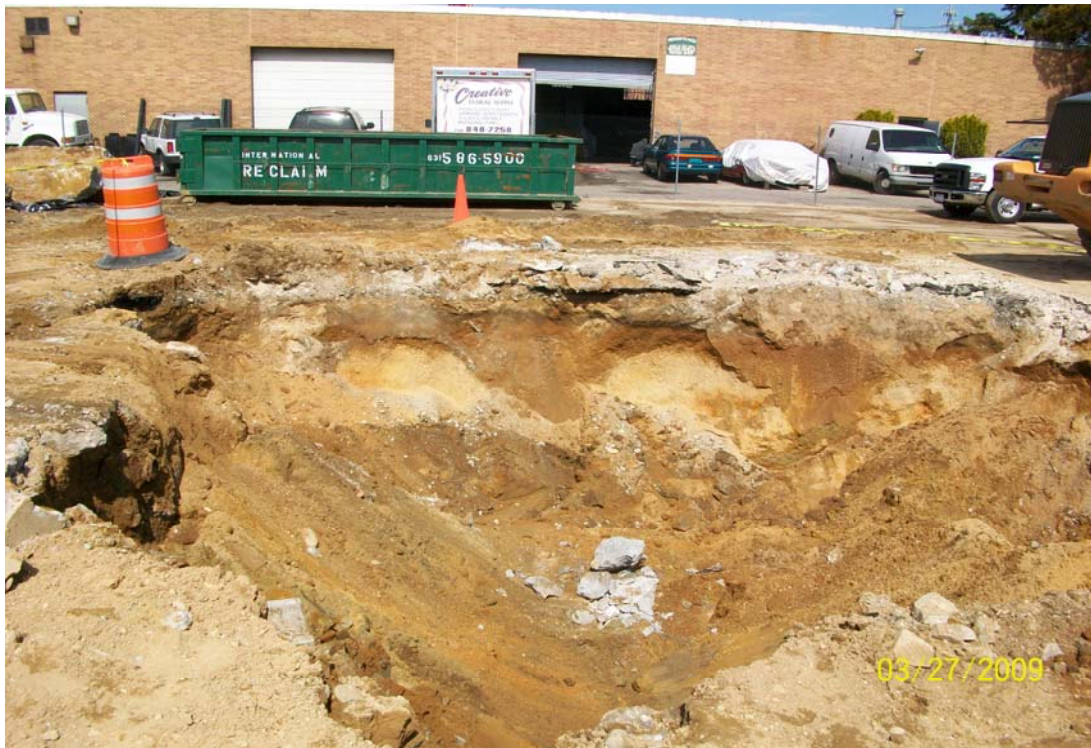
100_00241.jpg - Excavation at the end of the day, looking north.

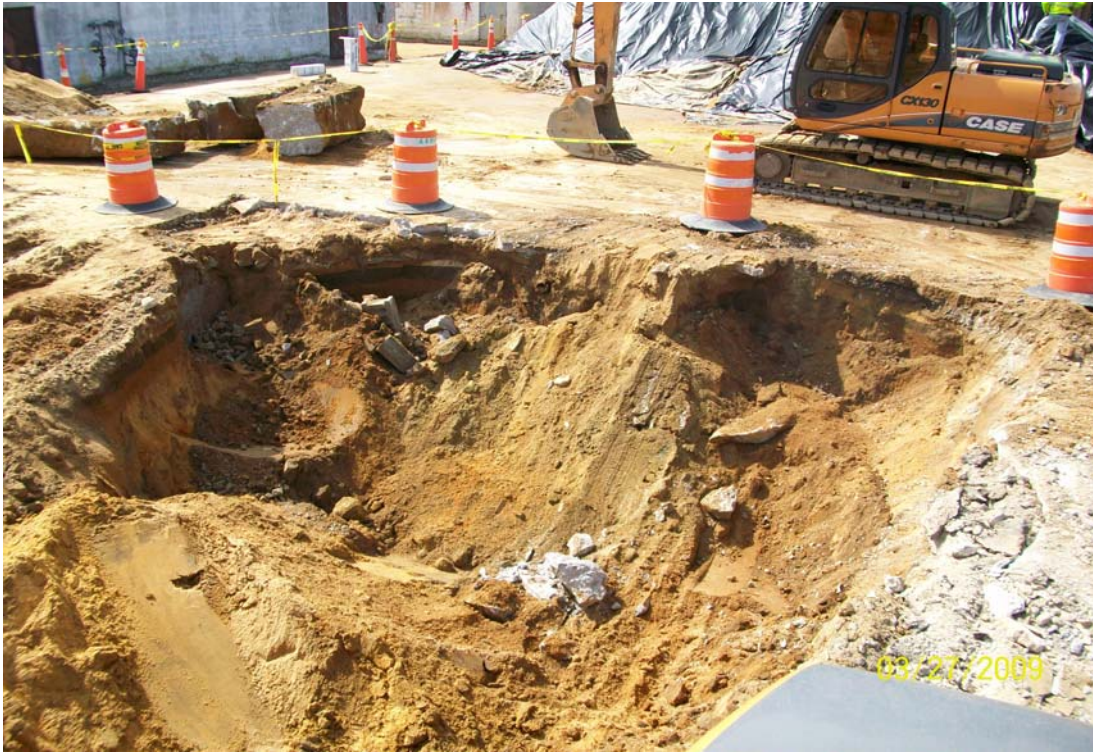
100_00243.jpg - Excavation at the end of the day, overhead view looking SW
