Project: Spectrum Finishing - Remedial Action  
 Contractor: EnviroTrac Environmental Services  
 CDM Job No: D-006956 Site No. 1-52-029  
 CDM Project Manager: John Blaum

### DAILY REPORT

Date: 30-Mar-09  
 REPORT No. 110  
 PAGE No. 1

**PHOTOGRAPHIC LOG**  
**30-Mar-09**  
**CDM Job No. D-006956**  
**Spectrum Finishing Remedial Action**  
**SITE No. 1-52-029**

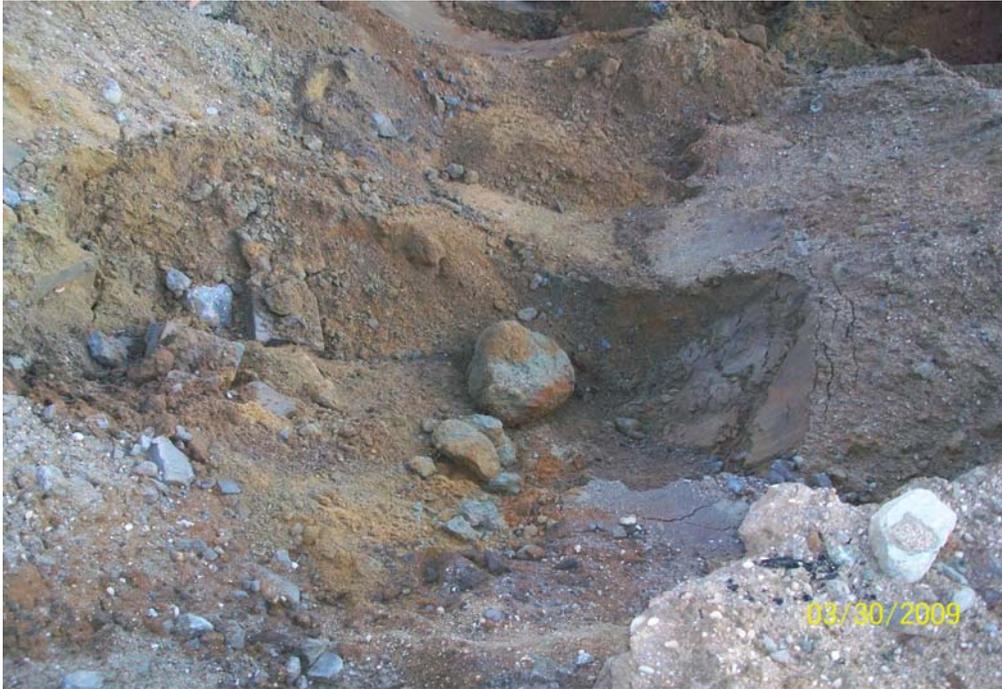
100\_00276.jpg - Green chunks of material from the bottom of sump-1.

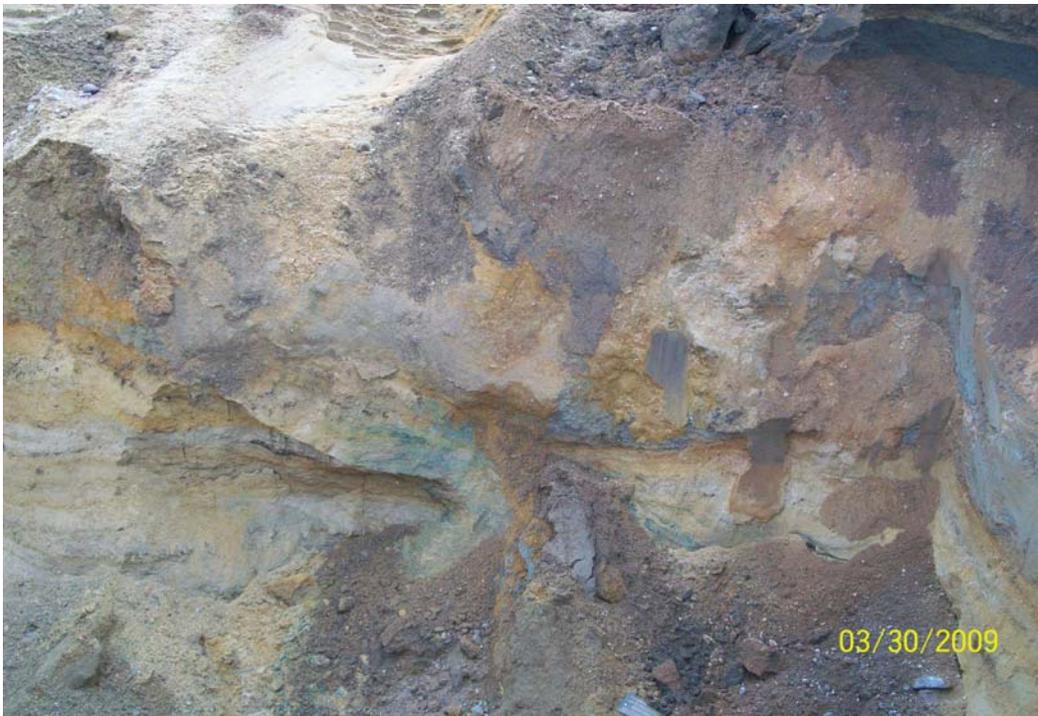
100\_00279.jpg - Green/red stained soil on side of sump-1, looking NE.

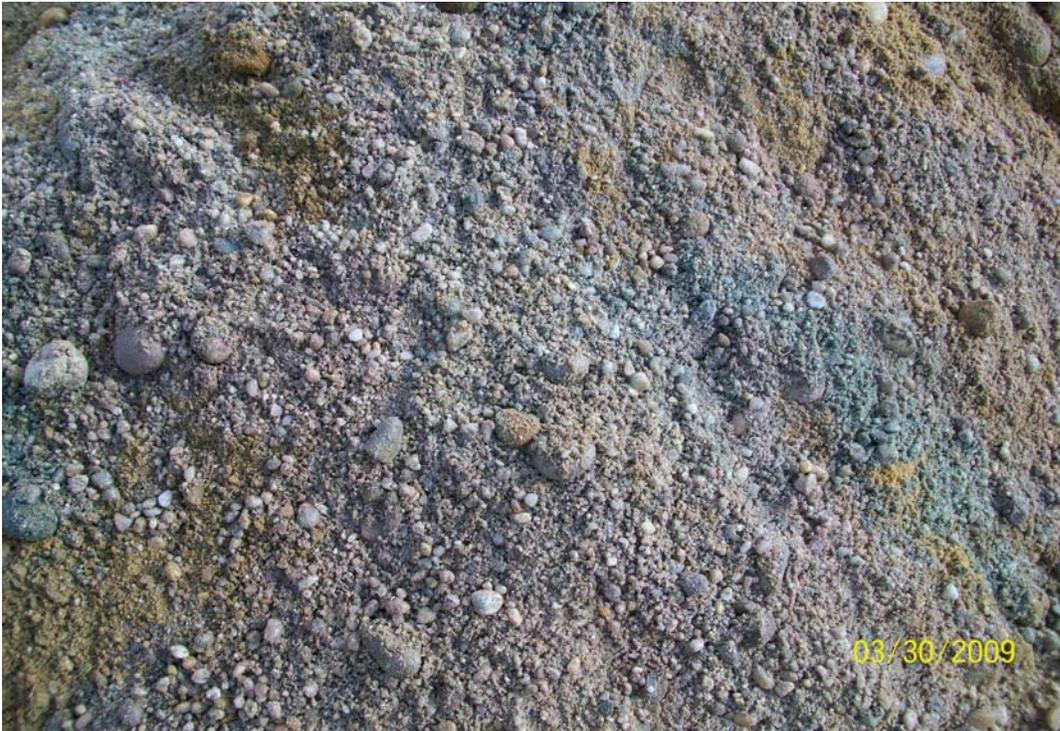
**100\_00282.jpg - Green/red soil in pile removed from sump-1.**

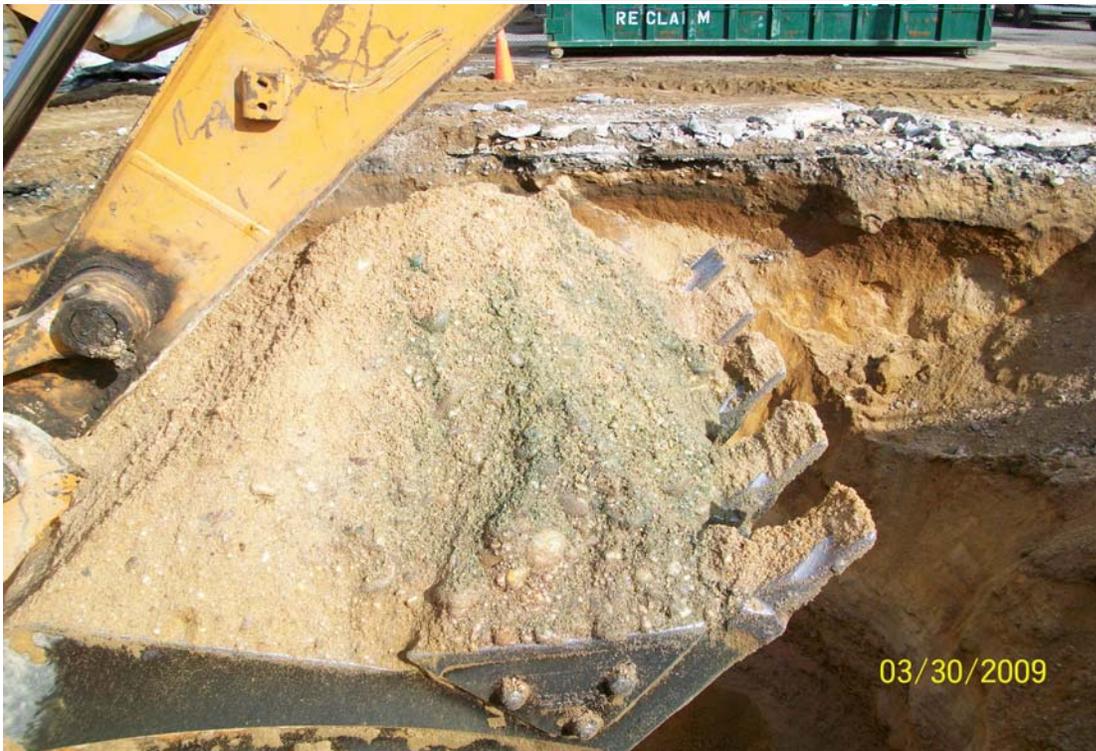
**100\_00283.jpg - Green/red soil in excavator bucket from the bottom of sump-1, ~16'.**

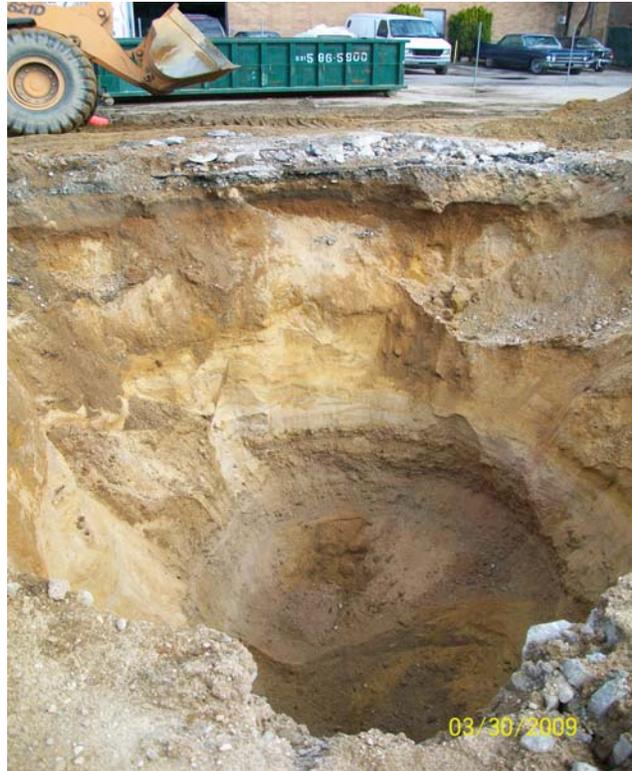
**100\_00284.jpg - Excavation at the end of the day of sump-1 looking west.**

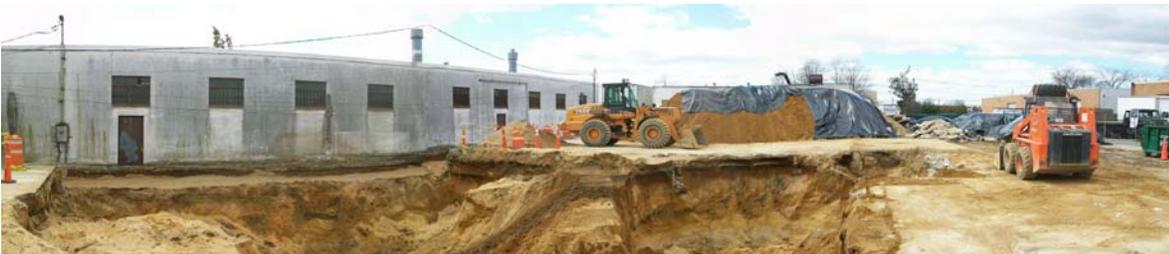
**100\_00287.jpg - Excavation at the end of the day, panoramic view looking NW.**
