Project: Spectrum Finishing - Remedial Action  
 Contractor: EnviroTrac Environmental Services  
 CDM Job No: D-006956 Site No. 1-52-029  
 CDM Project Manager: John Blaum

### DAILY REPORT

Date: 3-Apr-09  
 REPORT No. 114  
 PAGE No. 1

**PHOTOGRAPHIC LOG**  
**3-Apr-09**  
**CDM Job No. D-006956**  
**Spectrum Finishing Remedial Action**  
**SITE No. 1-52-029**

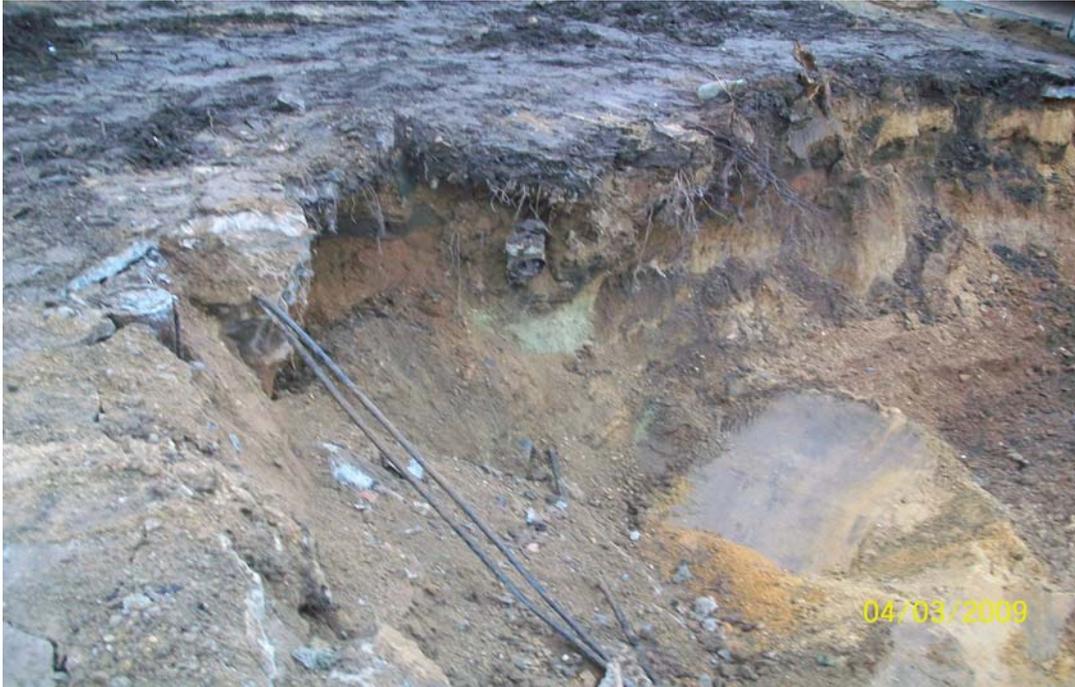
100\_00322.jpg - Green contaminated soil in NE corner of excavation

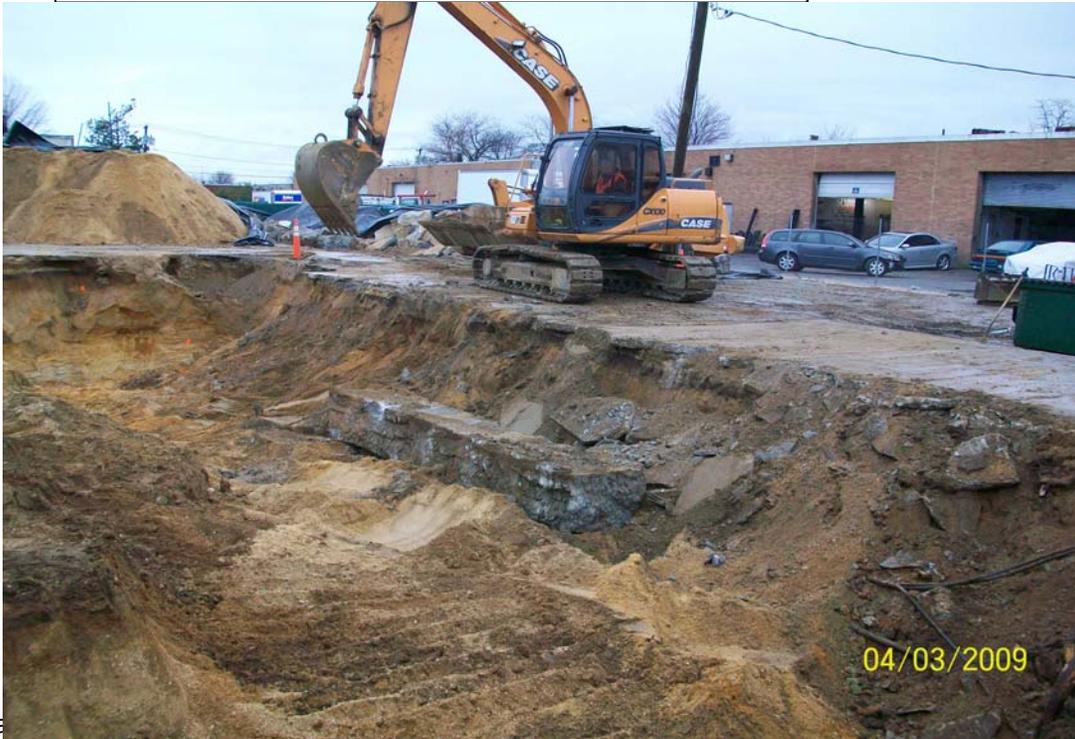
100\_00323.jpg - North foundation wall down, looking NW

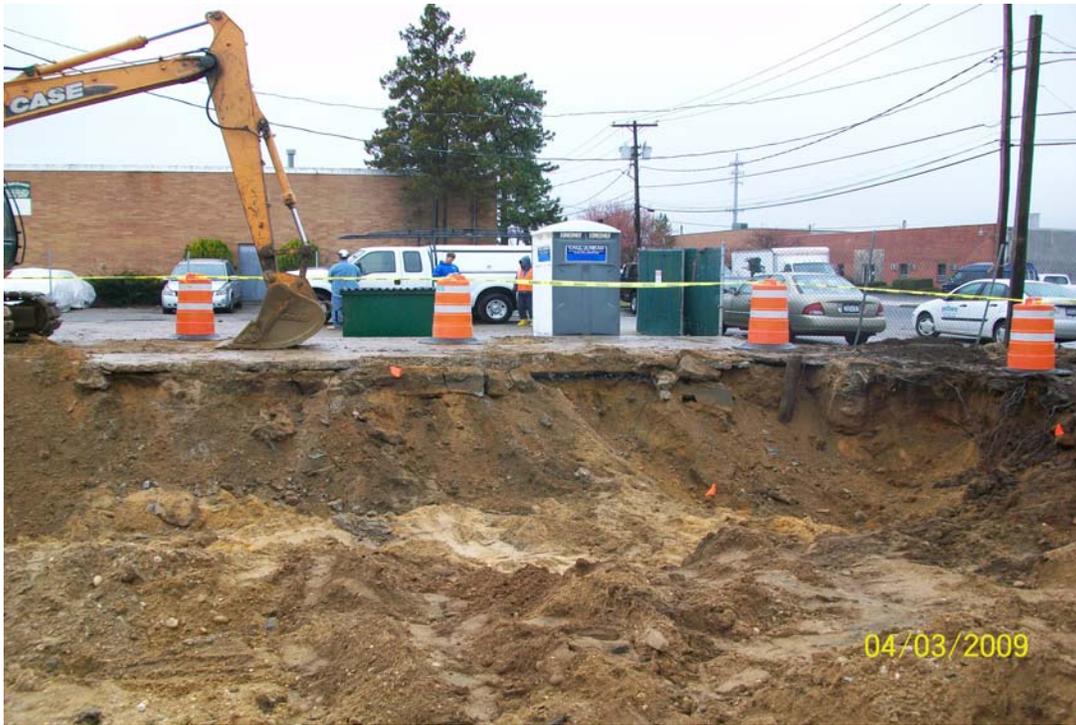
100\_00324.jpg - Excavation at the end of the day, looking north

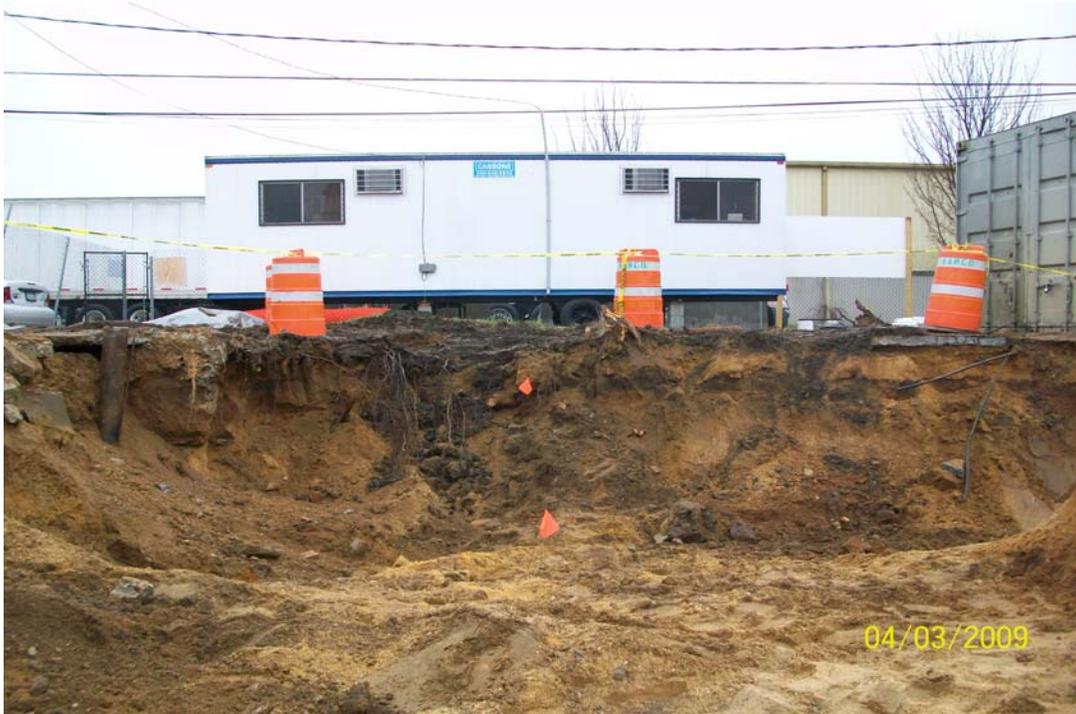
100\_00325.jpg - Excavation at the end of the day, looking east

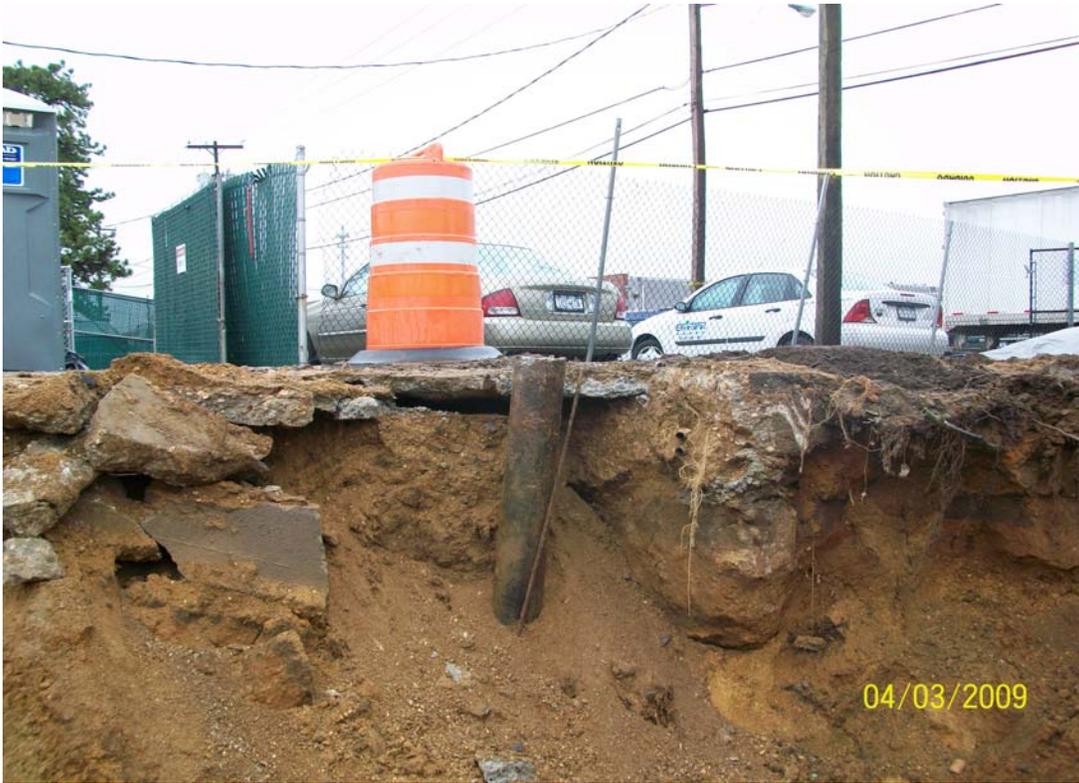
**100\_00326.jpg - Close-up of fire main, looking north**

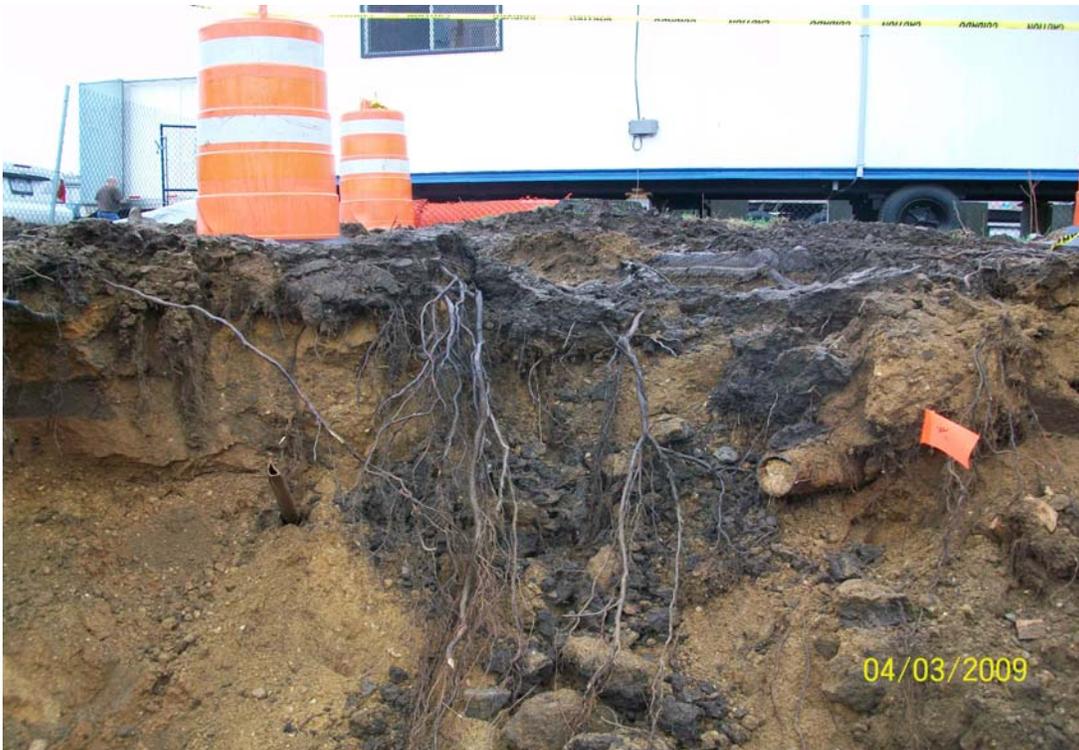
**100\_00327.jpg - Close-up of water main (left) and sewer pipe (right) looking east**

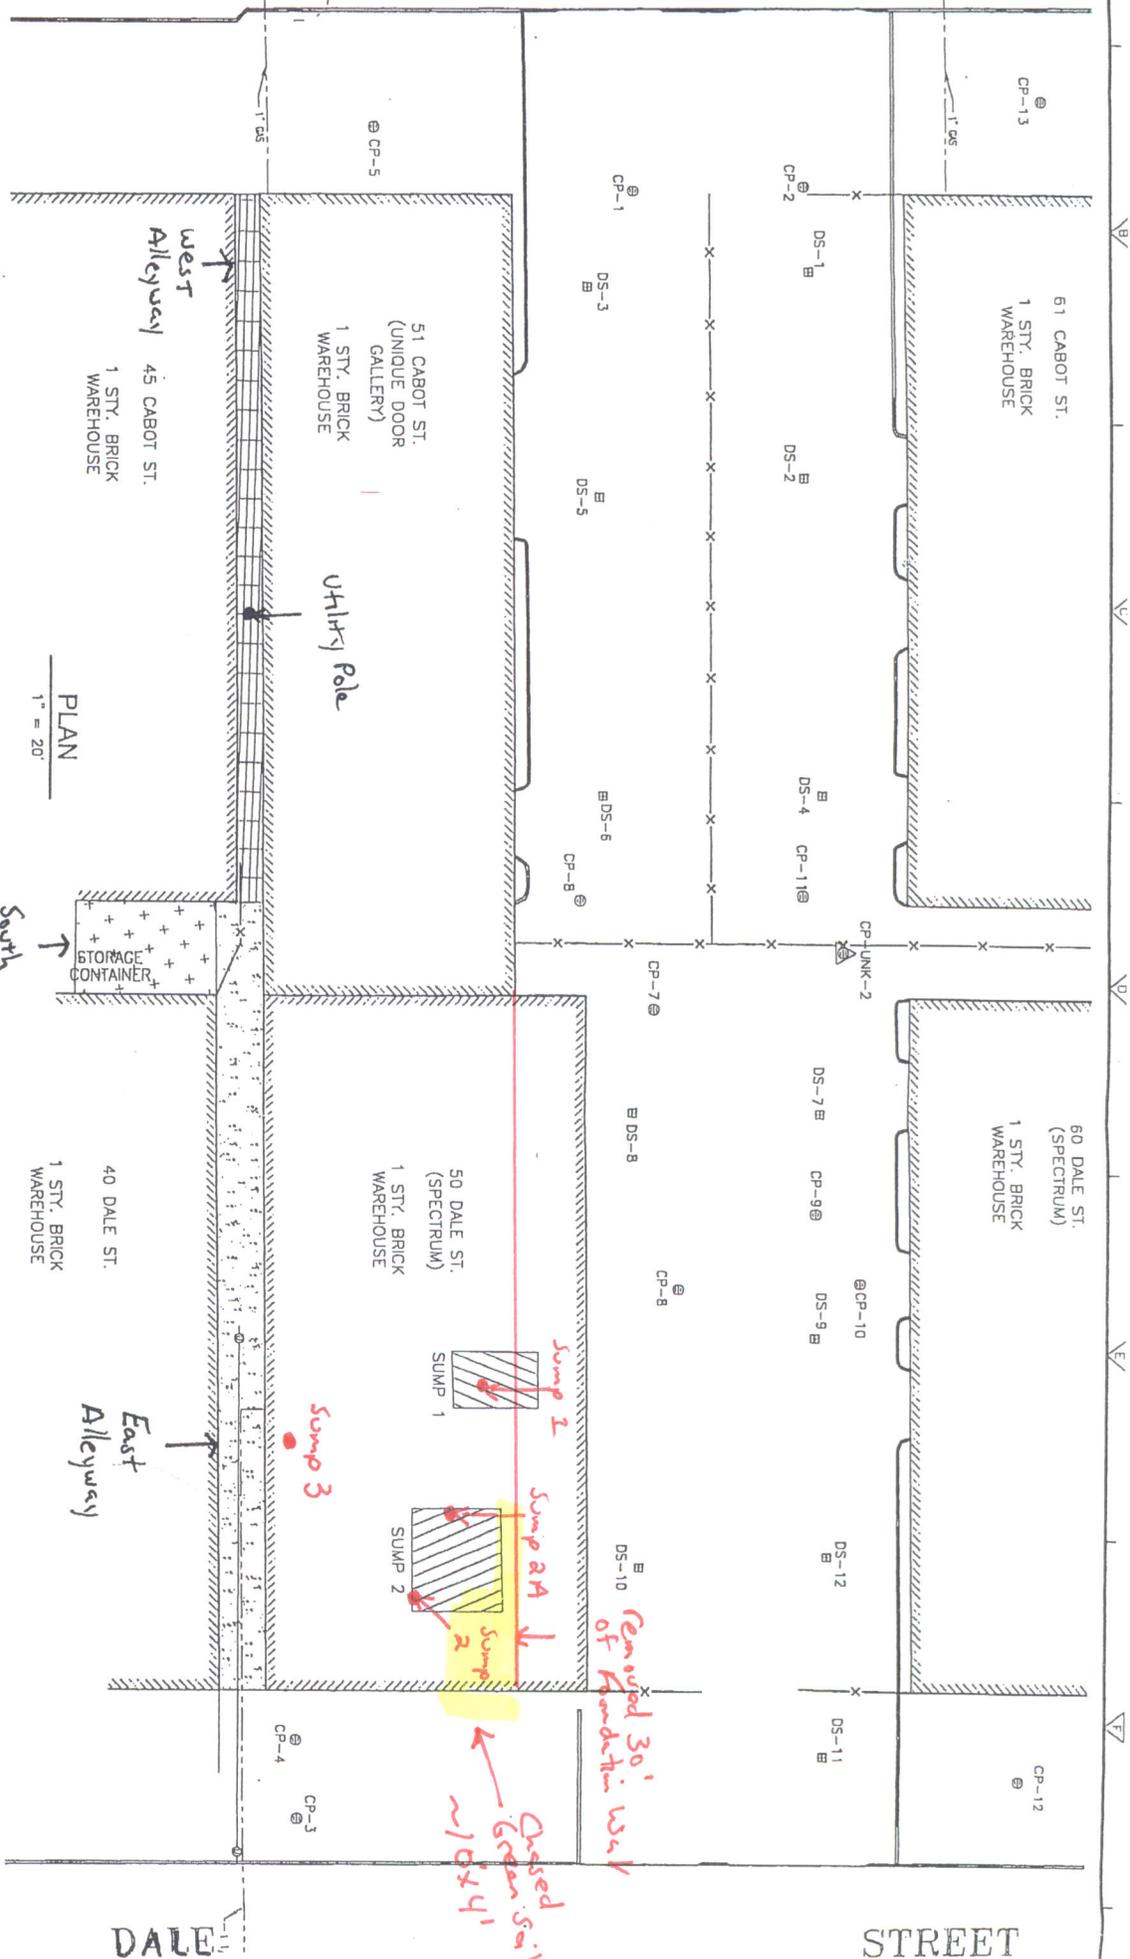
PLAN  
1" = 20'

Sump 1  
Sump 2  
Sump 3  
Sump 2A  
Sump 2  
Removed 30' of Foundation W/S  
Graded soil  
~16x4'
