Project: Spectrum Finishing - Remedial Action
 Contractor: EnviroTrac Environmental Services
 CDM Job No: D-006956 Site No. 1-52-029
 CDM Project Manager: John Blaum

DAILY REPORT

Date: 18-May-09
 REPORT No. 145
 PAGE No. 1

PHOTOGRAPHIC LOG
18-May-09
CDM Job No. D-006956
Spectrum Finishing Remedial Action
SITE No. 1-52-029

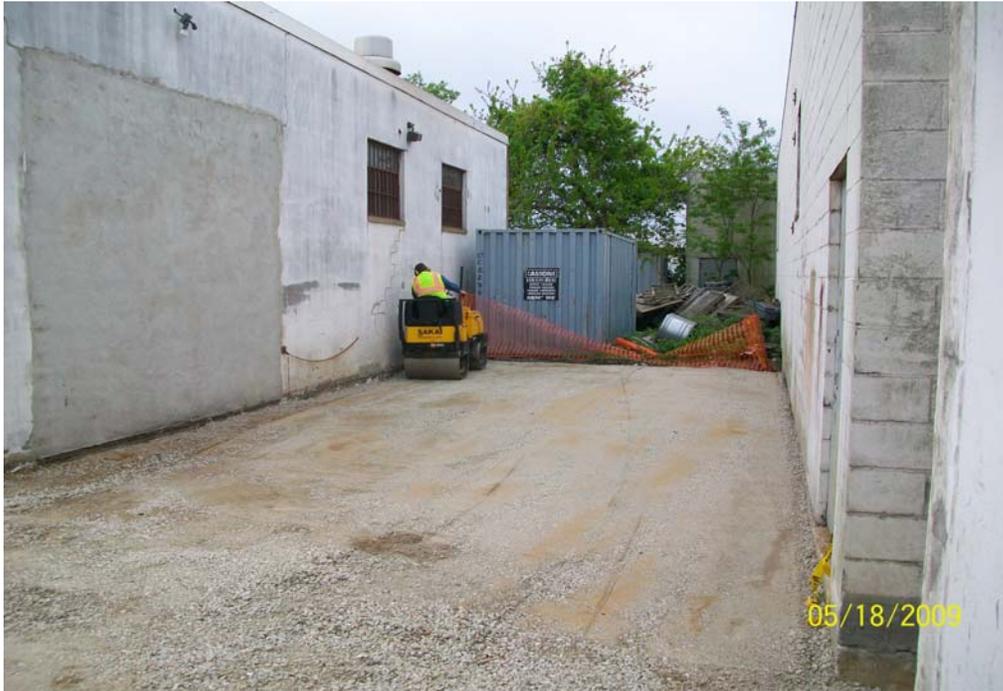
100_00616.jpg - EnviroTrac compacting RCA in south alleyway

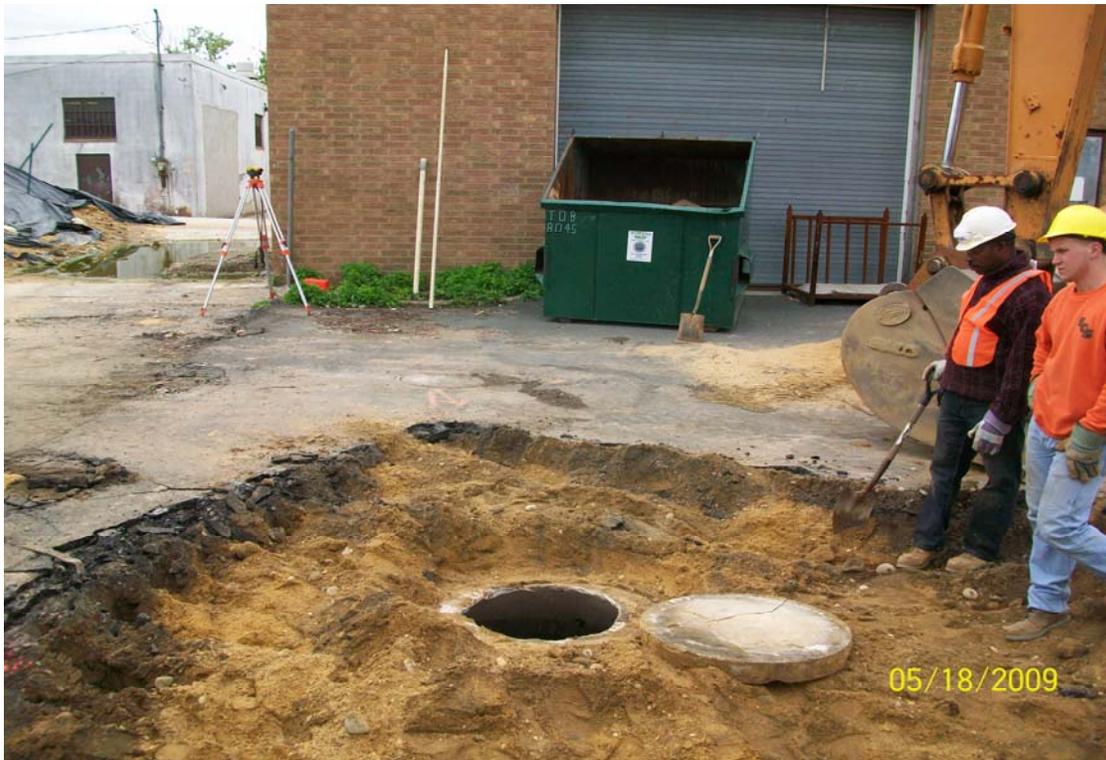
100_00617.jpg - Location of CP-6A (51 Cabot St.) previously unknown overflow to CP-6

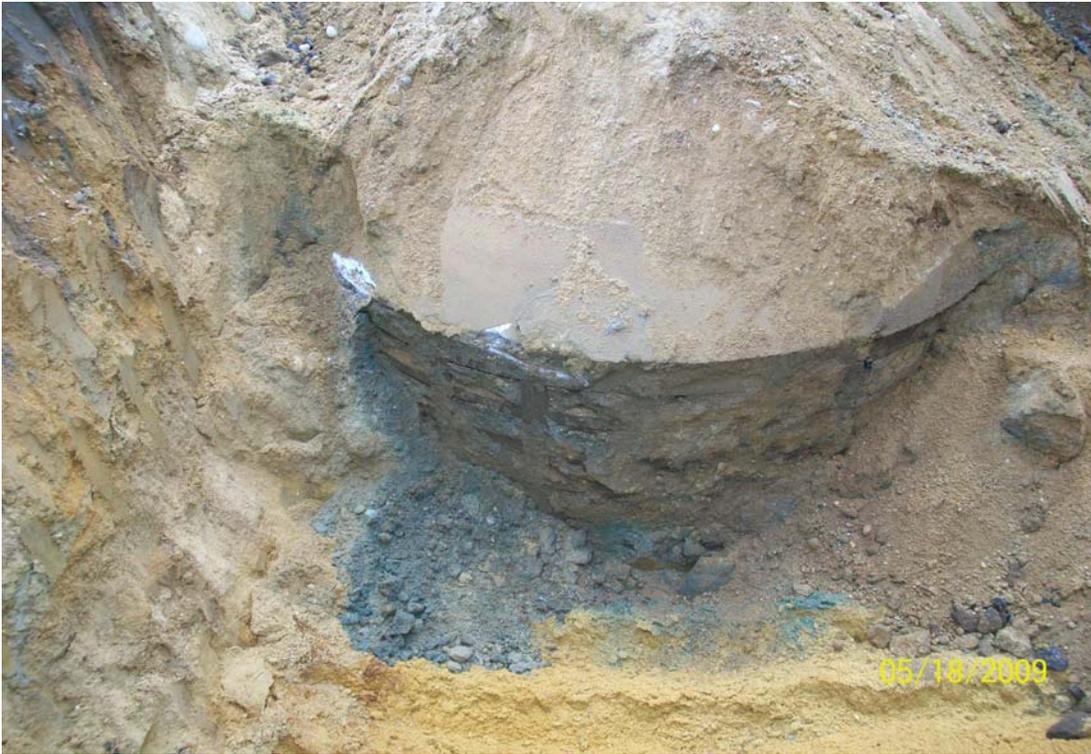
100_00620.jpg - Visibly contaminated green soil next to CP-6A

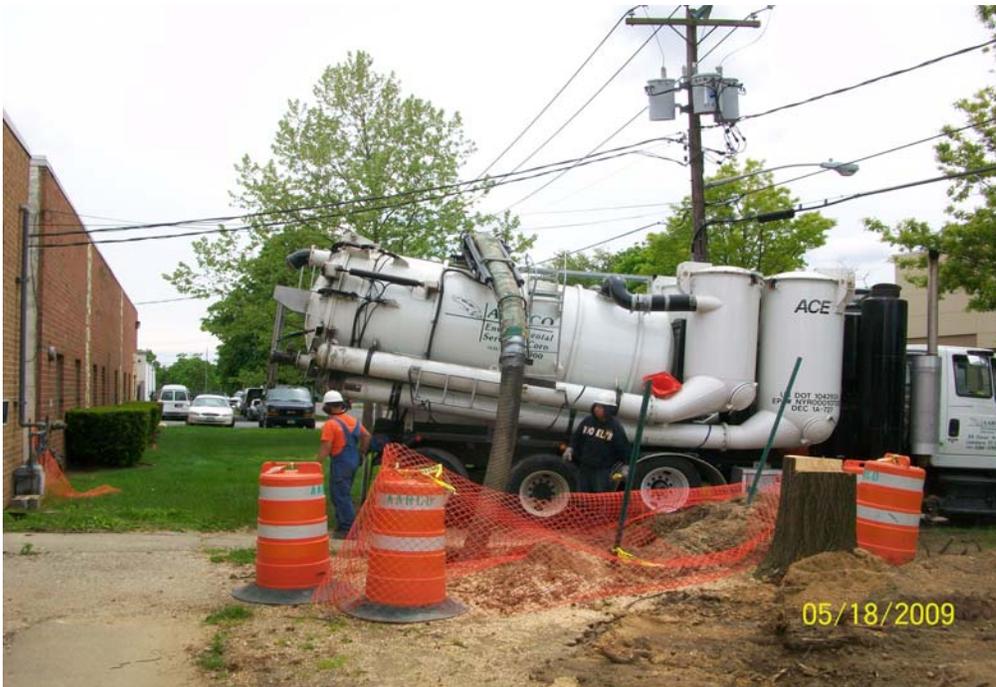
100_00624.jpg -AARCO cleaning out CP-5 (51 Cabot St.)

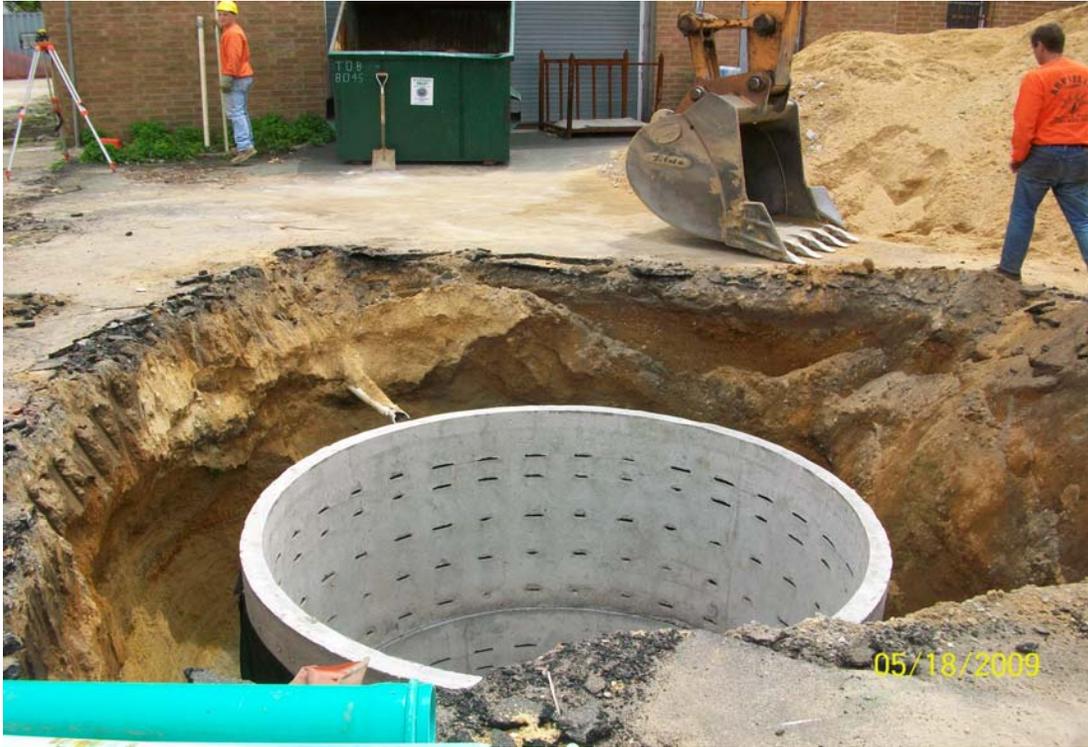
100_00626.jpg - PDS-6 installed in location of CP-6A by Cork and Sons

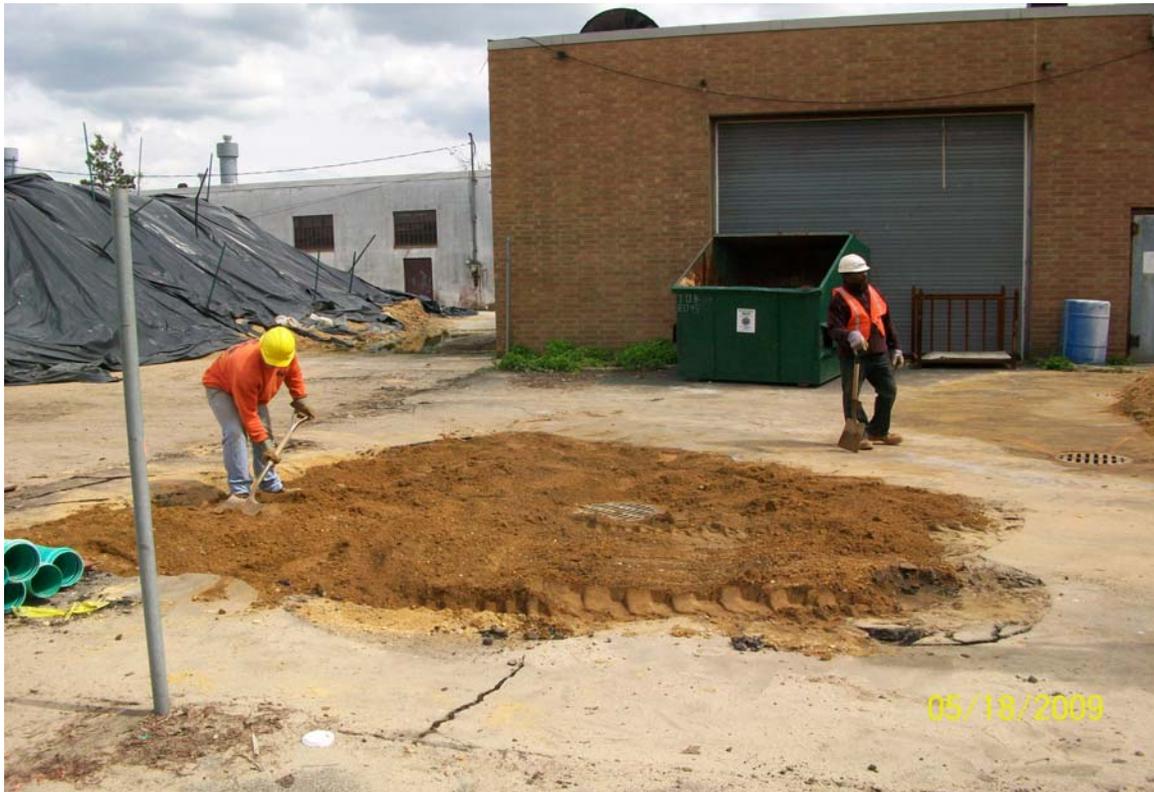
100_00628.jpg - PDS-6 backfilled to grade

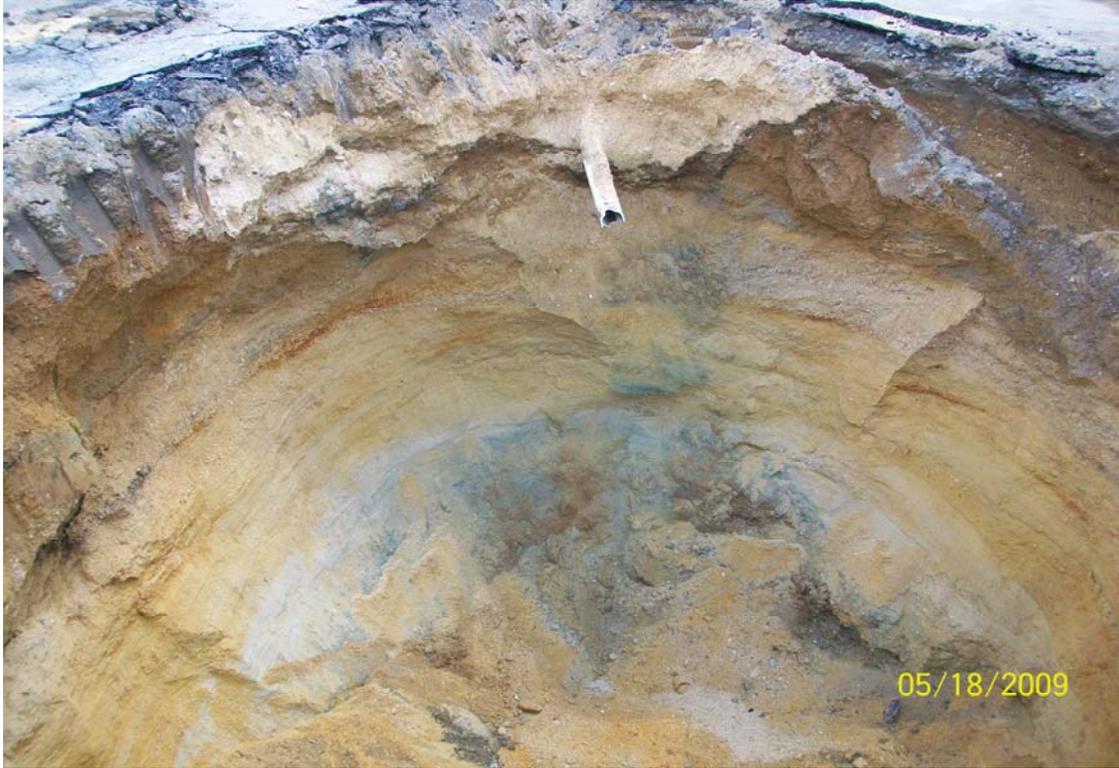
100_00623.jpg - Visibly contaminated green soil left on south wall of CP-6A,6-12' BGS
