Re: Stop & Shop Supermarket Center
Union Blvd.
West Islip, N.Y.
SMES # 09-282

Forwarded herewith are the results of septic system and storm water run-off drywell leaching structure assessment and remediation activities recently completed at the above referenced facility. The scope of work, completed in general conformance with our letter of 6/7/09 under your supervision and direction, included the following:

**Stop & Shop
Union Avenue
West Islip, N.Y.
SMES Project # 09-282**

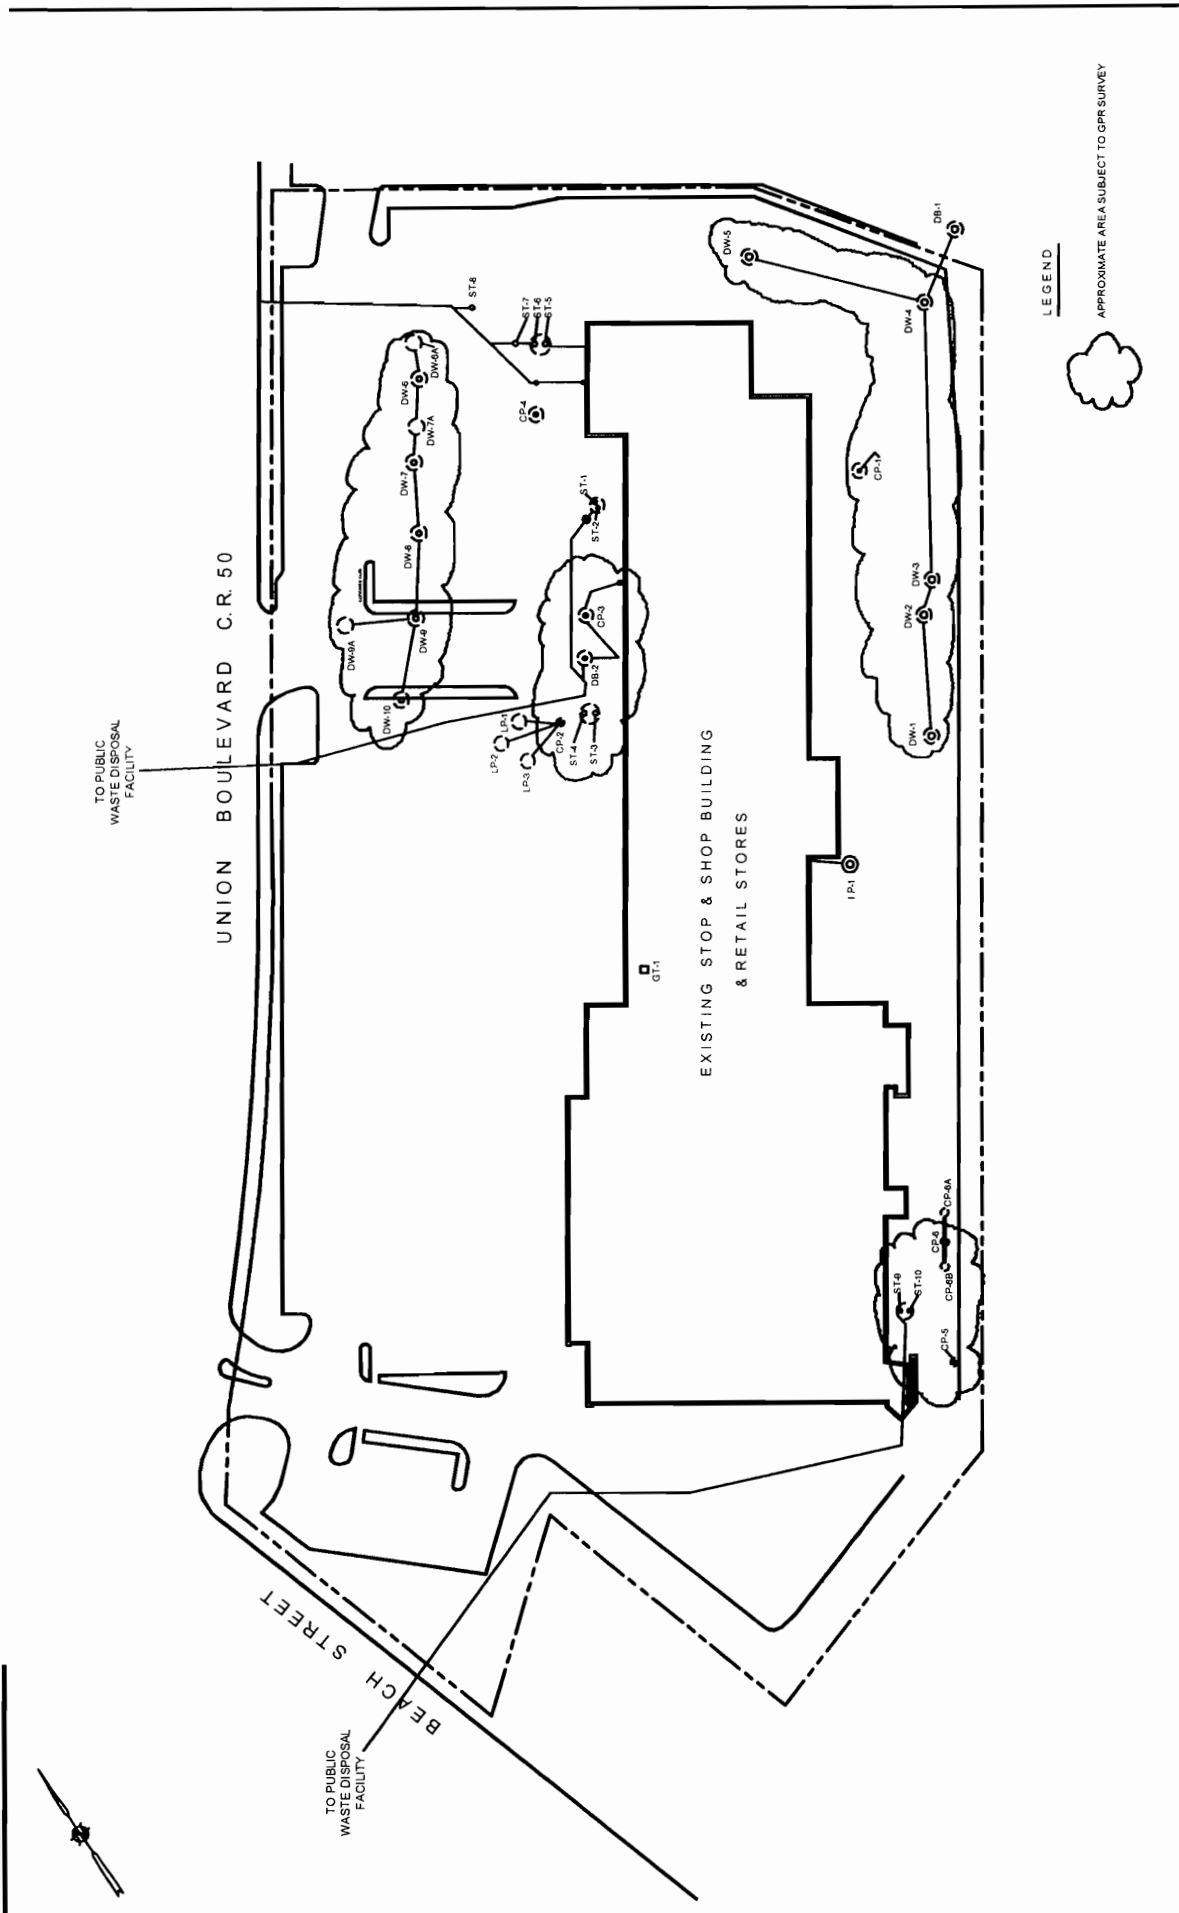
SOIL MECHANICS ENVIRONMENTAL SERVICES			
3770 MERRICK ROAD - SEAFORD, L. I, NEW YORK - (516) 221-7500			
FIGURE NO. 1			
STOP & SHOP			
WEST ISLIP, NEW YORK			
SCALE	SCHEMATIC	DATE	JULY 28, 2009
		REVISED	N/A
		JOB NO	08S282

Geophysical survey of suspect areas on the subject property, utilizing ground Penetrating radar (GPR), was conducted to confirm the presence of all active/inactive sub-grade septic system and storm water run-off drywell structures (see Figure #1). The survey was completed utilizing a Geophysical Survey Systems, Inc. (GSSI) SIR System - 2 (Subsurface Interface Radar) equipped with a 400-Mhz antenna unit.

Subsequent to completion of geophysical survey a series of exploratory test pit excavations were completed at identified GPR anomalies to confirm the presence and or absence of suspect structures. Based on the results of the aforementioned and visual inspection of structures during implementation of remedial efforts, the following sub-grade structures, which were previously inaccessible, were identified (see Table A for a complete sample summary):

- LP-1, LP-2, LP-3;
- CP-6A, CP-6B; and
- DW-6A, DW-7A, and DW-9A.
