**FINAL REPORT**  
**CONSTRUCTION QUALITY ASSURANCE**  
**HUNTINGTON/EAST NORTHPORT LANDFILL**  
**FINAL CLOSURE SYSTEM**  
**SUFFOLK COUNTY, NEW YORK**

**APPENDIX Y**

**PANEL AND SEAM REPAIR**

**FIELD SKETCHES**

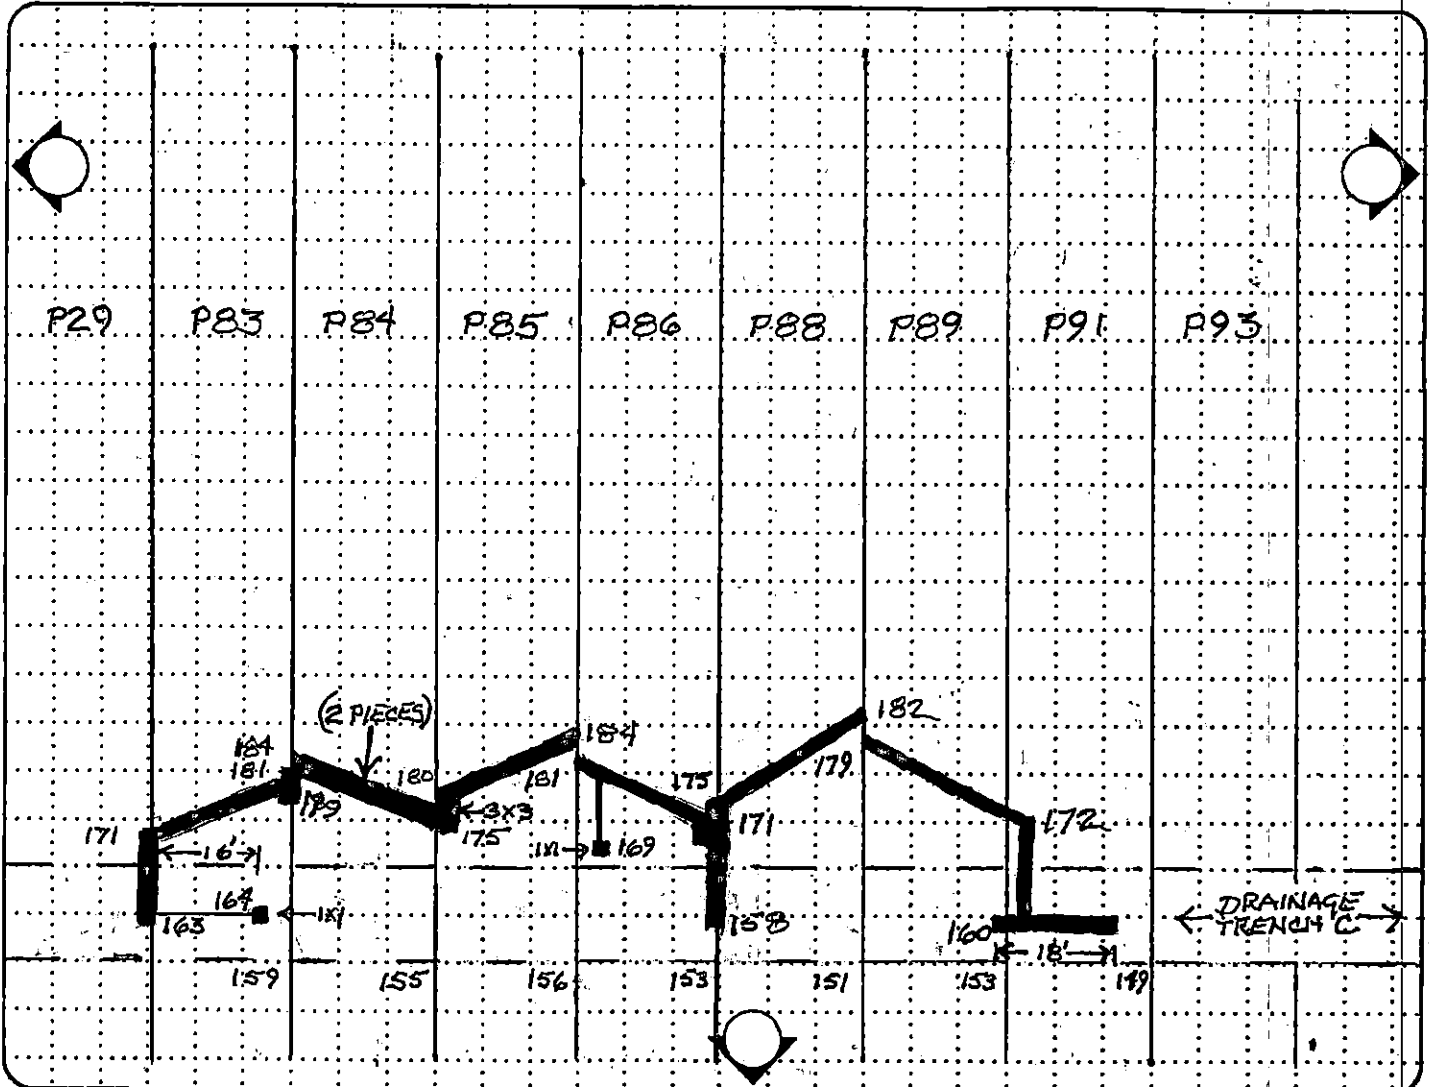
SEAM NO.:	<b>REPAIR DUE TO BRIDGING IN CHANNELS</b>
PANEL NO.:	
AVG PANEL LENGTH:	
AVG PANEL WIDTH:	
AREA: (ft <sup>2</sup> )

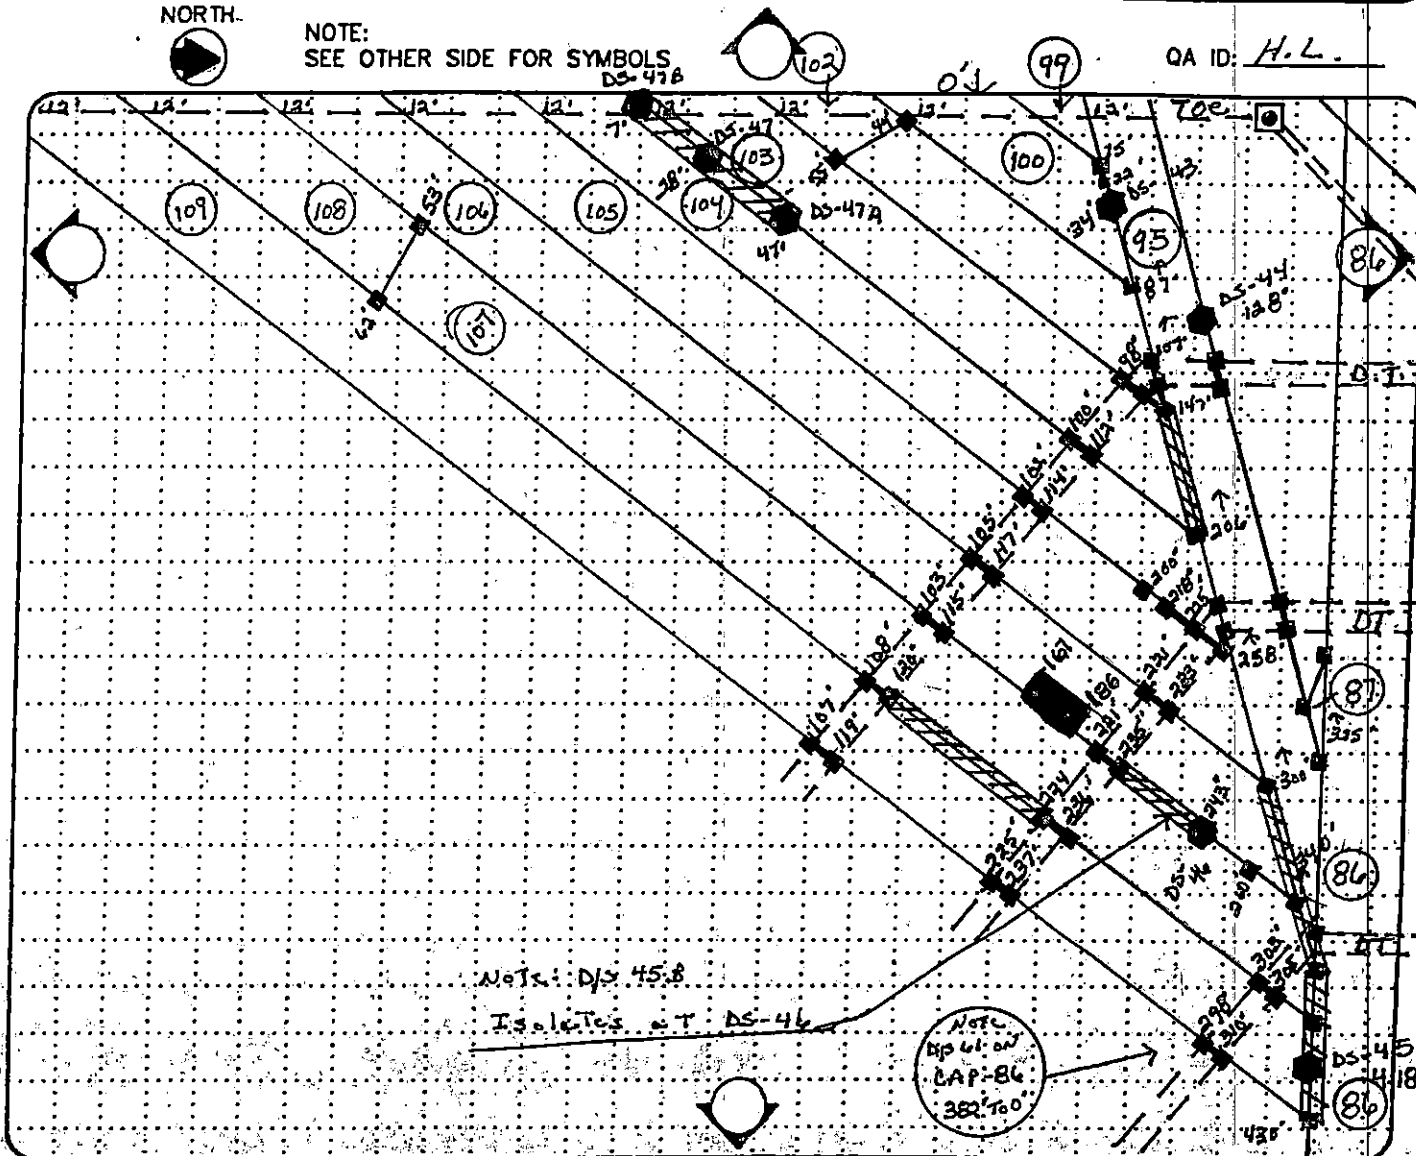
REPAIRS ON PANEL P106 @ SECT. 18  
AFTER SOILS REMEDIATION
